KURG at Boxley Abbey: 13-15 July 2020

Introduction

Kent Underground Research Group (“KURG”) was invited by the Society for the Protection of Ancient Buildings (“SPAB”) to participate at their working party at Boxley Abbey on 13-15 July 2020.

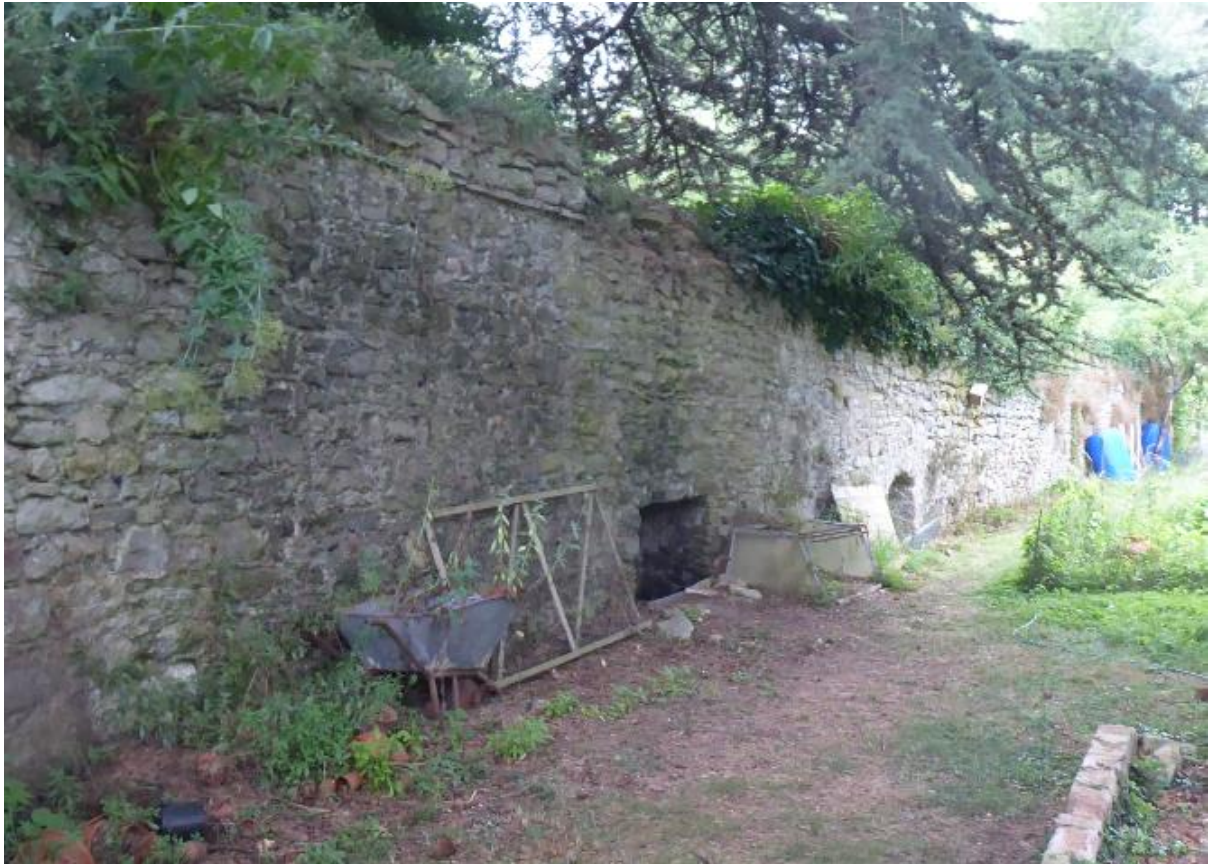
Exterior of reredorter looking east. The rectangular west entrance (R6) is in the centre of the picture and the arched central entrance (R5) is clearly visible to its right. The filled in arch of the east entrance is not clearly visible in this picture. The extreme eastern limit of rodding (R1) is between the two blue plastic barrels at the extreme right of the picture.

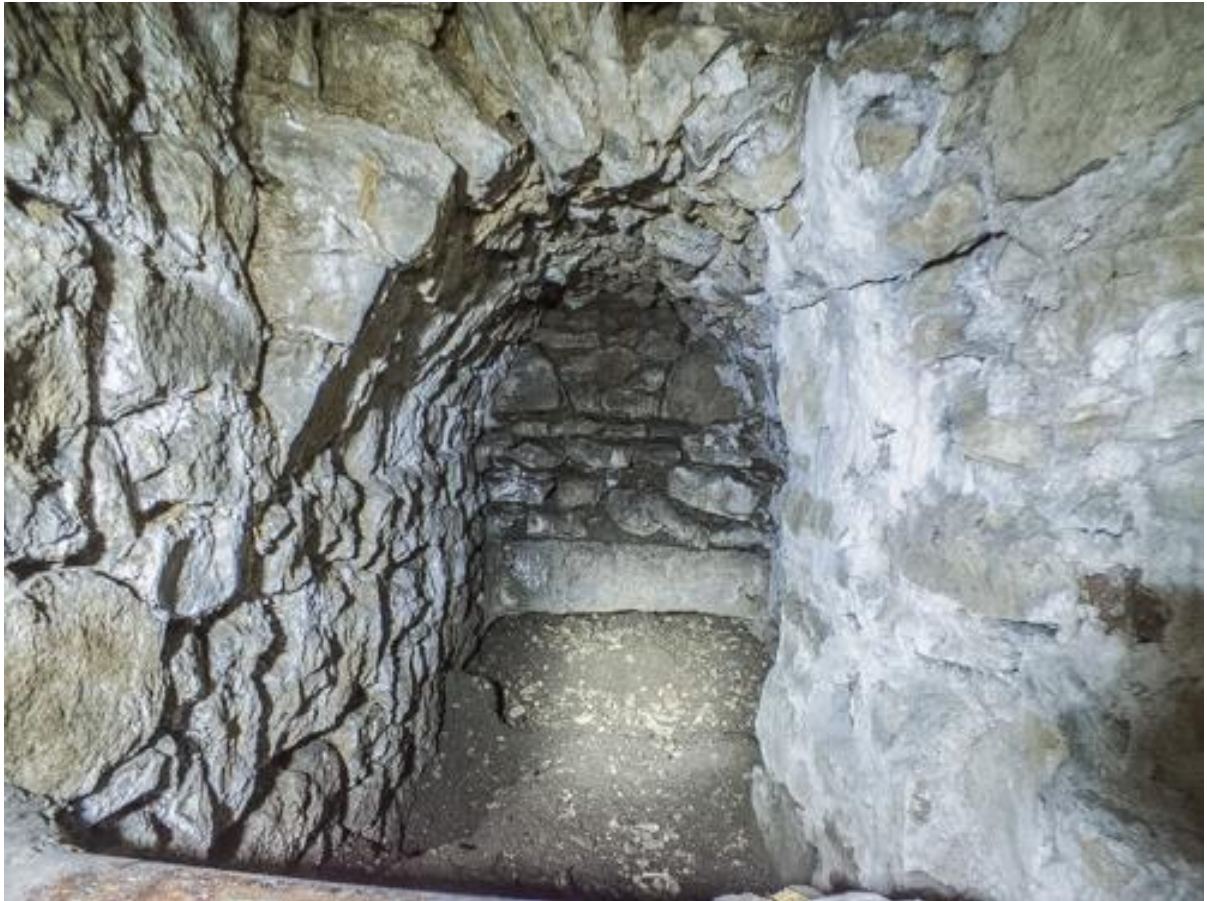
The large horizontal stone at the centre of the picture is position R2. A small part of the top of the horizontal pipe (R3) is visible in the bottom left corner.

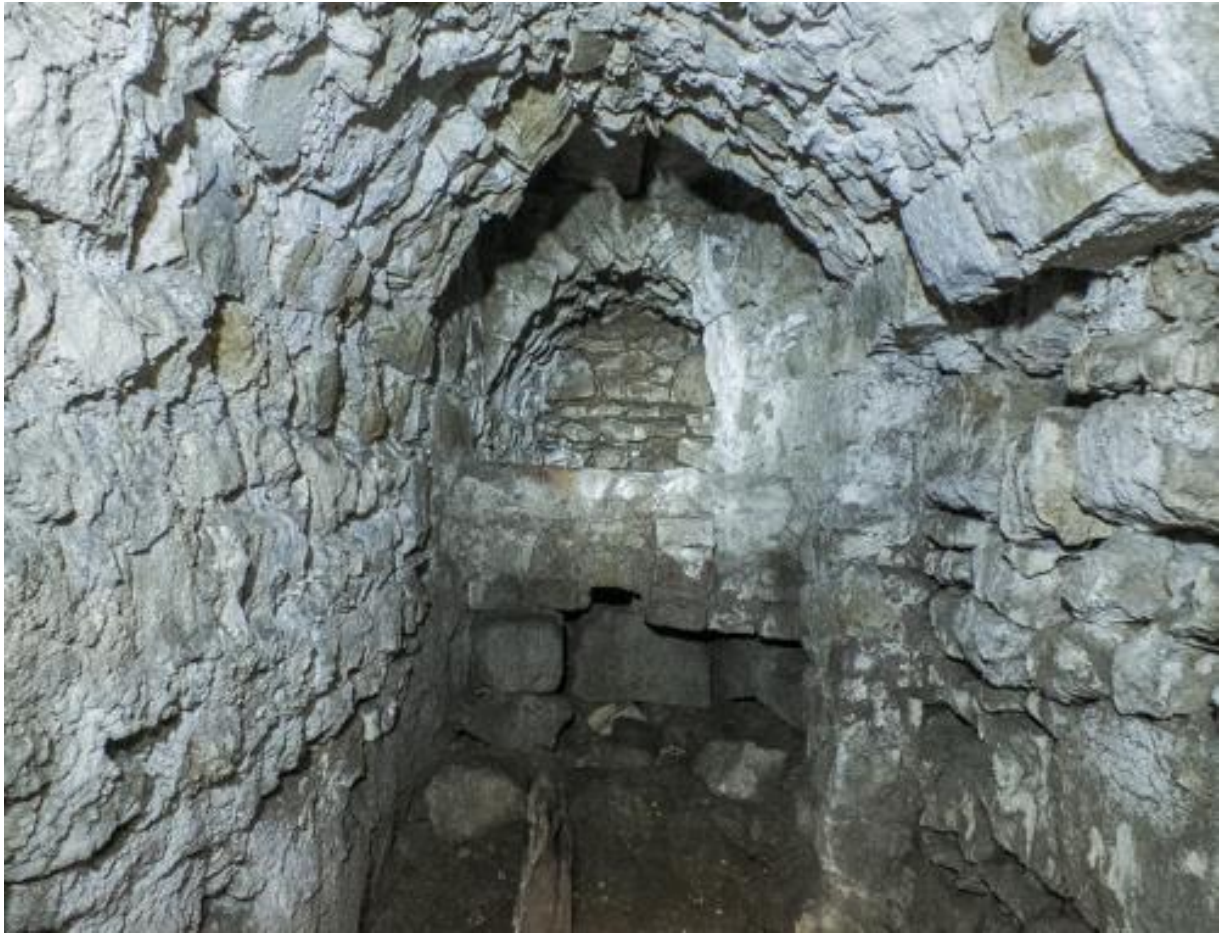
The pipe across the reredorter (R3) on top of a half-height wall is visible in the centre of the picture. The pipe is a Victorian (?) clay pipe. The lower edge of the arching on the right (south) projects over the wall – giving almost an “eave” effect at the lower level of the arching. The position R3 on the inside roughly matches the position of the filled in east entrance (R4) most visible from the exterior. At all entrances, there is a hole in the roof up to the pavement along the wall line in the garden above. This hole is bridged by corroding steel beams and stone slabs.

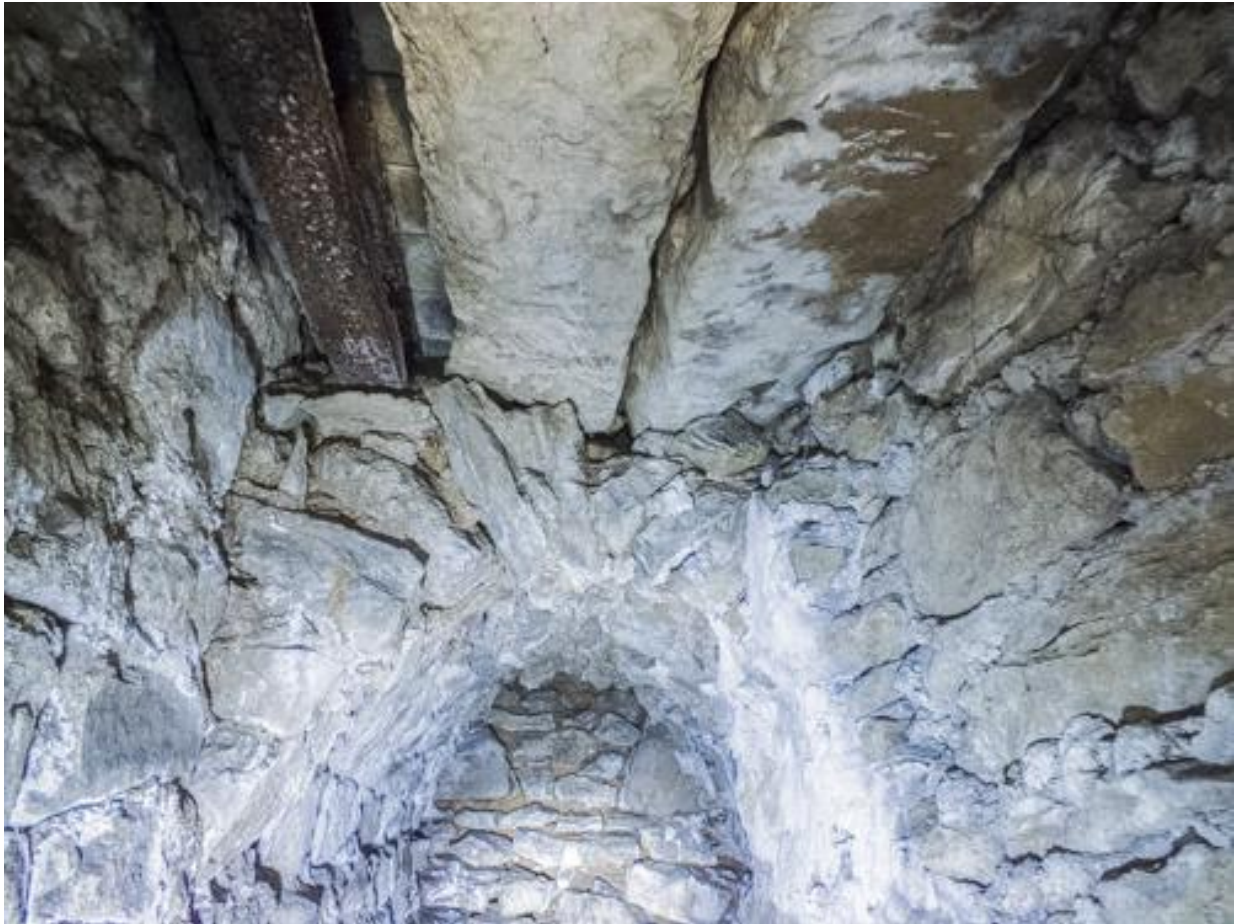
A view of the hole in the roof by the filled in east entrance.

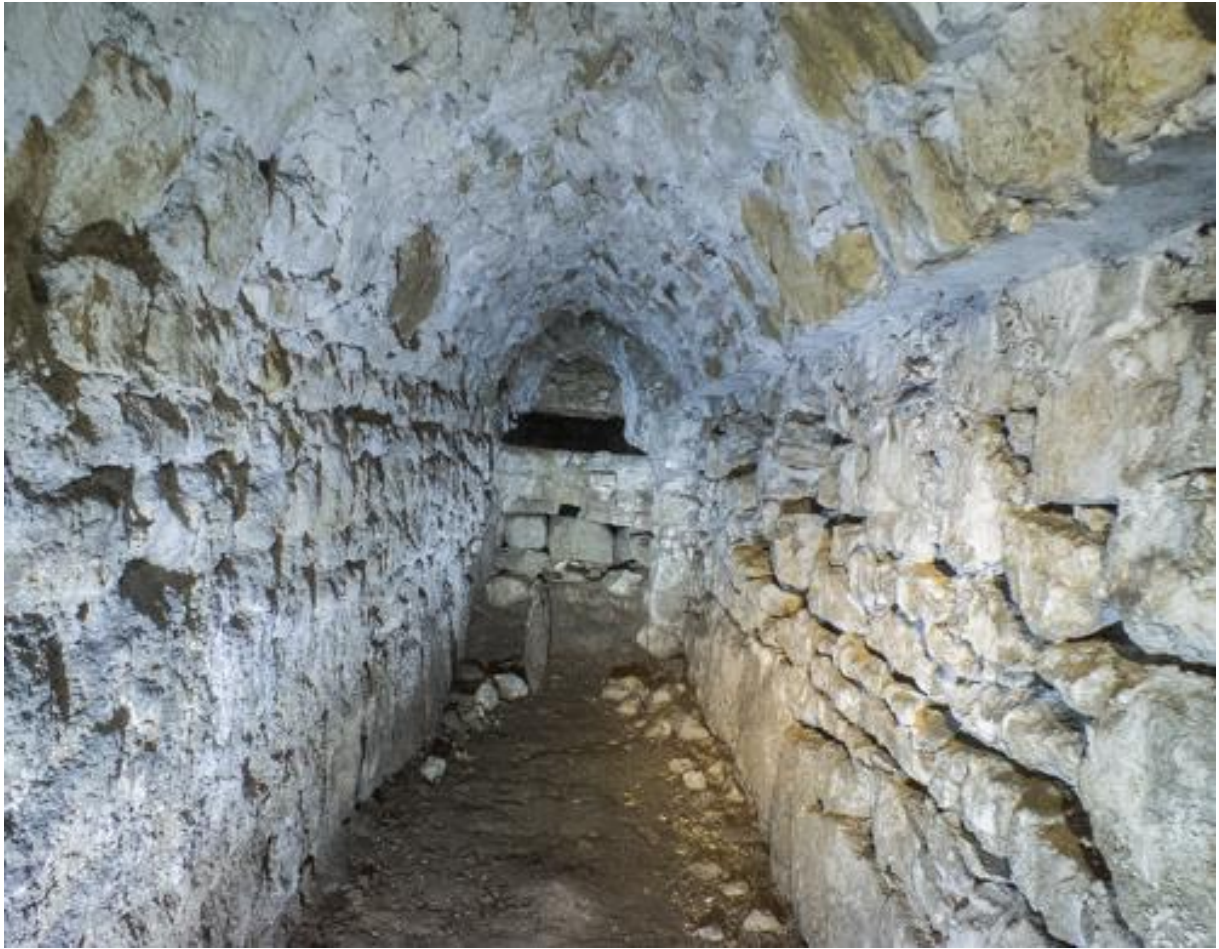
A more distant view of R3. The projecting lower edge of the arching on the right (south) can be seen running the full length of the wall.

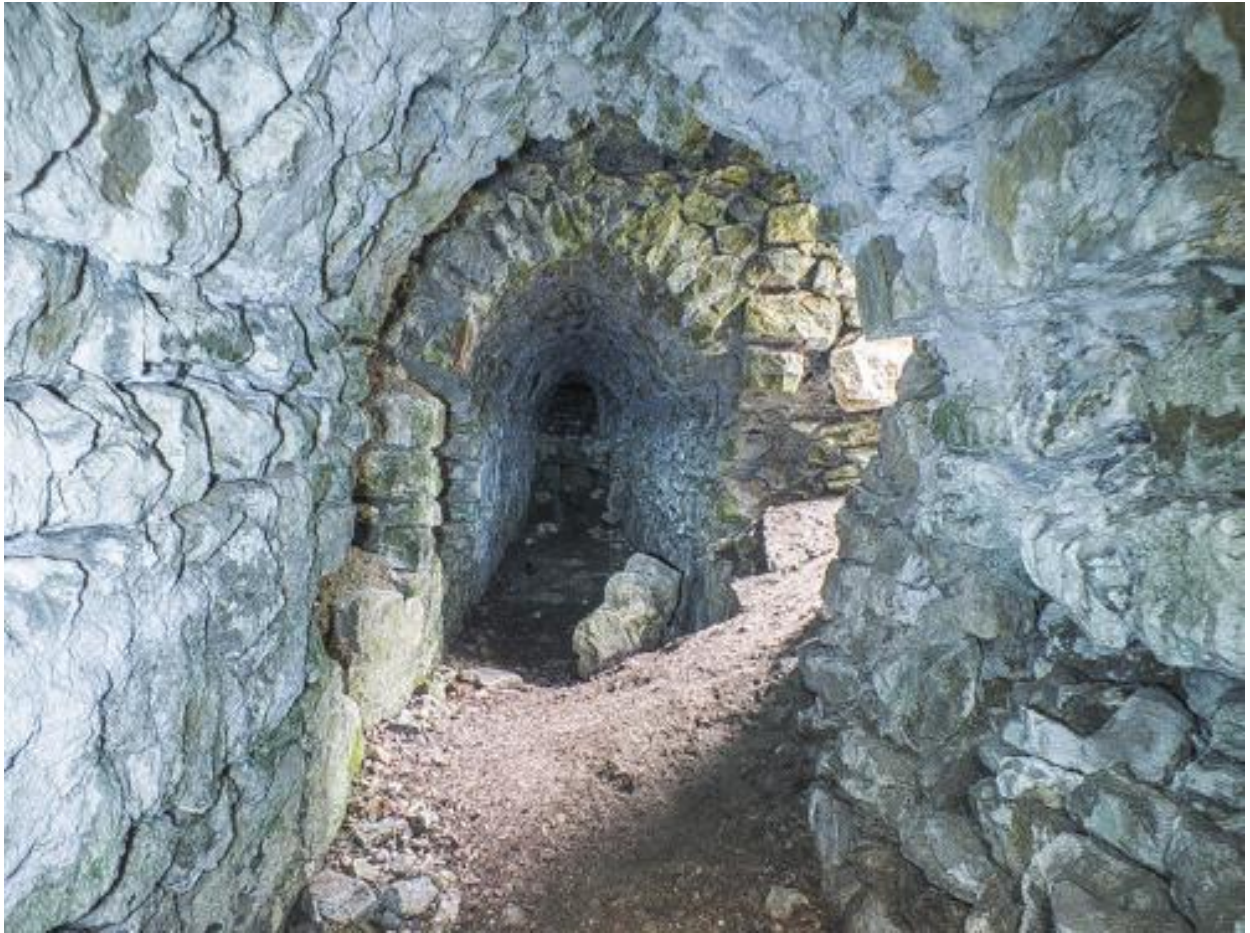
The central entrance (R5) is on the right. Again, the projecting lower arching on the right continues. It is also noticeable that the stonework on the right (south) wall is of poorer quality than the left (north) side. The gap in the arching by the entrance is also apparent.

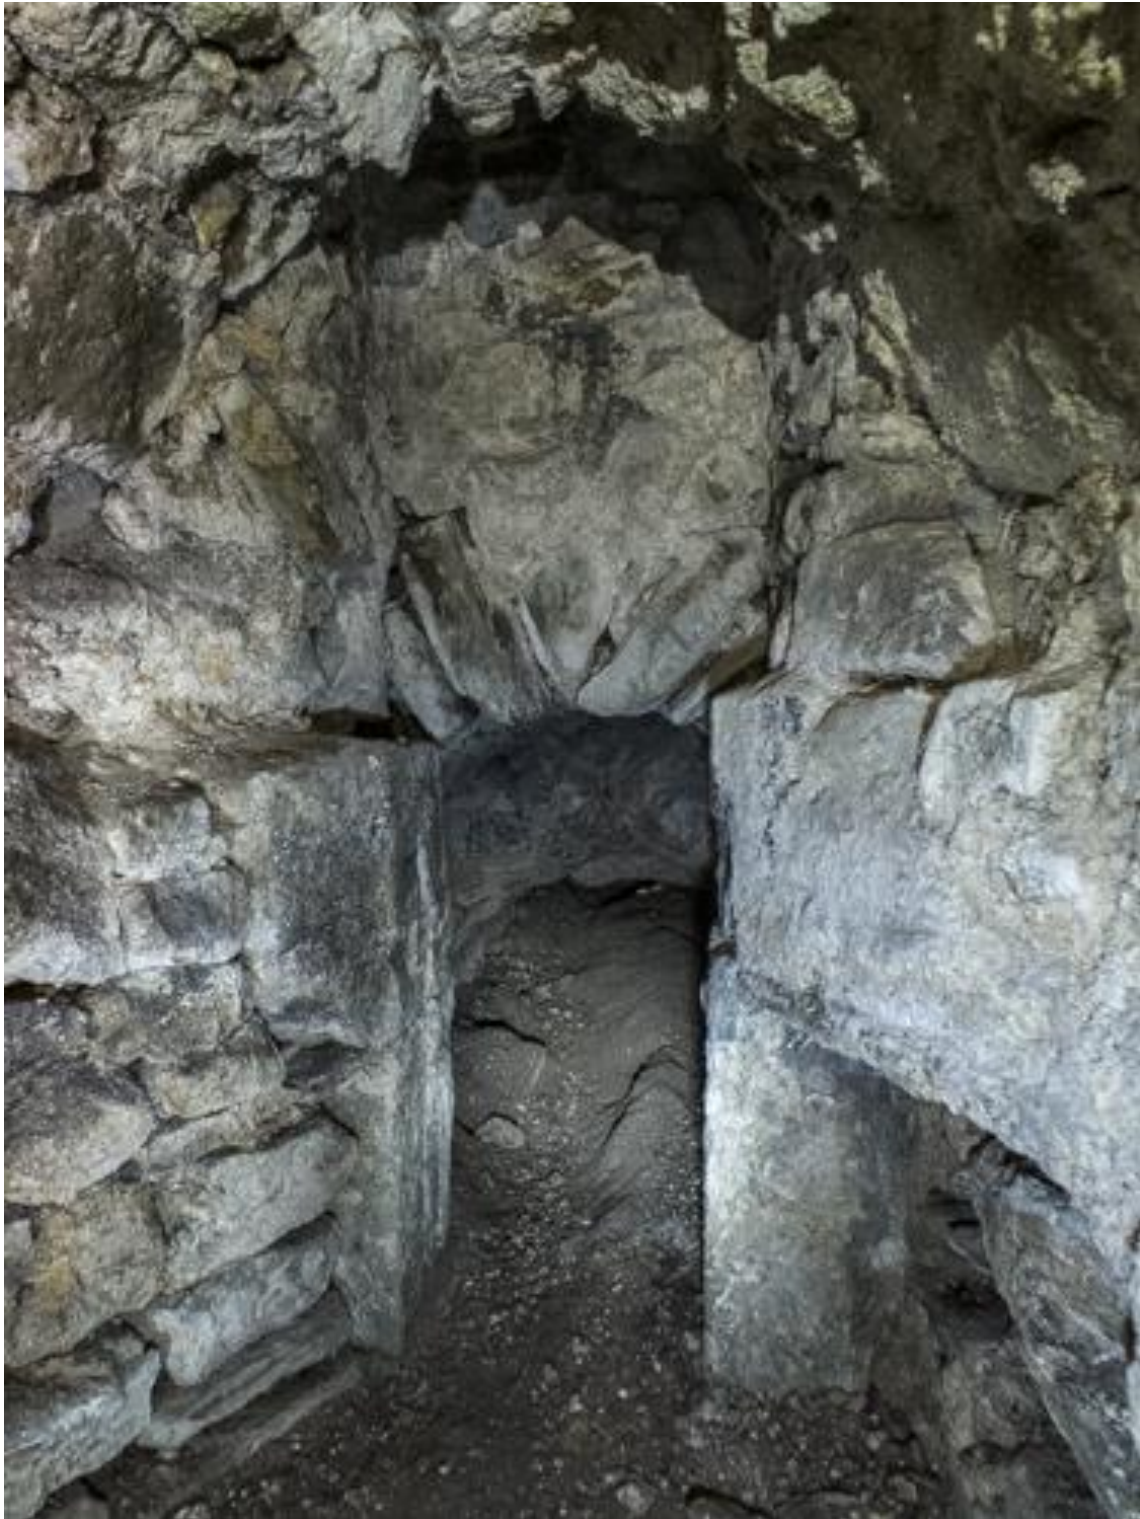
The constriction between the two grooved pillars of the sluice (R7). Behind is the lower arch at the end of the sluice chamber, followed by a lower arch (R8). The right (north) wall here shows considerable calcification of the stones above the level of the lower of the two stones forming the (north) grooved pillar, but little calcification below that level. This is indicative of there being historically a normal level of standing water at that point – probably caused by water leaking around the sluice gate above the joint in the northern grooved pillar. This also tends to confirm that water flowed from east to west. The stone forming the lower arch (R8) also has calcification markings similar to those seen in limestone caves around fossil streamways.

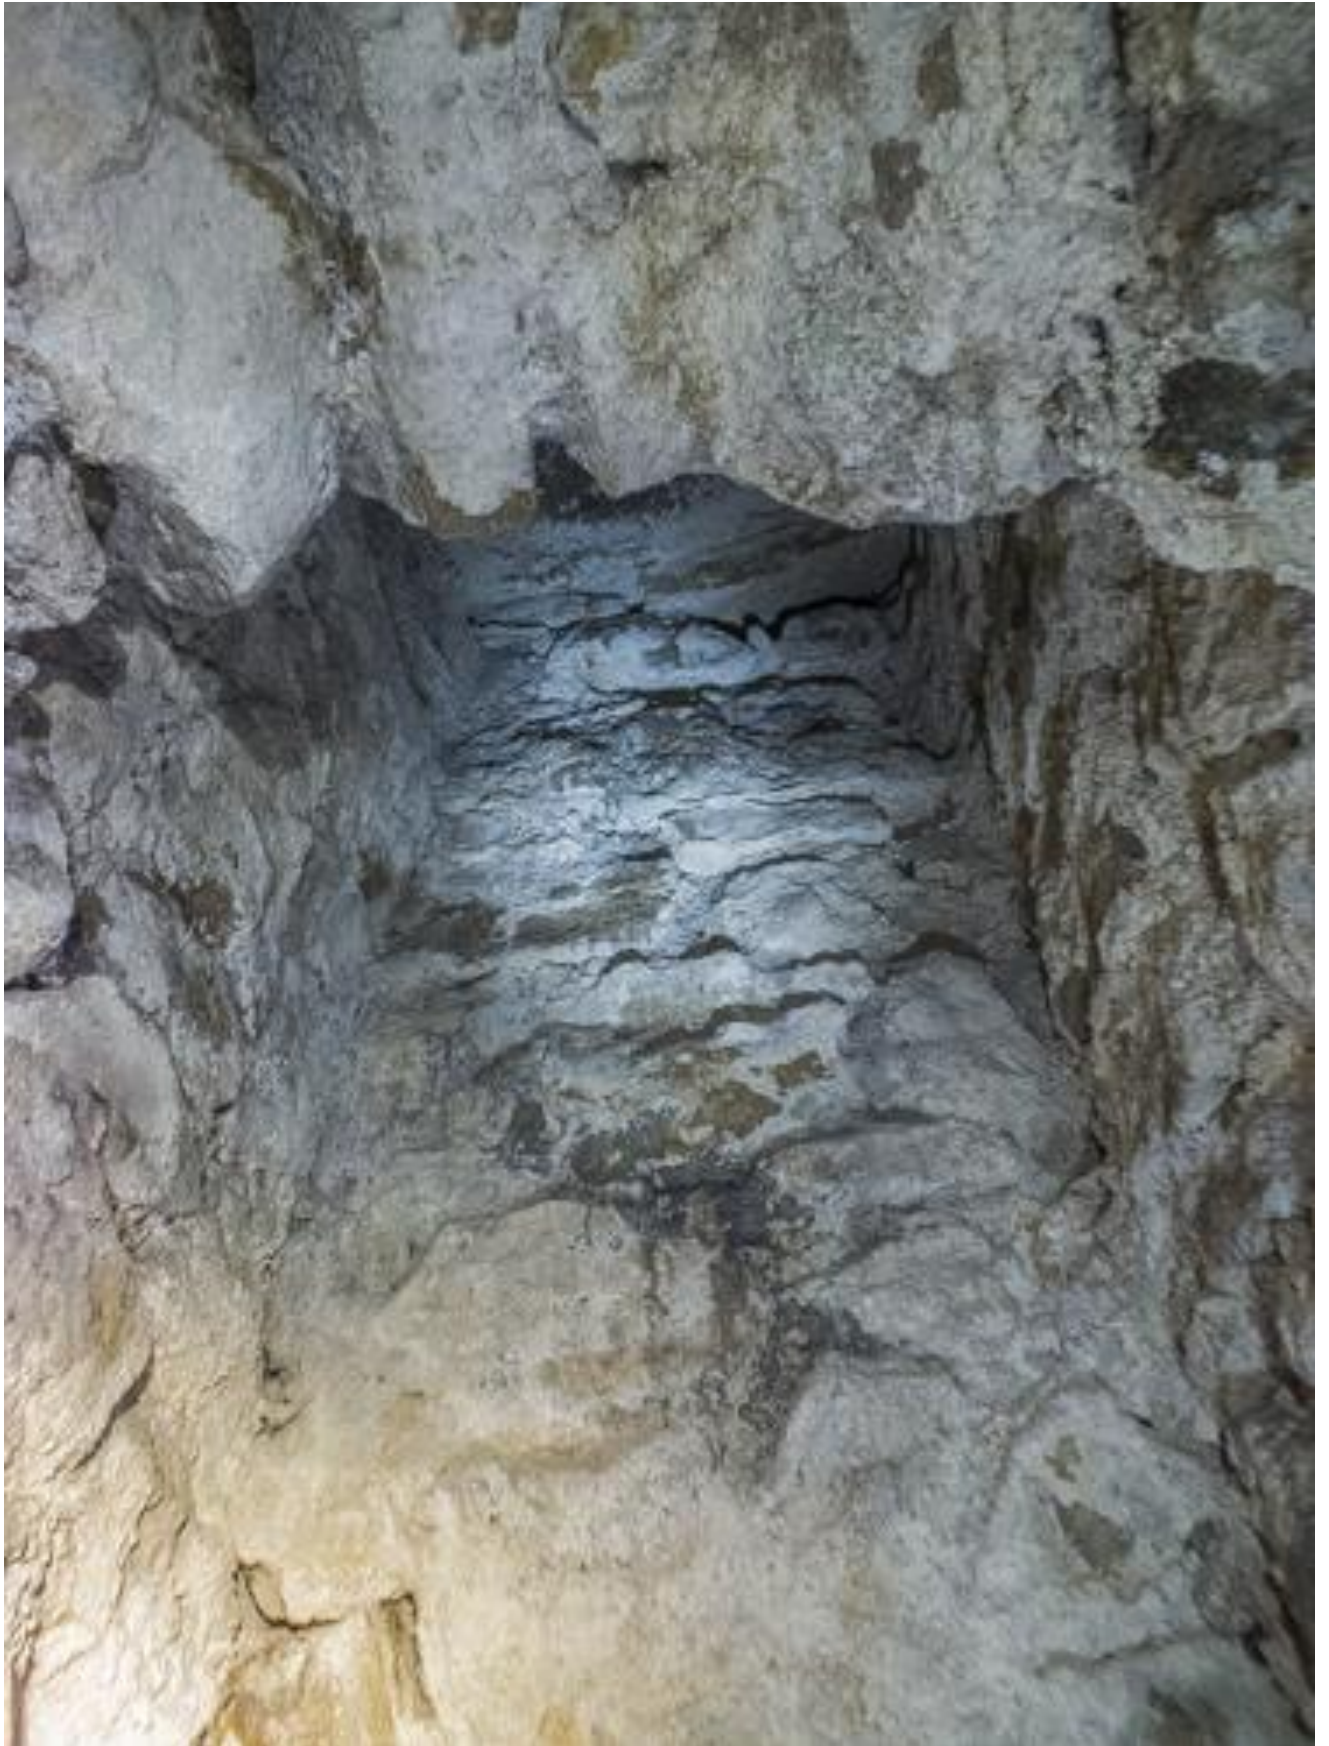
View of the broadly square cross-section shaft above the sluice through which the mechanism to lift the sluice gate would have operated.

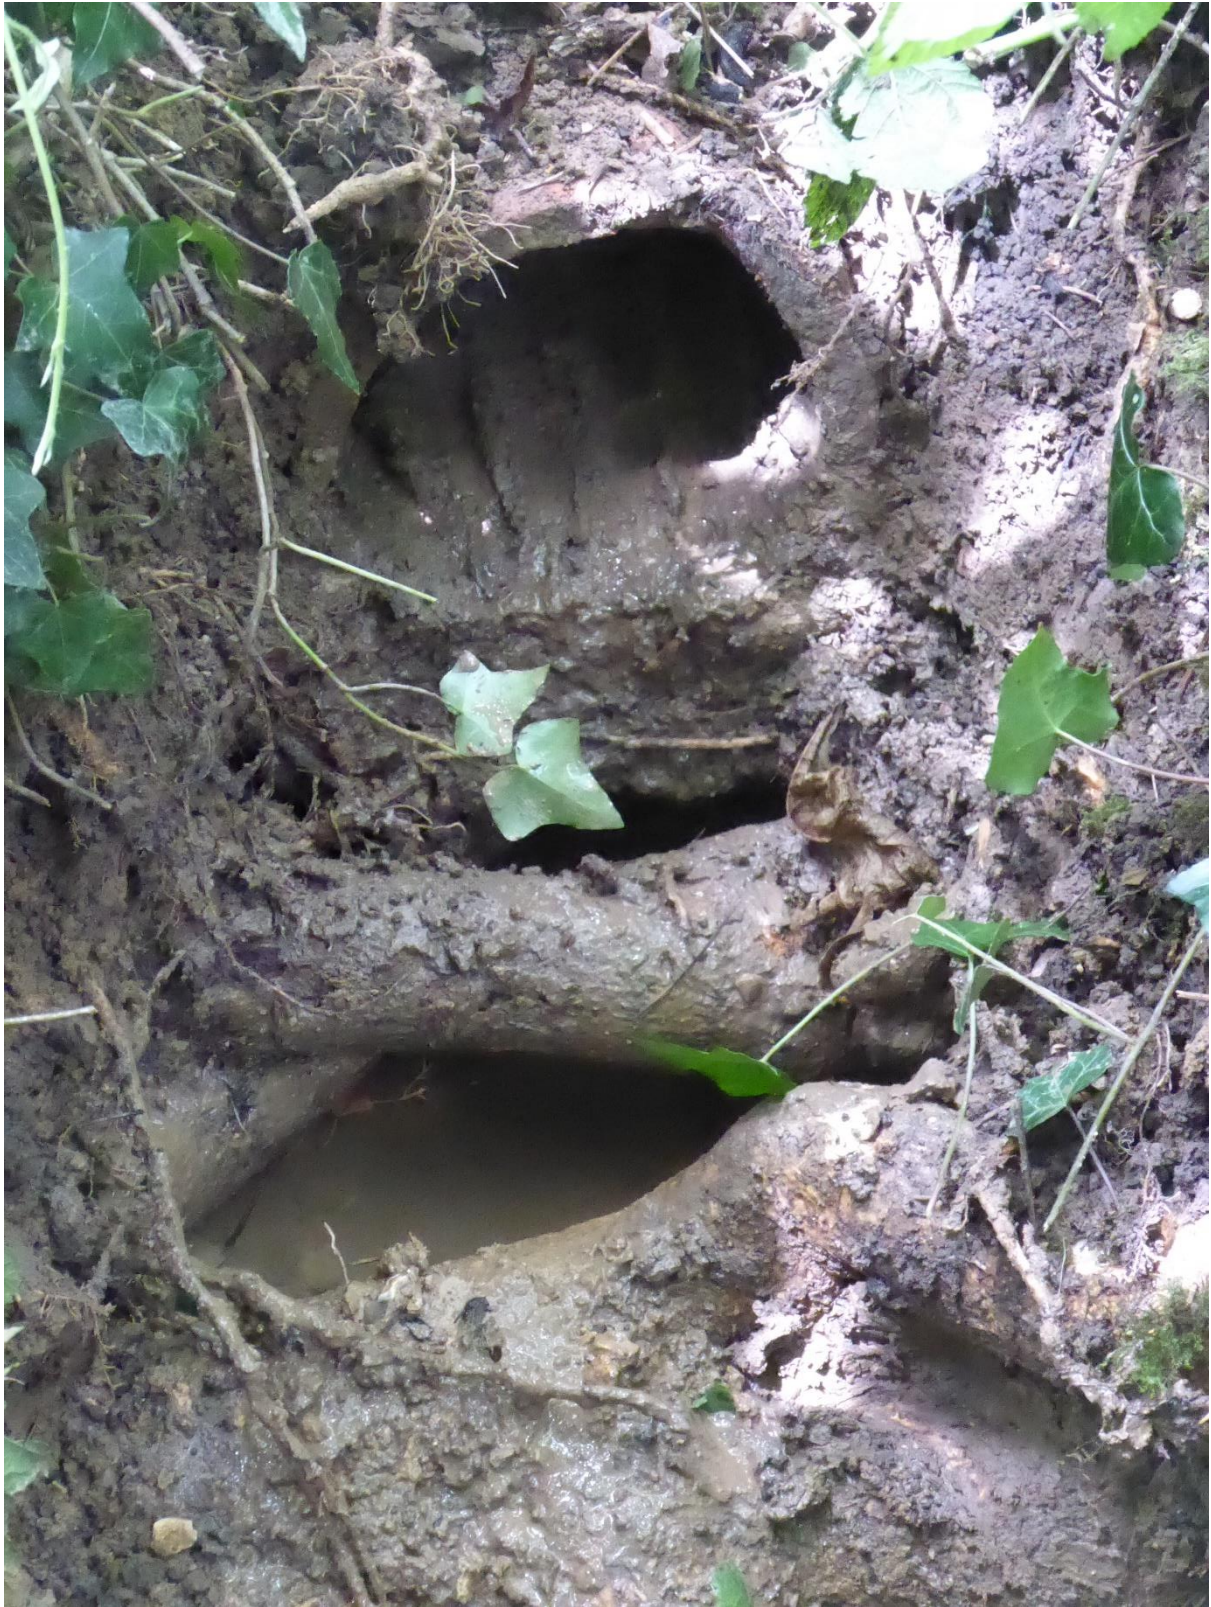
Close-up of SEP 1: Ceramic field drain at top, with water dripping through tree roots below.

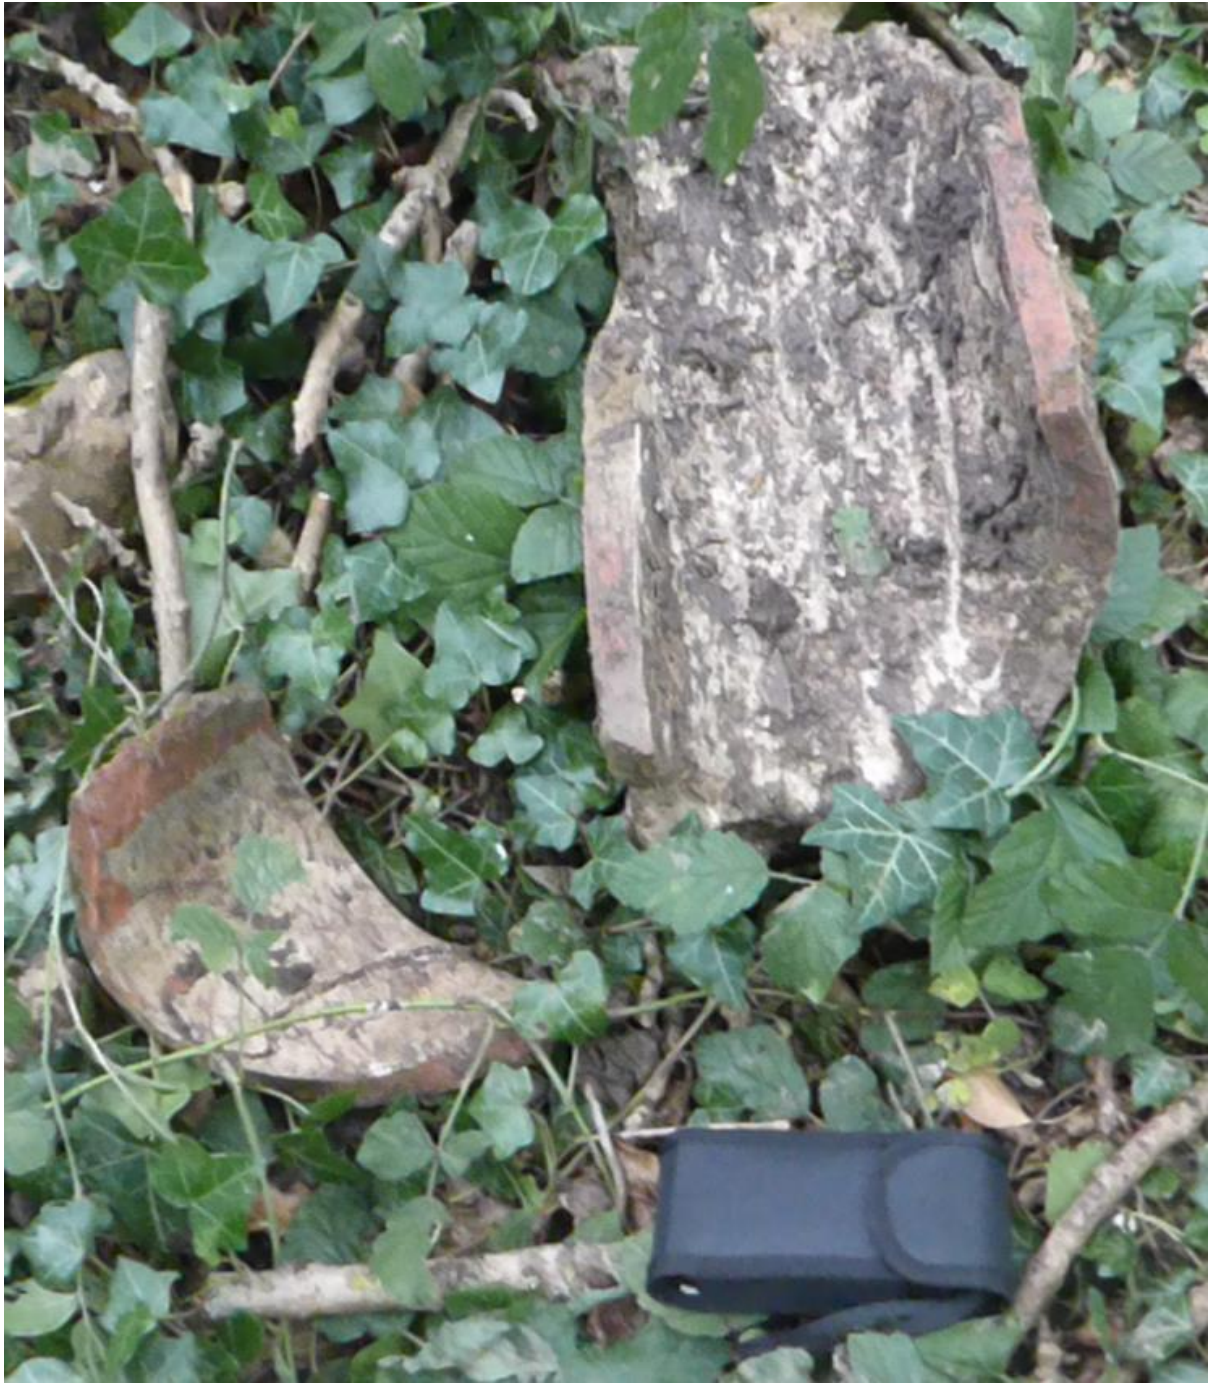
Broken pieces of ceramic field drain associated with SEP 1, with GPS case for scale (13 cm long).

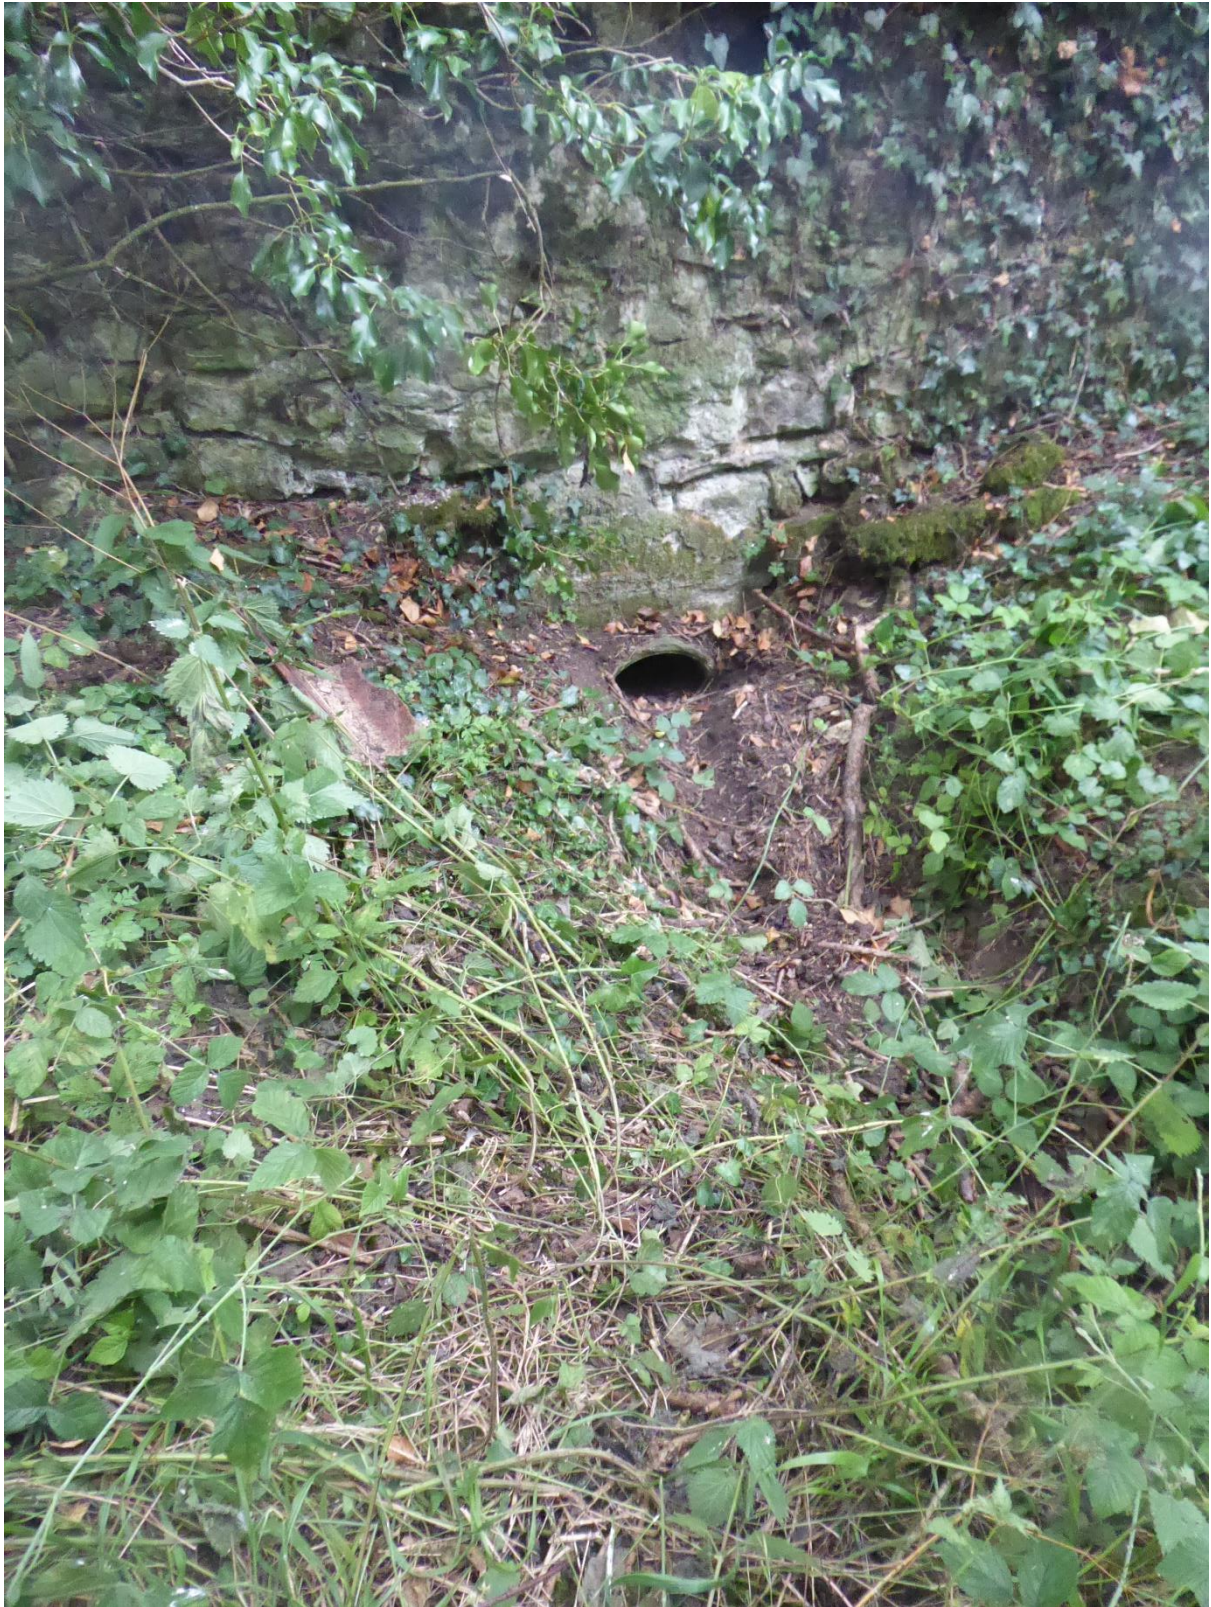
Drainage channel at SEP 5 that appears to let water in from the fields outside the wall of the abbey complex.

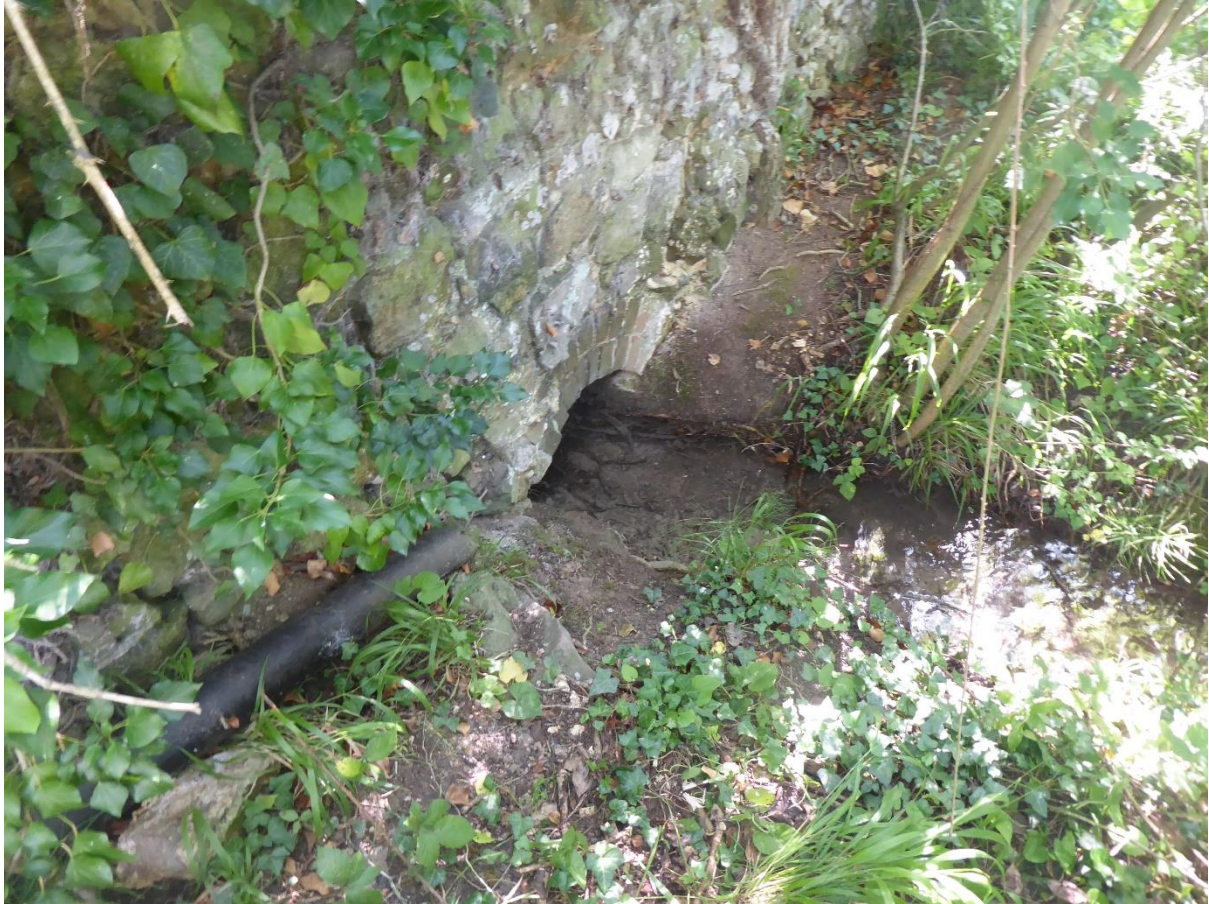
The inlet running under the abbey walls at NP 1.

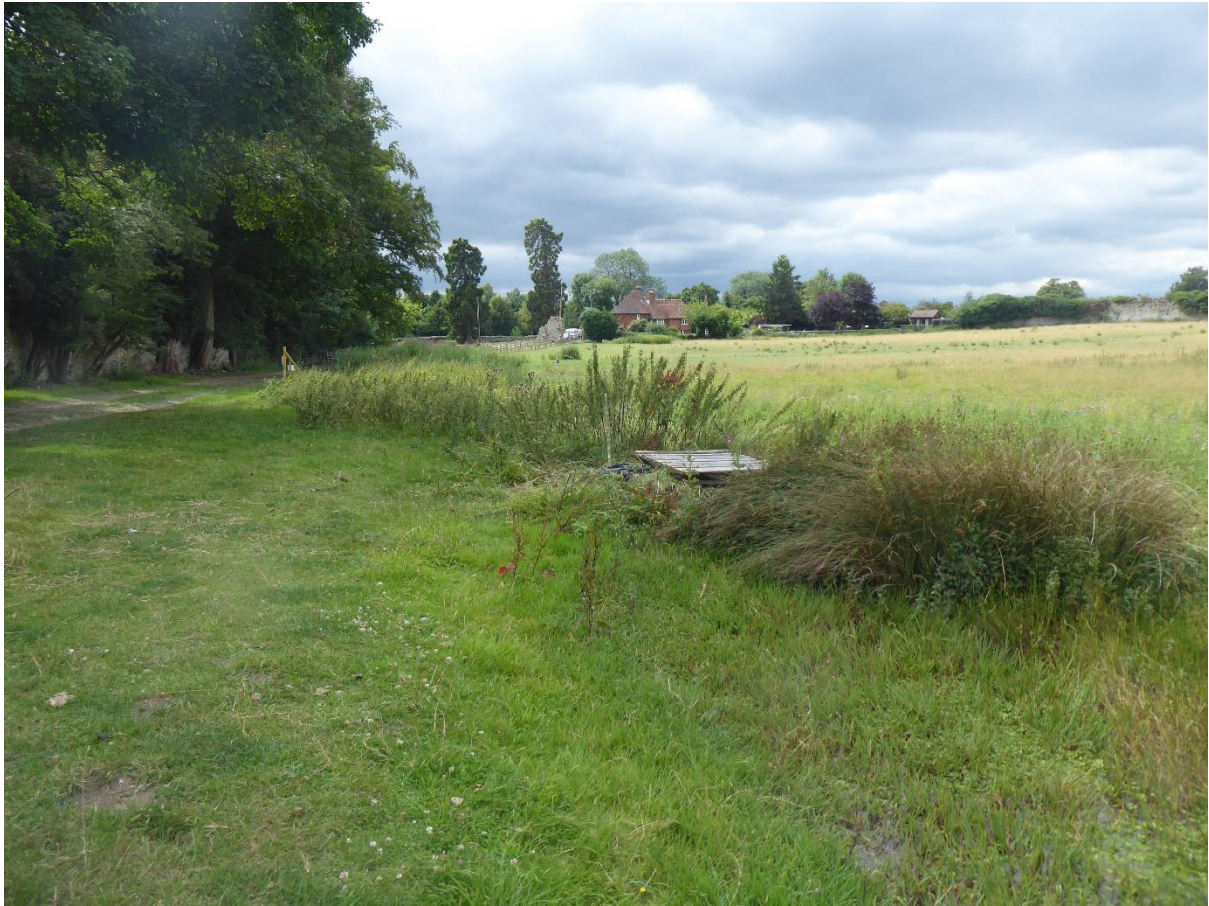
View of NP 4 (under the wooden covering in the centre of the picture) from the east. NP 4 is at the start of where the 1801 survey indicated that the “brook here runs underground”. It is now a penstock, where water is dammed up to drive much of the flow along the “eastern drainage channel” (as it is known in this report) which starts by running underground to the left of this picture to then flow down the former abbey nave. The residual flow continues (now mostly above ground) to form the “western drainage channel” (as it is known in this report).

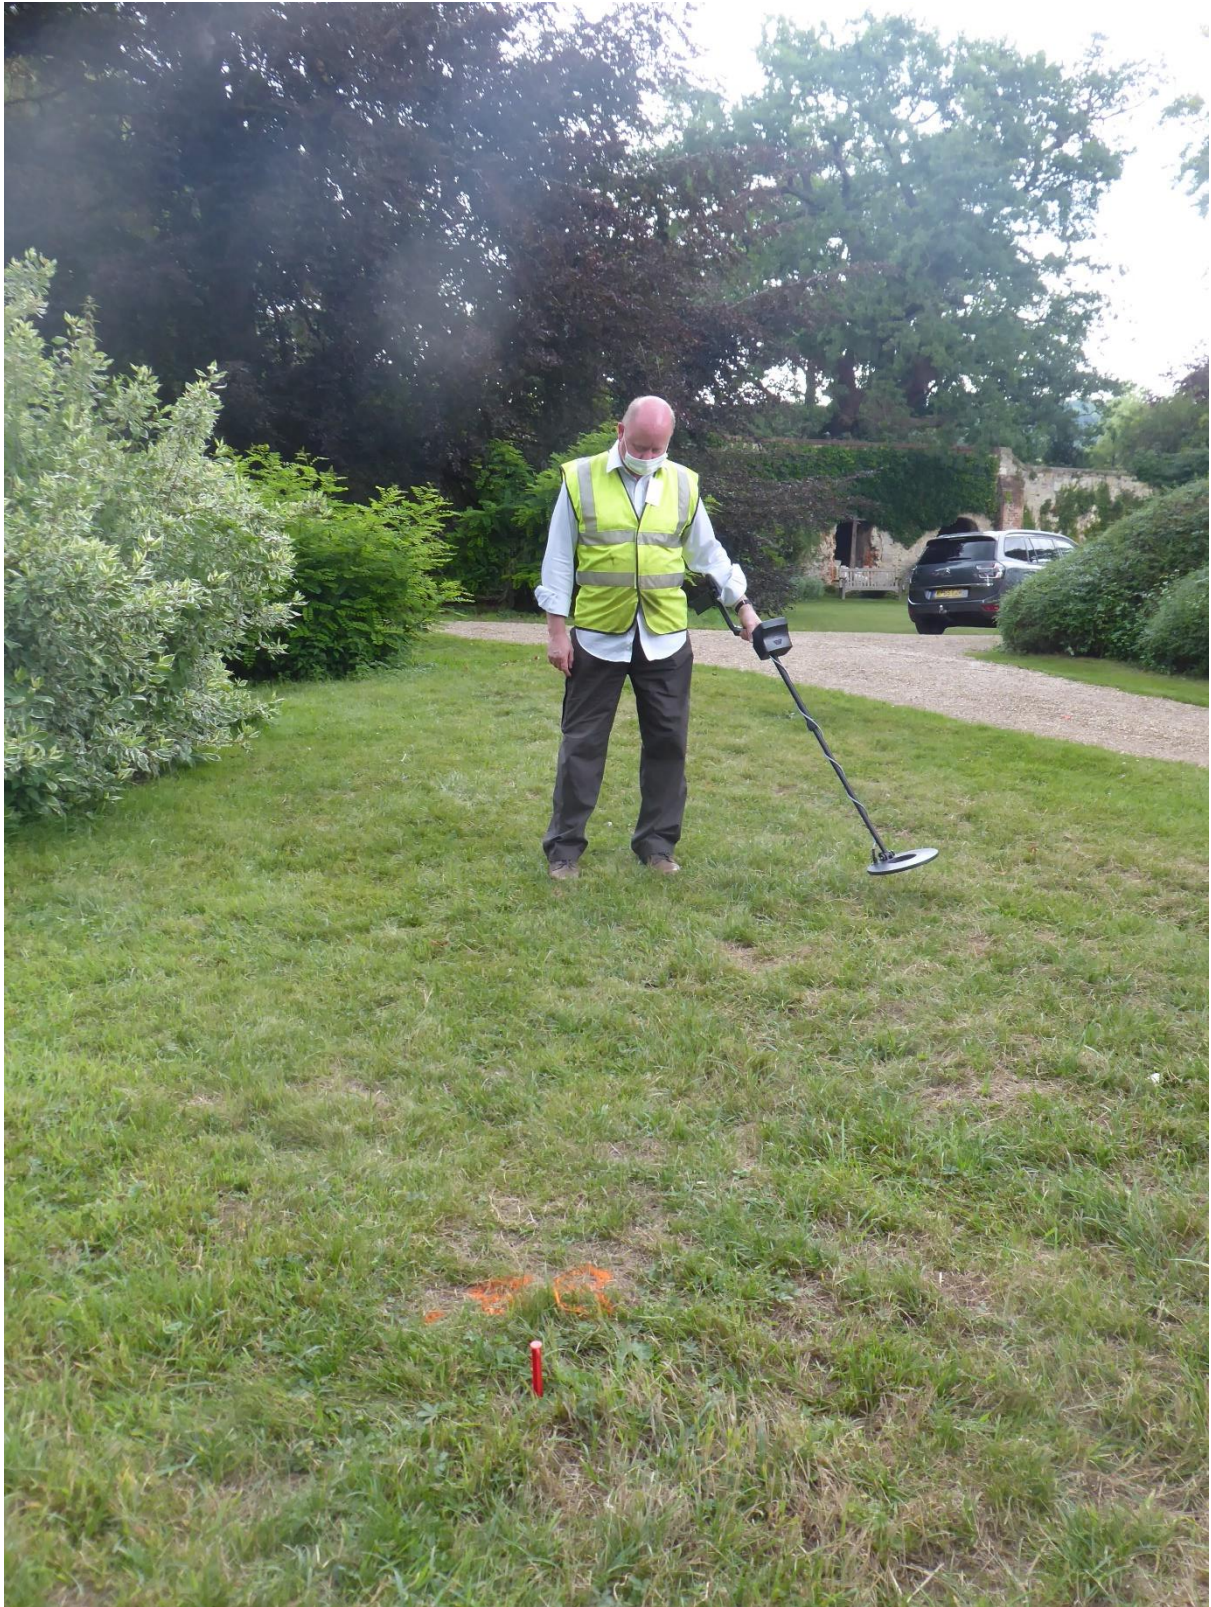
EDC 6 in the foreground. The line back up to EDC 5 is being found (surprisingly effectively) by a metal detector. It broadly heads under, but to the right of the trunk of, the copper beech in the distance and then to the left of the end wall of the terrace.
