KURG at Boxley Abbey: 13-15 July 2020

Introduction

Kent Underground Research Group (“KURG”) was invited by the Society for the Protection of Ancient Buildings (“SPAB”) to participate at their working party at Boxley Abbey on 13-15 July 2020.

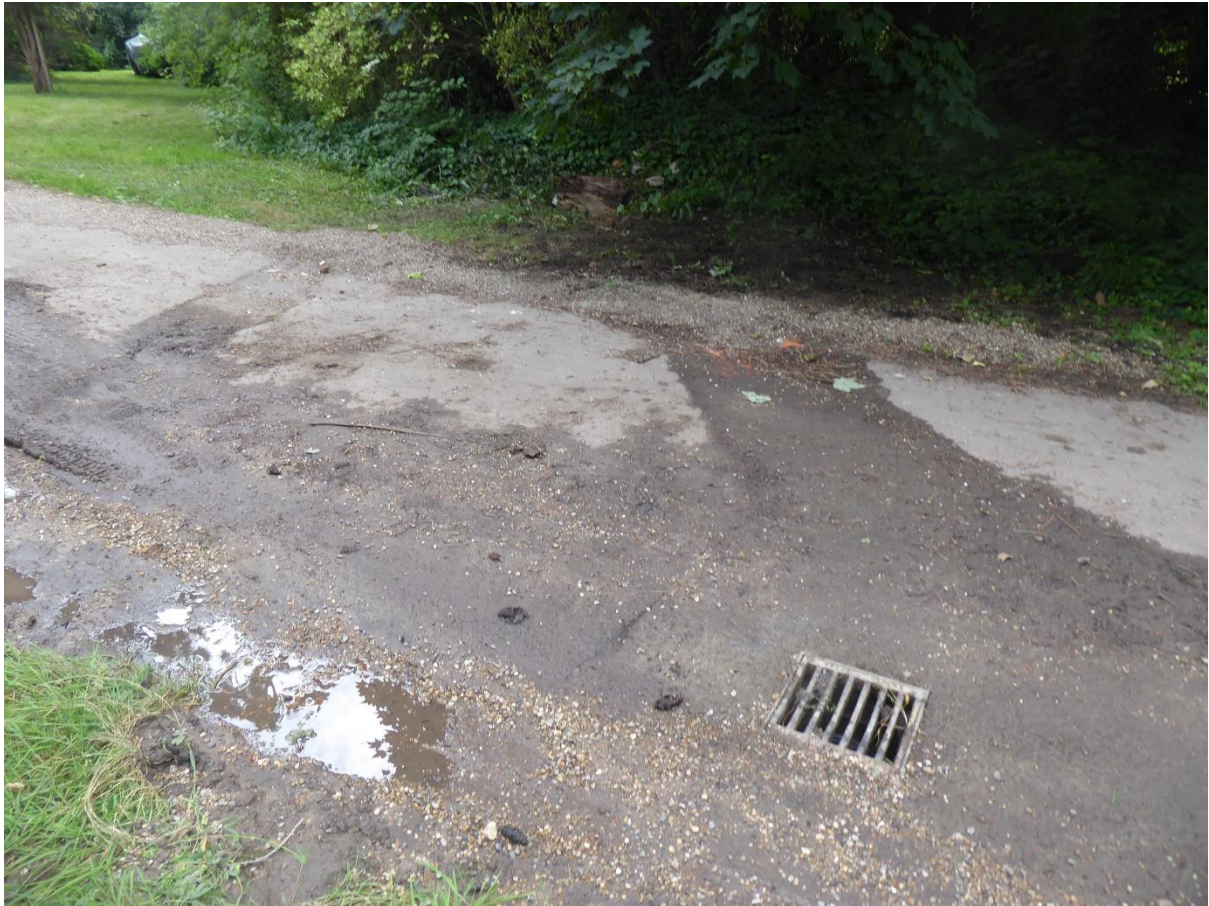
The drain in the drive forming WDC 4. WDC 5 is covered by a log just visible under the trees a few metres beyond the tarmac. The orange markings on the tarmac mark the position of a blockage (now removed) in the black plastic pipe running from WDC 3 to WDC 5. The two lines of tarmac patches over the lines of underground pipes can be seen clearly (these are referred to in the section on remedial work on the western drainage channel below).

As noted in the previous section, a blockage in the black plastic pipe between WDC 3 and WDC 5 caused water to be forced up from WDC 3 and run over the surface to the road drain at WDC 4. This was damaging the ground and the road surface. During a visit in the very wet February of 2020, water was also then running over the ground beyond the drive and down the track through to the Hospitium.

We found that we were able (through much use of drain rods) to clear the black plastic pipe between WDC 3 and WDC 5. The blockage was caused primarily by a brick (apparently Georgian era) that had been brought into the pipe – presumably by water flow. On clearing the blockage, water no longer flows across the surface. However, the rather tight “S” bend of the black plastic pipe, relatively low incline, together with its corrugated nature and relatively small diameter relative to flow will mean that it is likely to be prone to blockage in future.

We investigated WDC 4. The main part of it is simply a silt/gravel trap that needs periodic emptying (we partially did so). However, it has a junction near the surface that leads to a pipe that flows roughly south easterly initially. Pushing a traceable cable down through this pipe led to the cable being detected around 3 or 4 metres short of WDC 3. We therefore believe that there used to be some form of linkage to WDC 3 that is no longer in place. However, it is also apparent, that the flow of water from WDC 4 must head down a different direction under the drive and out through to a pipe junction somewhere between WDC 5 and WDC 7. It is possible that this is in fact at WDC 6 near a large tree, where the sonde could not progress when pushed in from WDC 7.

There is a question of how to keep the water from running on the surface in future wet conditions. Clearly the two basic points of maintenance are to:

- Keep the black pipe from WDC 3 to WDC 5 running clear.
- Keep the silt/gravel trap in WDC 4 clear.

However, it seems likely that the rate limiting step for water flow is the section from WDC 3 to WDC 5 (or WDC 6), where the pipe seems to be laid at less of an incline than around WDC 7 (say). It would be interesting to see whether a link could be made easily from WDC 3 to WDC 4 at below ground level to give an additional relieving line of flow – as there is some evidence that such a line may exist in part and this may involve less work than a more comprehensive solution.

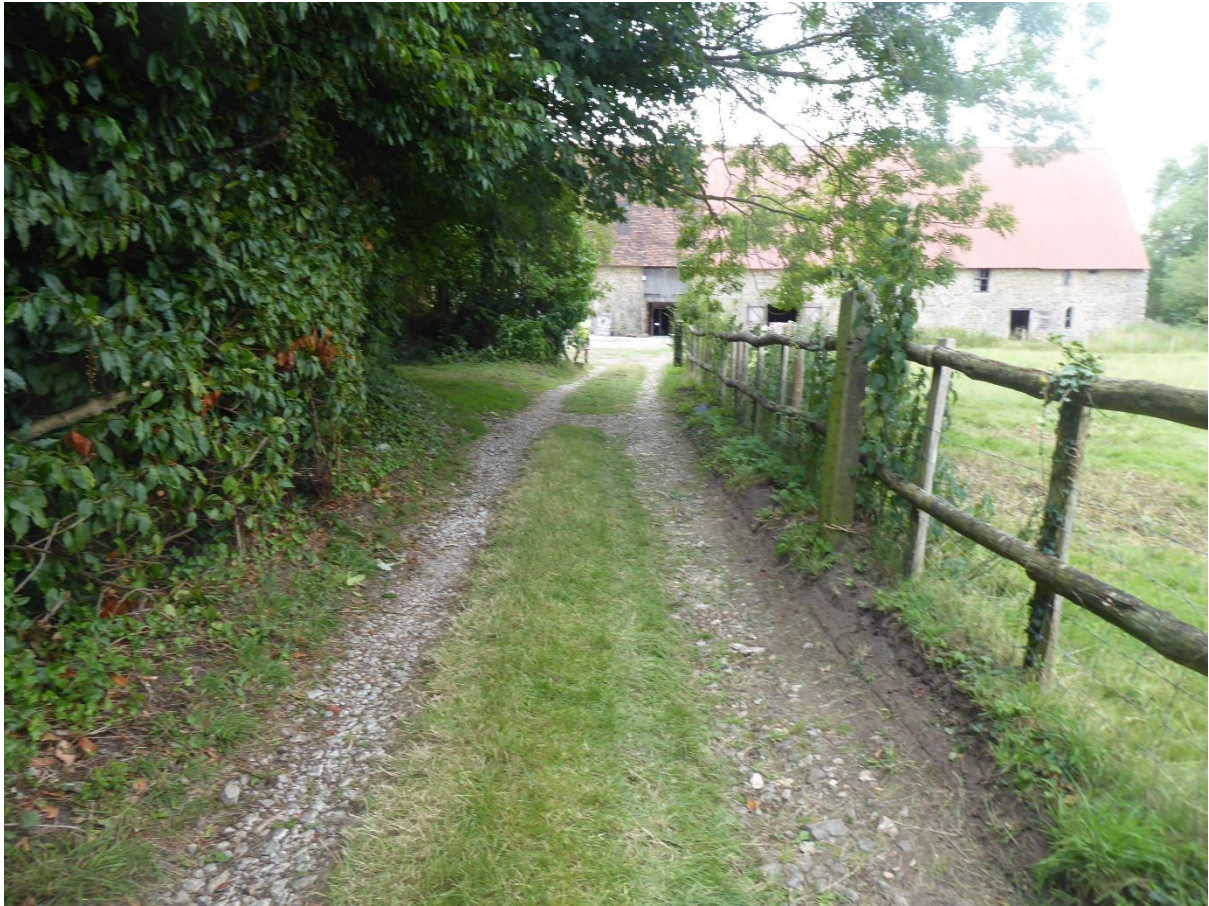
The access point at WDC 7 is under the hedge on the left of the track roughly opposite the fence post seen here on the right.

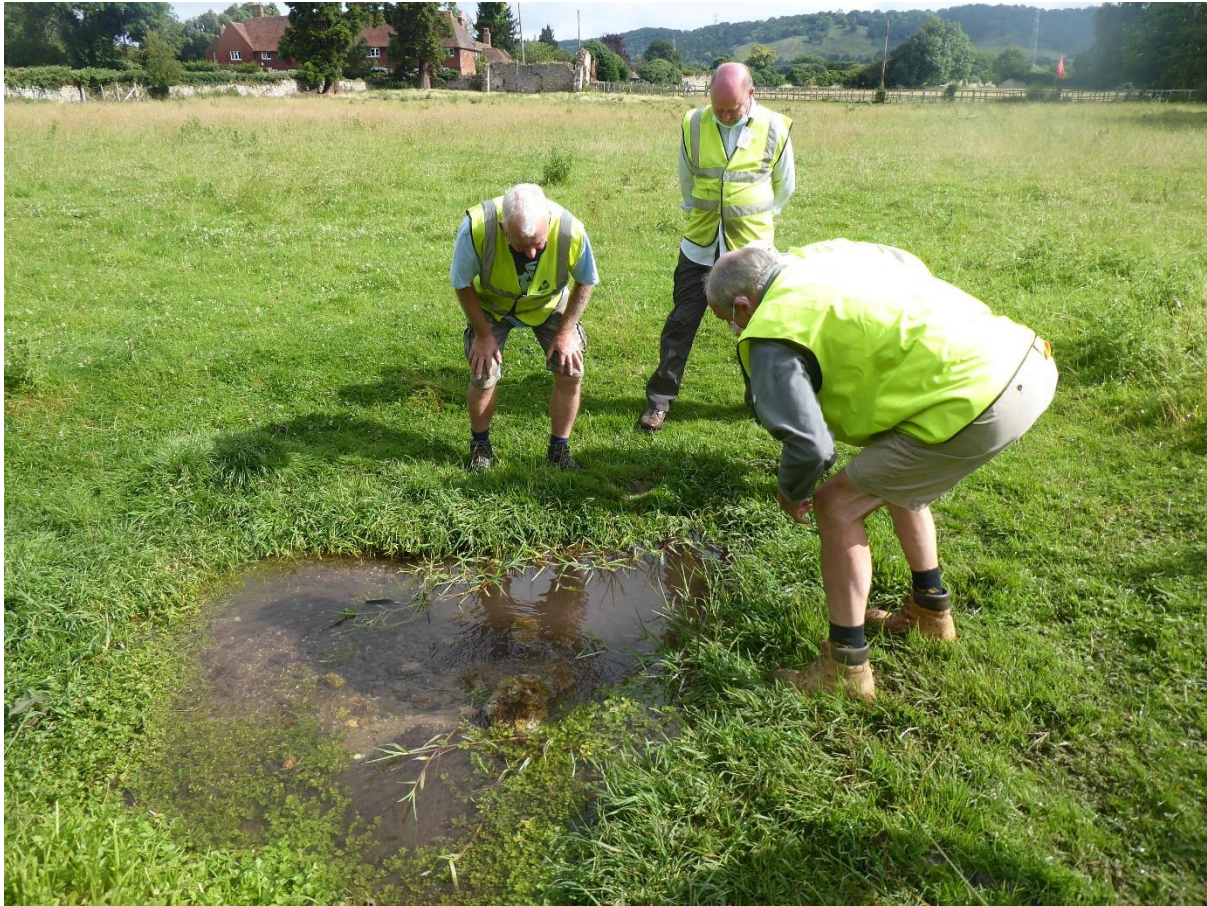
The upwelling at WDC 9 before flowing into the pond to the west of the Hospitium.

The flow from WDC 9 is above ground and into a pond to the west side of the Hospitium. In July 2020, this pond was largely dried out and overgrown, although it had held significant water in February 2020. No work was done to track the flow from the pond down to the southern end of the site, but it seems likely that towards the southern end it will have been affected by the construction of the M20.
