THE SPAB RESEARCH REPORT 2

The SPAB Building Performance Survey 2013 Interim Report

OCTOBER 2013.

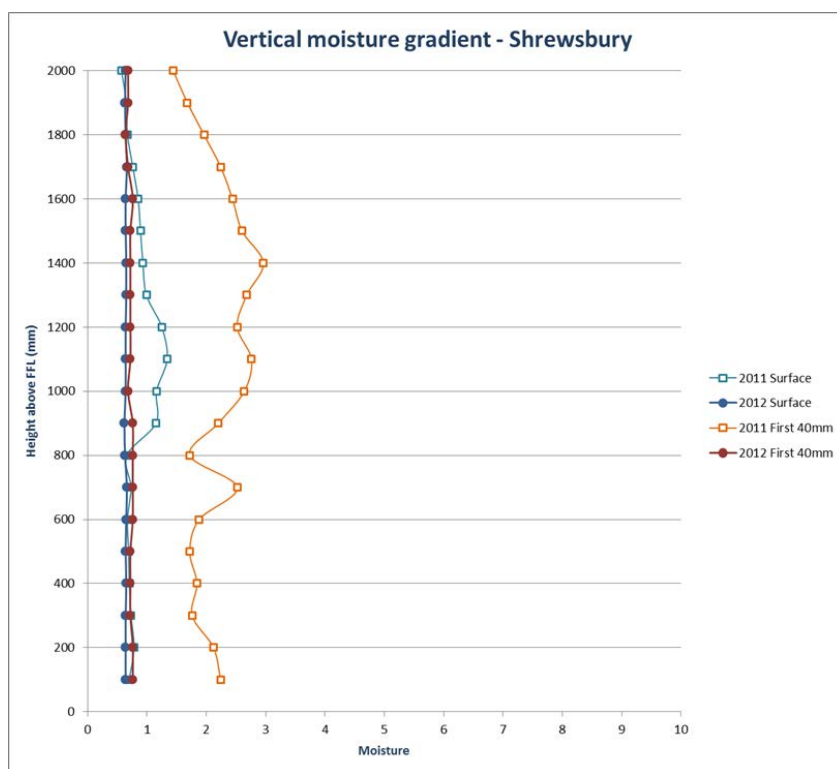
The following observations concern moisture readings taken at the interior surface and sub-surface of the walls at Shrewsbury, Drewsteignton, Riddlecombe and Skipton (Figures 2 - 5). In general all four walls, post-refurbishment, have seen a decline in moisture readings at both surface and sub-surface levels. The two walls, Shrewsbury and Drewsteignton (Figures 2 and 3) that have been subject to internal wall insulation in the form of sheet materials, PIR and Woodfibre board, show similar patterns of behaviour. Previously, in 2011, the surfaces of these two walls appeared to be fairly stable and dry (there is a brief deflection mid-way up the plot for the wall in Shrewsbury which has been accounted for as the effect of water moving into the interior surface along a lintel). The 2011 plots for the sub-surfaces of these walls, about 40mm back, were a little more dynamic and indicated the influence of ground water at the base of the walls. The measurements taken in 2012 show both the plots of surface and sub-surface moisture

occupying the 'dry' end of the nominal moisture scale. This indicates something about the limitation of these methods of measurement as a means by which to assess moisture risk in internally insulated solid walls. The internal surface and sub-surface of the walls at Shrewsbury and Drewsteignton are drier as this is where a new insulating layer of dry sheet material has been applied. The affect of this build-up to the internal face of the wall is to move the zone of moisture measurement away from the original masonry part of the wall. It is in the solid masonry part of these walls that we have previously seen fluctuating moisture readings indicating a dynamic environment influenced by external forces such as ground water and/or rain, therefore, whilst it is true to say that the internal leaves of these walls appear to be slightly drier this is not necessarily the case for the walls as a whole.

Figure 2. Pre and post refurbishment measurements of surface & sub-surface moisture at Abbeyforegate, Shrewsbury, 2011 & 2012.

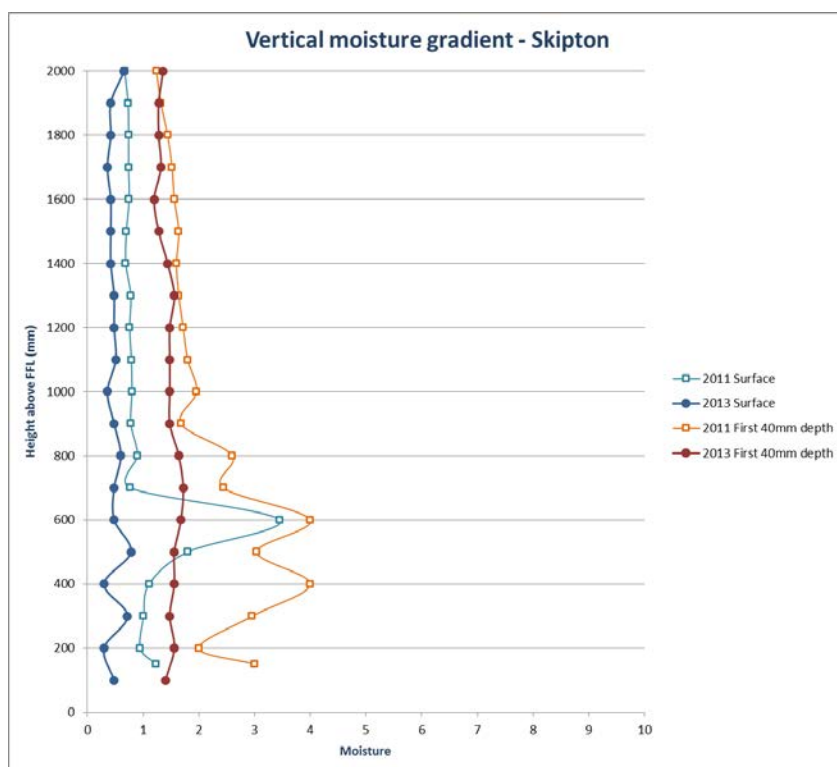
The other wall in the study that has been internally insulated using a hemp/lime plaster is the wall at Skipton. In comparison with the other IWI walls which have been insulated with sheet material the surface and sub-surface measurements of moisture at Skipton show some differentiation (Figure 4). The differentiation may reflect the fact that the sub-surface material is still in the process of drying but also, as the plaster is directly coupled to the masonry in this instance, rather than measuring the dry sheet material, there is some influence of the masonry component in the measurements gathered 40mm back from the wall surface at the sub-surface level. However, the 2013 post refurbishment measurements do indicate that in comparison with the measurements taken pre-refurbishment in 2011 the surface and sub-surface of the wall at Skipton has, at least nominally, become 'drier'. And in addition the influence of ground water at the base of the wall and possibly water tracking in to the internal wall face under the window cill is less significant at the surface and sub-surface level than it was prior to refurbishment.

Figure 4. Pre and post refurbishment measurements of surface & sub-surface moisture at White House Farm, Skipton 2011 & 2013.

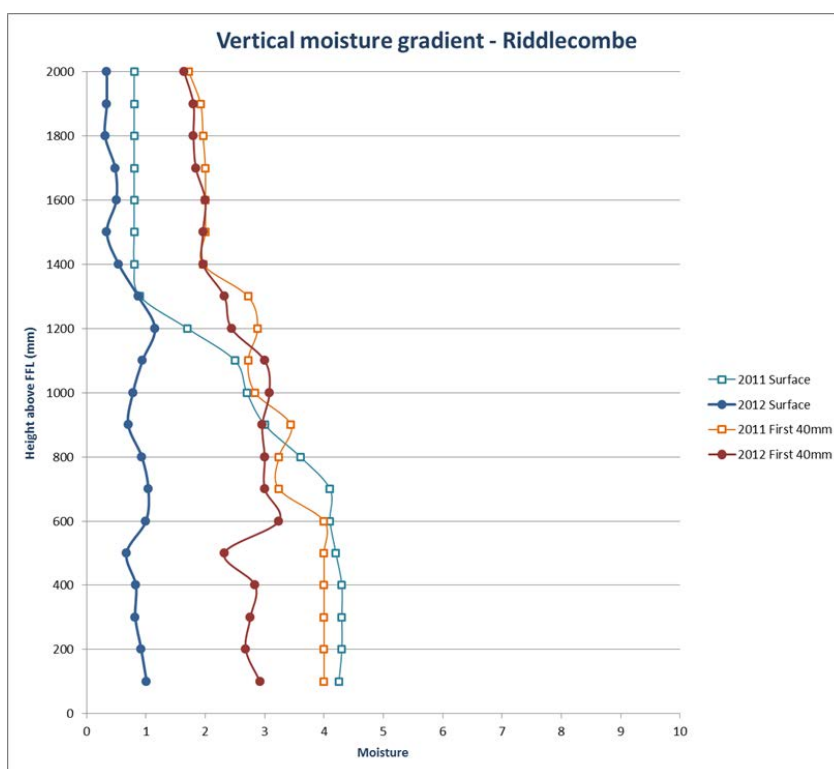
The graph for Riddlecombe, an externally insulated wall, is somewhat different but also shows the general declining trend for surface and sub-surface moisture (Figure 5). At this property the vapour permeability of both the internal and external finishes of the walls has, in theory, been increased by the application of lime-based finishes and both the moisture buffering and evaporation potential of these materials could account for the improvement in moisture readings taken here in 2012. This improvement is particularly pronounced for the lower part of the wall and it should be noted that the stone plinth (300mm) upon which the cob wall sits has received an additional coat of stabilising mortar to both its interior and exterior face which could alter moisture readings for this part of the wall. Also of note, however, is that above 1400mm readings for sub-surface moisture at Riddlecombe return to those previously recorded, pre-refurbishment, in 2011. This suggests that beyond the internal wall surface moisture conditions deeper within the wall have not really altered as a result of the refurbishment work. This may be a reflection of the fact that high %RH and possibly high moisture levels within this wall continue to be a feature of the wall at Riddlecombe.

Figure 5. Pre and post refurbishment measurements of surface & sub-surface moisture at The Firs, Riddlecombe, 2011 & 2012.

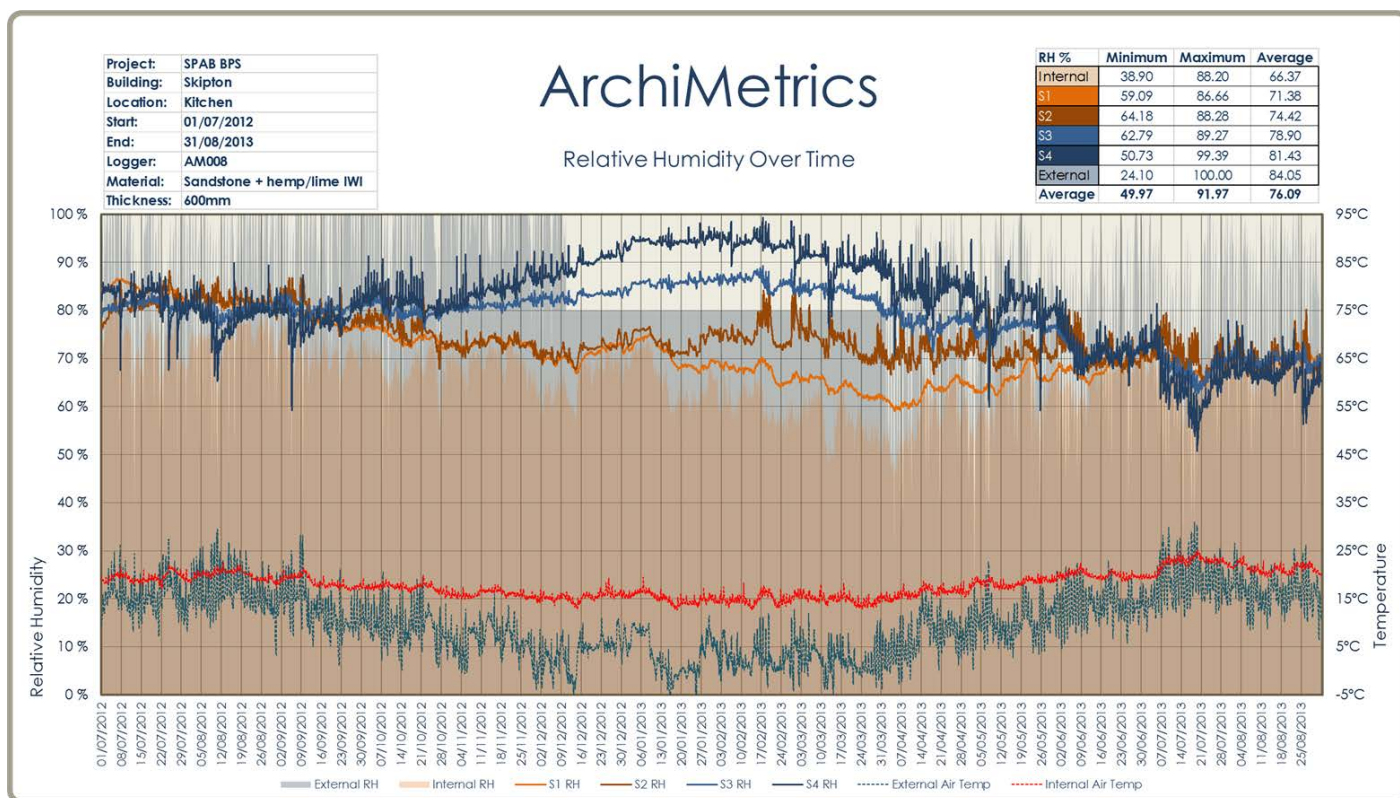
The graph for Skipton, Figure 7, shows a contrasting trend of downward %RH over the reported monitoring period. This could be a reflection of the generally warmer conditions experienced in the summer of 2013 where external as well as interstitial %RH (sensors 4-2) is shown to be lower than that of

the previous summer, combined with the drying that is occurring to the internal wall finishes measured by sensor 1. The wall at Skipton also shows moments of vaporisation behaviour, similar, if less pronounced to that seen at Riddlecombe as well as the affect of its fissured construction in that responses to external conditions mapped at sensor 2 are sometime more pronounced than those plotted for sensor 3, the sensor that is physically closer to the outside possibly as a result of erratic air-pathways through the wall. At Shrewsbury the extended period of peak 100% RH measured at sensor 4 seems at first glance to be alarming, however this peak should be read within the context of responses over an annual cycle which show that %RH reduces at the onset of warmer spring weather and averages 83.49%. It is also worth noting that unlike the other walls in this sensor 4 at this location is placed in much closer proximity to external conditions, 30mm back from the external wall face and this, combined with the generally open and porous nature of this wall, as previously observed results in extreme responses. Given the potentially volatile nature of the wall, including its south-facing aspect, %RH measurements made at this location are, with the exception of sensor 4, remarkably stable.

Figure 7. Relative Humidity over time, White House Farm, Skipton, 2012 -13.

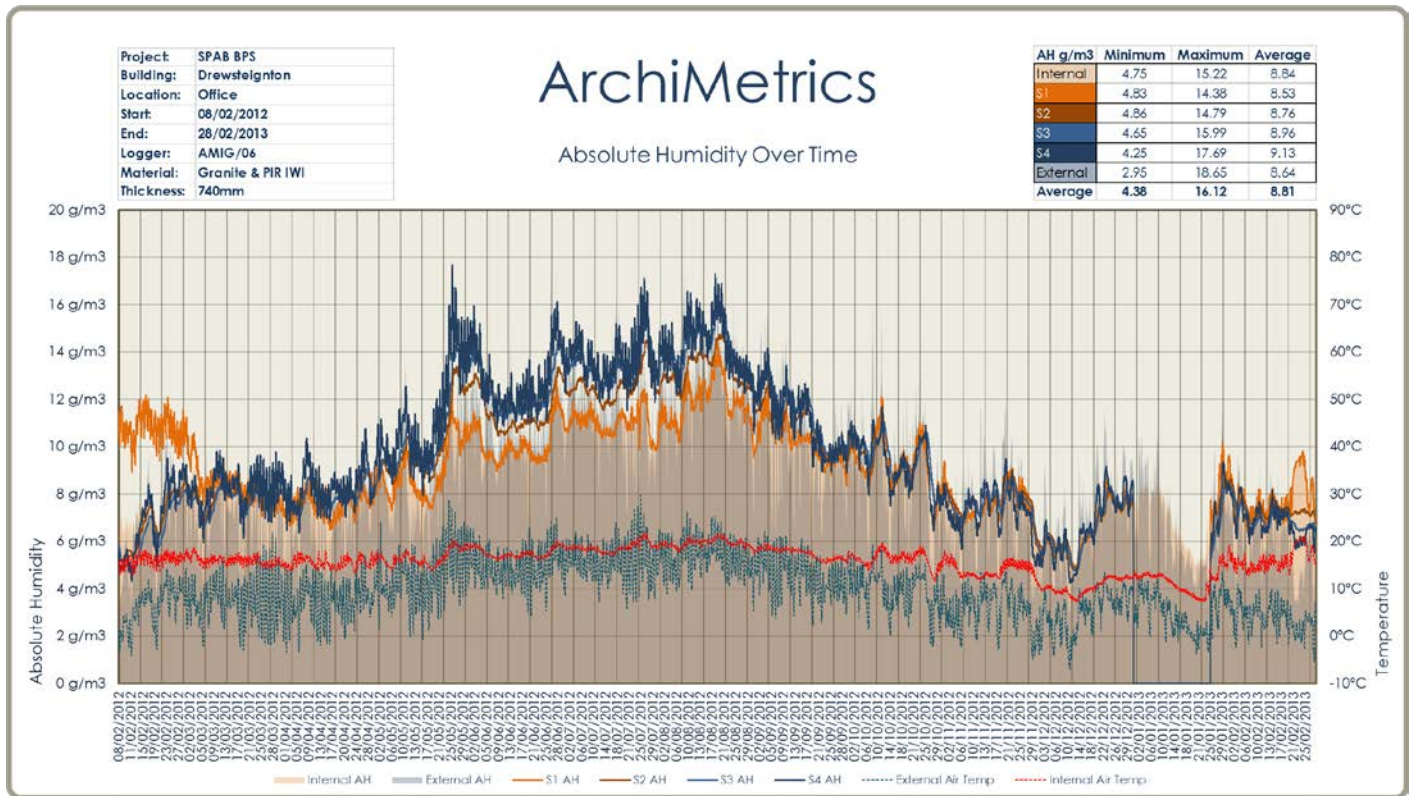
where it is only from January 2013 onwards that this arrangement is seen. (The peak absolute humidity at sensor 1 seen early on in Figure 12 is as a result of the drying of the gypsum skim on the plasterboard drylining). Drewsteignton also differs from the walls at Shrewsbury and Skipton in another way in that it seems to reverse a dispersal pattern. At Shrewsbury and Skipton measurements of the weight of vapour through the wall are more dispersed and differentiated during the winter, presumably, as with %RH, as a result of a greater temperature gradient through the wall section. However, at Drewsteignton a greater differentiation between g/m^3 of vapour is found in the summer and measurements of the weight of vapour through the wall section become more aligned in wintertime.

Figure 12: Absolute Humidity over time, Sensors 1 - 4, Mill House, Drewsteignton 2012 - 2013.

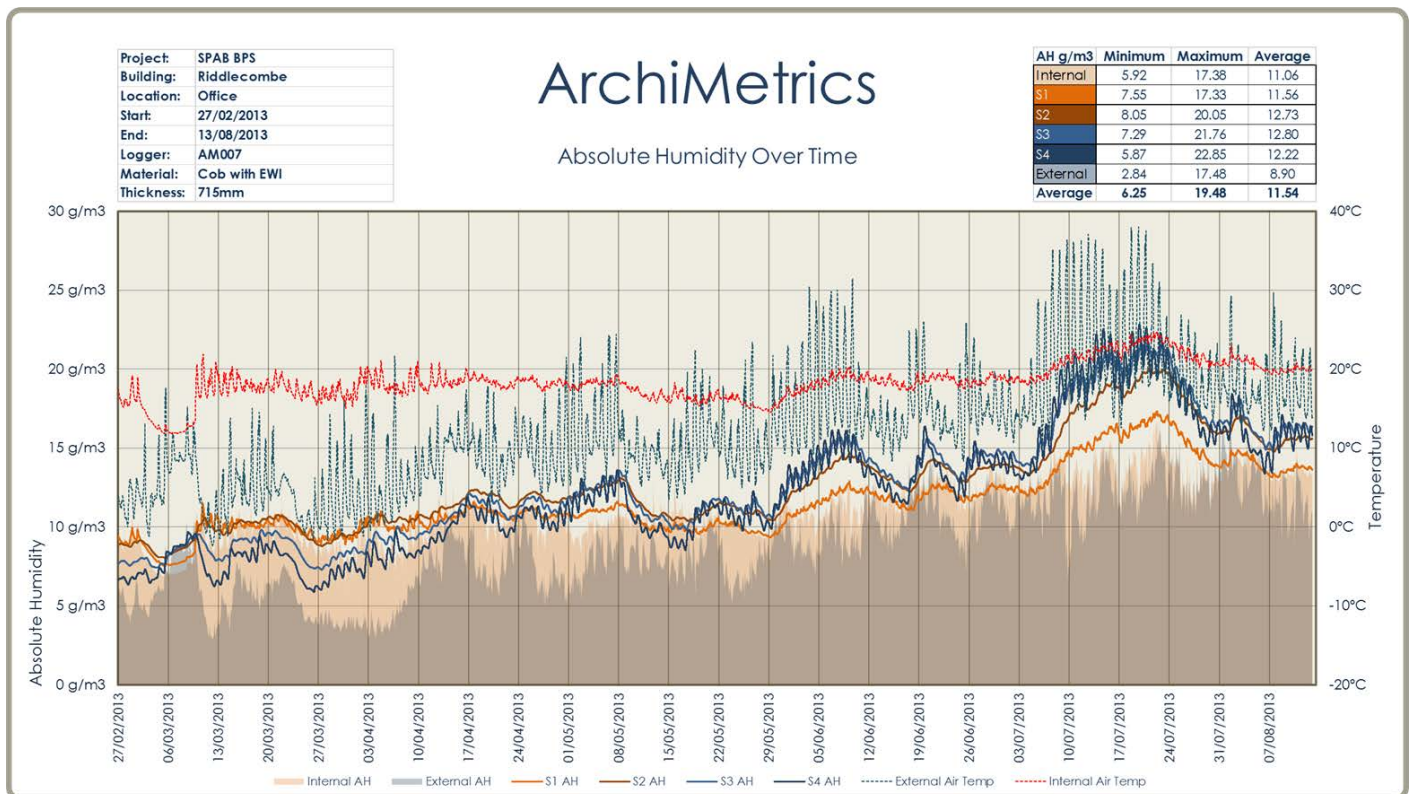
Although the graph for Riddlecombe, Figure 13, covers a shorter time period the increase in absolute humidity here also follows the seasonal pattern and increases with increasing external temperatures/external absolute humidity. There is, however, a significant difference in the plots of absolute humidity for the wall at Riddlecombe compared with those at the other locations. By and large, plots of absolute humidity in the other walls broadly match, sit between or fractionally surmount, those of internal and external levels of absolute humidity showing a close correlation between internal/external and interstitial conditions. At Riddlecombe plots of interstitial absolute humidity are detached from and significantly higher than those of external humidity and also internal absolute humidity from May 2013 onwards. This suggests that there is an additional factor or factors driving quantities of vapour in this cob wall independent of ambient internal and external vapour conditions. In the previous discussion on %RH and in the individual report on Riddlecombe it is suggested that excess moisture is contained within the cob as a result of a past failing external render as well as water added to the wall during the re-rendering process and this is vaporising during periods of warm temperatures as sun falls on the south-facing wall. This might explain the detachment seen between internal and external vapour conditions and those within the wall, as the moisture within the cob material provides an additional and independent source of vapour.

Figure 13: Absolute Humidity over time, Sensors 1 - 4, The Firs, Riddlecombe February - August 2013.

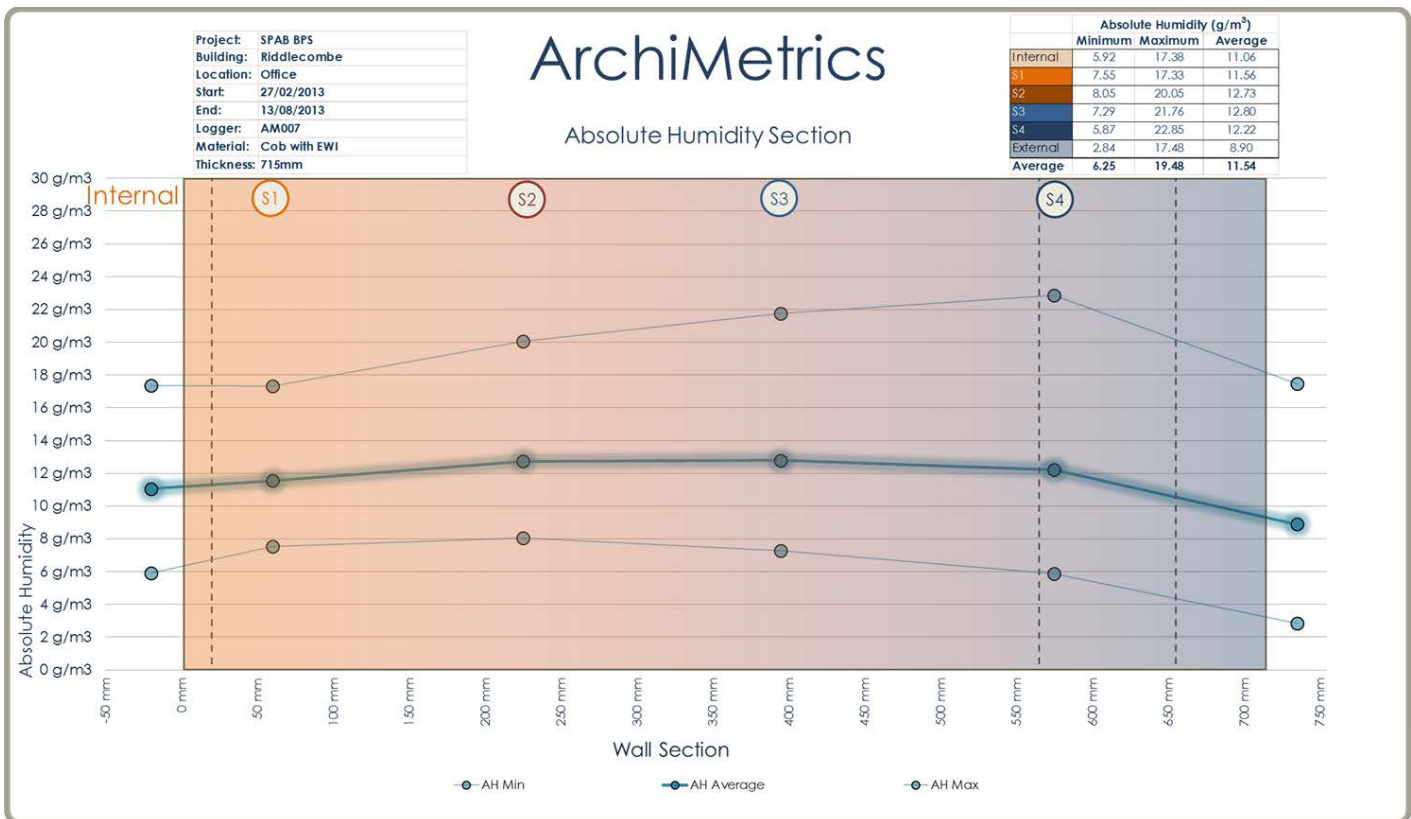
As can be seen from the compilation of data given in Table 4, on average the walls at Skipton and Riddlecombe contain the highest weights of vapour g/m³, although the weight of vapour in Riddlecombe far exceeds that of Skipton in relation to the other two walls in the study, being approximately 38% greater than that of the walls at Shrewsbury and Drewsteignton, as oppose to just 11% greater in the wall at Skipton. The walls at Drewsteignton and Shrewsbury bear very similar averaged quantities of vapour, and these in turn closely match averages calculated for the walls which also include internal and external absolute humidities. This suggests that there is a close relationship between the ambient vapour conditions surrounding these walls and the vapour behaviour within the wall itself. In Table 4 the highest averaged measurements of weight of vapour through each wall section is marked in bold, this shows that for the walls at Shrewsbury and Drewsteignton the highest averaged weight of vapour is found at sensor 4, at the exterior side of the walls, but for Skipton this is located at sensor 1 close to the internal wall face. It is suggested that this is a reflection of the wet hemp/lime finishes which are in the process of drying during the reported monitoring period and that this in turn influences the overall average weight of interstitial vapour recorded for this wall and explains why this is raised in relation to the average which takes account of internal and external conditions. However, the discrepancy between the average interstitial absolute humidity recorded at Riddlecombe and this same quantity including internal and external conditions is less easily explained unless, as is suggested elsewhere, there is an additional source of vapour that influences this wall, possibly in the form of additional moisture bound within the cob.

Figure 17: Absolute Humidity Section, The Firs, Riddlecombe February - August 2013.

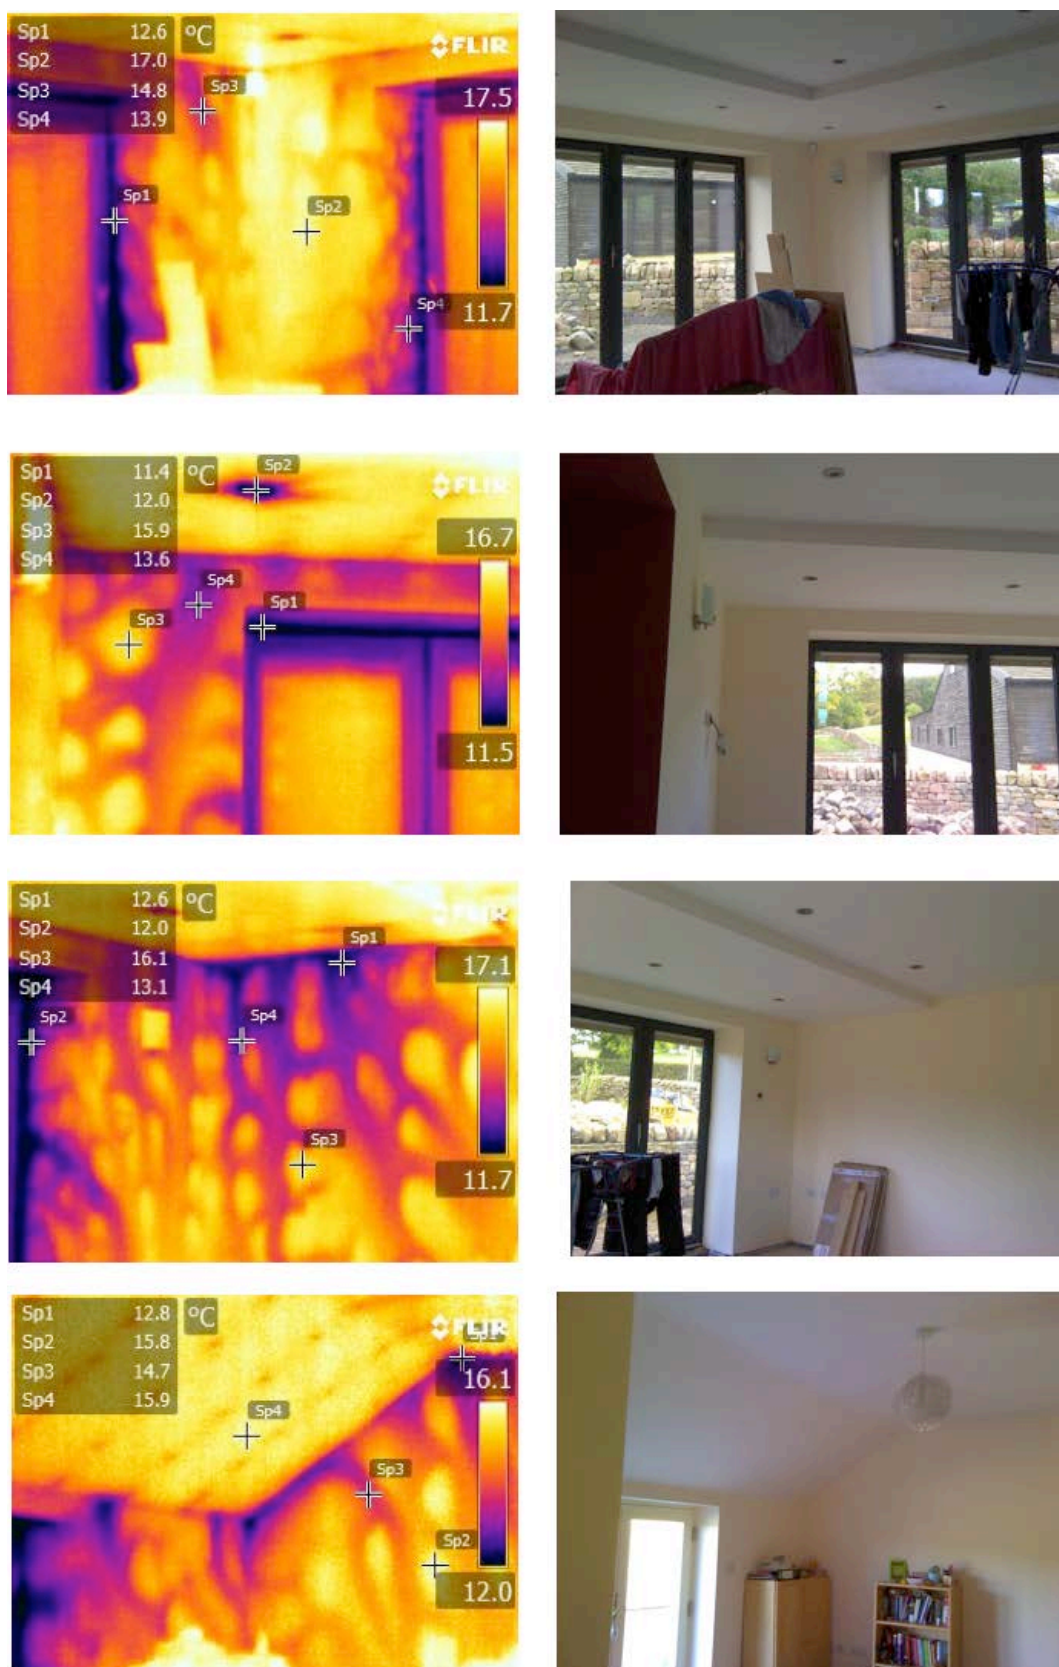
Unlike the older part of the building, the new addition displays a great range of temperatures under the air permeability test conditions (Figure 50). The pattern displayed is likely to relate to the location of plaster dabs. The images also show some ingress around the door frames and light fittings.

Figure 50. White House Farm, Stirton, Skipton - Addition to dwelling. Top – North east corner of addition, middle – north wall and east wall, including section which protrudes, bottom – north east corner on bedroom on first floor of addition.

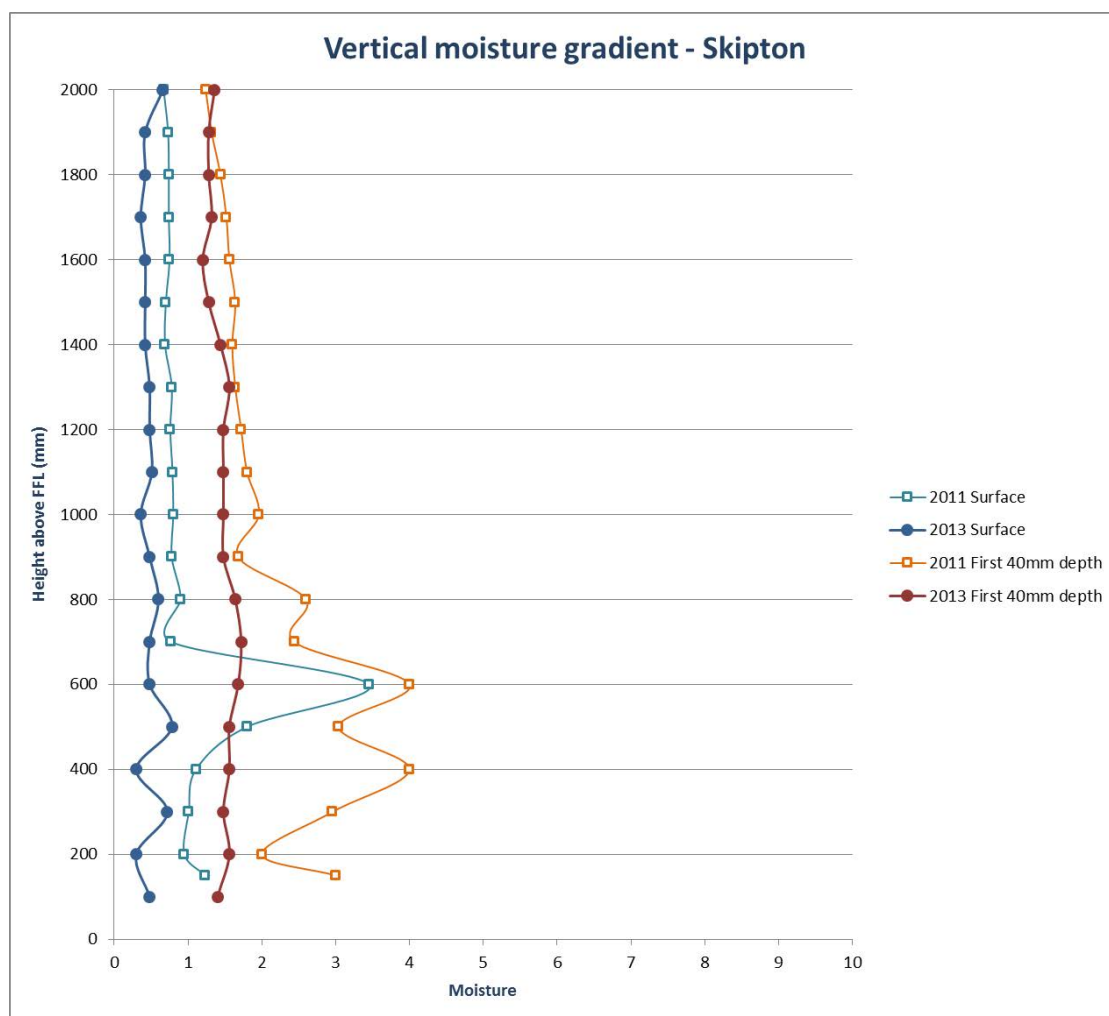
The 2011 moisture profiles show fluctuating levels of moisture both at the surface and sub-surface of the wall below the height of 1000mm - 1200mm. There is a particularly severe deformation of the surface moisture gradient recorded at 600mm above finished floor level which coincides with the bottom of the window cill leading to speculation that moisture may be tracking from the exterior to the interior wall face, beneath the stone window cill leading to a concentration of moisture at this location. Or this may be the affect of the cill creating a thermal bridge and therefore cooling the interior wall face at this point leading to increased surface and sub-surface humidity. It is interesting to note that this affect seems to have completely disappeared in the 2013 set of measurements. In 2013 both the surface and sub-surface measurements have moved towards the 'drier' end of the moisture scale and whilst, quite low down, the surface of the wall shows a slightly erratic profile in general both gradients are more stable. This apparent reduction and stabilisation in the surface and sub-surface moisture profile for the wall may be due to the addition of 40mm of lime and hemp/lime plaster to the interior wall face. Measurements only penetrate approximately 40mm into the wall therefore this new layer moves the zone of measurement away from the stone wall itself and so the presence of moisture within the masonry of the wall is no longer being directly measured. It may also be that the hemp and lime as relatively vapour permeable and hygroscopic materials have a beneficial affect with regard to humidity levels and that the surface and sub-surface of the wall appears drier in 2013 as these materials, given appropriate internal conditions, promote evaporation from the internal wall surface. This may also help to explain the disappearance of the 'cill affect' in the measurements from the refurbished wall in that the internal finish encourages the evaporation of any penetrating moisture or this may simply be because the zone of measurement zone no longer penetrates as far as the masonry.

Figure 4. Pre and post refurbishment measurements of surface & sub-surface moisture at White House Farm, Skipton 2011 & 2013.
