1952 Boxley Abbey Drainage Investigation Report

Authorisation Sheet		
Client:	Society for the Protection of Ancient Buildings	
Project Title:	1952 Boxley Abbey Drainage Investigation	
Address:	ME14 3BU	
Prepared By:		
Name:	Dale Rose	
Position:	Underground Utilities Surveyor	
Date:	20/04/2020	
Checked By:		
Name:	Andrew Beardsley	
Position:	Managing Director	
Date:	21/04/2020

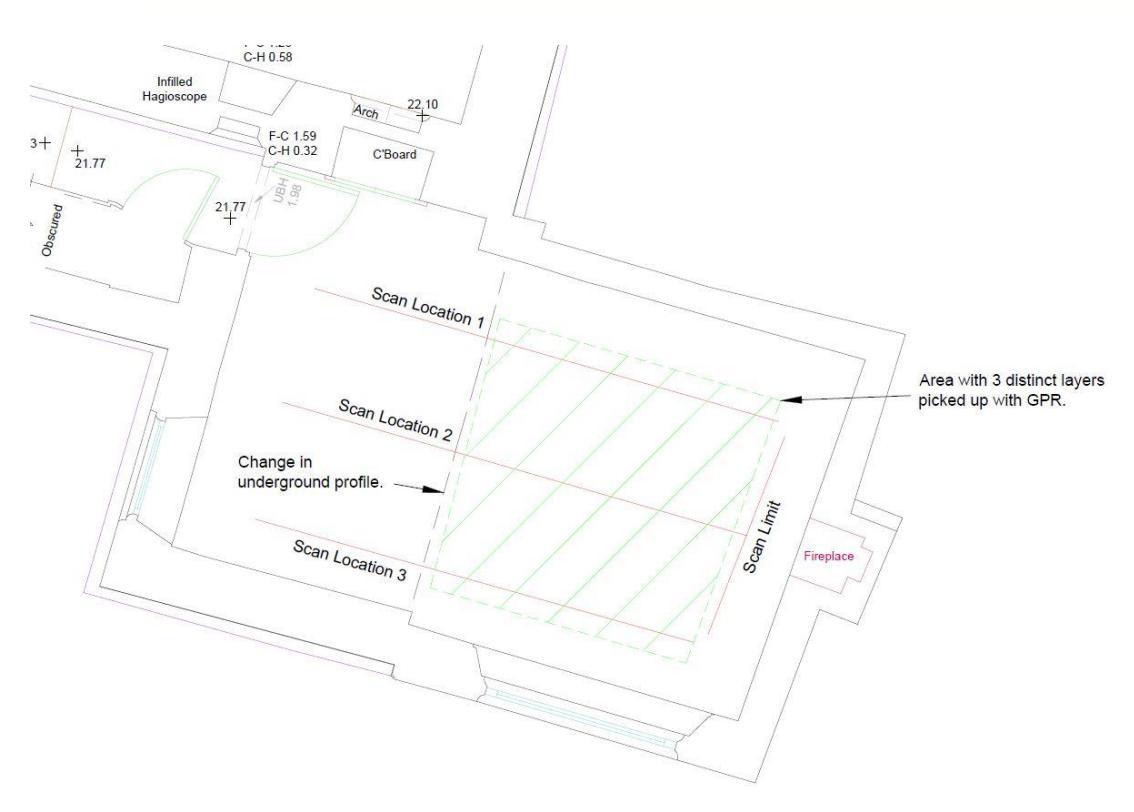
Image 1

A general sweep scan was used in the back room of the old house. See image 1 below which shows a sketch indicating the position of the GPR scans in the back room. Image 2 shows three distinct layers when scanning the floor. The top layer is assumed to be the flooring and is between 0.35/0.40 deep in places. The second layer ranges from 0.40 to 1.10/1.30 depth. The third layer is from the 1.30 depth and below. Image 3 shows the change in profile marked on the scan plan image.

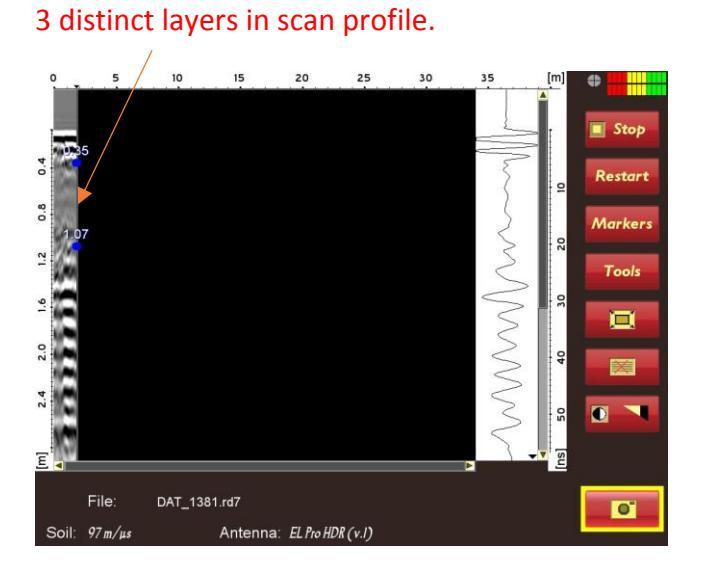
Change in profile through scan.
