Fireplaces, Flues and Chimneys

SPAB Technical Advice Note

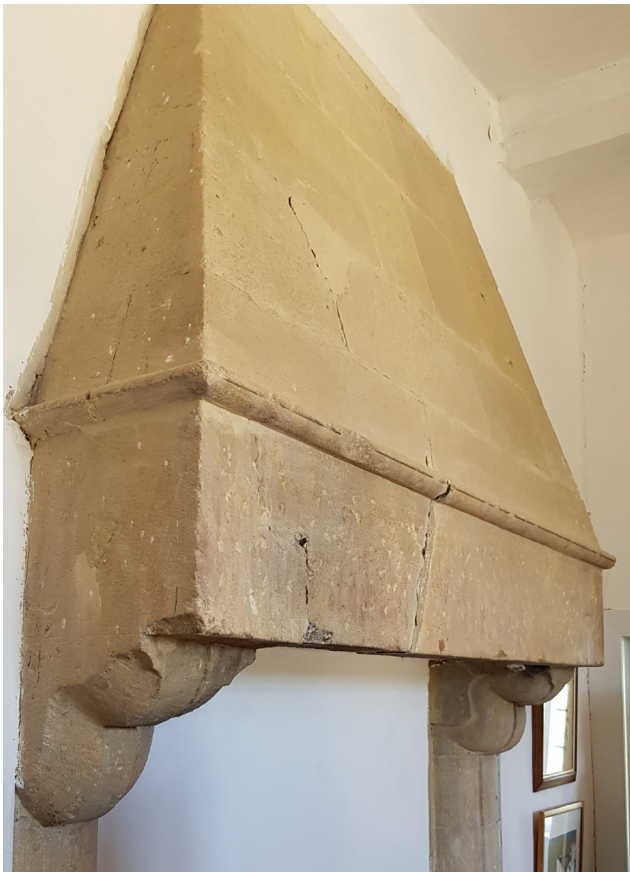
Figure 3: Corbelled stone hood, c1315. Gatehouse, Ham Court, Bampton, Oxfordshire.

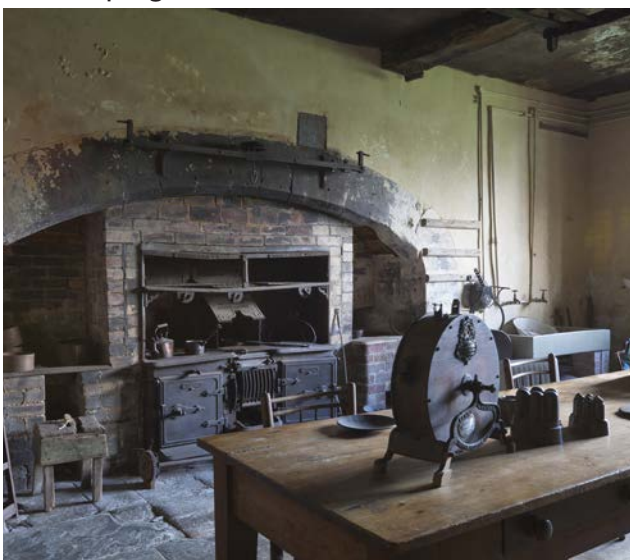
Figure 4: Flue with triplets of lancets, c1260. The Checker, Abingdon Abbey,

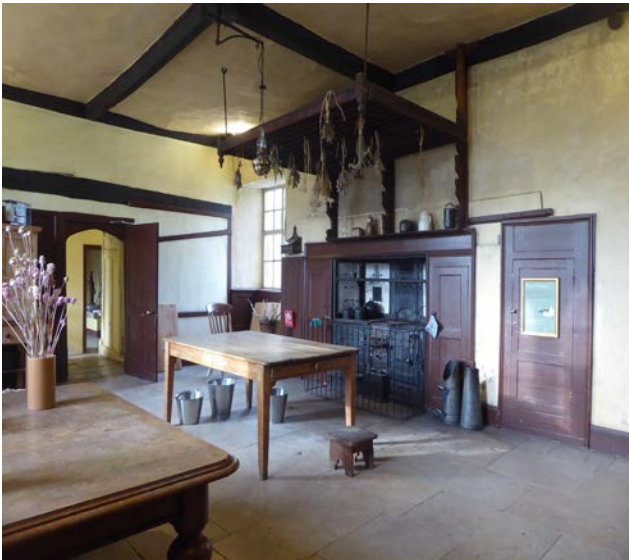
Figure 6: Kitchen, c1300-1900s. Manor Farm, Cogges, Oxfordshire. Open hall with inserted floor, lateral chimney stack with wide fireplace, later inserted cooking range and side cupboards. Note the spit rack above the fireplace. Photo: © Heather Horner, with thanks to Cogges Heritage Trust

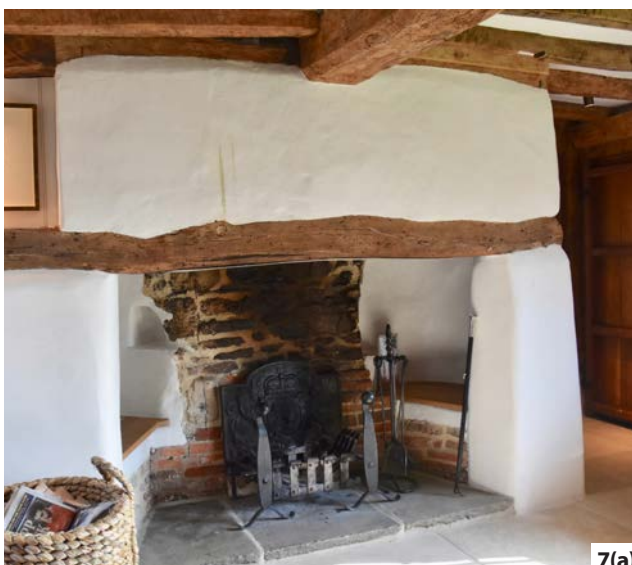
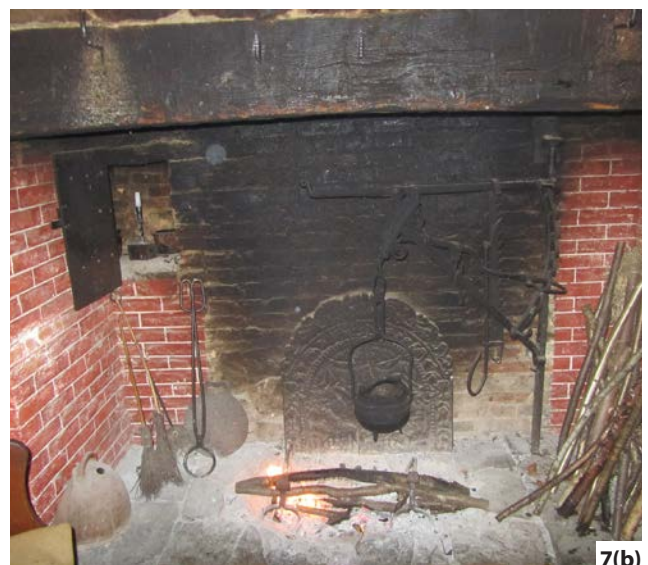
Figure 7: Inglenook fireplaces: (a) South Oxfordshire, c1600s, with seat alcoves either side for enjoying the warmth of the fire. The original flagstones under the grate would have been flush with the floor to allow debris to be swept into the hearth. (b) Kitchen fireplace, c1550, with pot crane, bread oven and cast iron fireback. Pendean, Weald and Downland Living Museum, West Sussex. Photos: Marianne Suhr (a) and Sally Stradling, with thanks to Weald and Downland Living Museum (b)

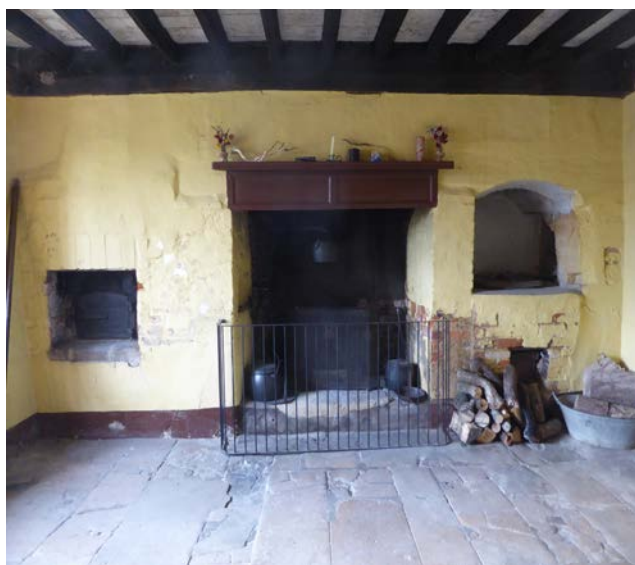
Figure 8: 'Back kitchen', c1600s-1900s. Manor Farm, Cogges, Oxfordshire. Main range in centre, bread oven to left, copper for washing clothes to right.
Photo: © Heather Horner, with thanks to Cogges Heritage Trust

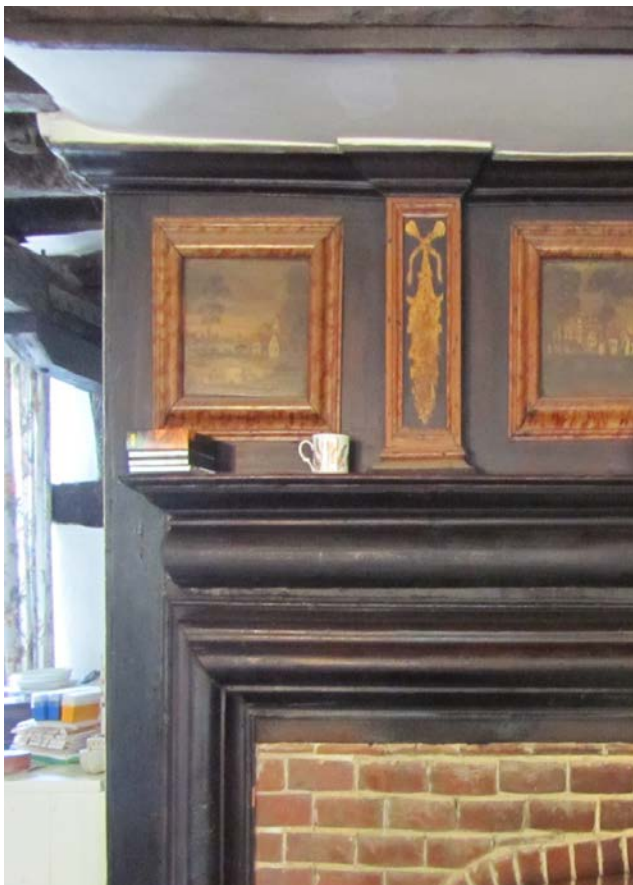
Figure 10: Detail, fireplace with bolection moulding, c1700s. Stevenston, Oxfordshire. Photo: Sally Stradling

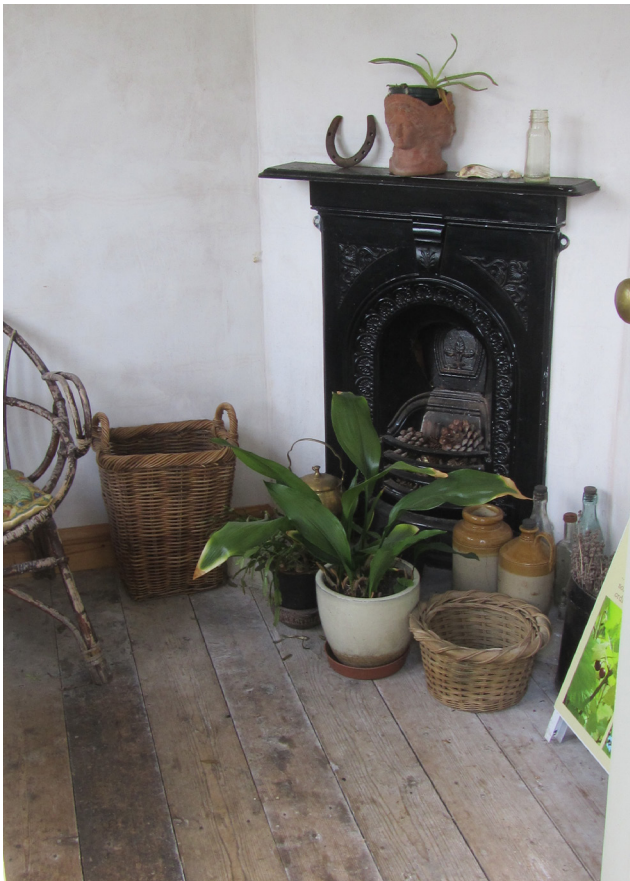
Figure 12: Mass-produced fireplace, c1875. Warwick.
Photo: Sally Stradling

Foundries, such as those of the Carron Company and at Coalbrookdale, mass-produced cast iron fire surrounds, sometimes with integral grates (see figure 12). Timber and plaster surrounds tended to be painted, and cast iron painted or blackleaded. A hierarchy of materials and decoration evolved for public and private rooms with greatest expense being lavished on the most frequented sitting rooms, while family bedrooms and attic rooms were provided with plain fireplaces, commonly of painted timber or cast iron.

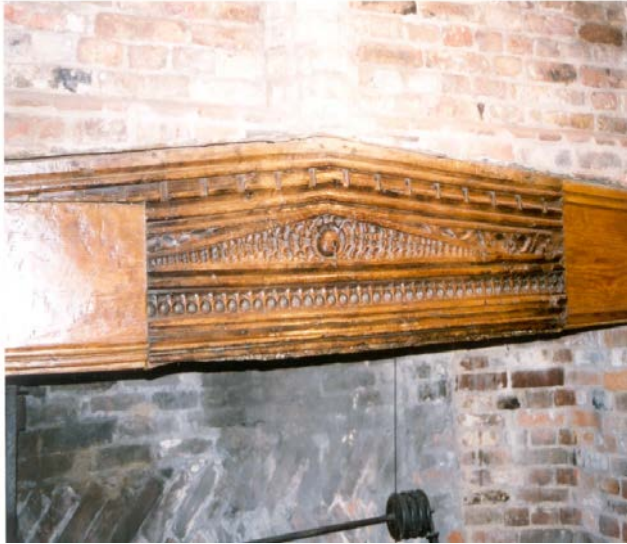
Figure 17: Repair is preferable to replacement, as with the repaired ends of this mantel beam. They respect the original but do not attempt to ape it. Photo: © Douglas D Kent

An abstemious approach should be adopted that prioritises repair *in situ* over wholesale removal and replacement, which is justified only where absolutely necessary (see figure 17). Such an approach includes keeping, wherever possible, any cranes, smoke jacks, hooks and items of chimney furniture, for example, grates, firebacks, firedogs and baskets that have historic associations with the building. It also places an emphasis on the retention *in situ* of ancient burn marks found on timber lintels and thought to be a deliberate, superstitious effort to protect the occupants and their possessions. Similarly items such as shoes, clothing or mummified cats, tucked away in chimneys to ward off evil spirits, should be retained in their original position (except where a fire hazard when they should be photographed and recorded *in situ* and then kept somewhere safely in the house).

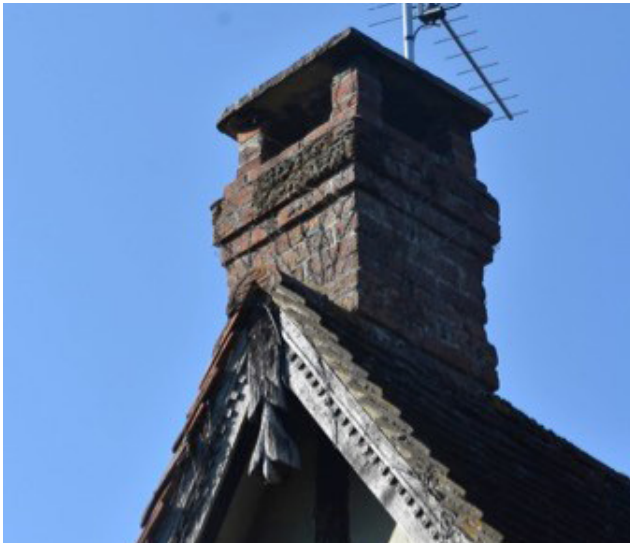
Figure 21: A 'dovecote' top can be used to protect large flue outlets from wind and rain, though is inadvisable on thatched buildings. A stone slab is placed above the flue opening raised on bricks at the corners. Such terminations should incorporate suitable bird mesh to stop nests being built under the slab. However, addition of a slab roof may affect the draw in certain situations. Always light a fire and check for unintended consequences before striking the scaffolding around the stack.

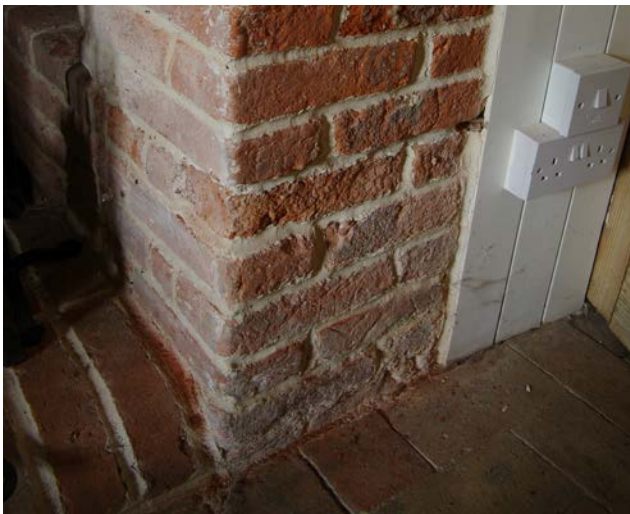
Figure 22: Spalling brickwork to inglenook fireplace due to aggressive cleaning.

Spalling to bricks around open fire

The faces of bricks frequently become powdery (spall) after they have been subjected to aggressive cleaning, for example, sand blasting. Spalling can be difficult to stop but a 15-20% dilution of potassium silicate may be soaked into the face of the bricks to help densify them. Potassium silicate is moisture open and, as the binder is often used to make fire cement, is safe to use near heat. There is very little to no visible change to the colour or surface texture when using potassium silicate (see figure 22).

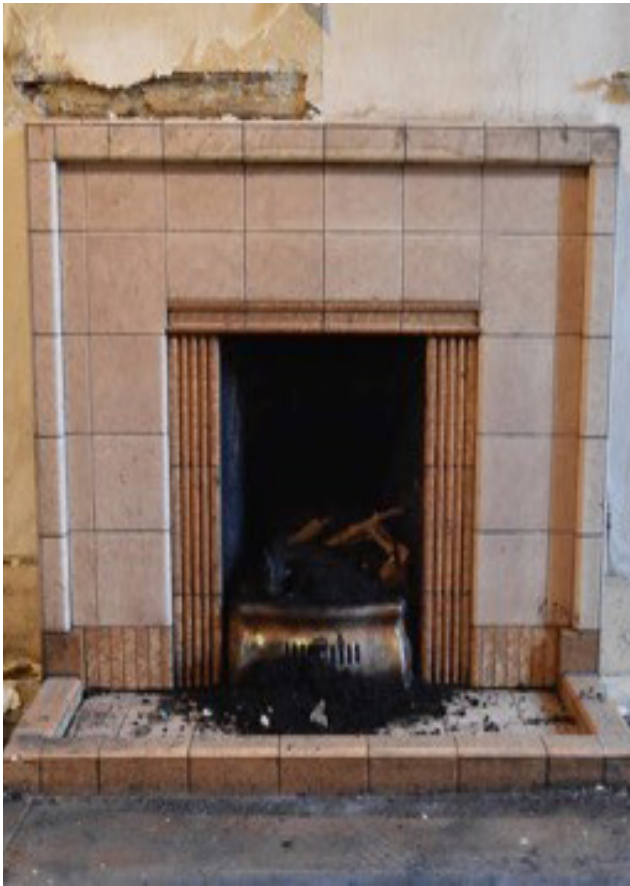
Figure 23: Later fireplace in earlier opening.
Photo: Marianne Sühr

Additionally, consideration should be given to whether the masonry that blocks an earlier opening is forming a structural support (see figure 23). Before masonry is removed wholesale, a trial removal of one or two masonry units could help ascertain structural stability. This investigation, often in conjunction with a camera, can also assist with establishing the condition of the flue, lintel and support, as well as determining whether the removal of later inserted material could result in collapse of masonry above. Advice should be sought from a suitably experienced structural engineer where the integrity of a structure is in doubt.

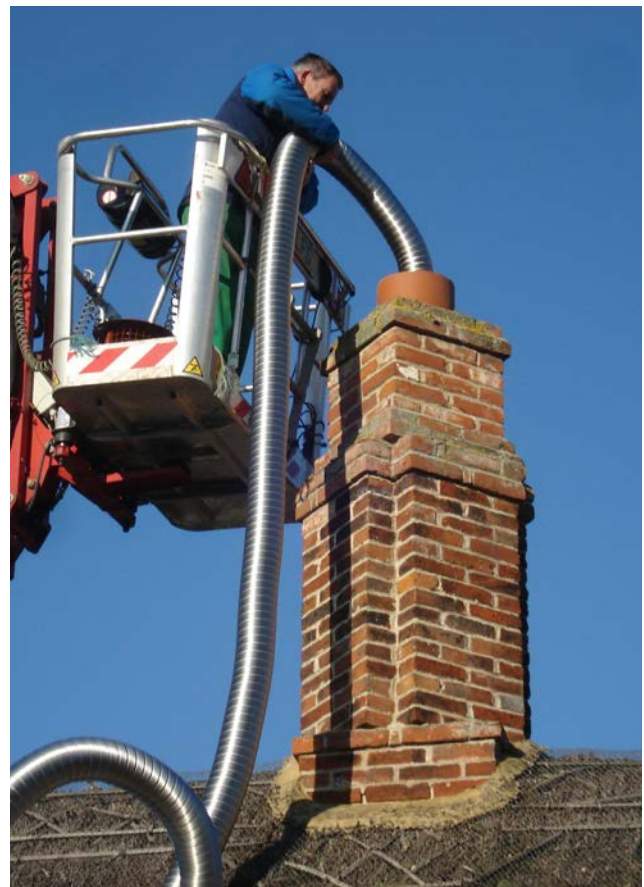
Figure 29: Flexible metal liner being inserted into chimney of thatched cottage to serve new gas stove after removal of a wood burner to reduce the fire risk.

It is advisable to insulate, or use pre-insulated, flexible liners to keep flue gases warmer, achieve a good updraught and reduce the likelihood of condensation with chimneys that are on outside walls or have tall stacks or wide flue diameters. Where the space around a lining is backfilled with loose-fill insulation, this should be breathable but not hydrophilic (moisture-absorbing), as well as incombustible. Foamed glass or expanded clay beads are ideal for this situation. They should not be mixed with mortar, otherwise eventual removal of the liner will be impeded.

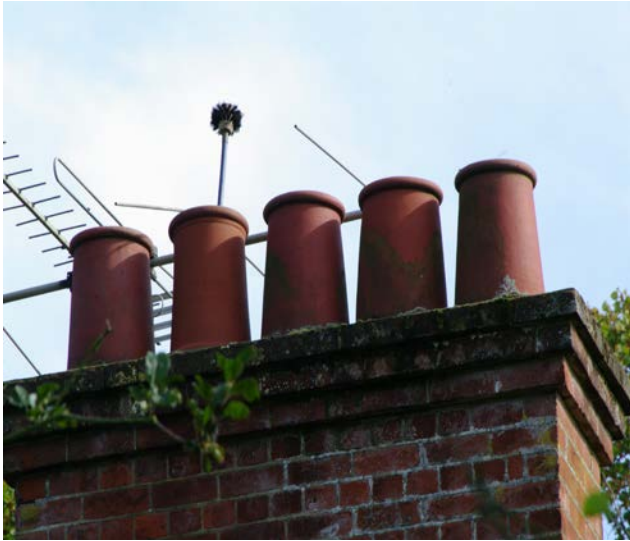
Figure 30: Chimney sweeping.

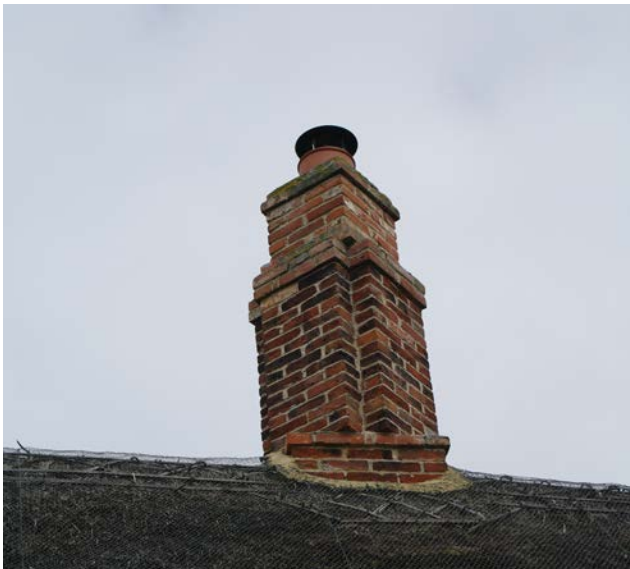
Figure 31: Chimney height raised on thatched cottage.

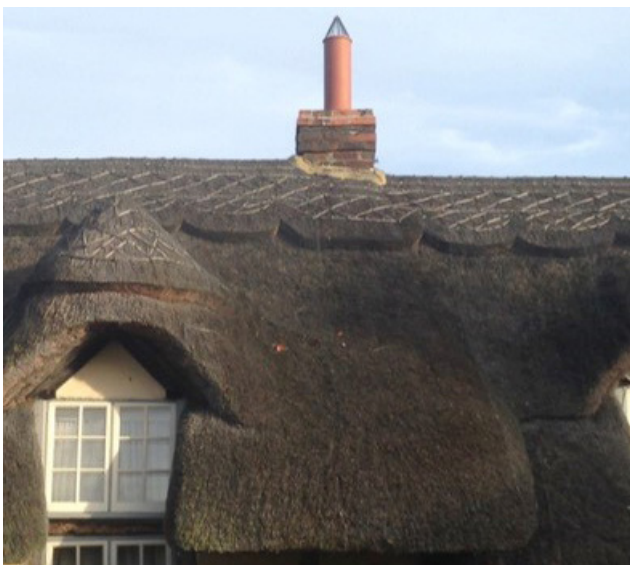
Figure 32: A chimney terminating less than the recommended 1.8 m above the ridge of a thatched building. The top of the terminal with an uninsulated pot is taken as being 150 mm above its base. The addition of a bird guard will reduce fire risk.

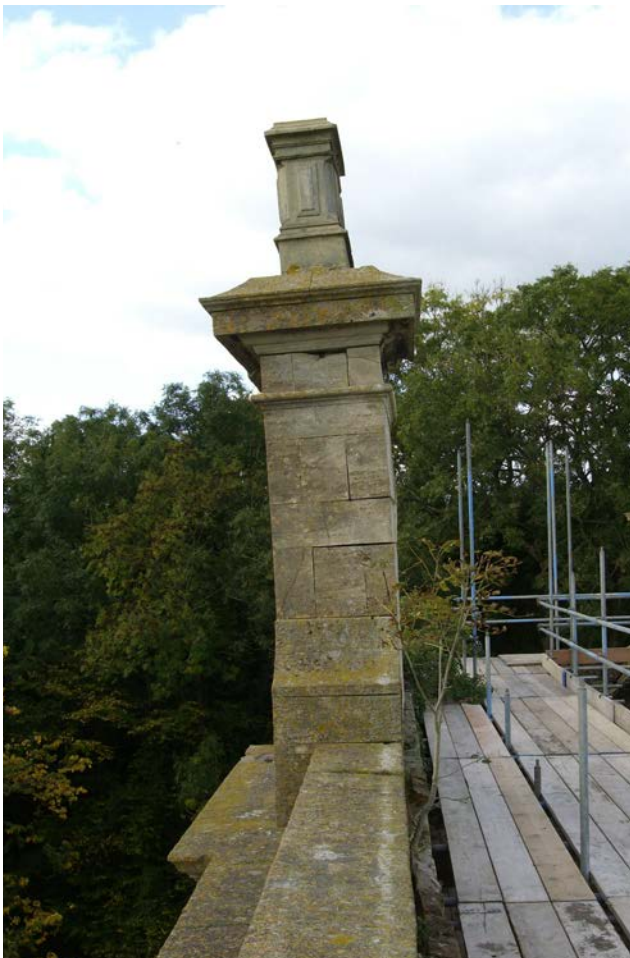
Figure 33: Structural instability.

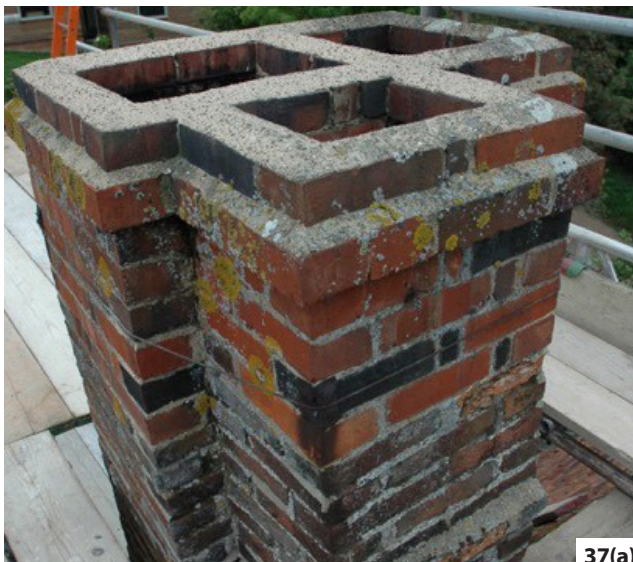
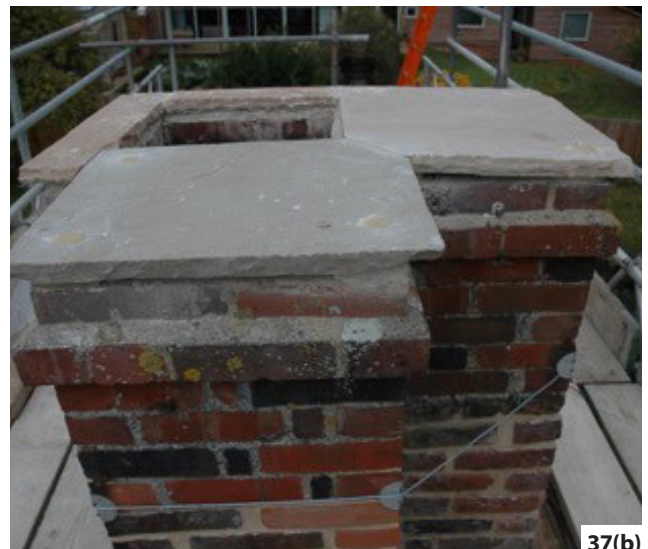
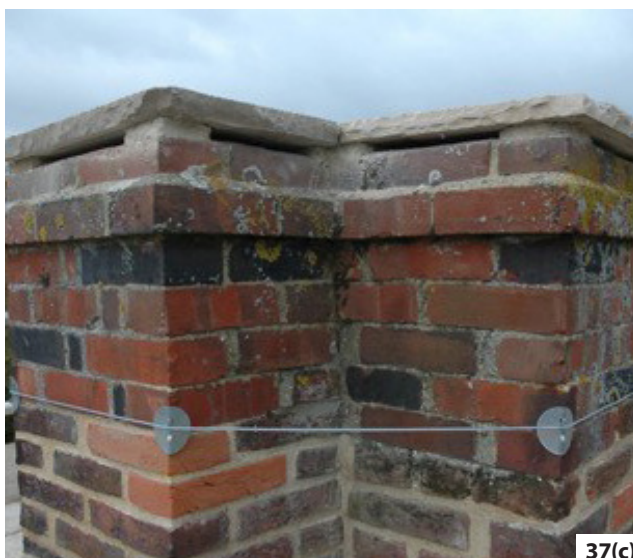
Figure 37: Chimney termination: (a) The stack shown in figure 34 from above. Note the exposure to the weather and previous attempts at repair using cement-based mortars. (b) The top of the stack protected with new stone slabs. The two redundant flues have complete slabs, the working flue has a stone capping to the brickwork. (c) The redundant flues have air slots to prevent condensation. (d) The finished stack, repaired using hydraulic lime mortar.

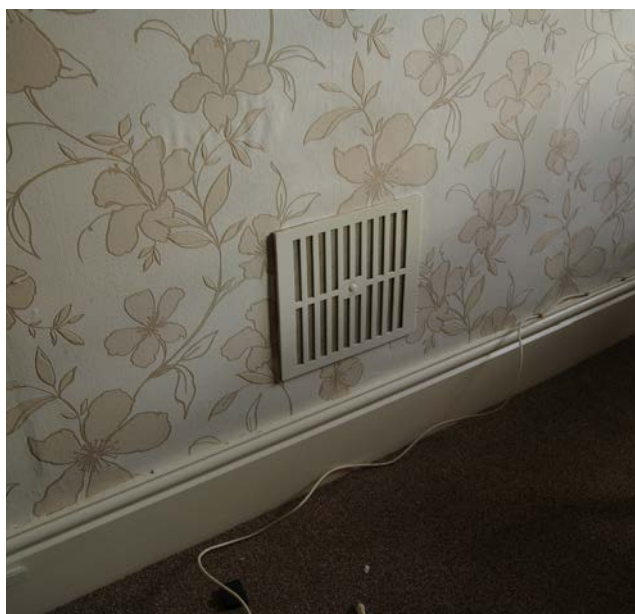
Figure 38: A redundant flue should be ventilated at the bottom where the fireplace opening is blocked off.
