The SPAB Building Performance Survey 2017

Interim Report

ArchiMetrics Ltd.

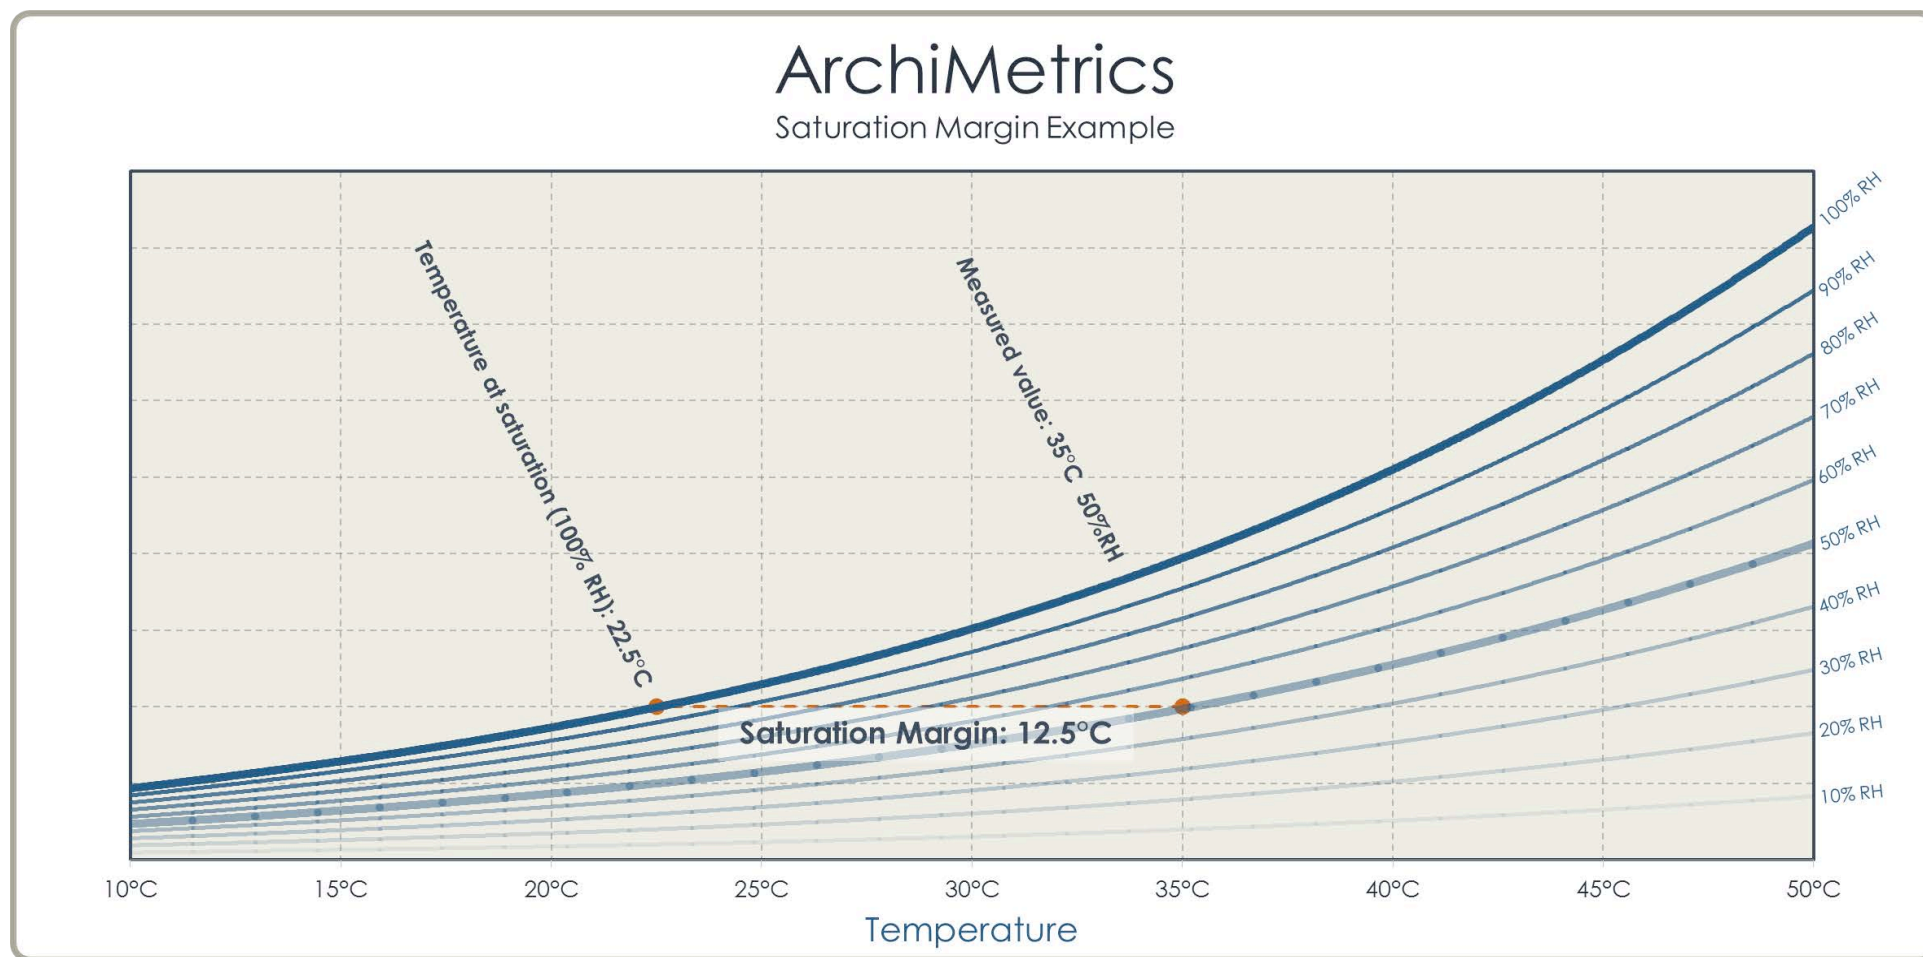
Figure 1. Illustration of saturation margin principle

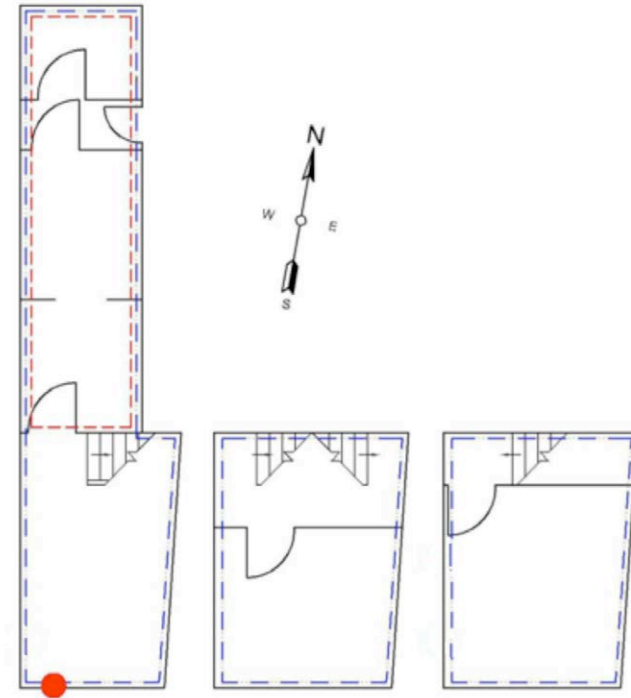
Figure 2. Plan of 116 Abbeyforegate, Shrewsbury, with ground floor on left hand side. The red dot indicates the location of monitoring equipment.

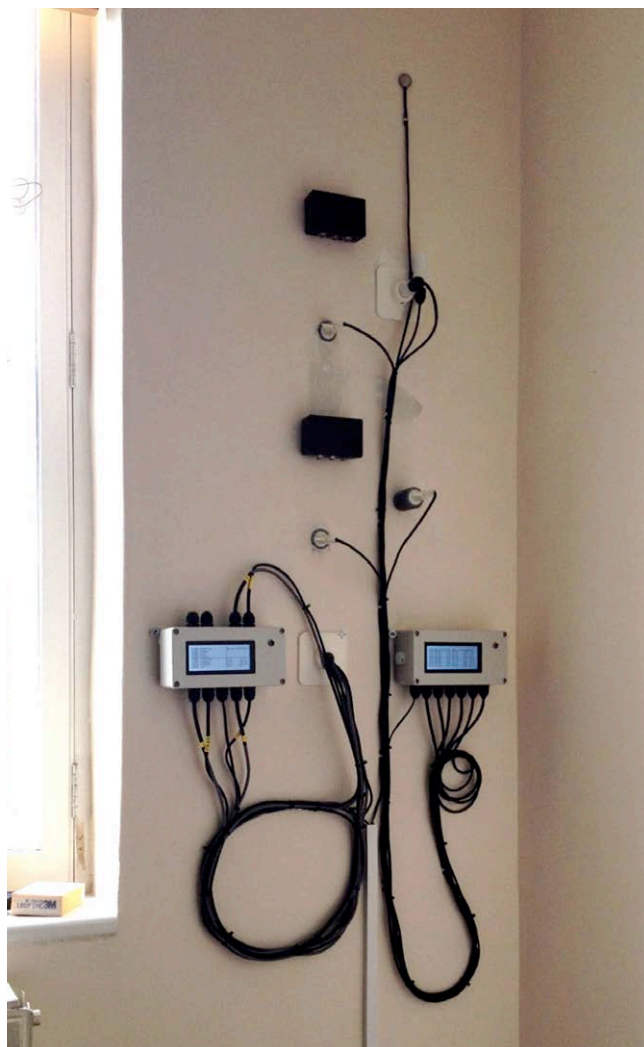
Figure 3. Interstitial hygrothermal gradient and material moisture monitoring, Shrewsbury.

Measurements of temperature and relative humidity (%RH) are being made through a section of south-facing brick wall of the living room at Abbeyforegate (Figures 3 and 4). Combined temperature and relative humidity sensors are located at four points within the wall at the heights and depths given in Table 1. This Table also gives details of the wall build-up before and after insulation (in green).

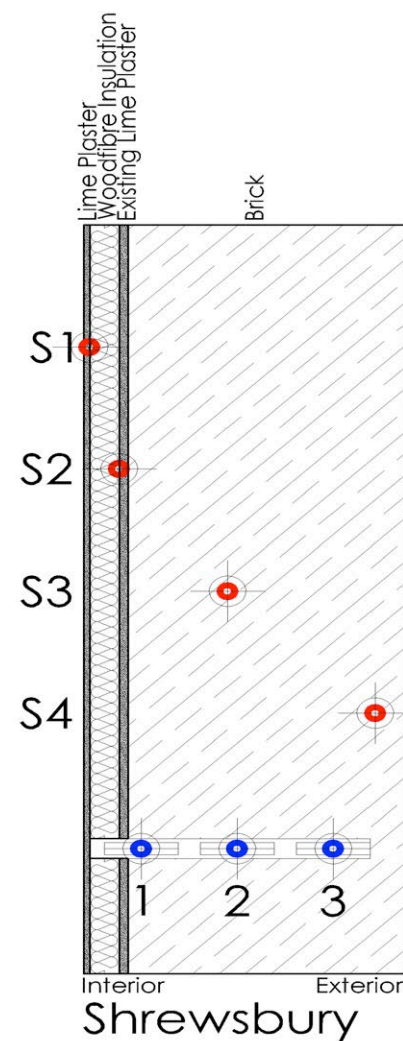
Figure 4. Position of wall sensors through section, Shrewsbury – red IHGM, blue material moisture.

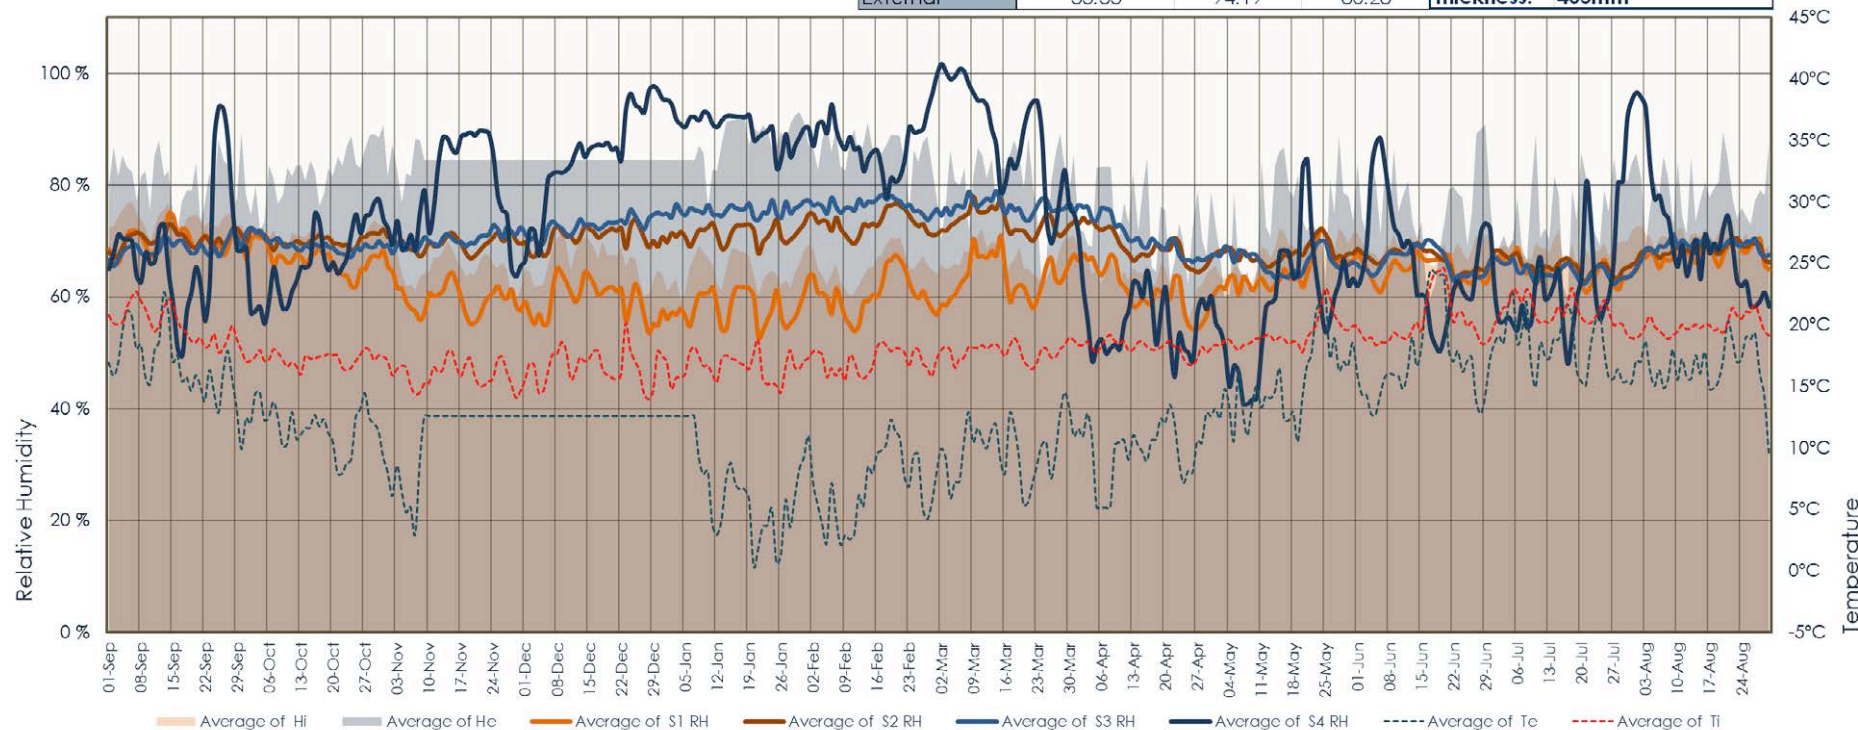
Figure 5. Relative humidity over time, daily aggregation, Abbeyforegate, Shrewsbury 2016-2017. (Ti = Internal temperature, Te = External temperature, Hi = Internal RH, He = External RH.)

Figure 5 shows the RH responses measured in and around the test wall at Shrewsbury over the past year. These show moisture vapour behaviour to be broadly consistent with those measured over previous

years, post-refurbishment. The %RH responses are quite dynamic and we have ascribed this to the condition of the wall. The wall is quite thin and made of porous and permeable brick, it is south-facing so receives direct sunlight as well as the affects of the prevailing weather, with pointing in a poor state of repair. These elements combine to create a changeable picture with regards to heat and air exchange for the wall with a concomitant effect on temperature and moisture behaviour. Of continued note are the extremes of response at sensor 4 located in close proximity to external conditions, 50 mm back from the external wall surface.

Moisture behaviour in the wall at Shrewsbury is closely linked with external weather conditions. This year (2016-17) %RH is generally lower throughout the section (Table 2) and the annual averages of %RH at sensors 3 and 4 are, in particular, much lower than those of the previous year. As can be seen in the aggregated data, Figure 5, there is a week at the start of March when %RH exceeds 100% at sensor 4. This is in contrast to previous years when records of %RH from this location, towards the external side of the wall, have exceeded 100% persistently for a number of months over winter.

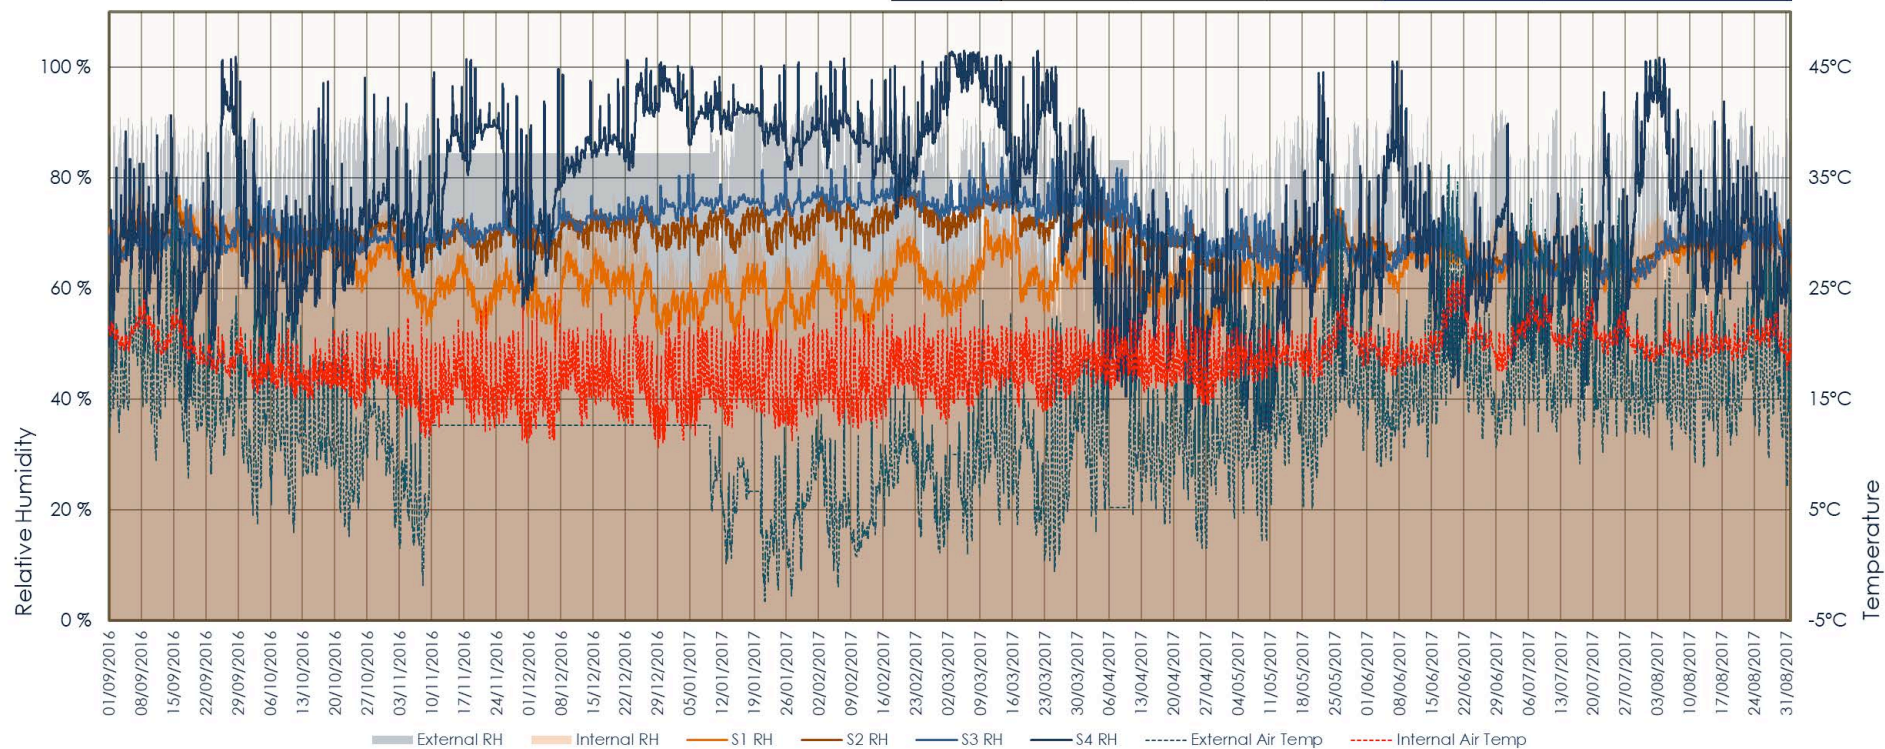
Figure 6. Relative humidity over time, full resolution, Abbeyforegate, Shrewsbury 2016-2017

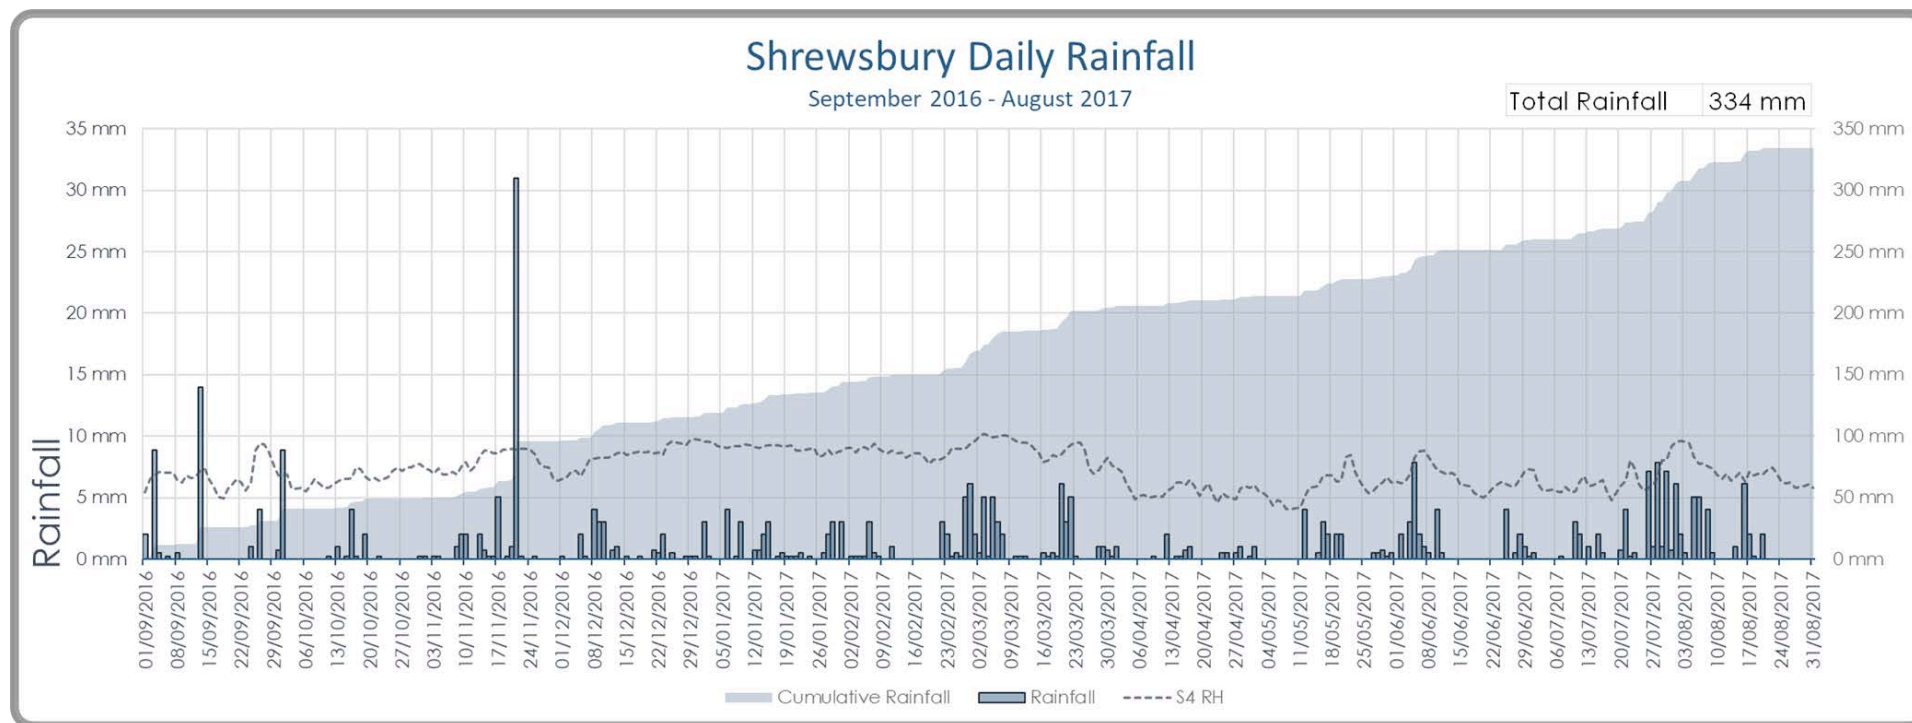
Figure 7. Daily and annual rainfall mm, including S4 RH trace, Shrewsbury 2016-2017.

The 'high' peaks of RH found for this year at sensors 3 and 4 are caused by a spell of wetter weather at the end of February/start of March. The wettest day of this period occurred on February 28th leading two days later, 2nd March, to the peak in sensor 4 and a week later, 9th March, to the peak at sensor 3. These peaks are best identified from the non-aggregated full resolution analysis in Figure 6. Following this, there is a period of rapid decrease in %RH measured at sensor 4, as has been observed in previous years over a similar time period, as material closest to the external environment dries by evaporation. Likewise, sensor 3 follows a similar but less extreme trajectory shortly afterwards for the same reason. Thereafter, occasional peaks in RH towards the external side of the wall can be accounted for by clusters of rainy days which occur sporadically through the remaining spring and summer months, Figure 7.

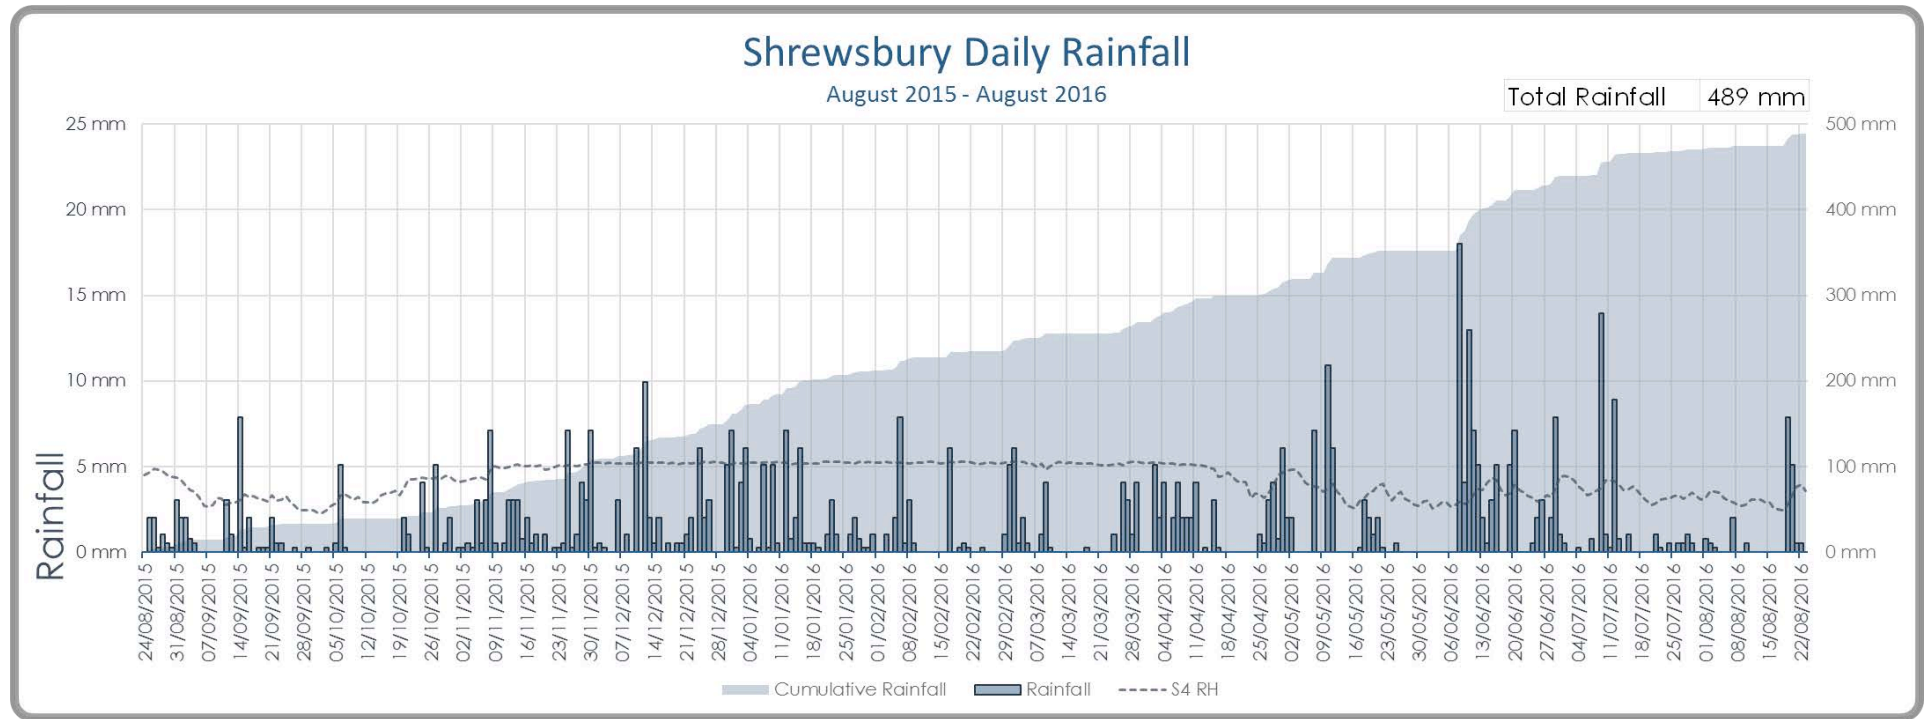
Figure 8. Daily and annual rainfall mm, including S4 RH trace, Shrewsbury 2015-2016.

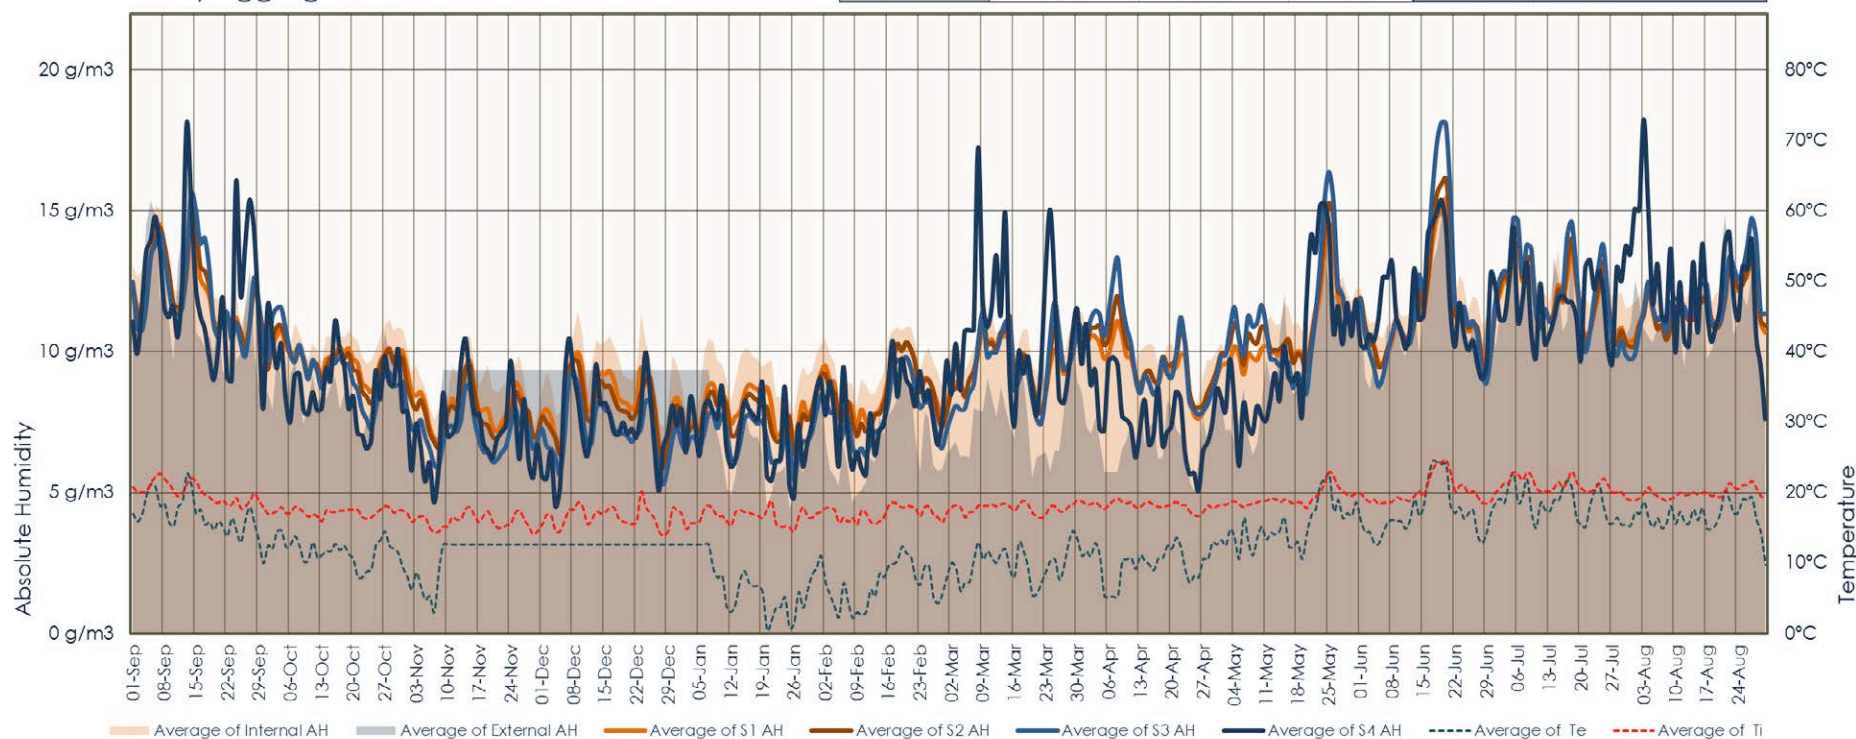
Figure 9. Absolute humidity over time, daily aggregation, Abbeyforegate, Shrewsbury 2016-2017.

Figure 9 shows an analysis of absolute humidity through the insulated wall section at Shrewsbury 1st September 2016–31st August 2017. Peaks in AH, measured as the weight of vapour, g/m^3 , can be indicative of materials drying through evaporation during periods of warm weather. This response is particularly marked in the wall at Shrewsbury as it is south-facing and receives plenty of direct solar radiation.

As can be seen in Figure 9, external temperatures start to rise at the end of February/beginning of March. In the second week of March, external temperatures reach a peak at around 25°C causing an 'evaporative' spike at sensor 4 (these peaks are more obvious in the full resolution analysis, Figure 10). This peak is followed by further diminishing temperature/AH spikes throughout the rest of March as drying takes place towards the external face of the wall. In April, as materials closest to the external wall face have now evaporated winter-accumulated moisture, this pattern of temperature/AH spikes can now be seen at sensor 3, as a similar drying process takes place deeper within the wall fabric. Throughout March and April evaporation

The final peak visible in Figure 9 occurs predominantly at sensor 4 around the 3rd August. It has rained every day in the preceding week (week commencing 27th July) and every other day of this week has seen daily rainfall totals of over 50 mm. It continues to rain into the week of the 3rd August, creating the longest period of persistent rain seen for this dry year. The RH over time analysis, Figure 5, not surprisingly shows an increase in humidity at sensor 4 during the week of rain and a peak of RH occurring at the end of this week. The

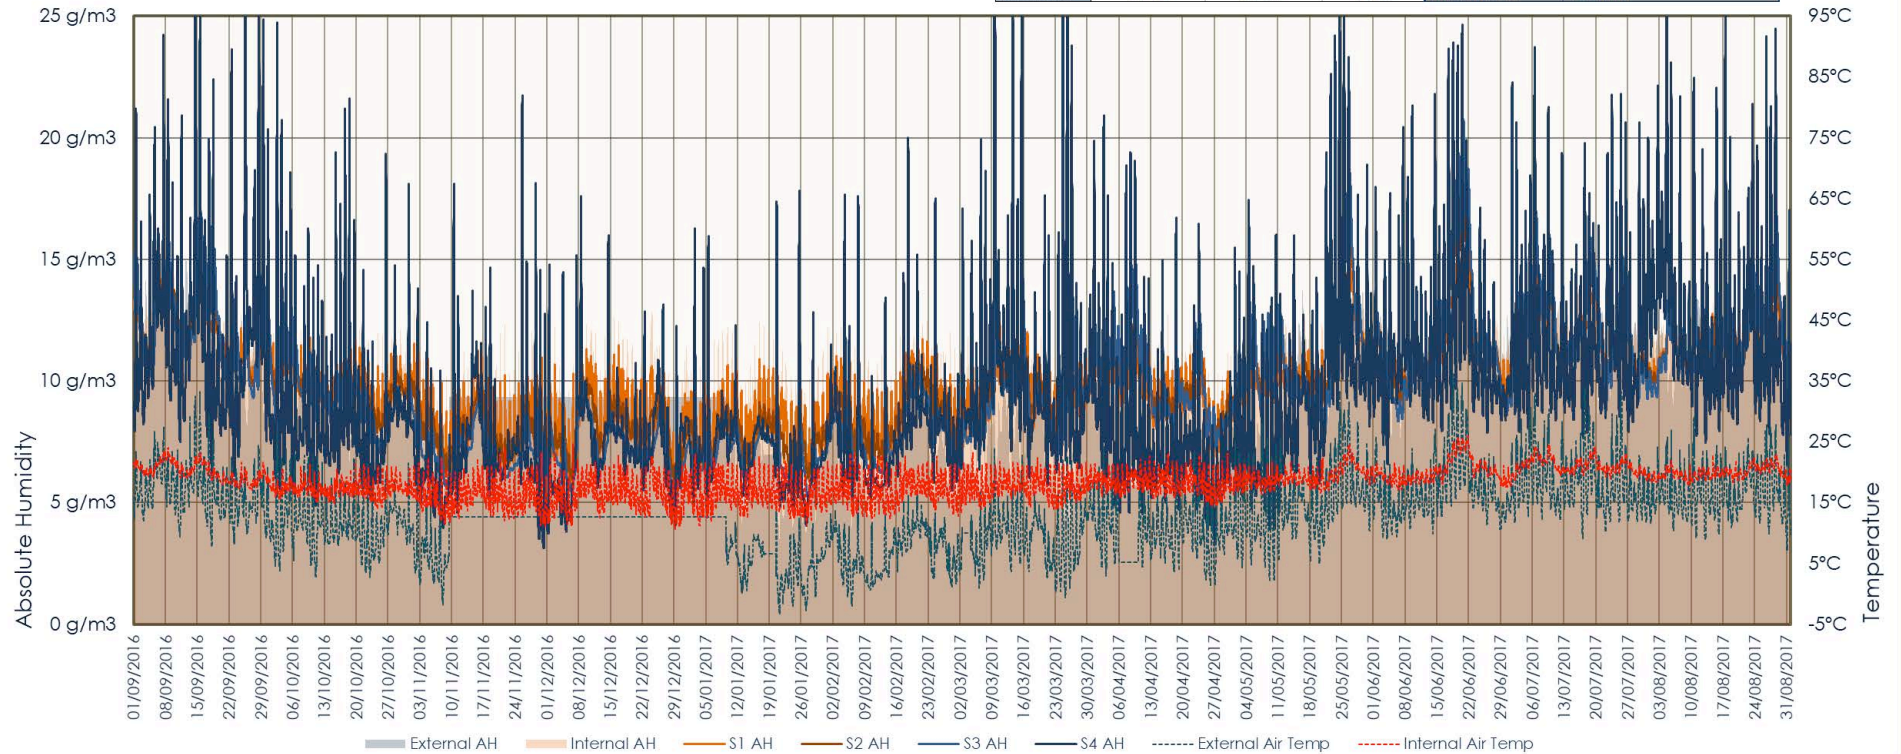
Figure 10. Absolute humidity over time, full resolution, Abbeyforegate, Shrewsbury 2016–2017.

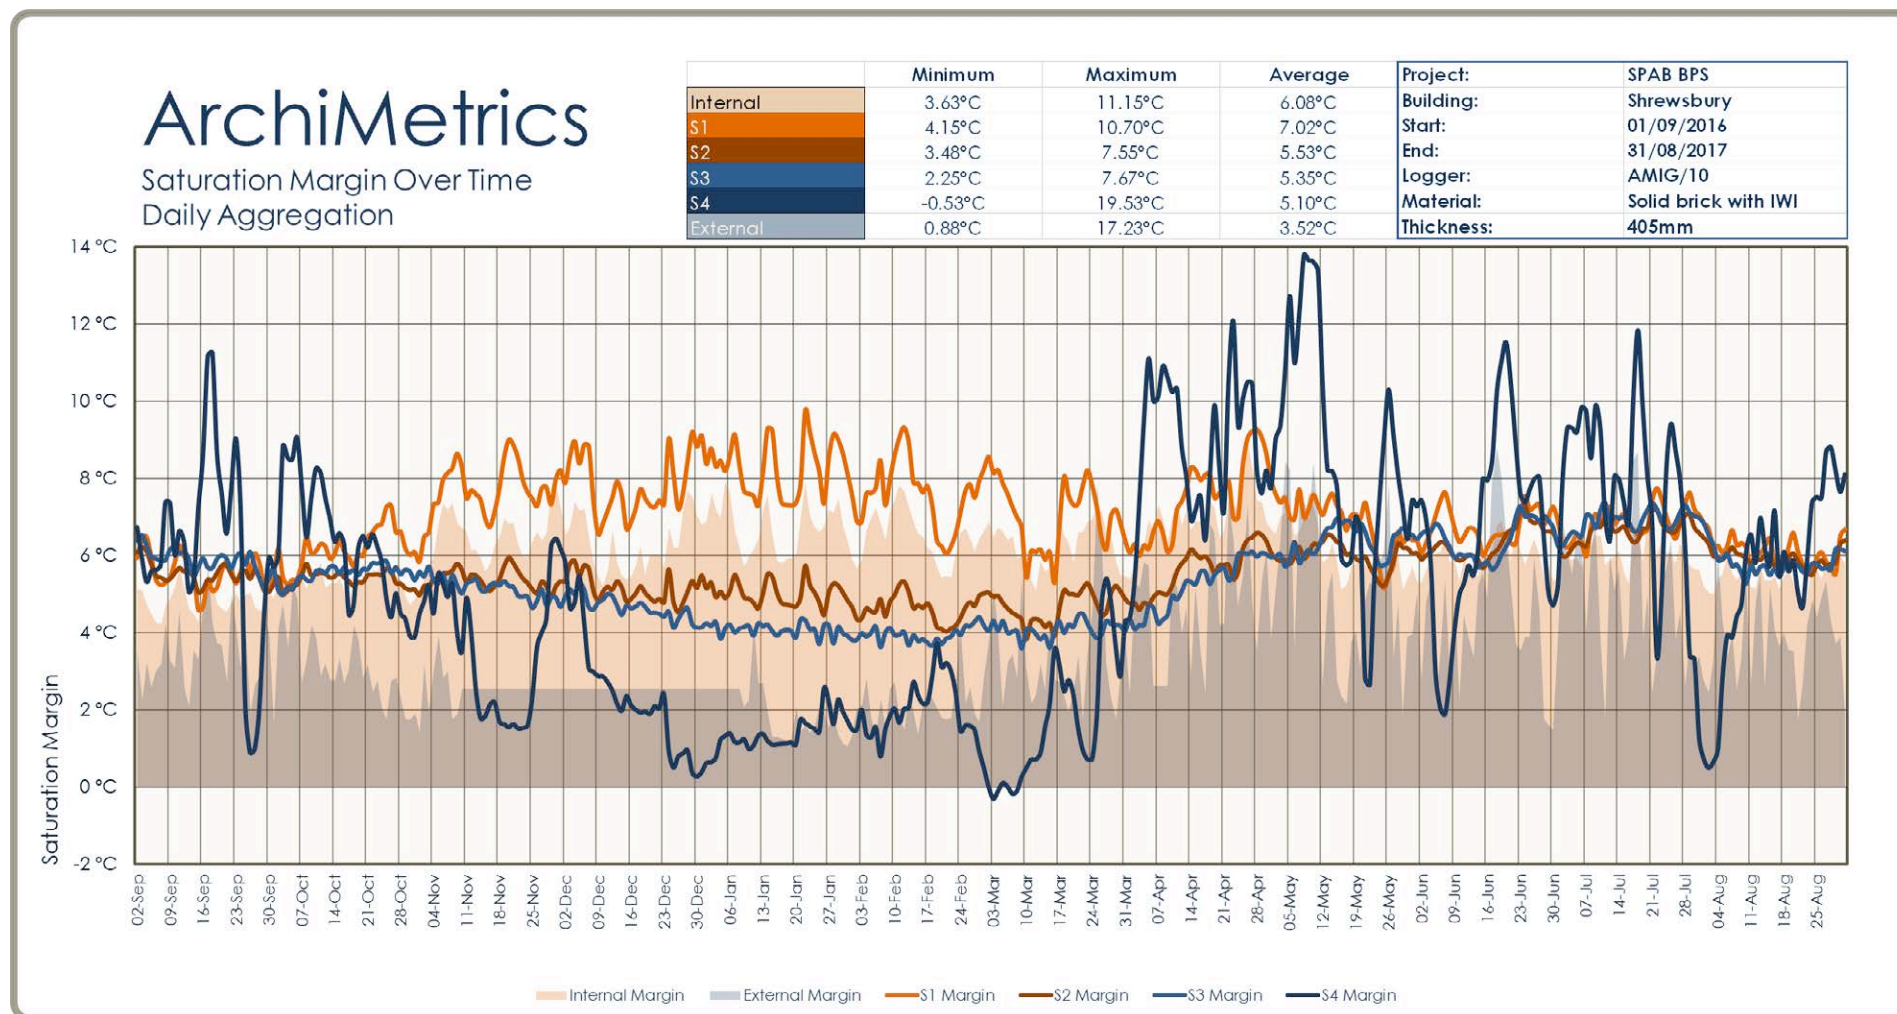
Figure 11. Saturation margin over time, Abbeyforegate, Shrewsbury 2016-2017.

Unusually, in comparison with previous years there is only a brief period of time over the 2016–17 winter when the wall at sensor 4 measures negative saturation margins, week commencing 3rd March 2017. The minimum margin recorded is less than that of one degree Celsius, -0.57°C . Once again, the plot of sensor 4 is closely related to external conditions, which have been particularly dry over the past twelve months of this year's analysis. Thus, this year we do not find an extended period of time over the winter months when the wall experiences saturation conditions towards the external wall leaf. The negative margins at sensor 4 are a function of a period of wet weather and cold temperatures towards the end of February, already noted in the RH over-time analysis, Figure 5, as the only time RH exceeds 100% during the analysis year. This nadir for sensor 4 is followed by a two-month period where margins at sensor 4 increase due to an extended period of 'drying' during the spring previously referenced in the AH analysis. As with the RH analysis, sensor 4 experiences the greatest variation in values over the year covering the widest range of RH and saturation margins of the four sensors in the wall as it experiences both the wettest and driest (hottest) conditions.
