The SPAB Building Performance Survey 2017

Interim Report

ArchiMetrics Ltd.

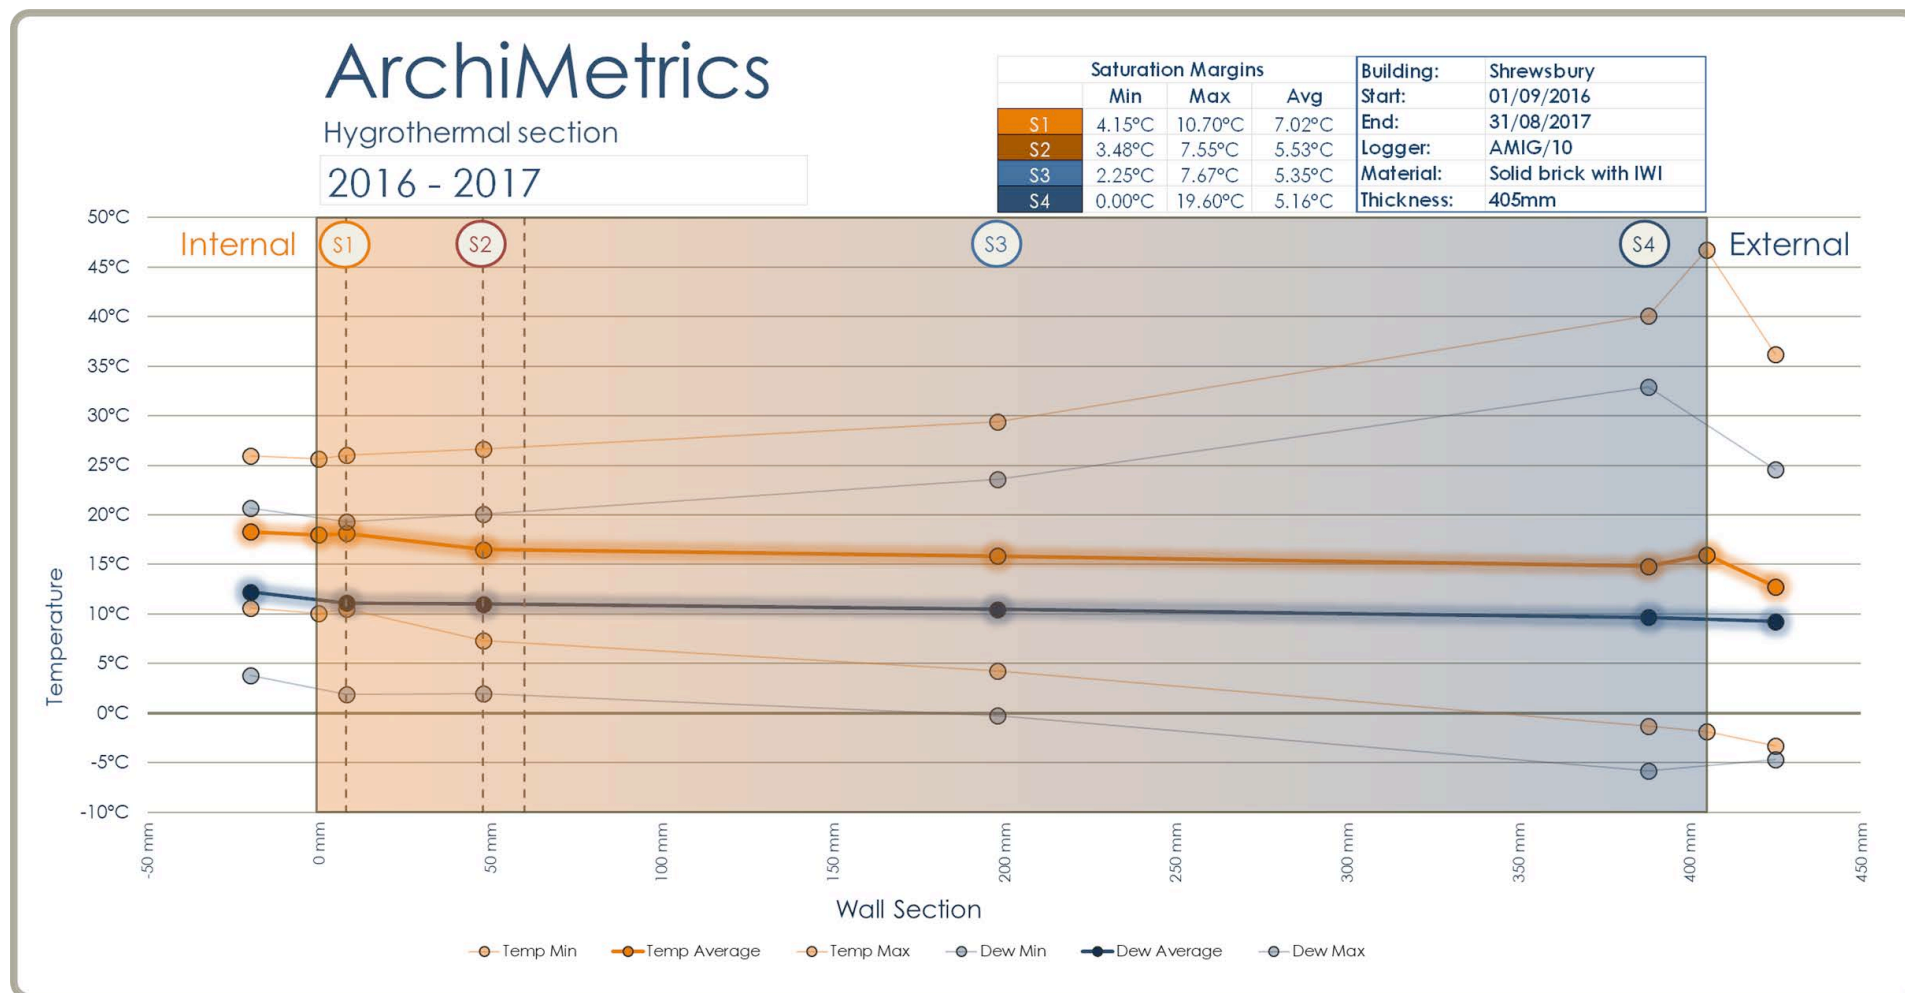
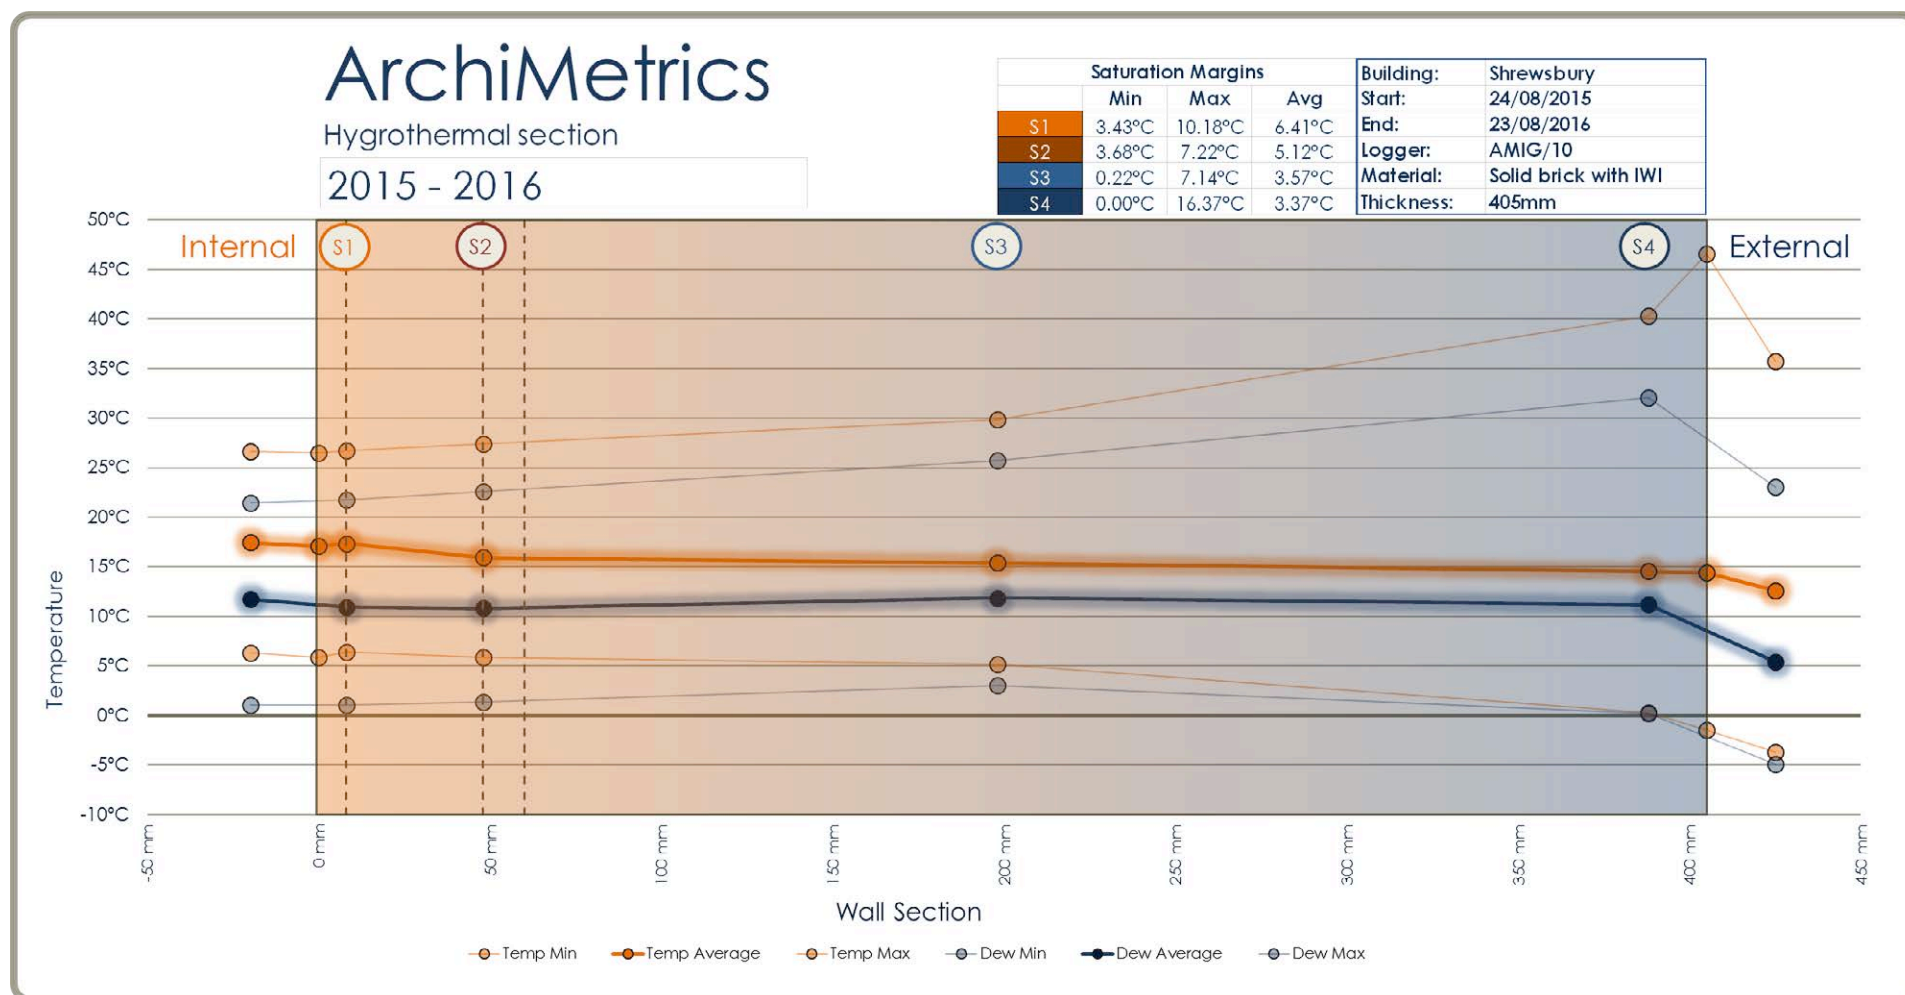
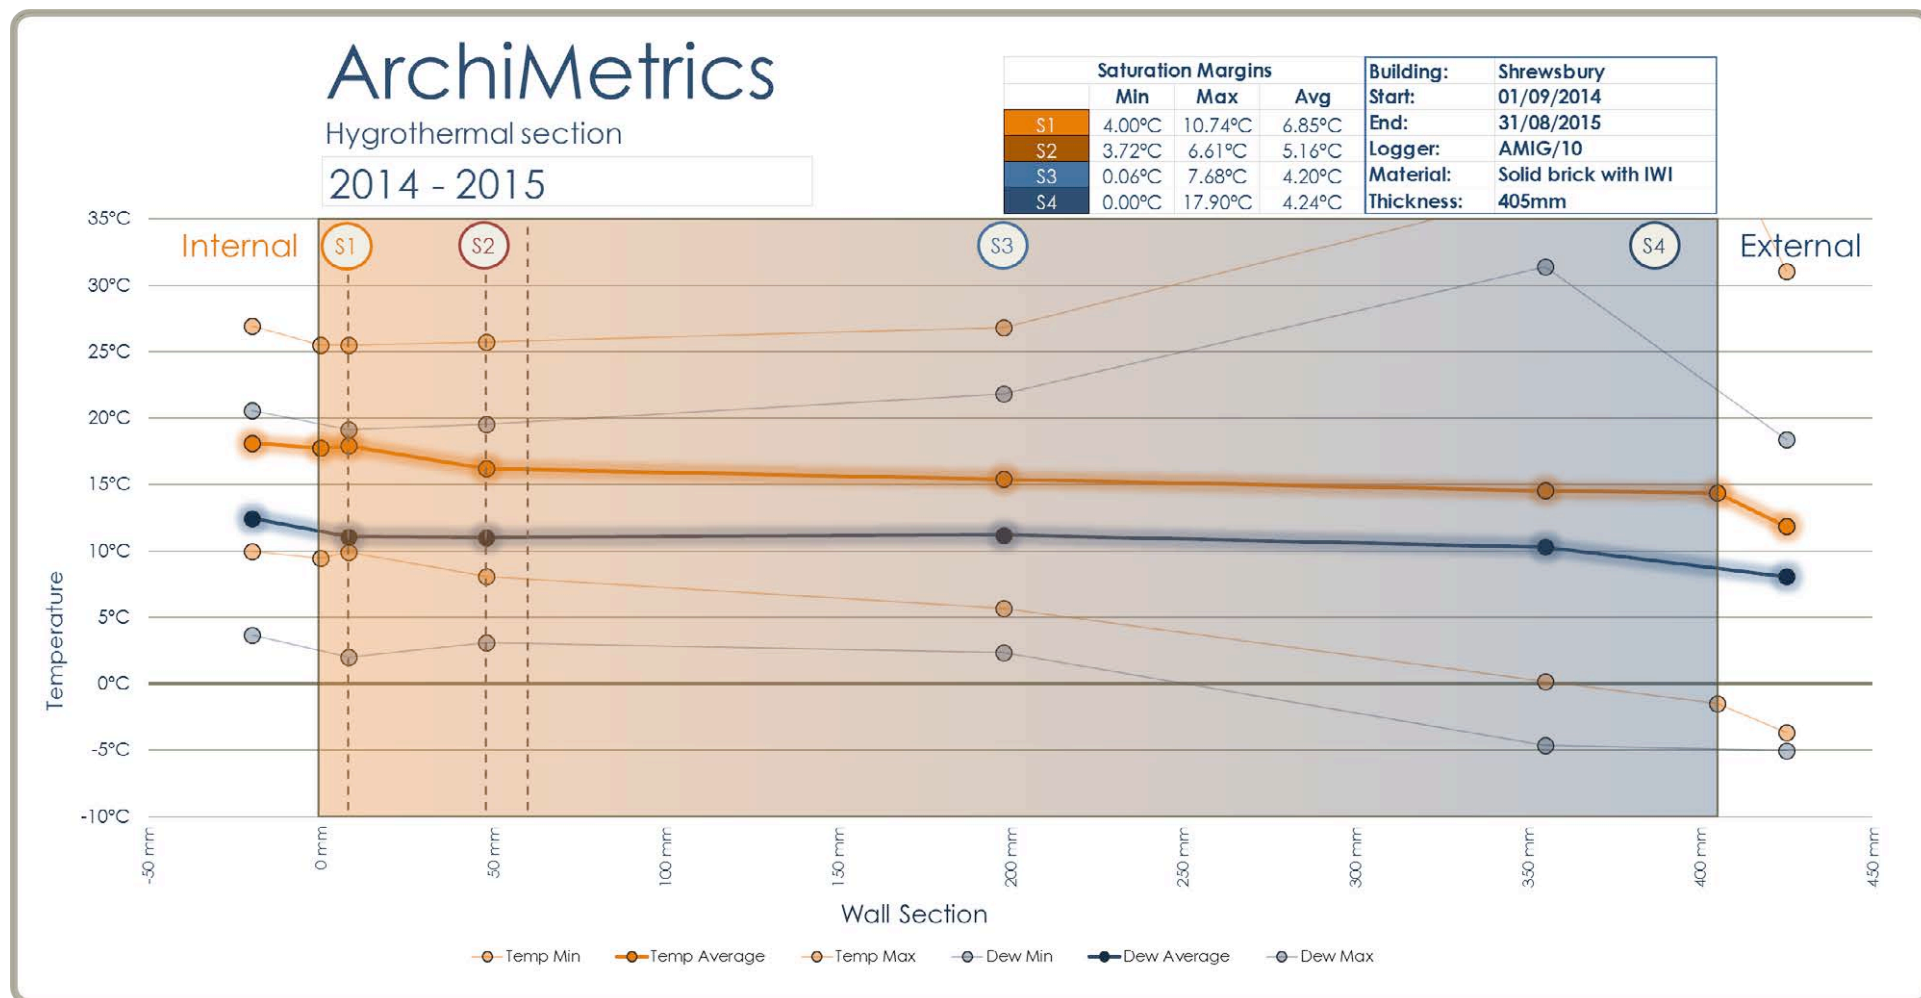
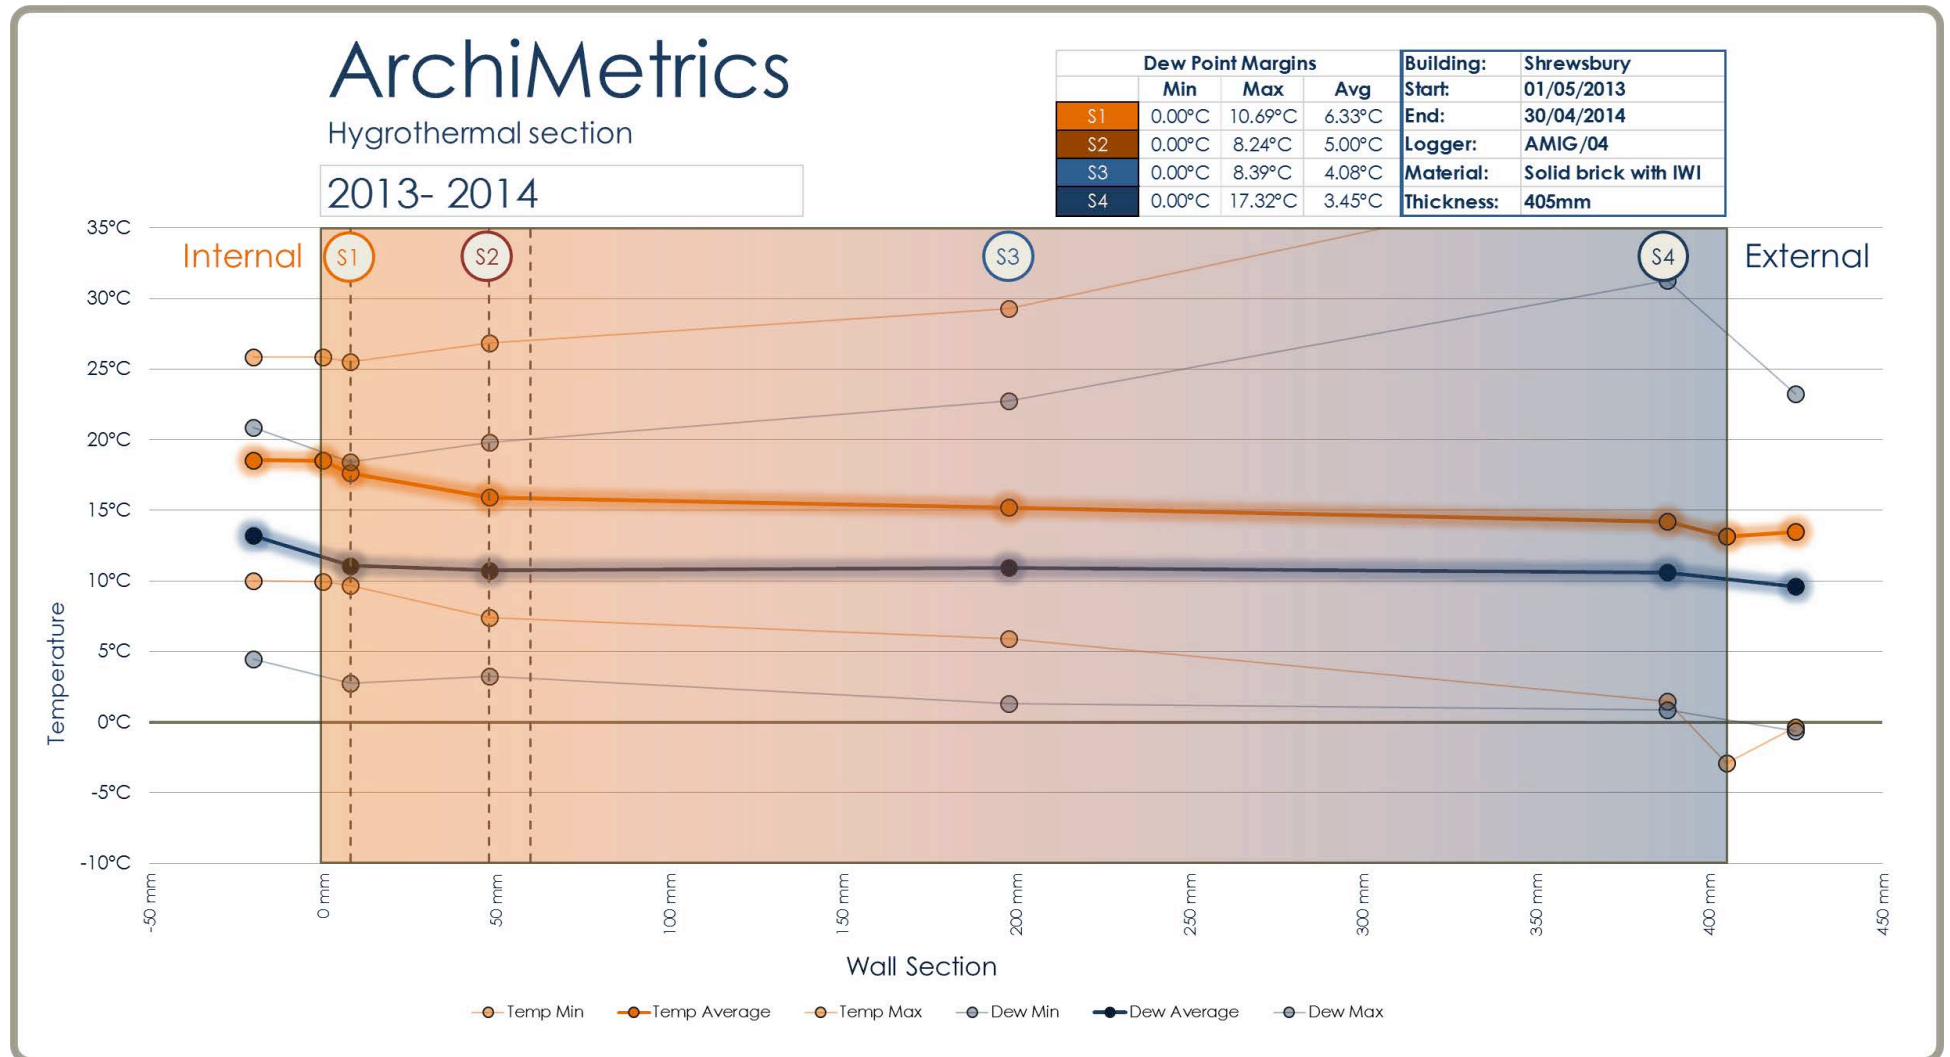
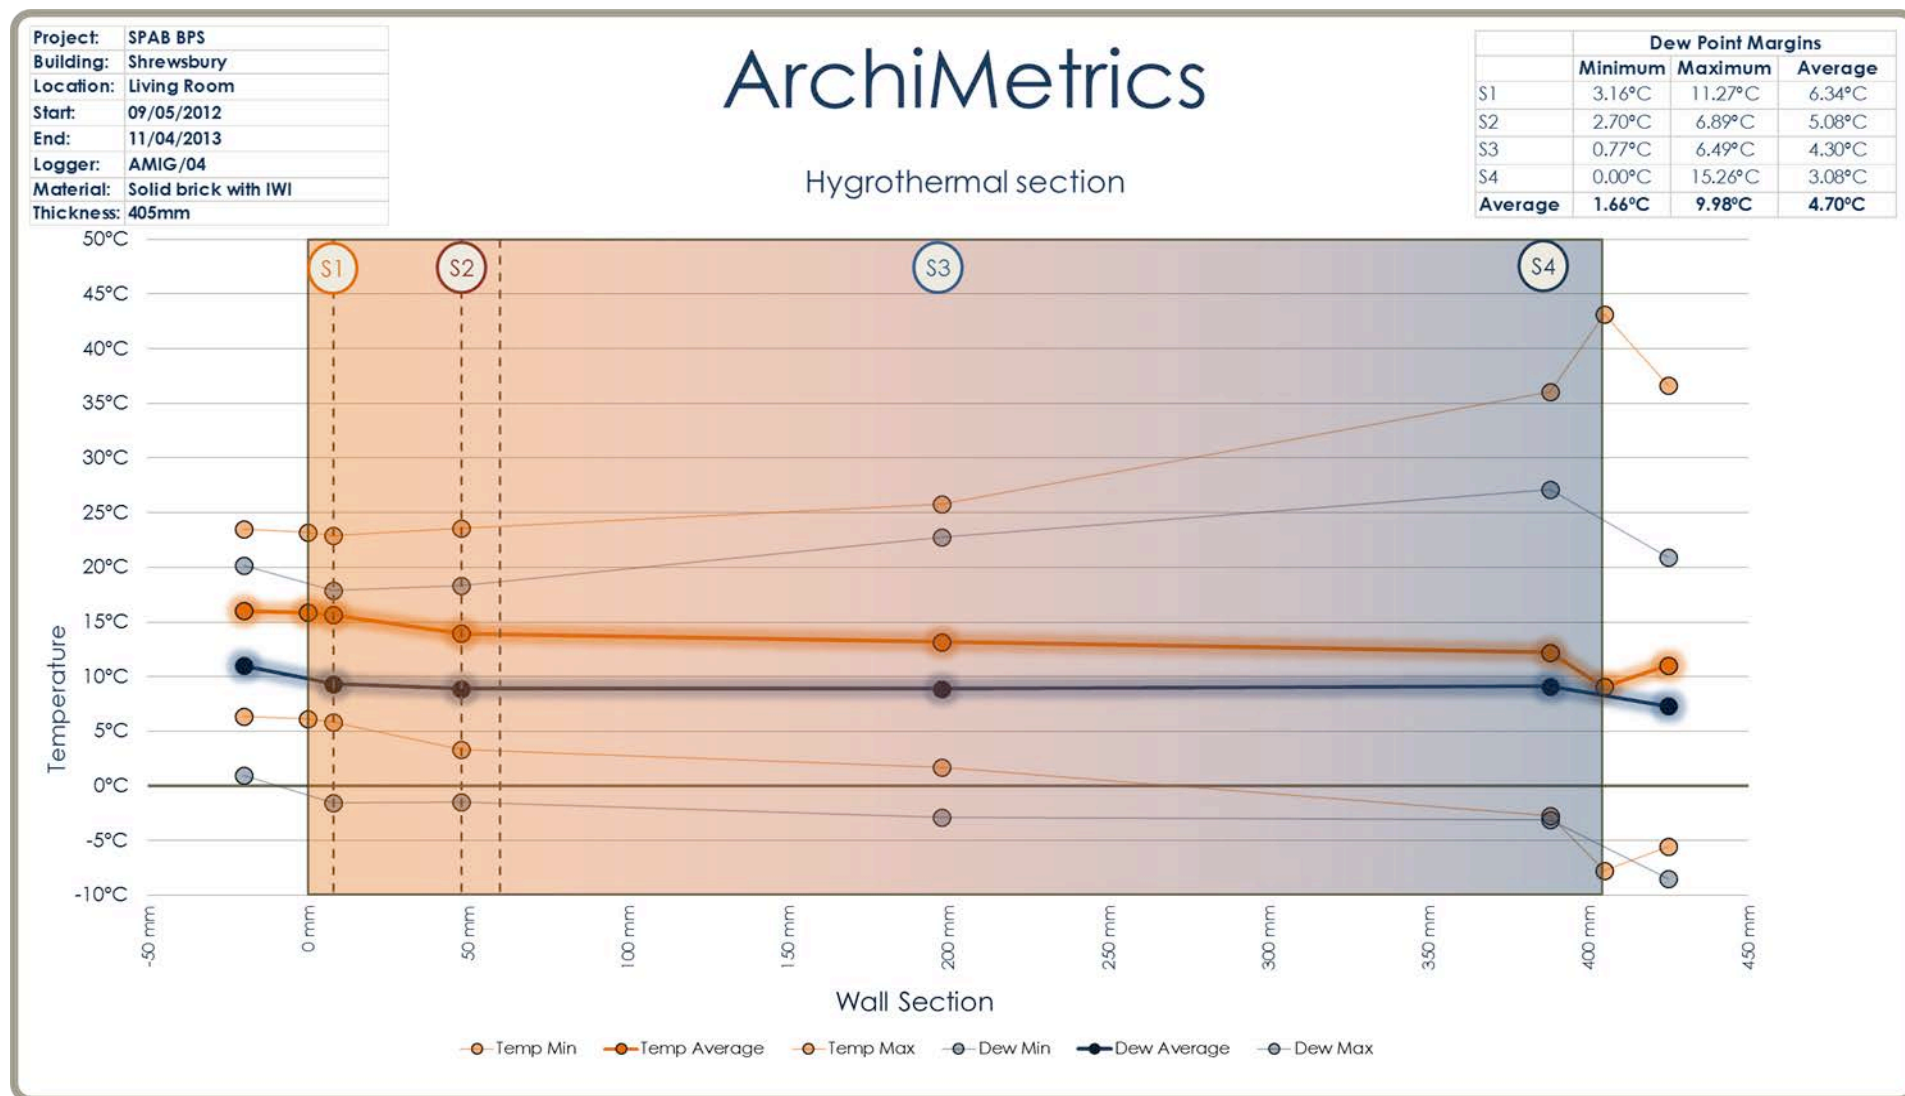
Figure 12. Hygrothermal section, Abbeyforegate, Shrewsbury 2016–2017 (capped).

Figure 13. Hygrothermal section, Abbeyforegate, Shrewsbury 2015–2016 (capped).

Figure 14. Hygrothermal section, Abbeyforegate, Shrewsbury 2014–2015 (capped).

Figure 15. Hygrothermal section, Abbeyforegate, Shrewsbury, 2013-2014.

Figure 16. Hygrothermal section, Abbeyforegate, Shrewsbury, 2012-2013.

Measurements of temperature and RH are also used to plot annual averages of measured temperature and dewpoint temperature gradients through the wall section (Figures 12-16). These analyses show the similarity and differences between the past five years. This year's analysis, Figure 12, shows (like Table 6), the widest average margins (with the exception of sensor 2) found through the wall section for the wall both pre- and post-insulation. Through the four measurement points, on average, we find no convergence of the two gradients which, in other thicker walls with a less sunny aspect, coalesce towards the external wall face as behaviour during the colder winter months dominates the analysis. This suggests that over an annual cycle the wall is performing within safe margins with regard to risks from moisture.

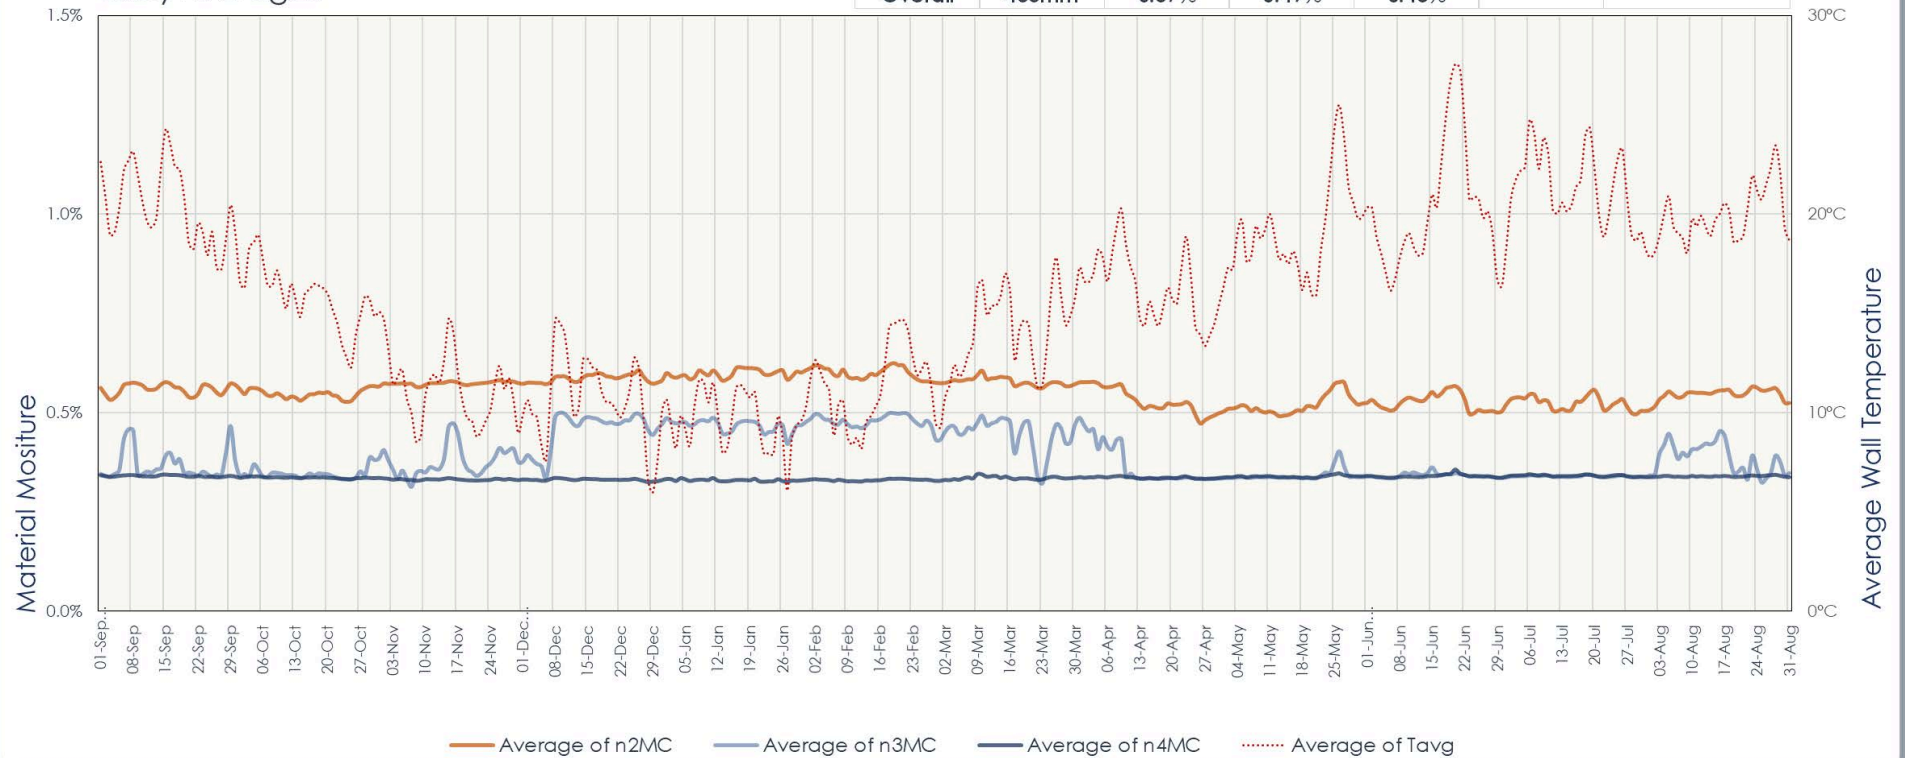
Figure 17. Material moisture content over time, Abbeyforegate, Shrewsbury 2016-2017.

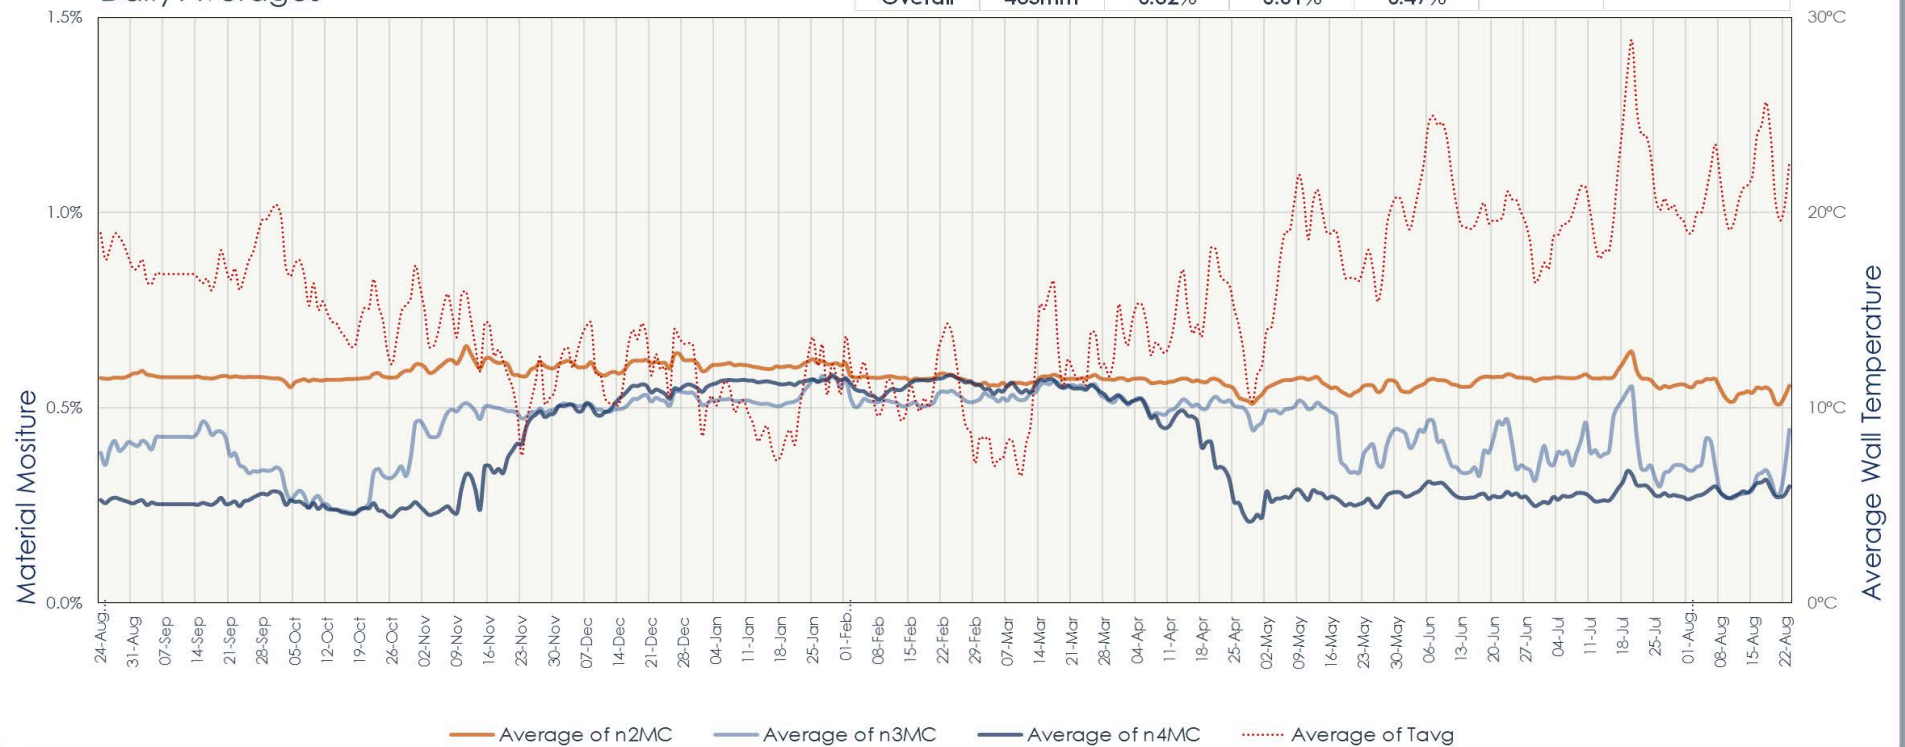
Figure 18. Material moisture content over time, Abbeyforegate, Shrewsbury 2015-2016.

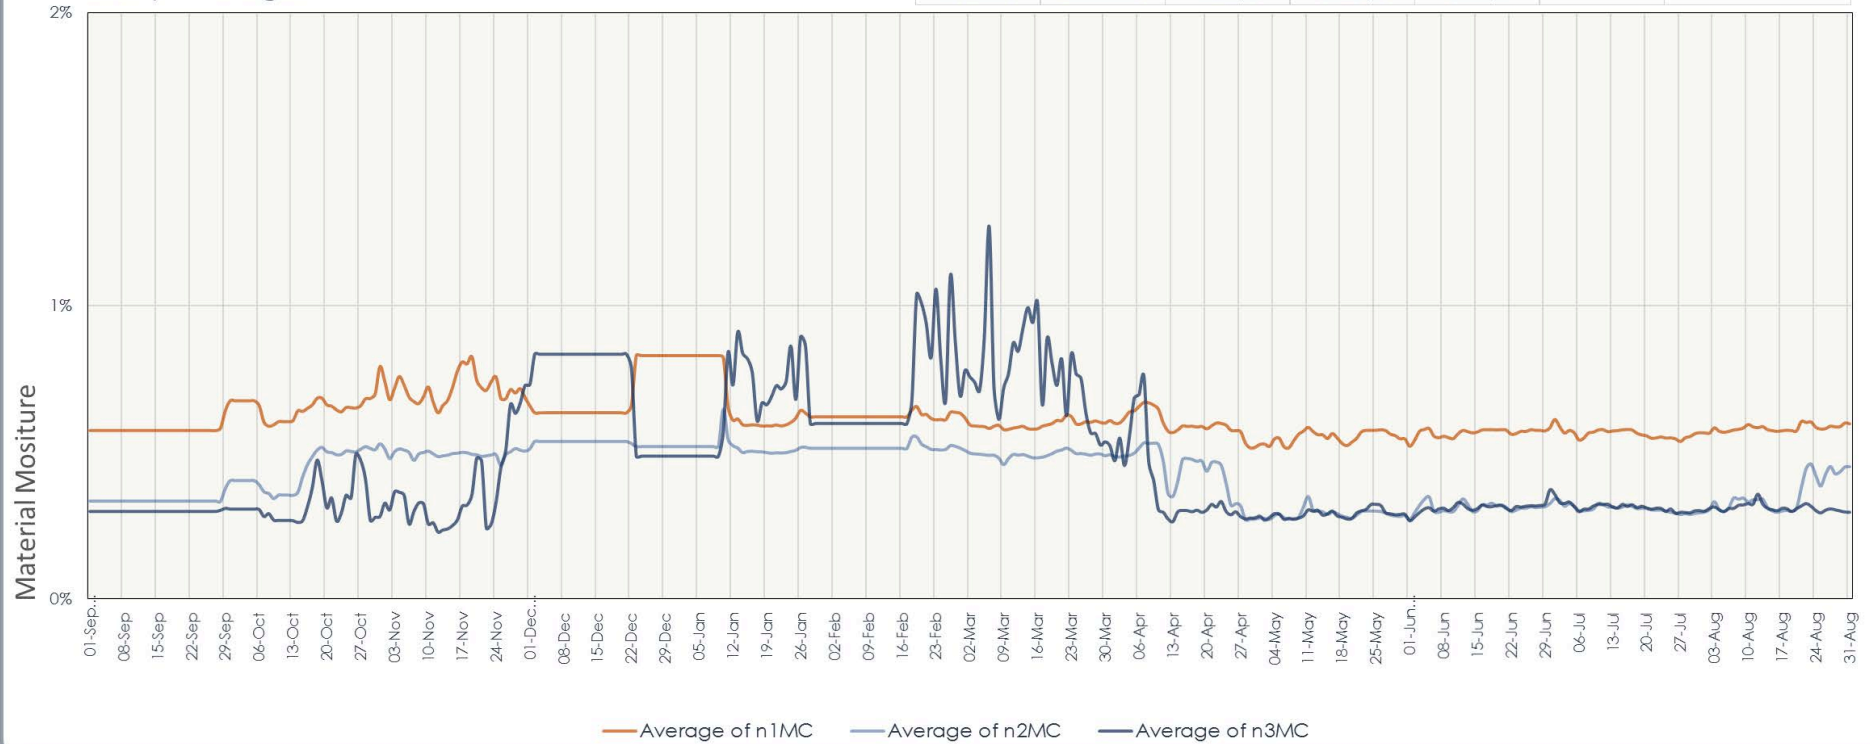
Figure 19. Material moisture content over time, Abbeyforegate, Shrewsbury 2014-2015.

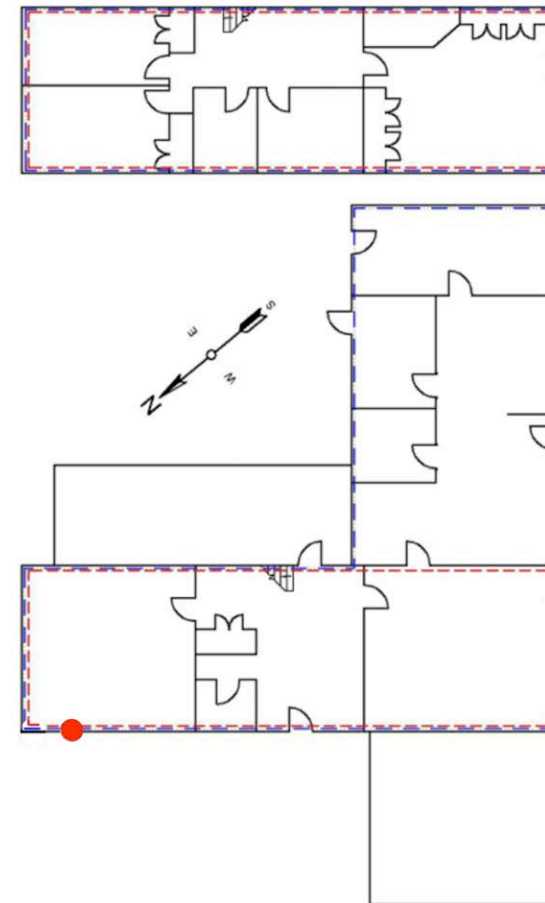
Figure 20. Plan of Mill House, Drewsteignton, the red dot indicates the location of the ground floor monitoring equipment.

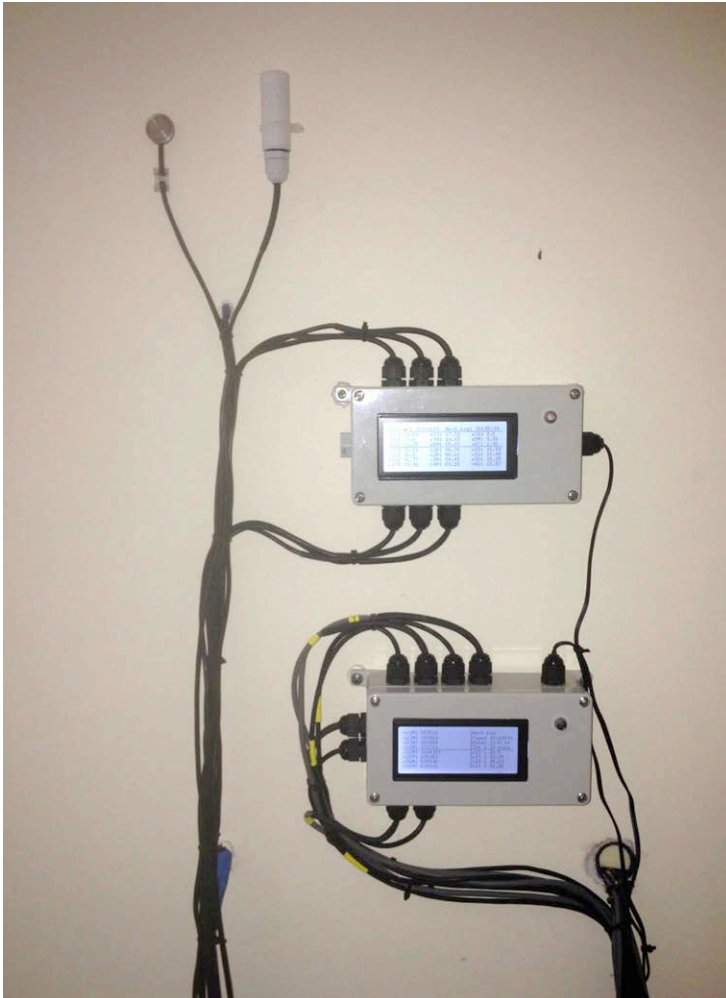
Figure 21. Interstitial hygrothermal gradient and material moisture monitoring, Drewsteignton.

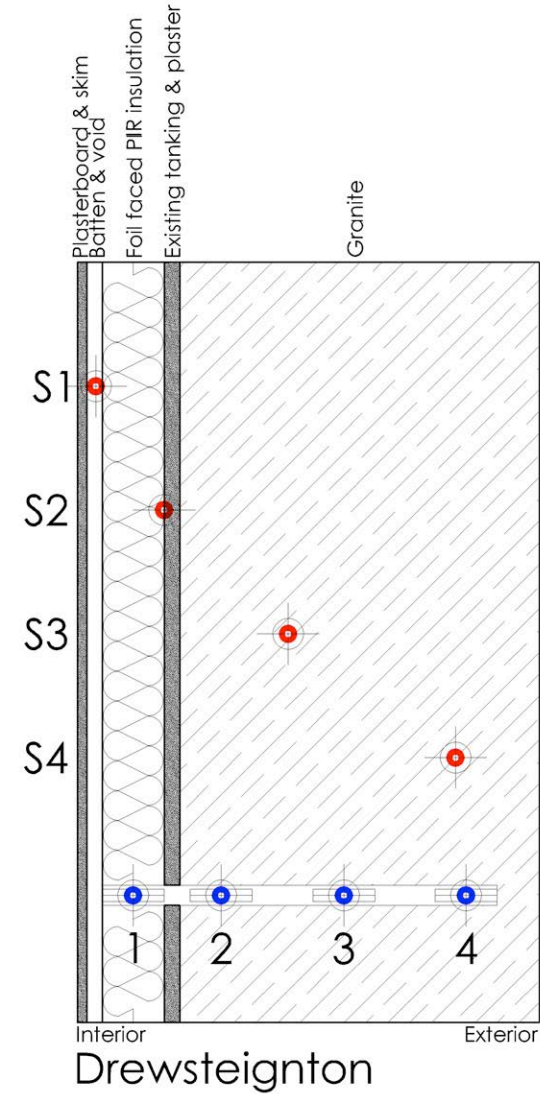
Figure 22. Position of wall sensors through section, Drewsteignton – red IHGM, blue material moisture

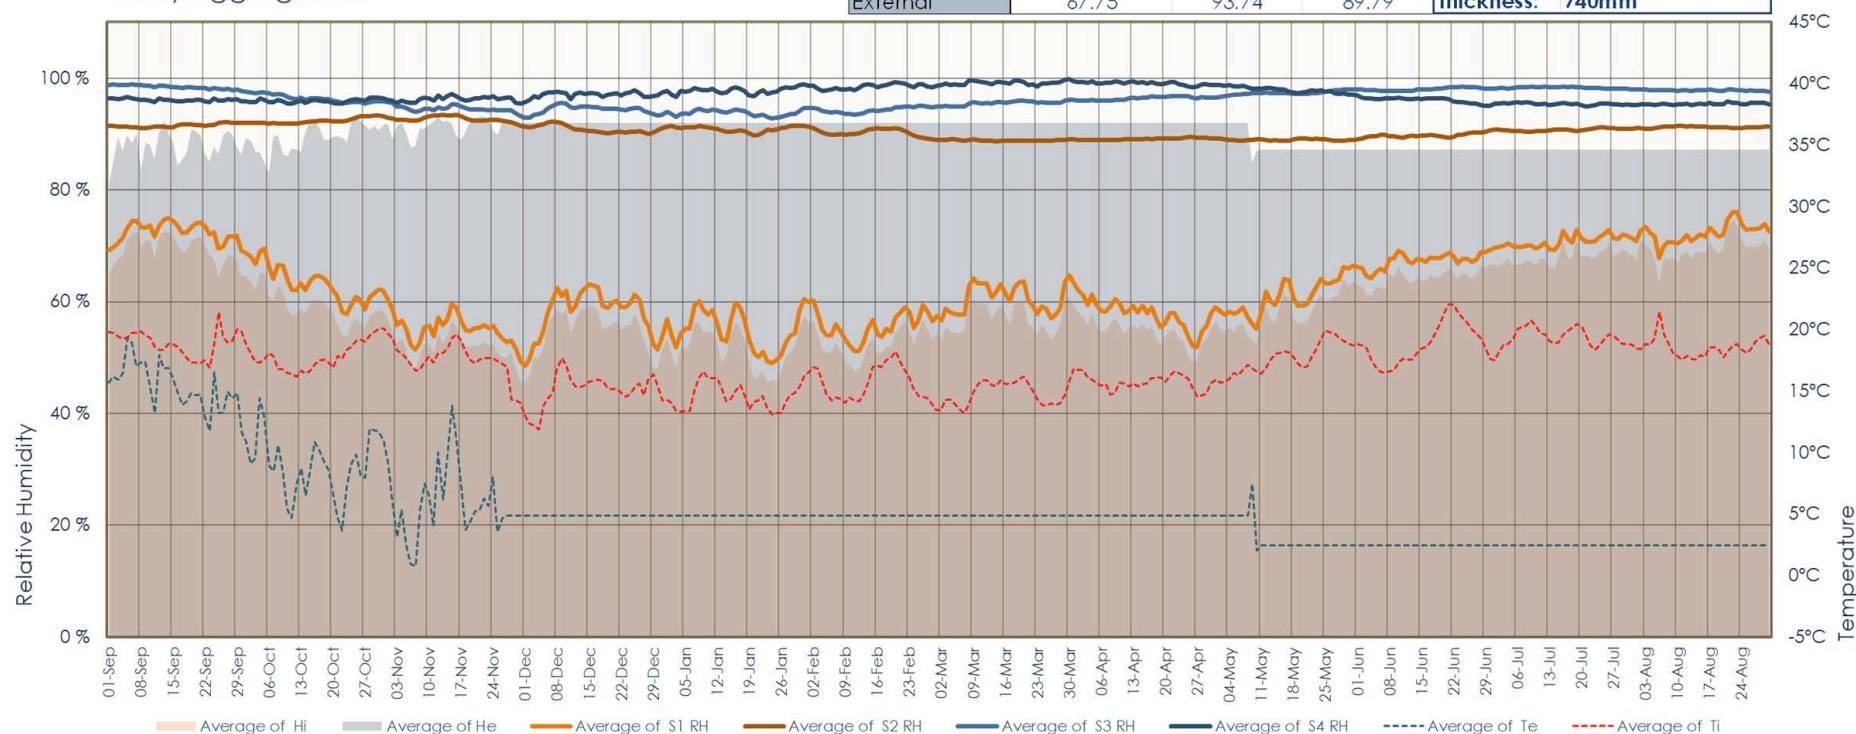
Figure 23. Relative humidity over time, daily aggregation, Mill House, Drewsteignton, 2016-2017.

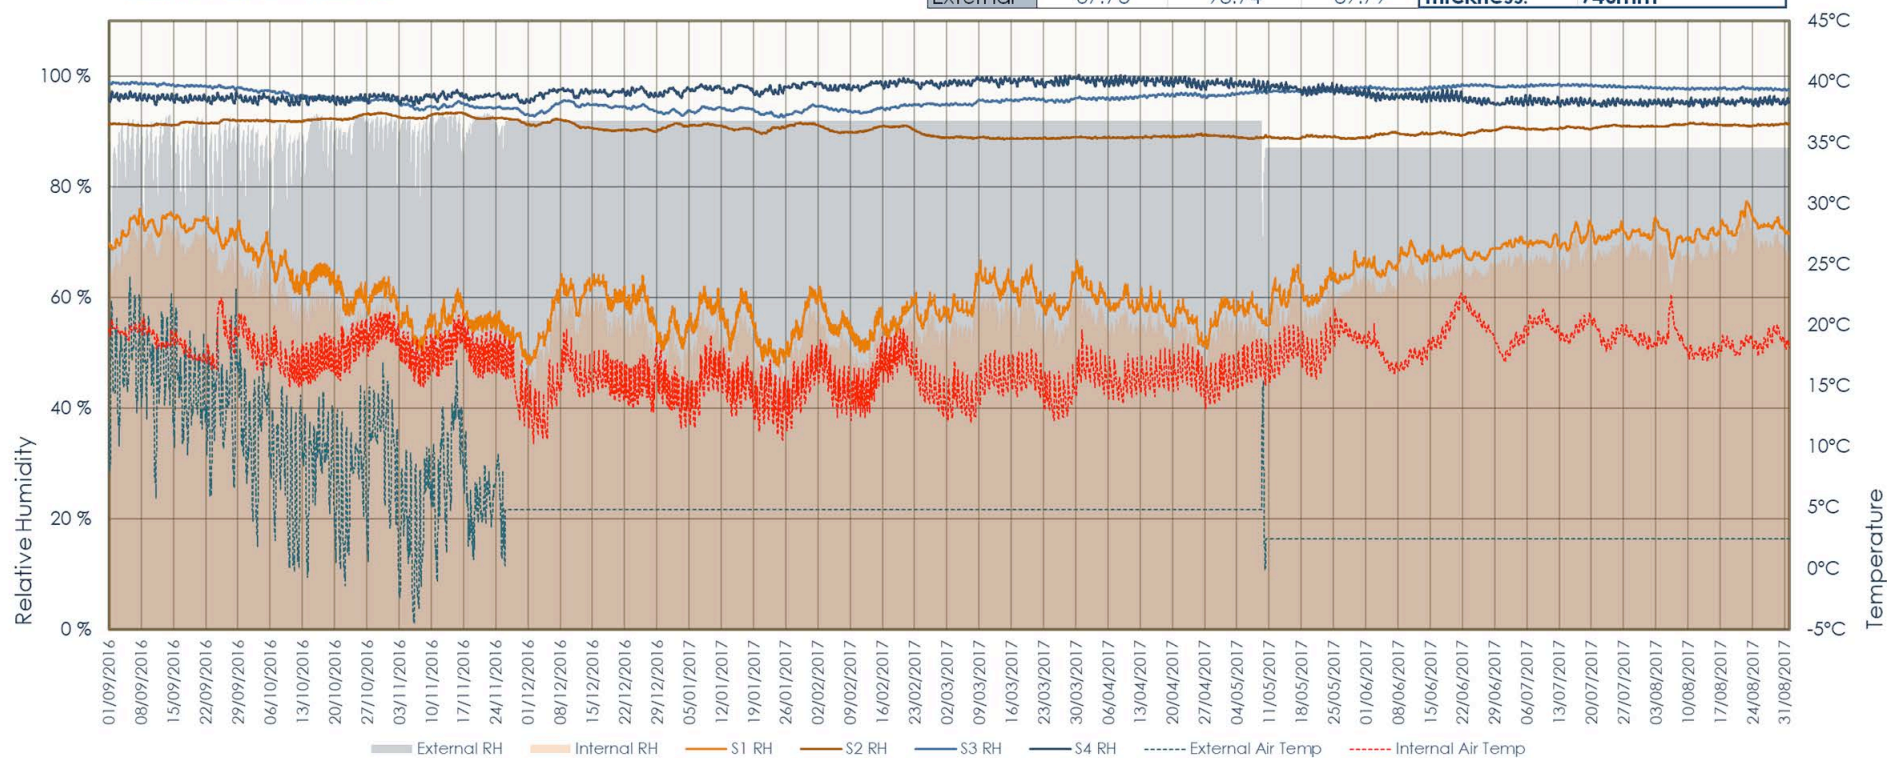
Figure 24. Relative humidity over time, full resolution, Mill House, Drewsteignton, 2016-2017.

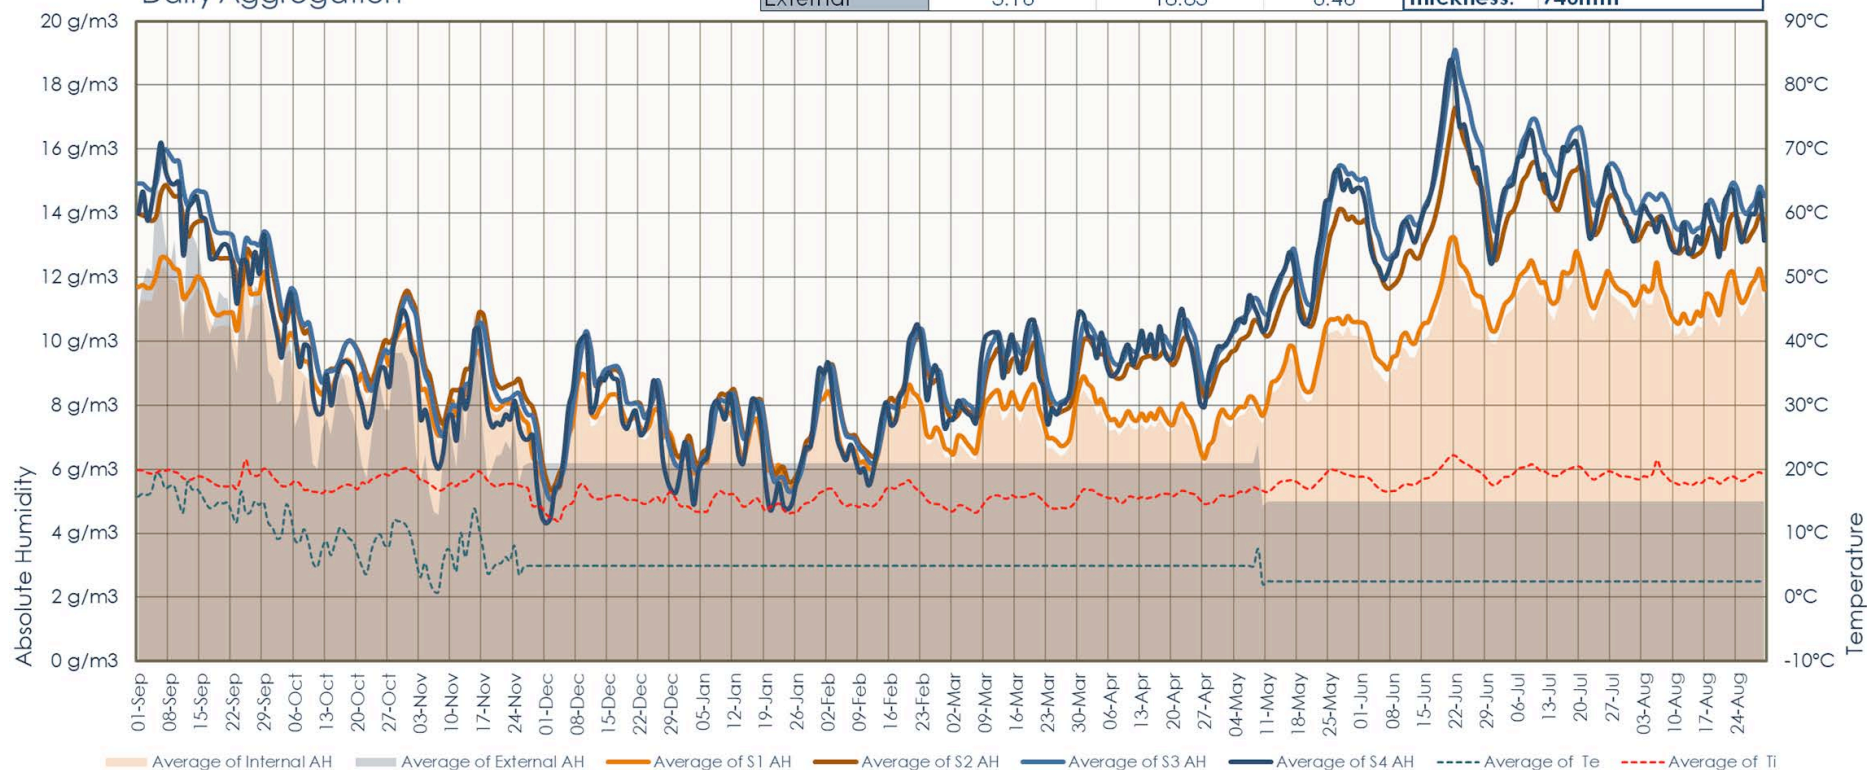
Figure 25. Absolute humidity over time, Mill House, Drewsteignton 2016-2017.

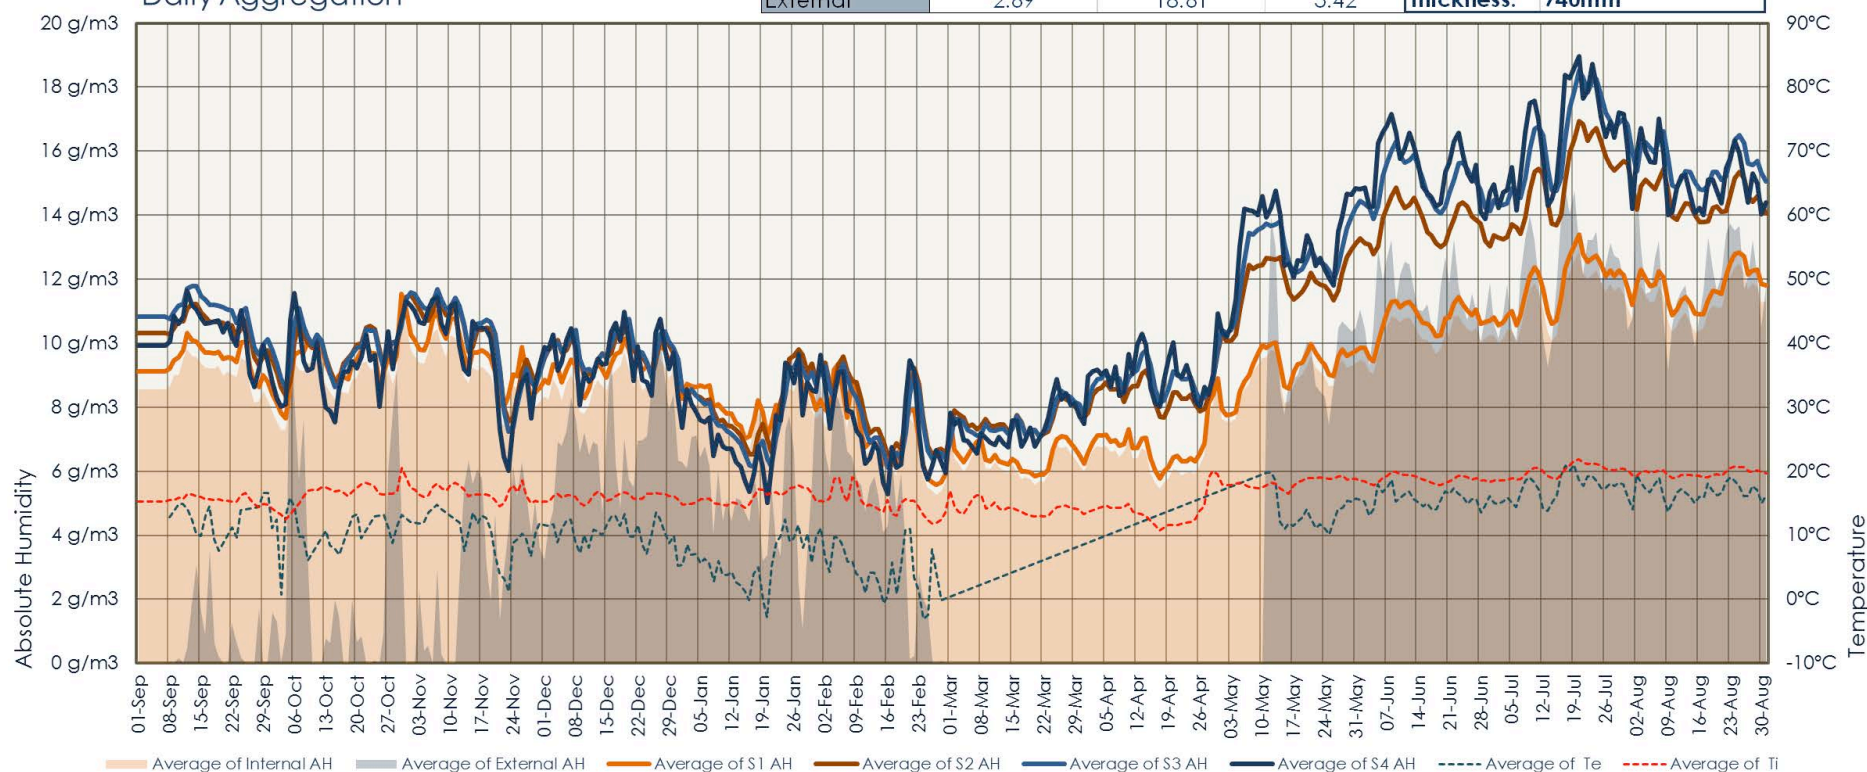
Figure 26. Absolute humidity over time, Mill House, Drewsteignton 2015-2016.
