The SPAB Building Performance Survey 2017

Interim Report

ArchiMetrics Ltd.

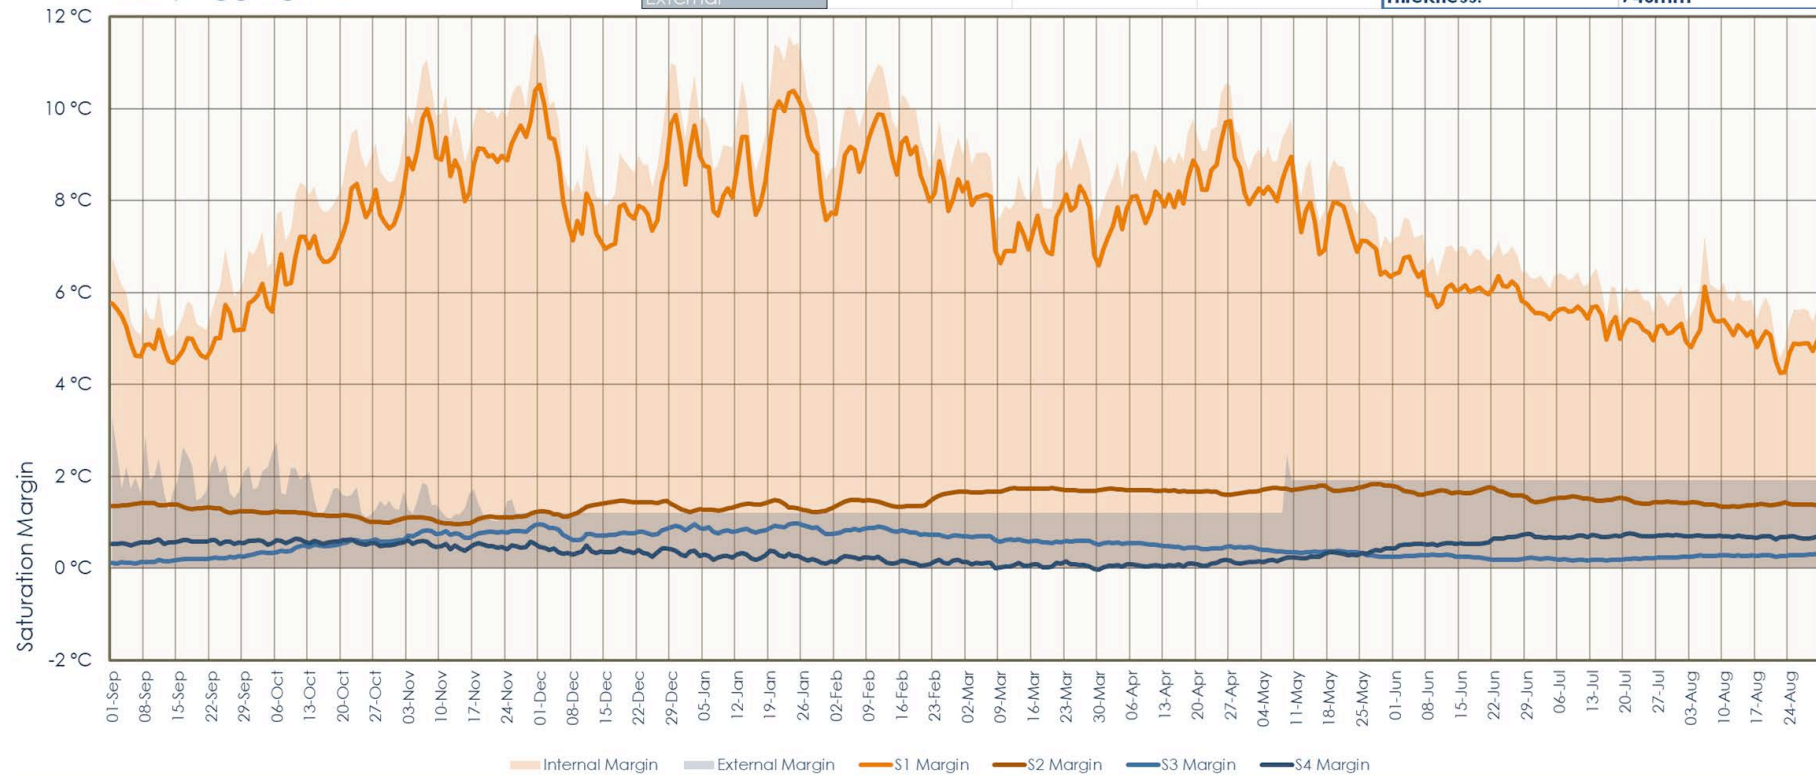
Figure 27. Saturation margin over time, Mill House, Drewsteignton, 2016-2017.

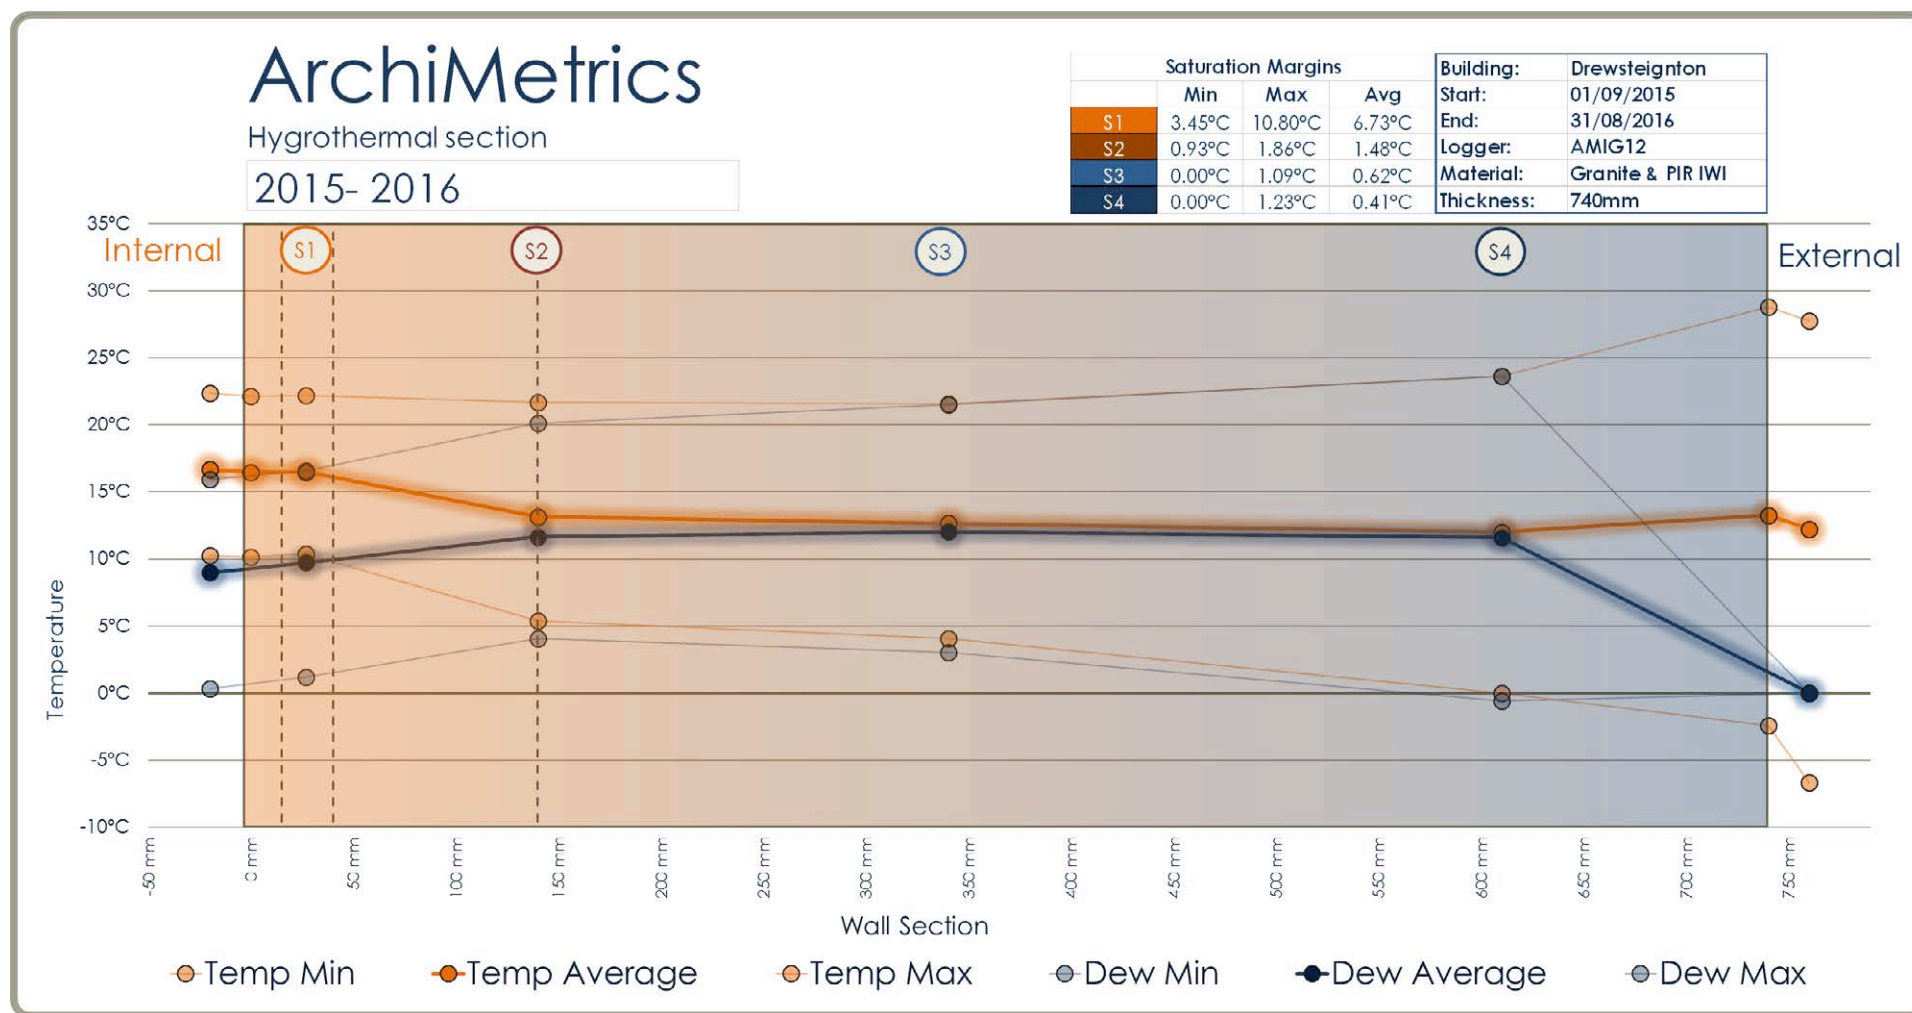
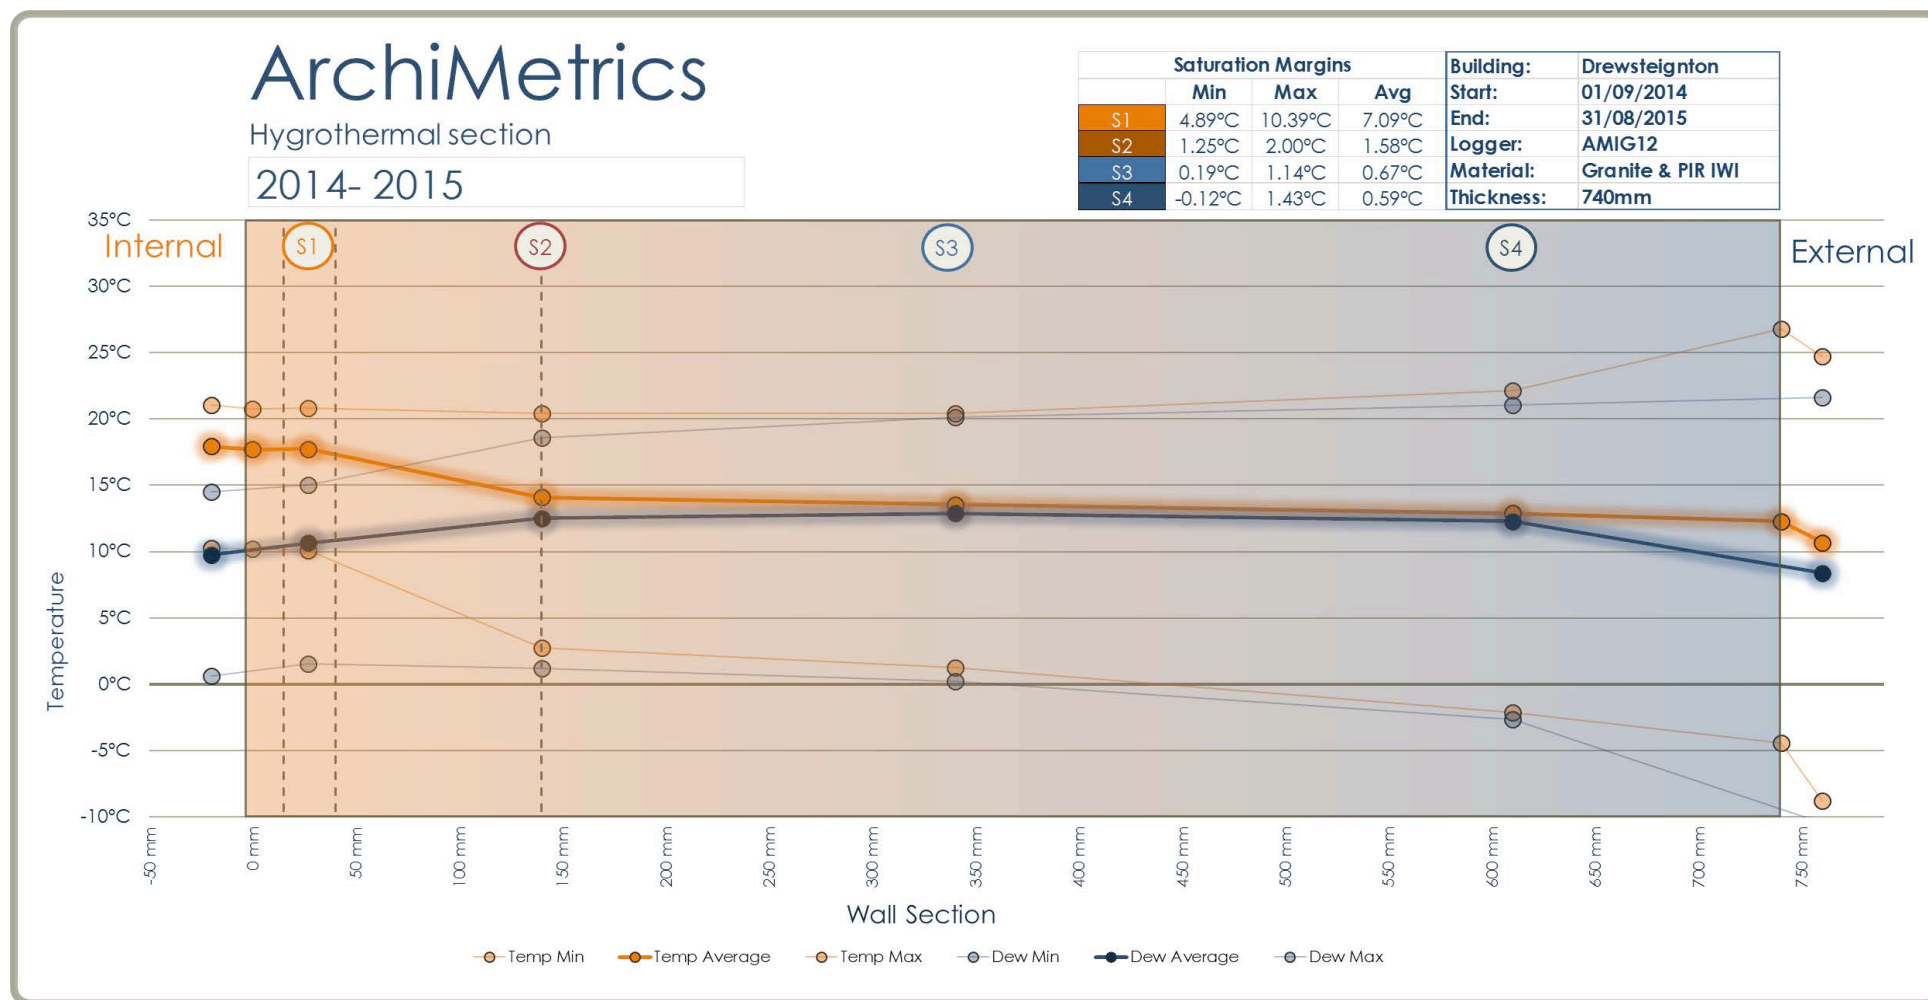
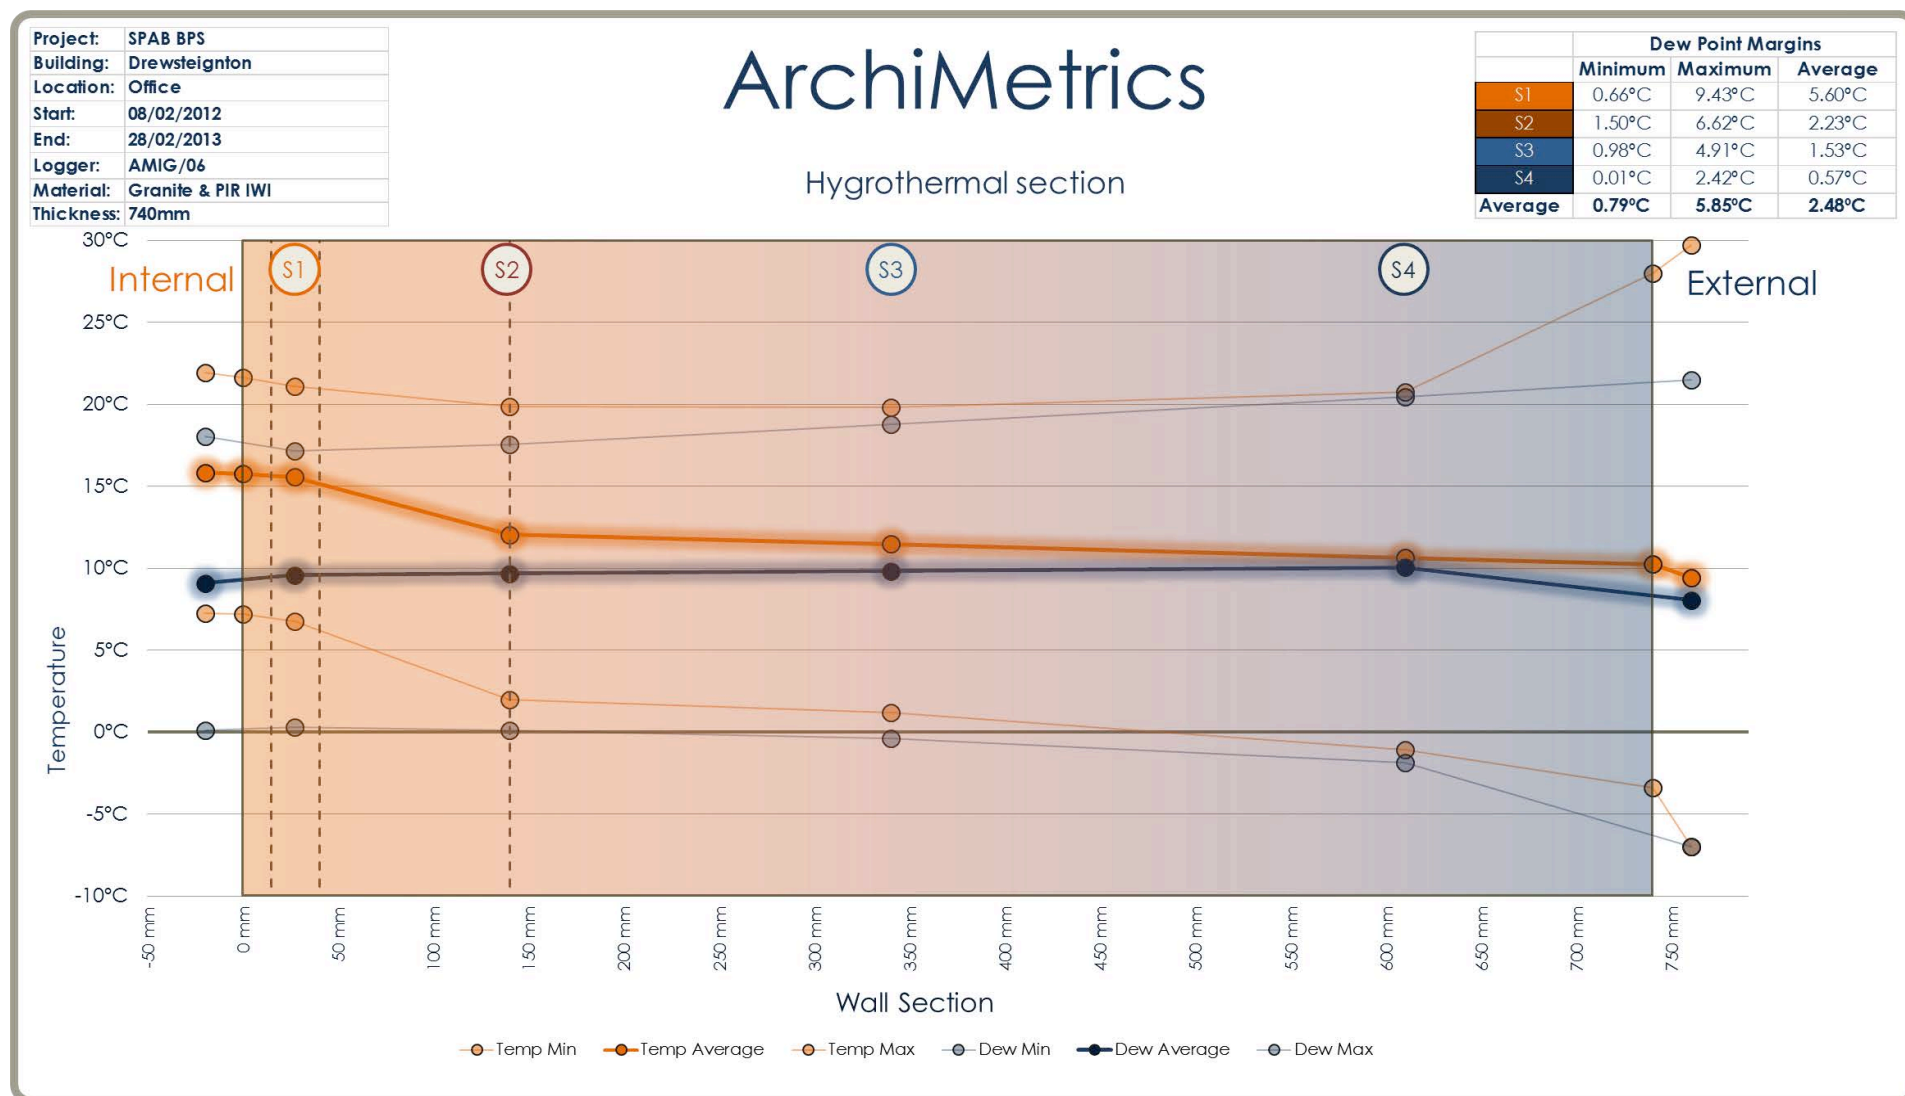
Figure 28. Hygrothermal section, Mill House, Drewsteignton, 2016–2017 (capped).

Figure 29. Hygrothermal section, Mill House, Drewsteignton, 2015–2016 (capped).

Figure 30. Hygrothermal section, Mill House, Drewsteignton, 2014–2015 .

Figure 31. Hygrothermal section, Mill House, Drewsteignton, 2013-2014.

Figure 32. Hygrothermal section, Mill House, Drewsteignton, 2012-2013.

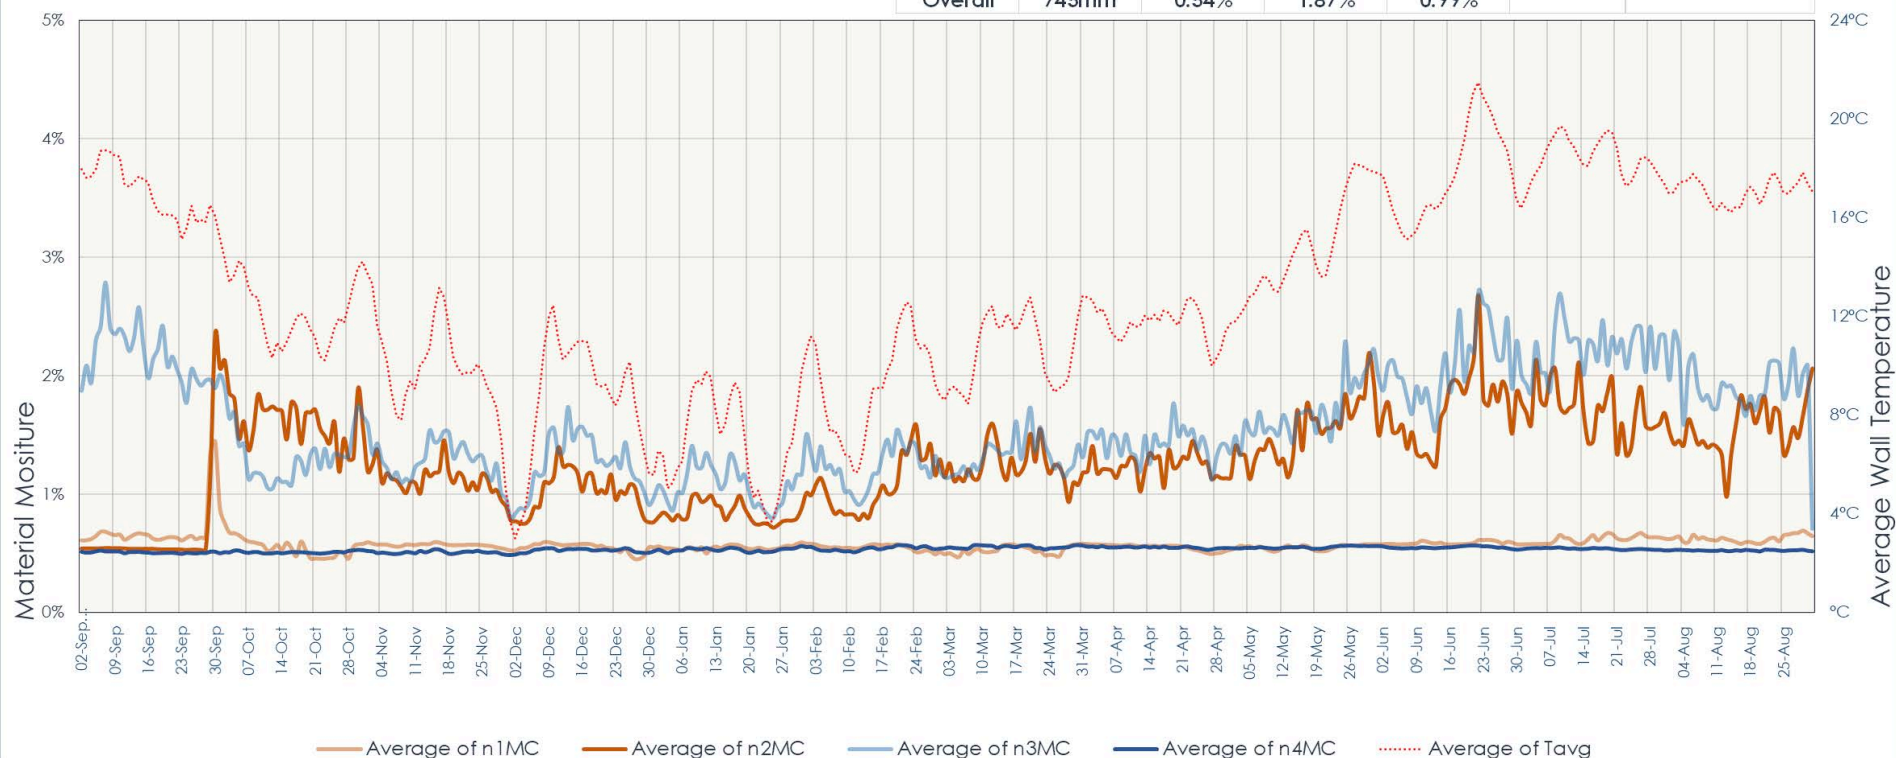
Figure 33. Material moisture content over time, Mill House, Drewsteignton, 2016-2017.

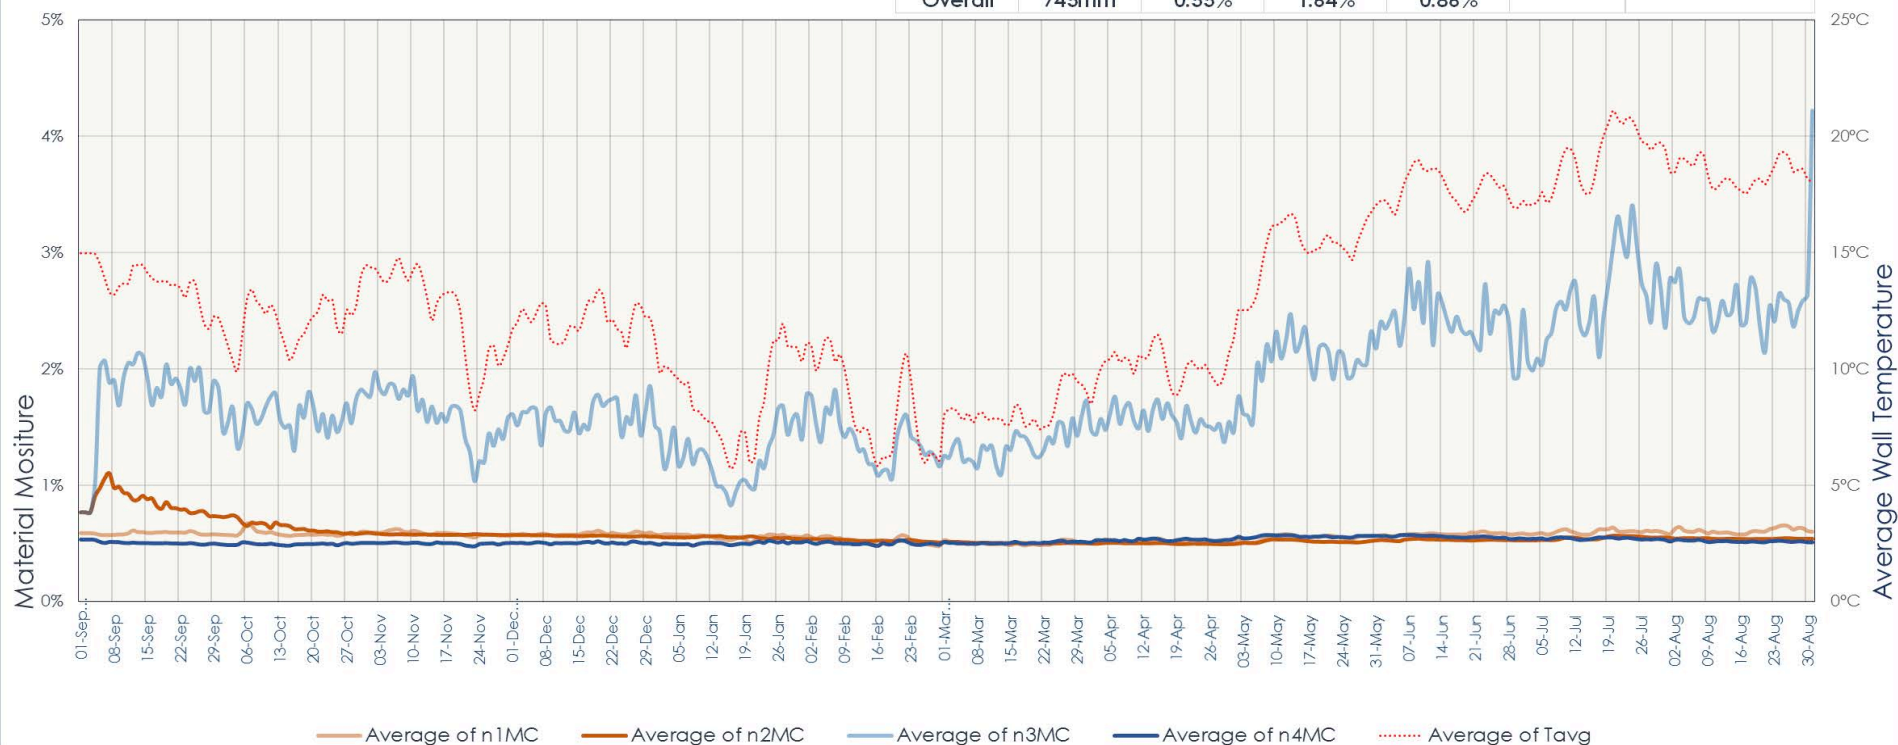
Figure 34. Material moisture content over time, Mill House, Drewsteignton, 2015-2016.

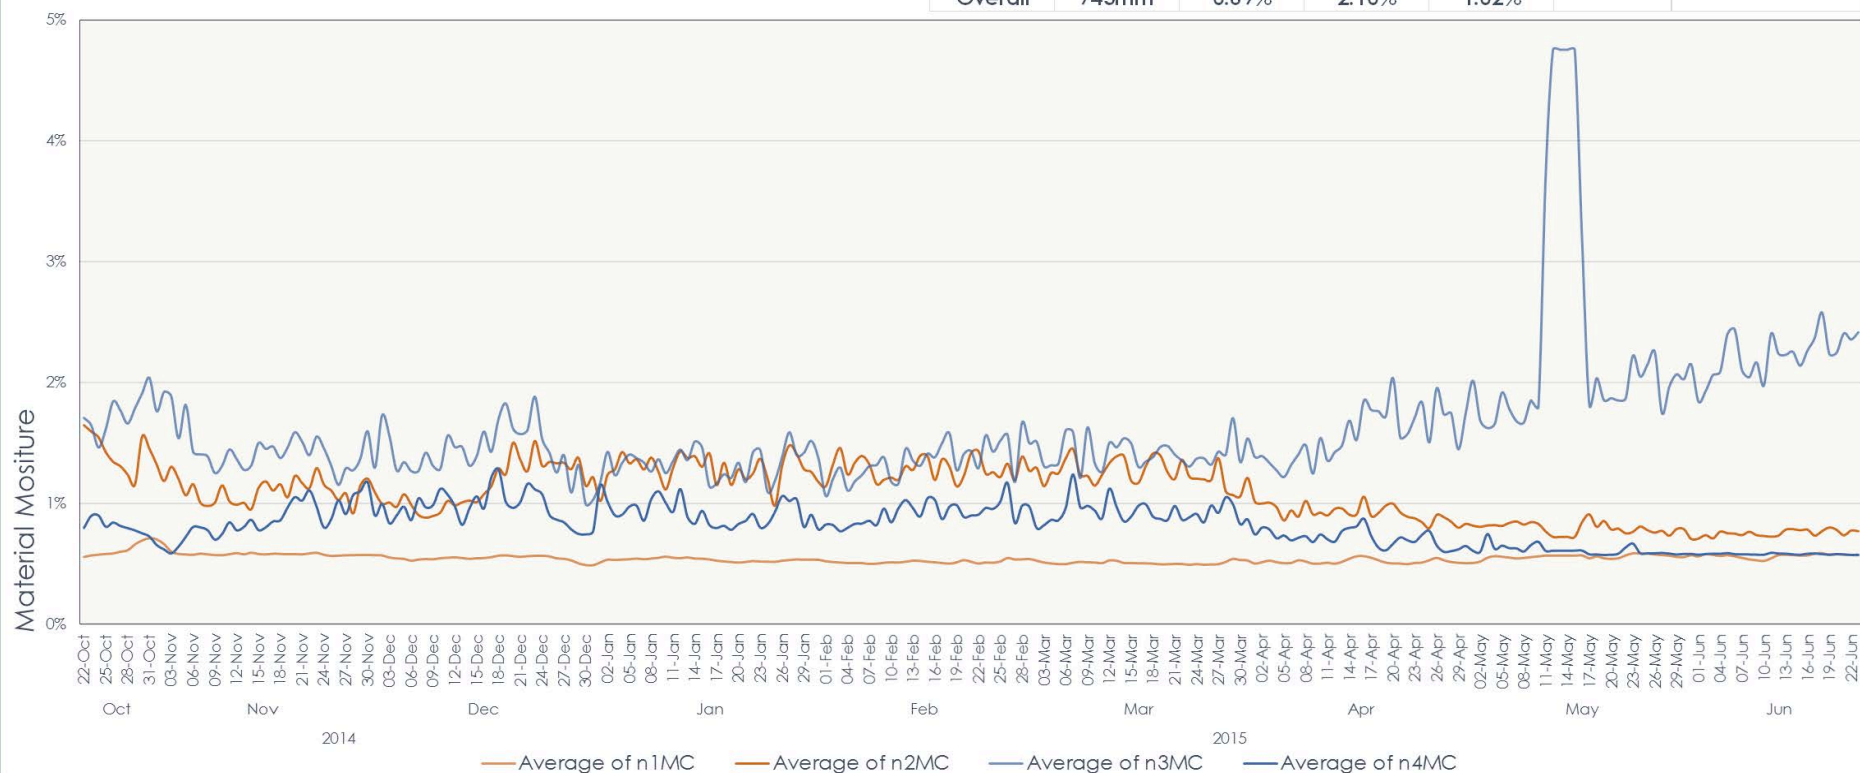
Figure 35. Material moisture content over time, Mill House, Drewsteignton, 2014-2015.

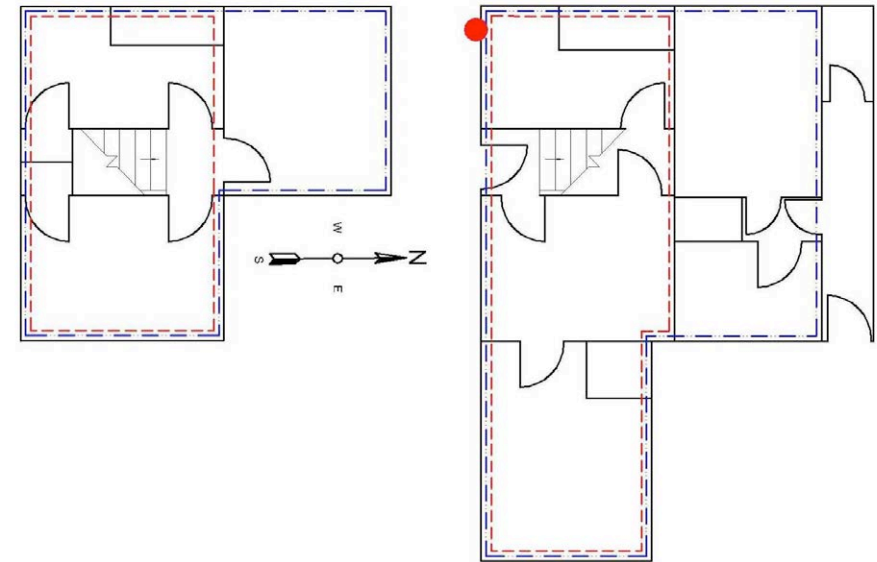
Figure 36. Plan of The Firs, Riddlecombe (ground floor on right hand side). Location of monitoring equipment shown by red dot.

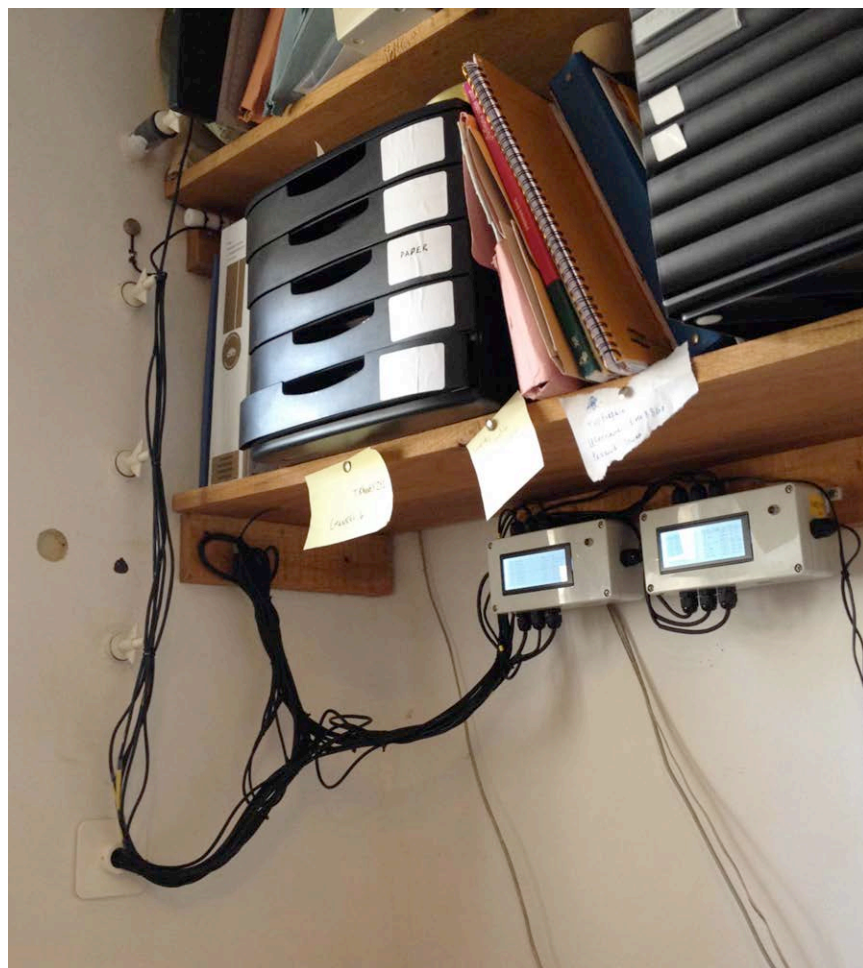
Figure 37. Interstitial hygrothermal gradient and material moisture monitoring, Riddlecombe.

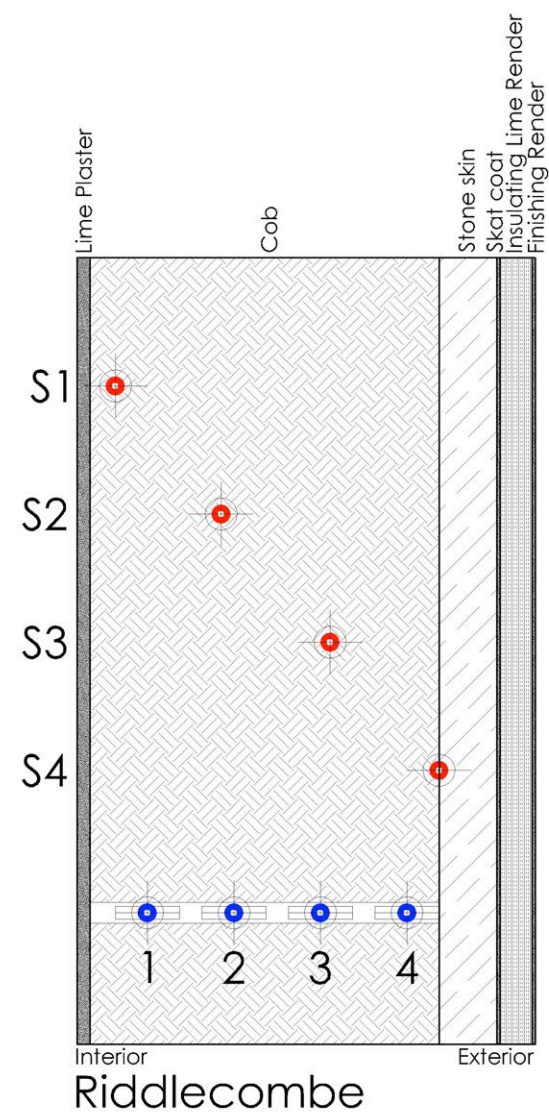
Figure 38. Position of sensors through wall section, Riddlecombe.

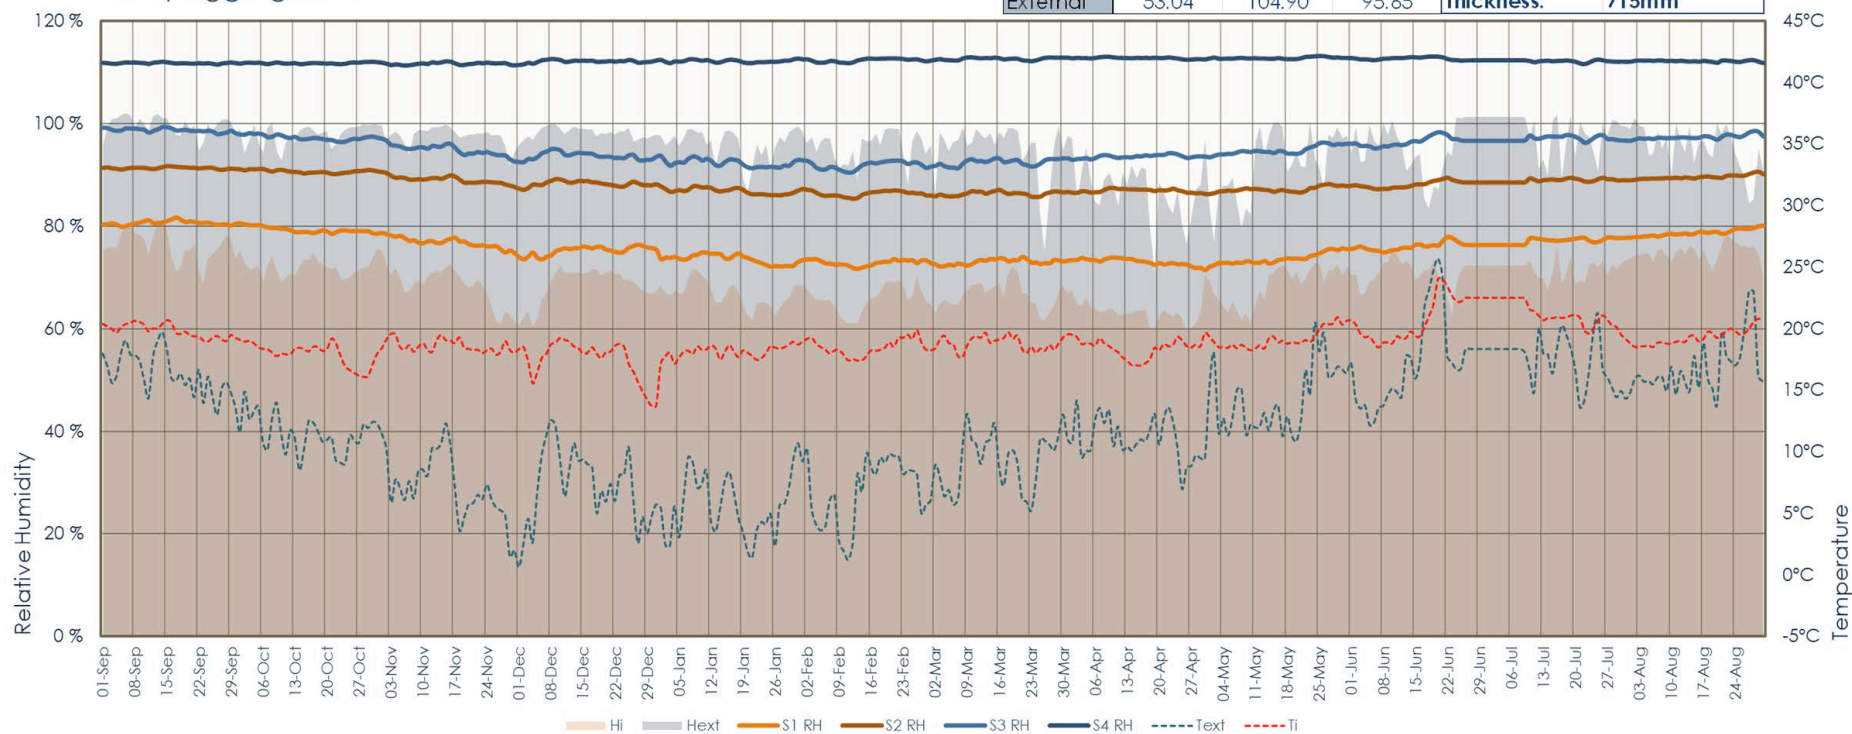
Figure 39. Relative humidity over time, The Firs, Riddlecombe 2016-2017.

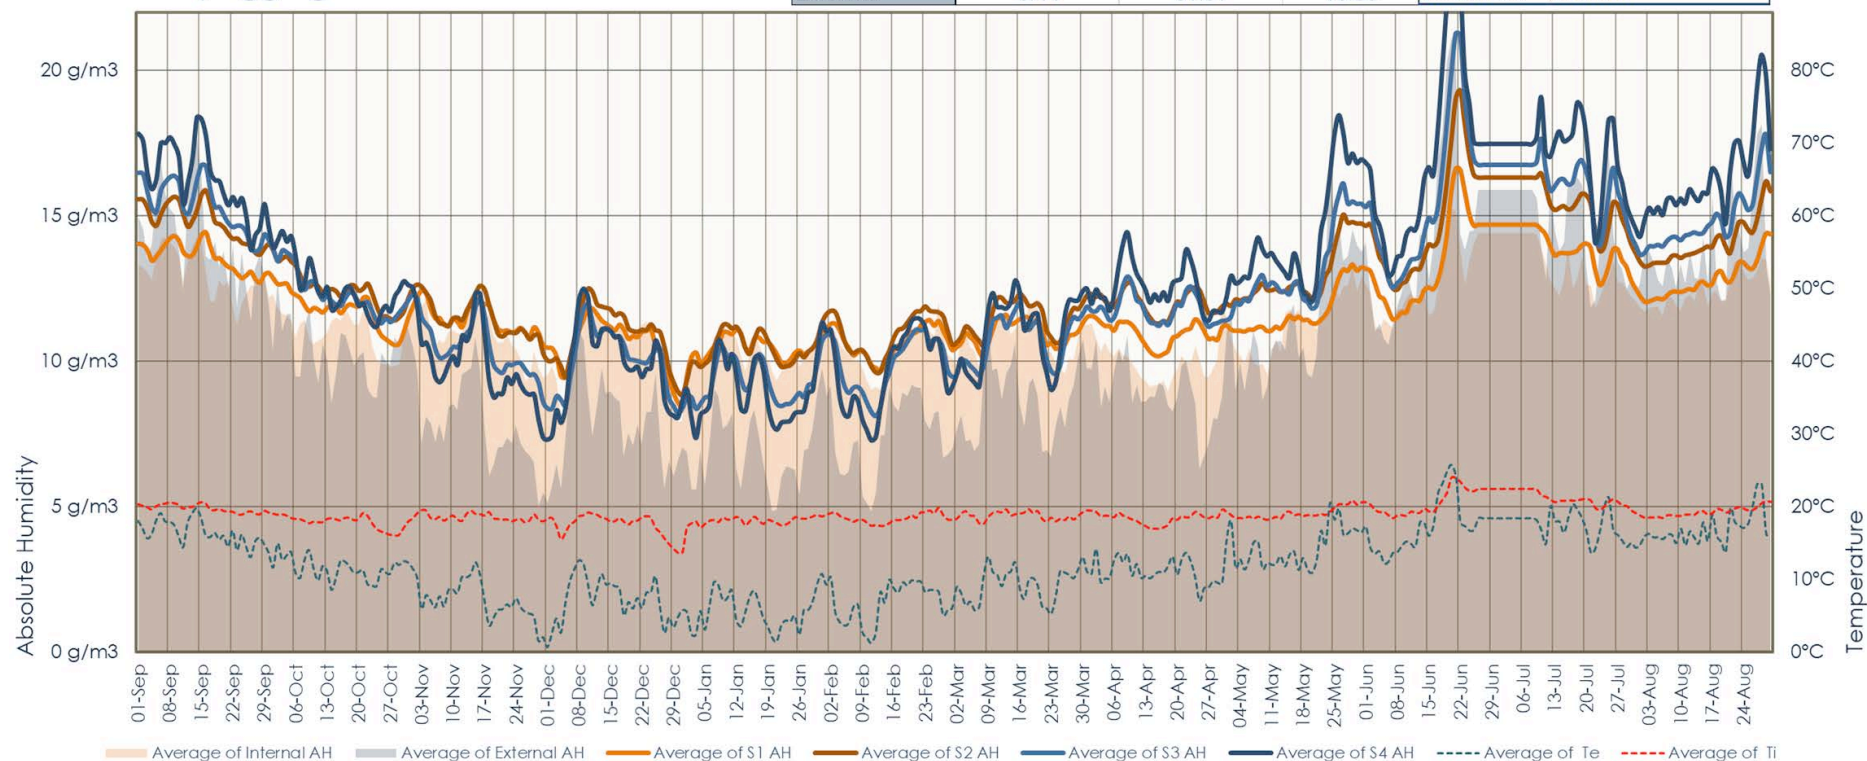
Figure 40. Absolute humidity over time, The Firs, Riddlecombe, 2016-2017.

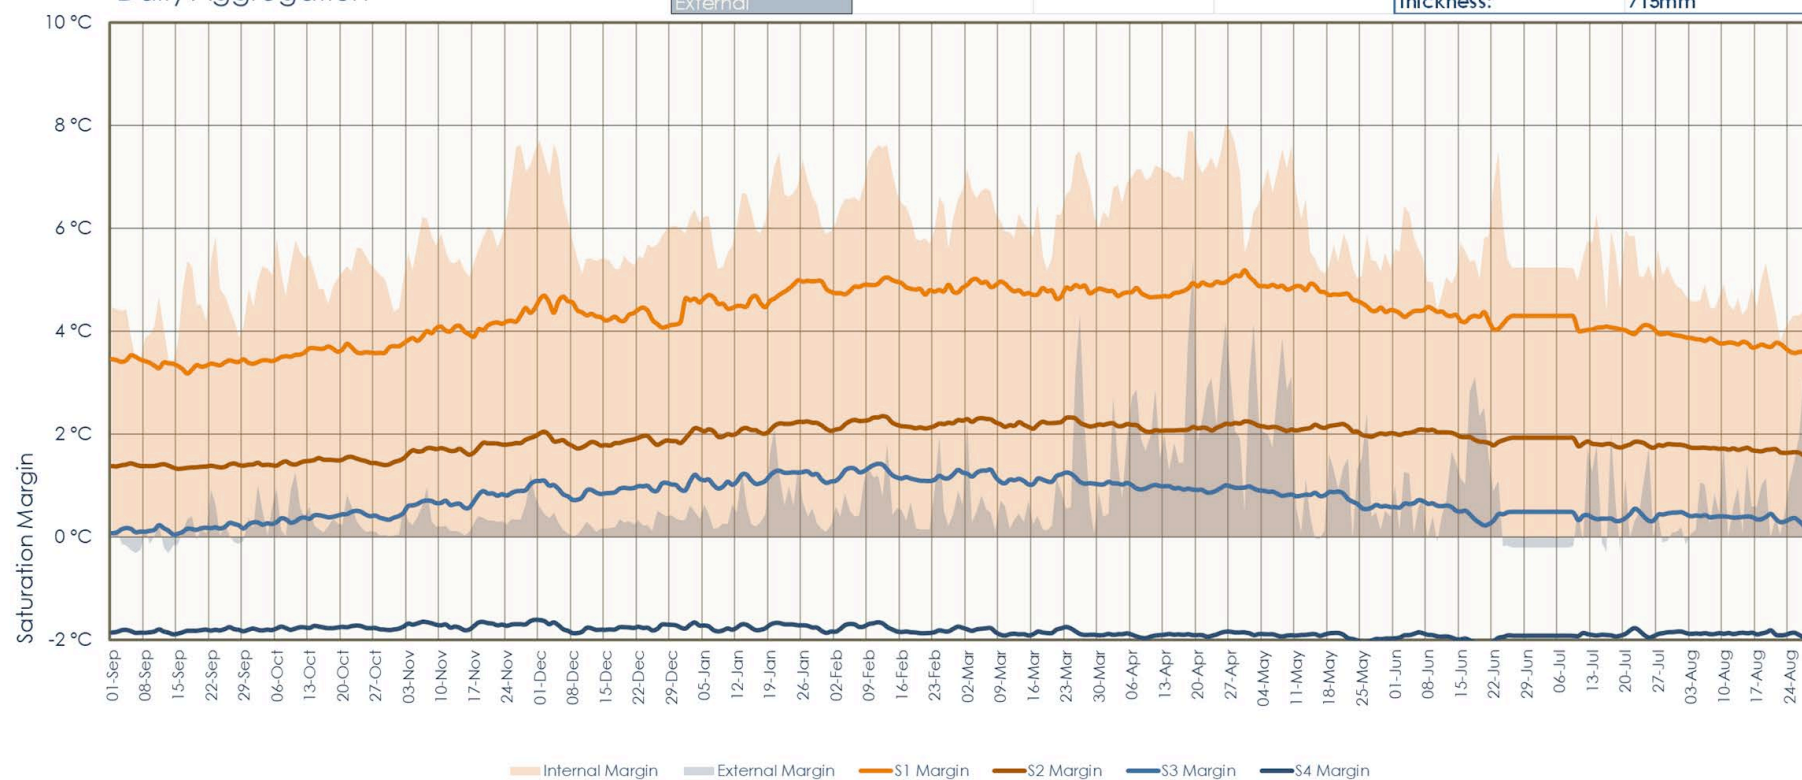
Figure 41. Saturation margin over time, The Firs, Riddlecombe, 2016-2017.
