The SPAB Building Performance Survey 2017

Interim Report

ArchiMetrics Ltd.

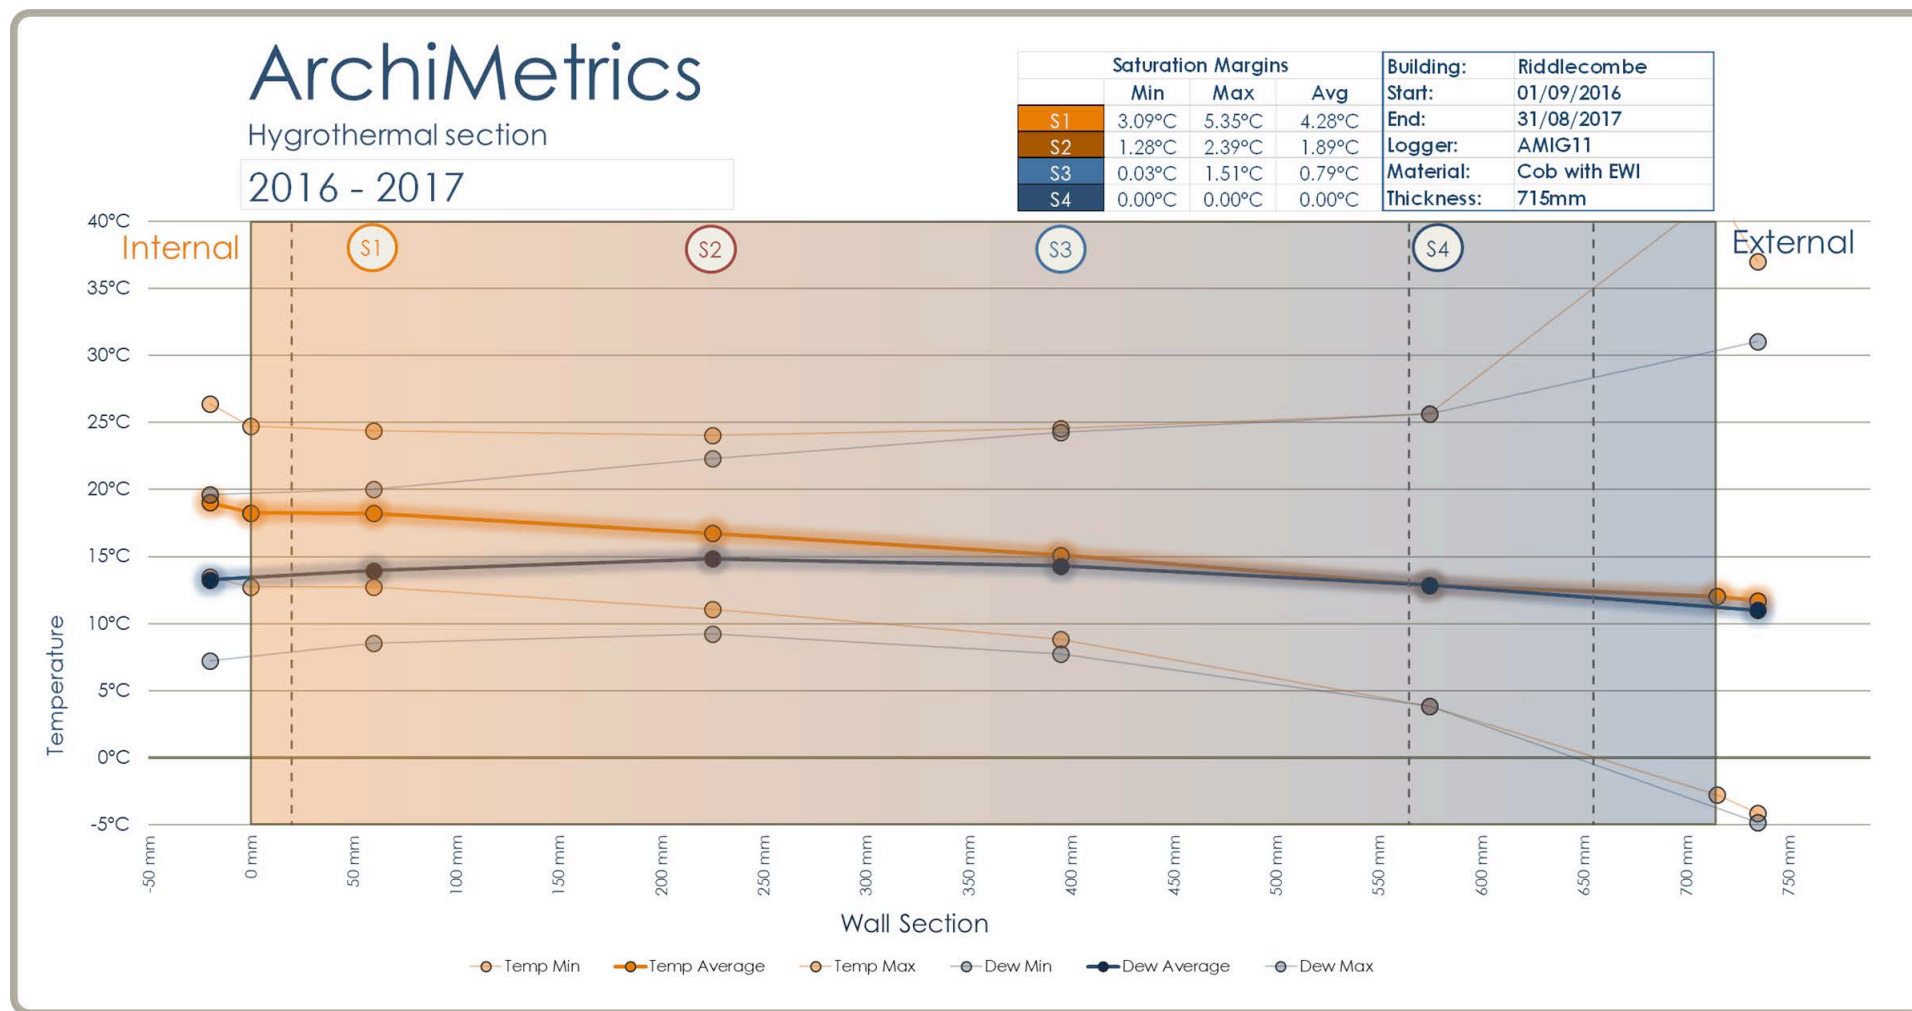
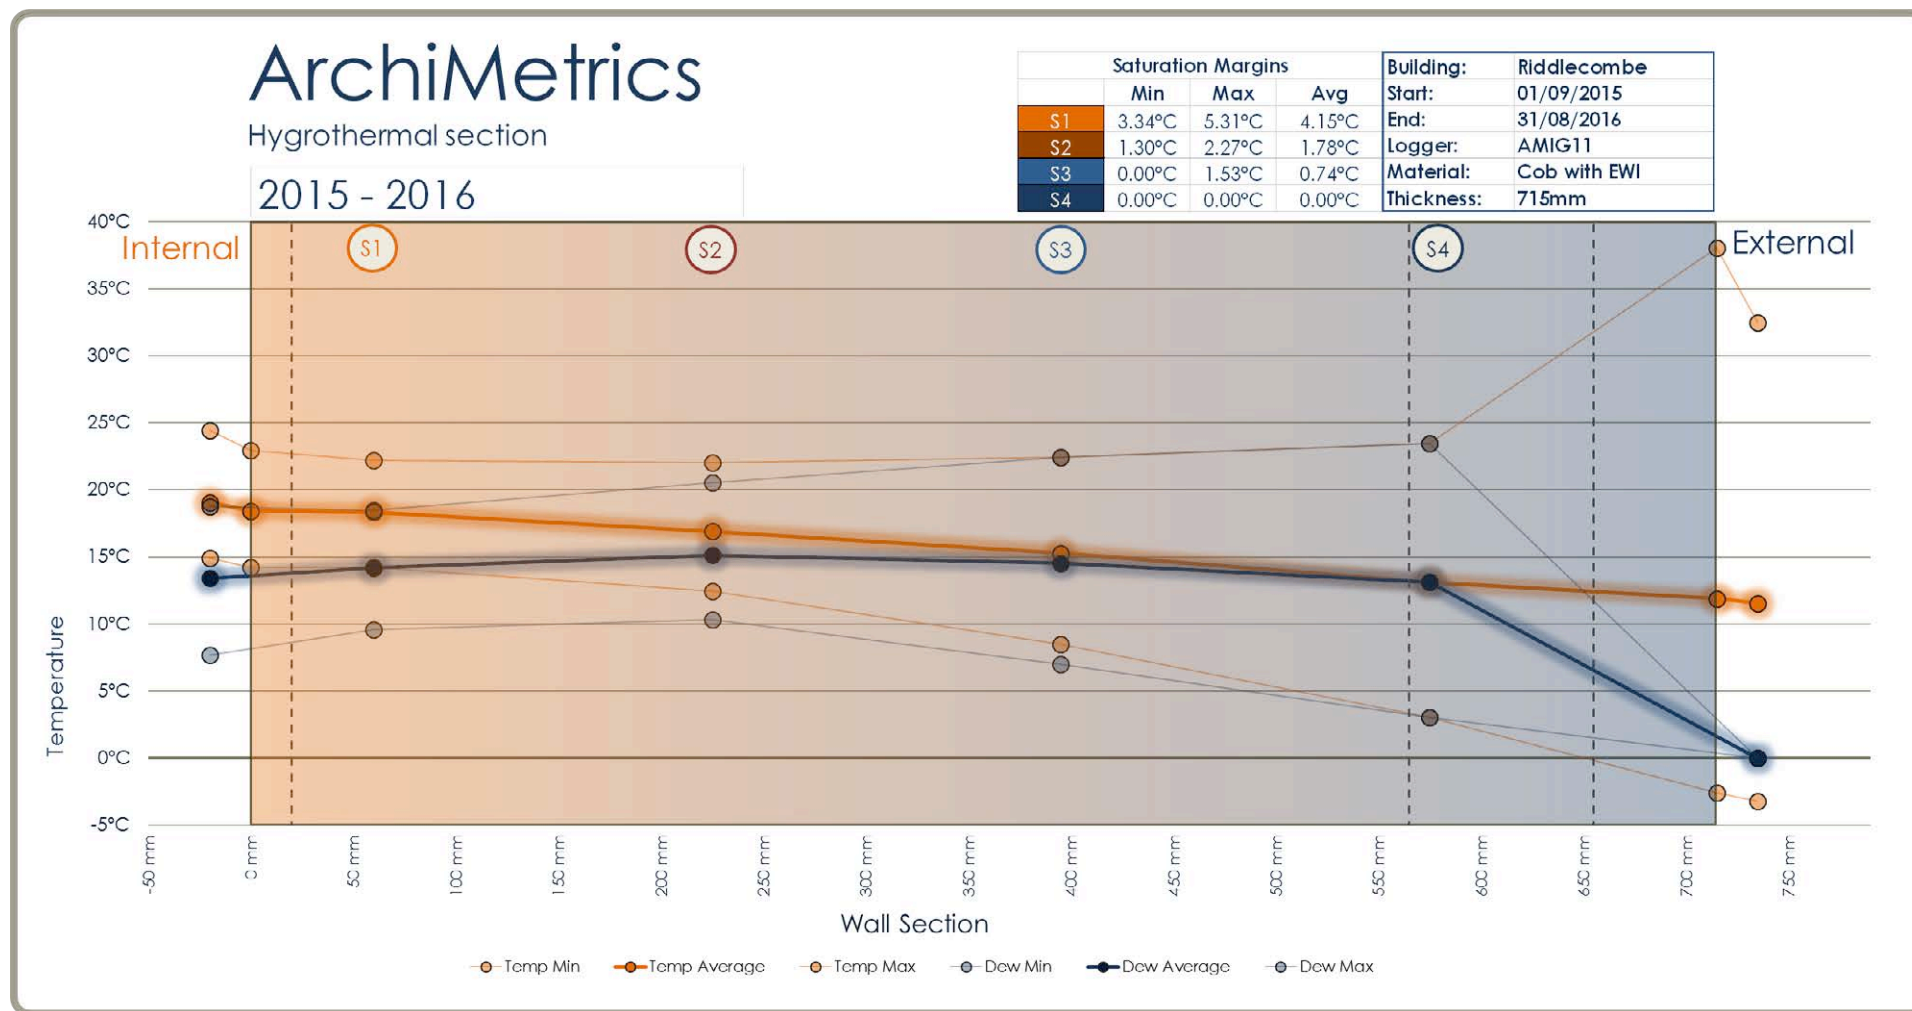
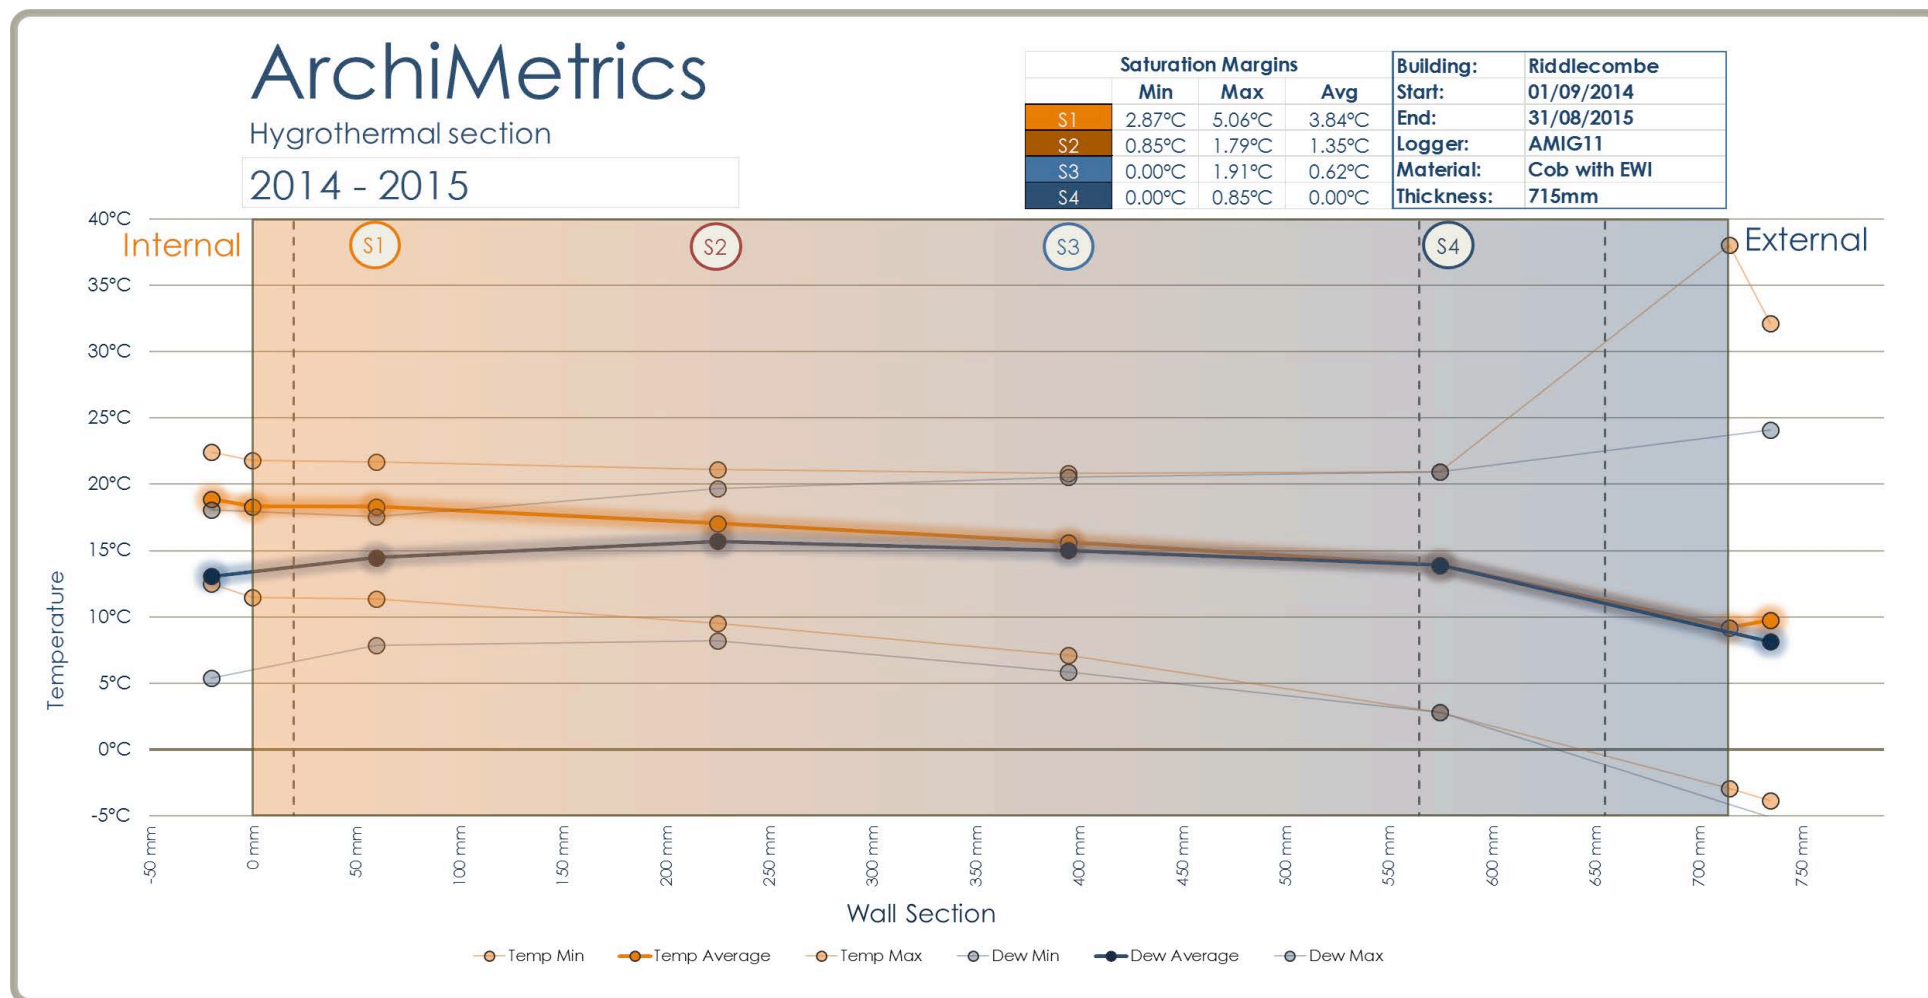
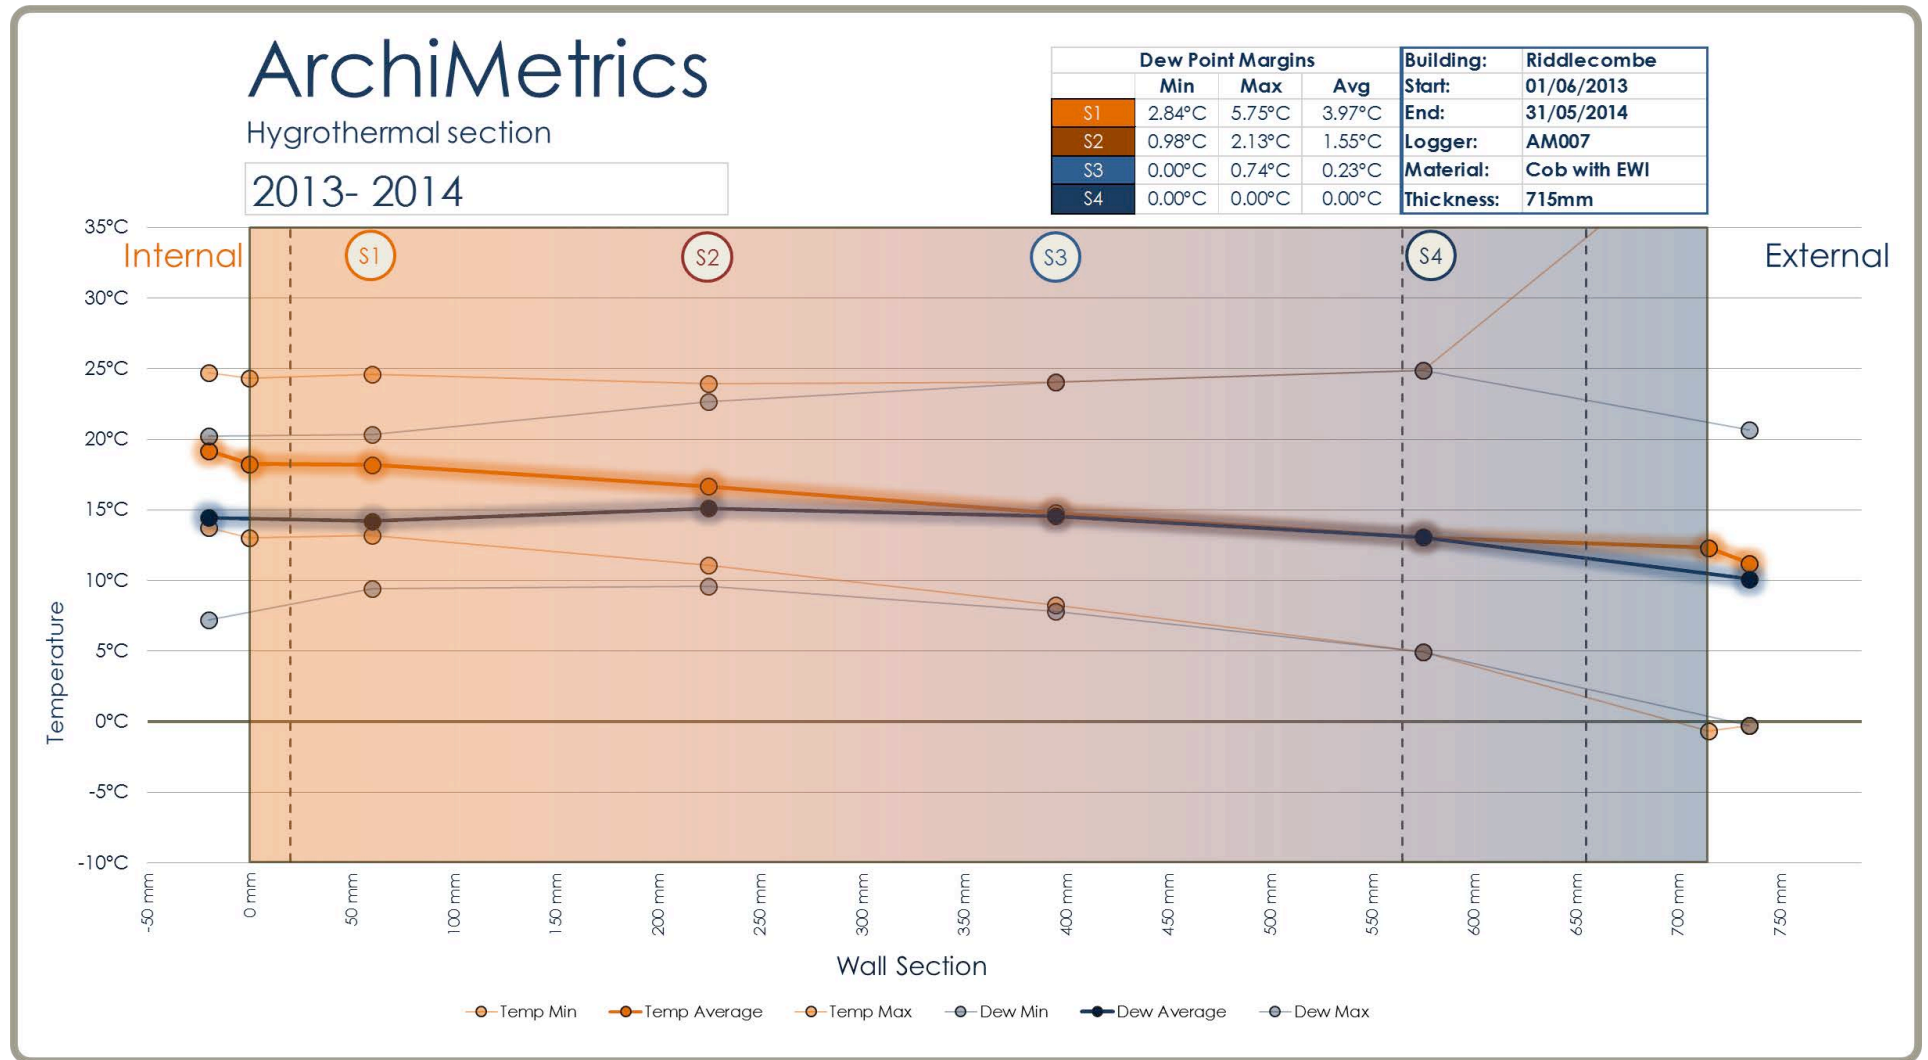
Figure 42. Hygrothermal section, The Firs, Riddlecombe, 2016-2017.

Figure 43. Hygrothermal section, The Firs, Riddlecombe, 2015-2016.

Figure 44. Hygrothermal section, The Firs, Riddlecombe, 2014-2015.

Figure 45. Hygrothermal section, The Firs, Riddlecombe, 2013-2014.

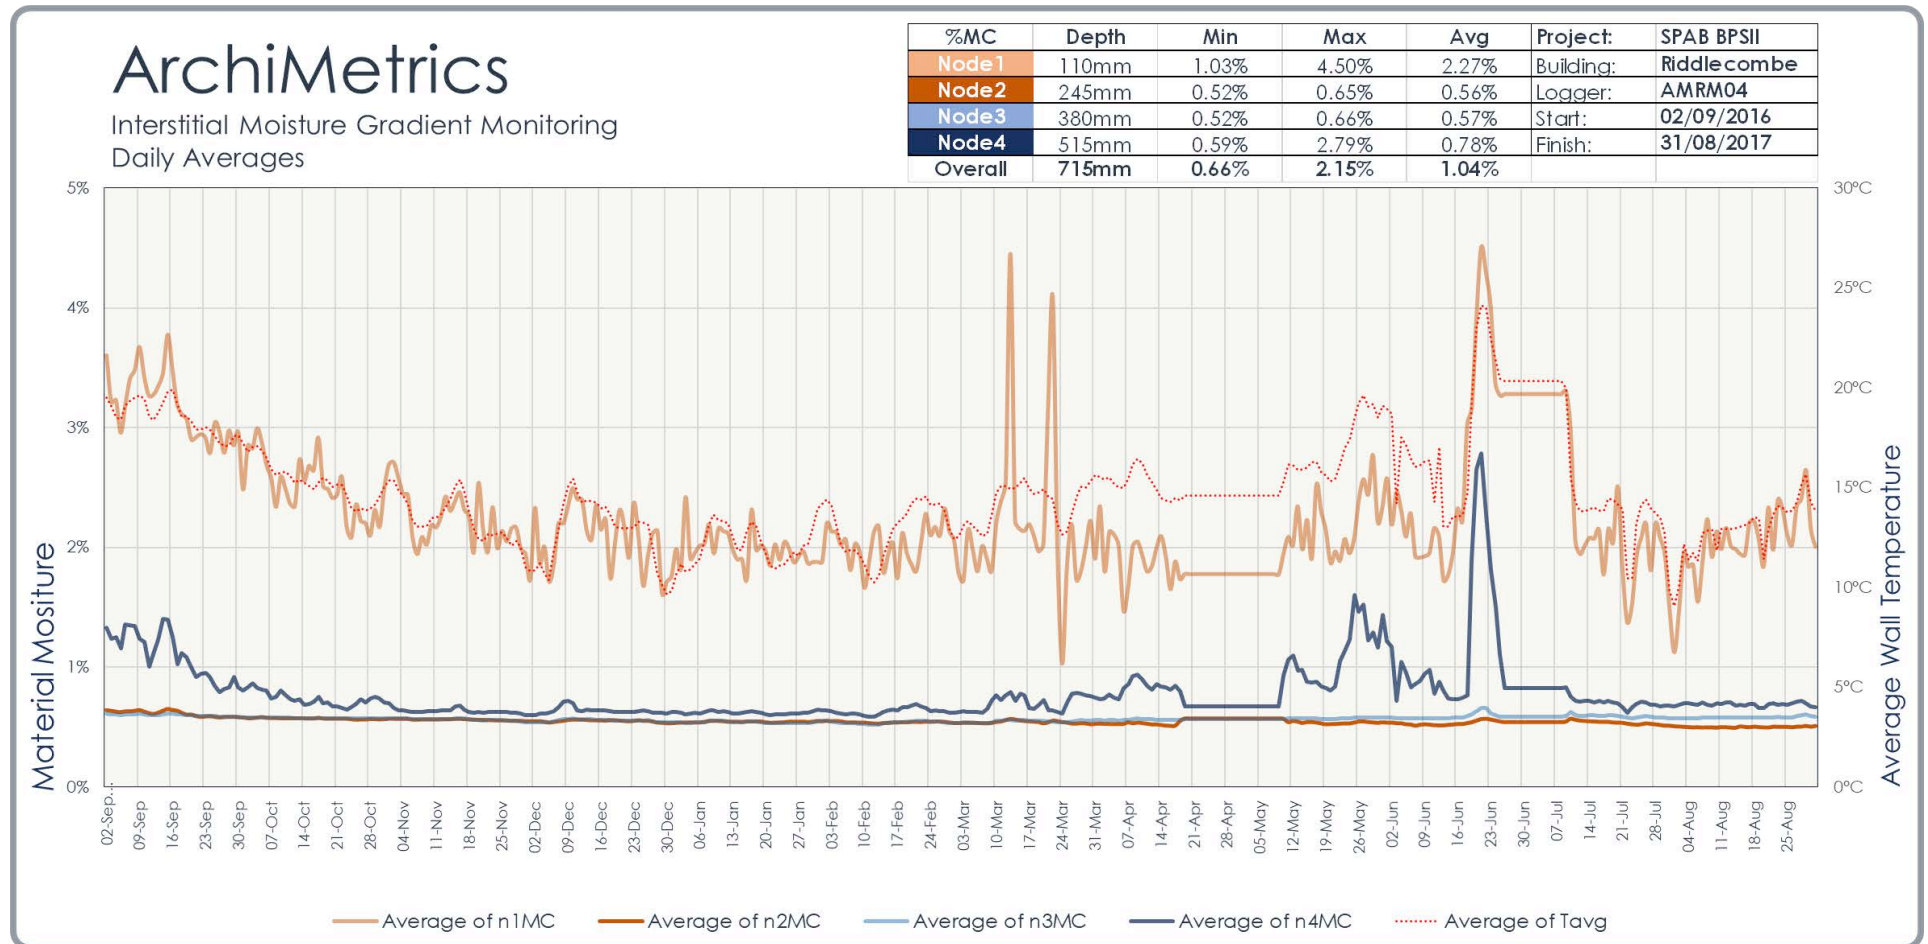
Figure 46. Material moisture content over time, The Firs, Riddlecombe 2016-2017.

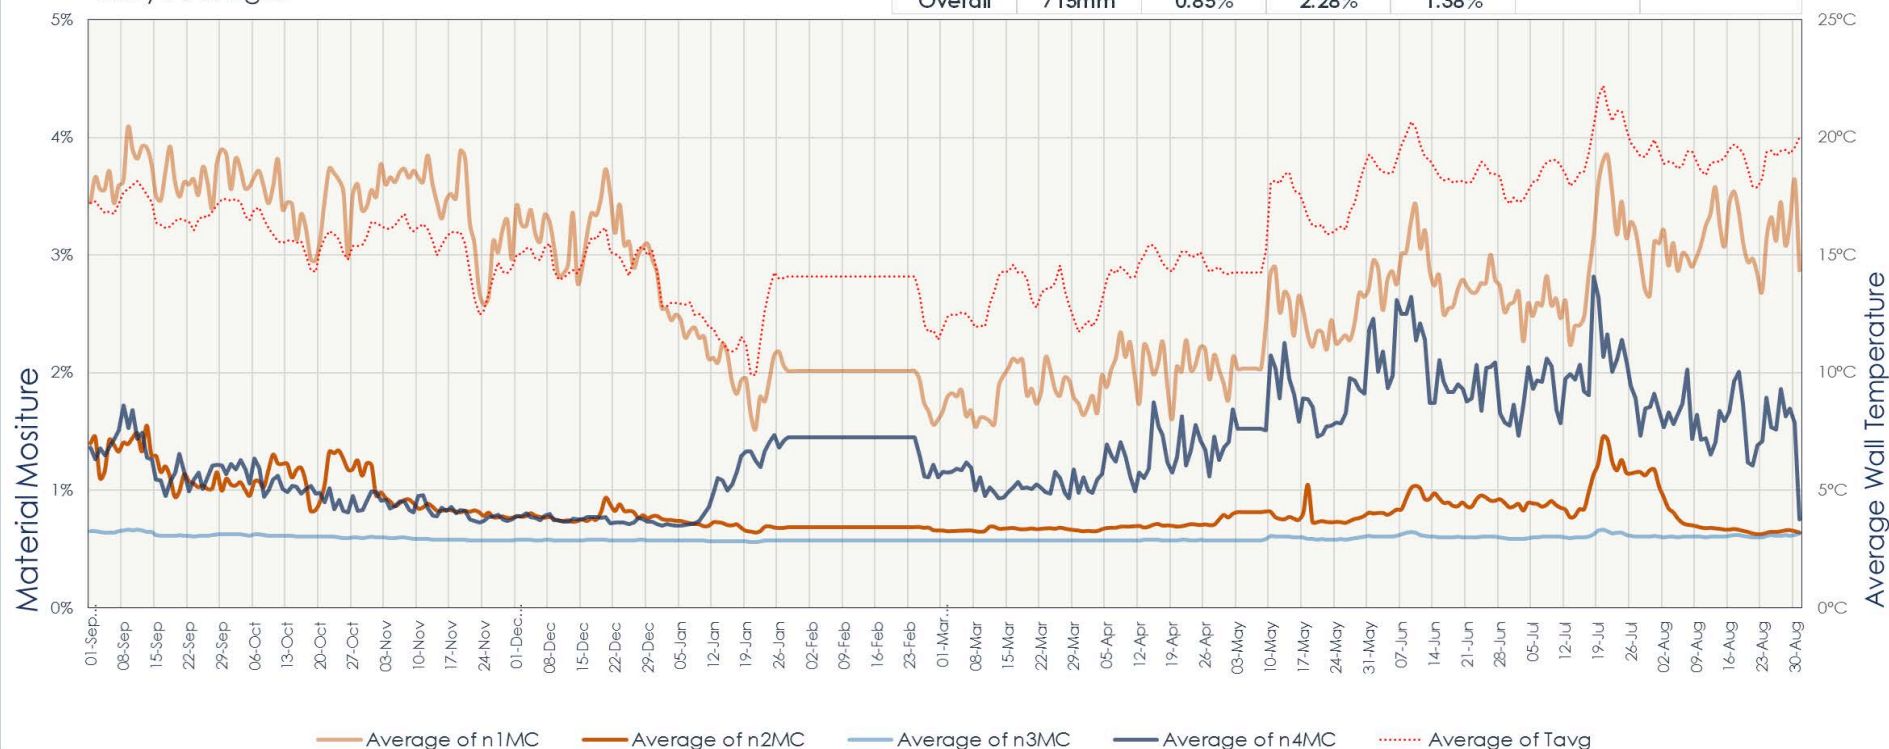
Figure 47. Material moisture content over time, The Firs, Riddlecombe 2015-2016.

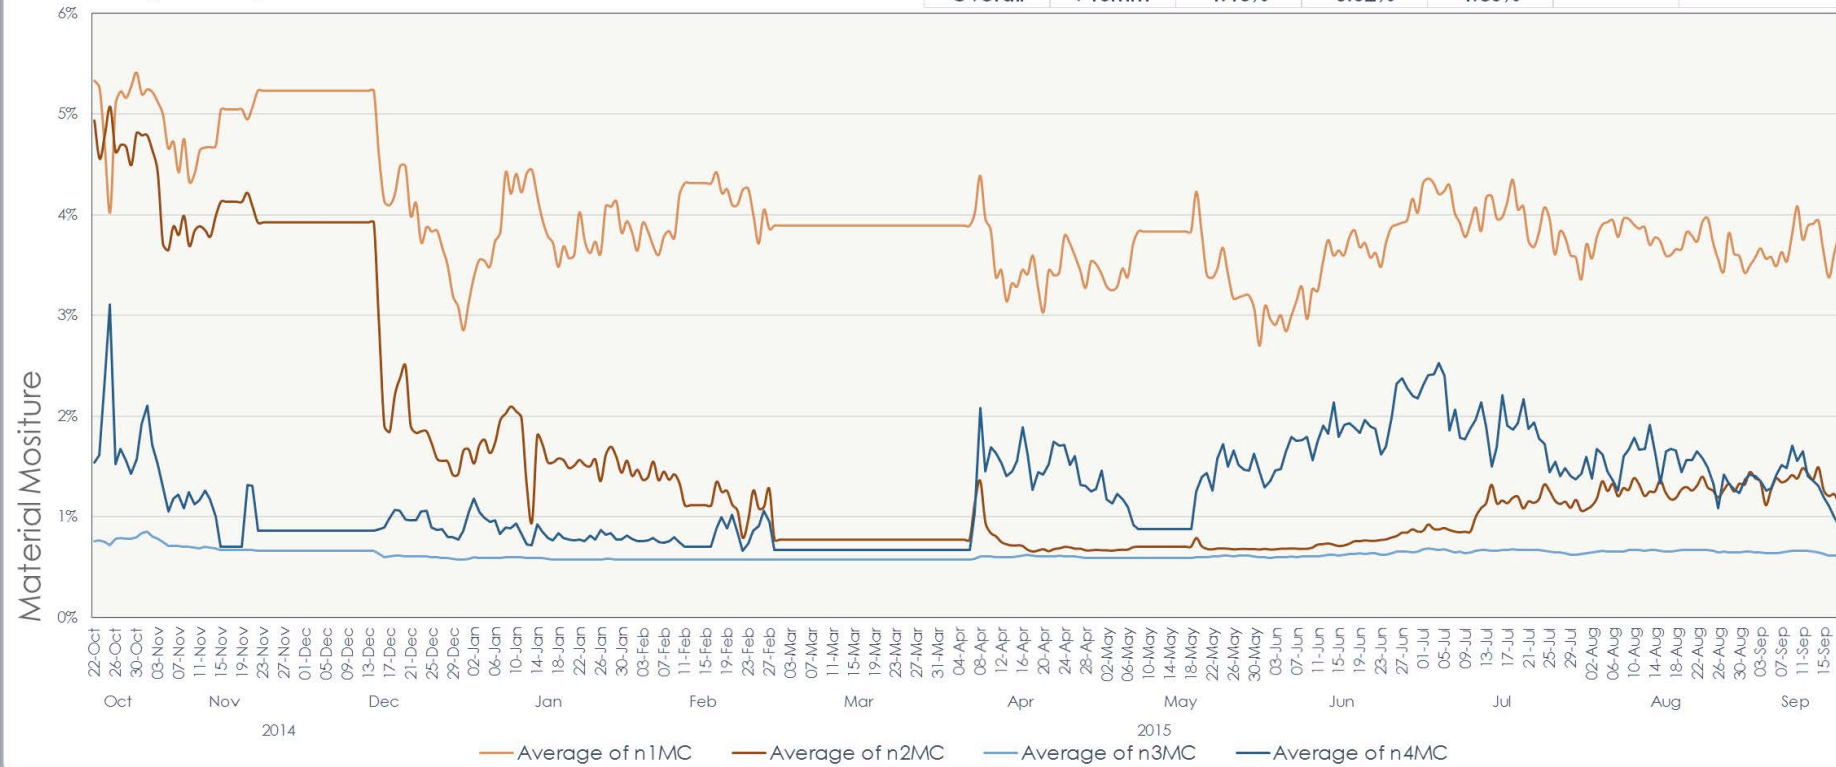
Figure 48. Material moisture content over time, The Firs, Riddlecombe 2014-2015

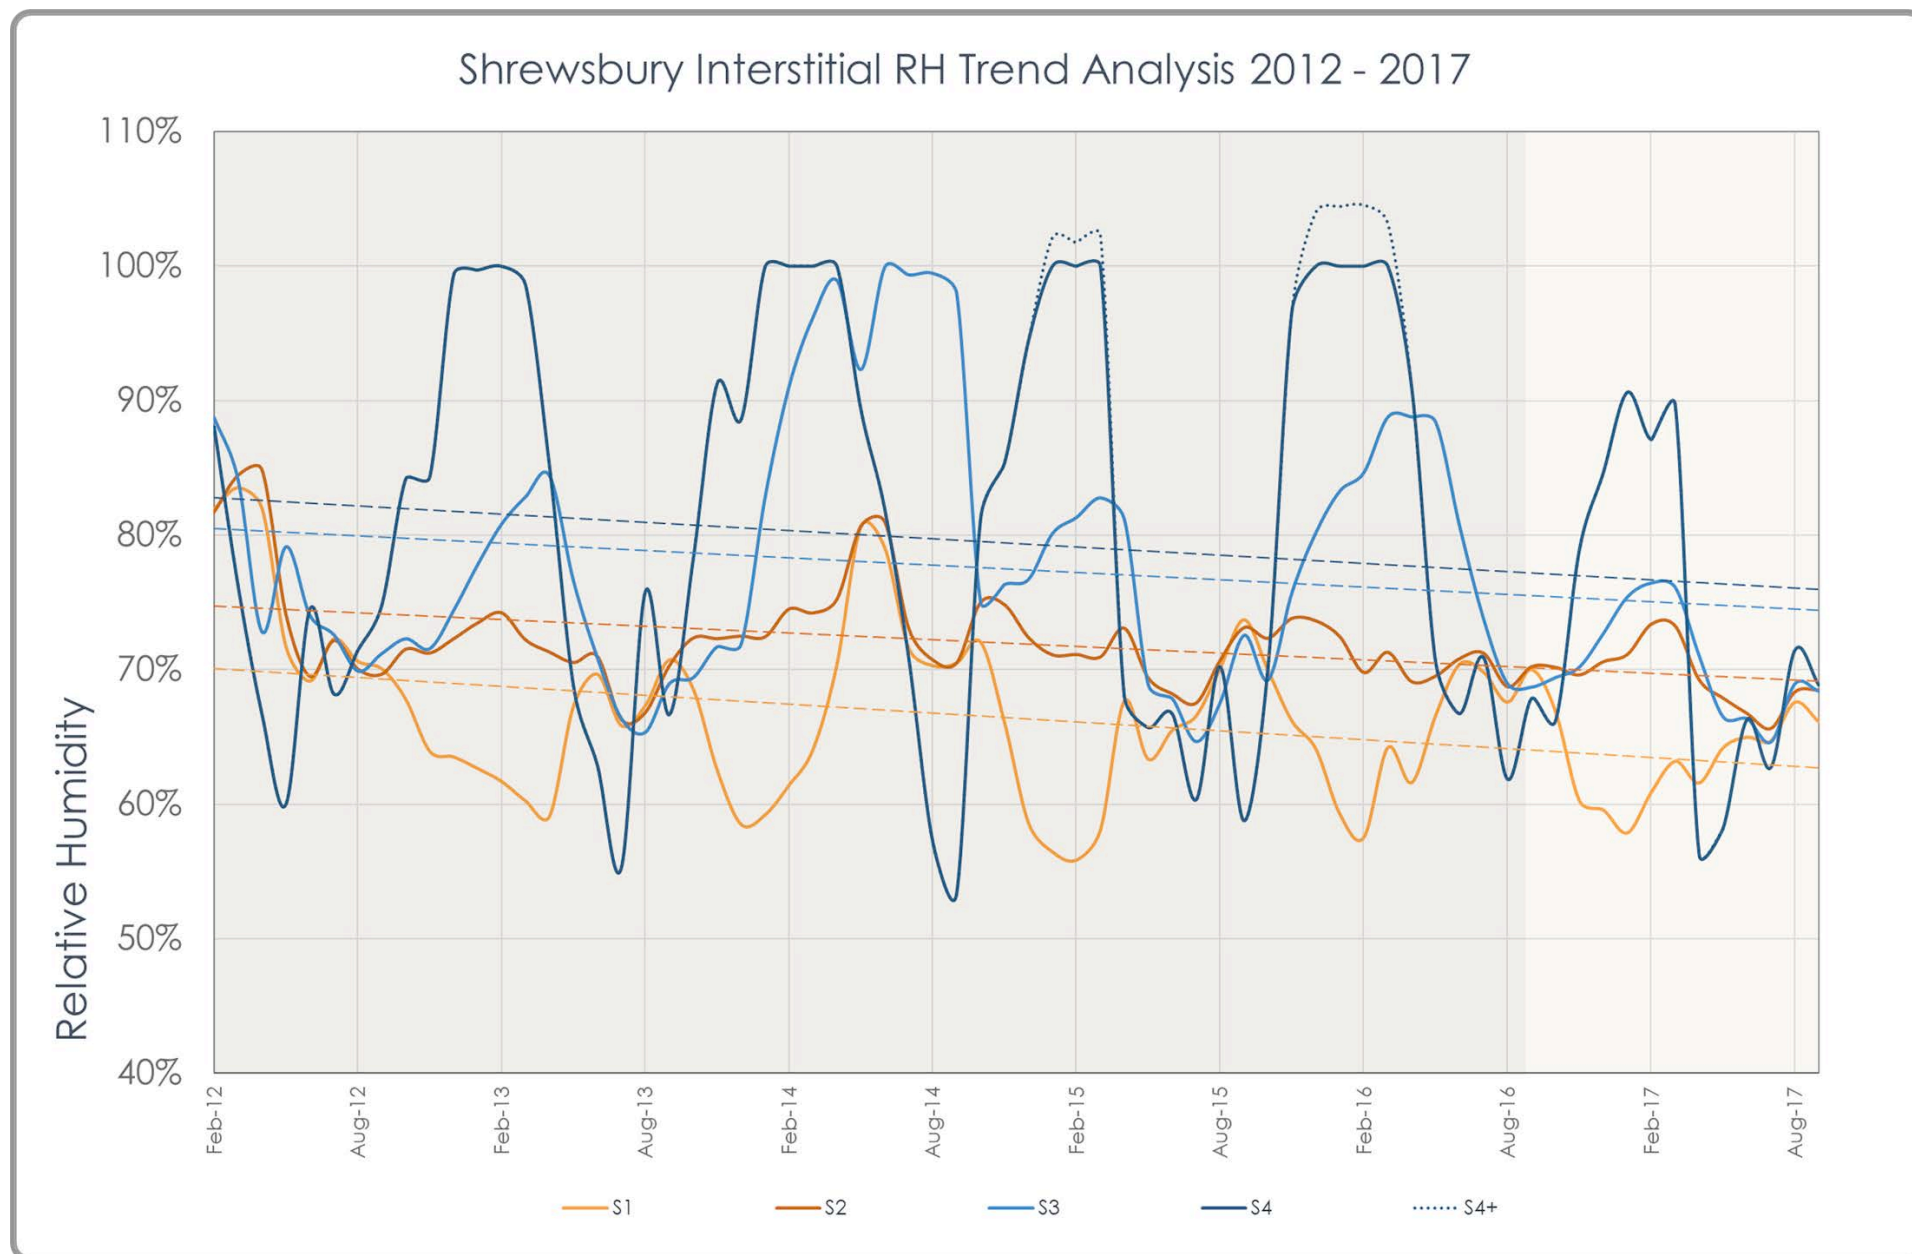
Figure 49. Relative humidity trends over time, Shrewsbury 2012-2017.

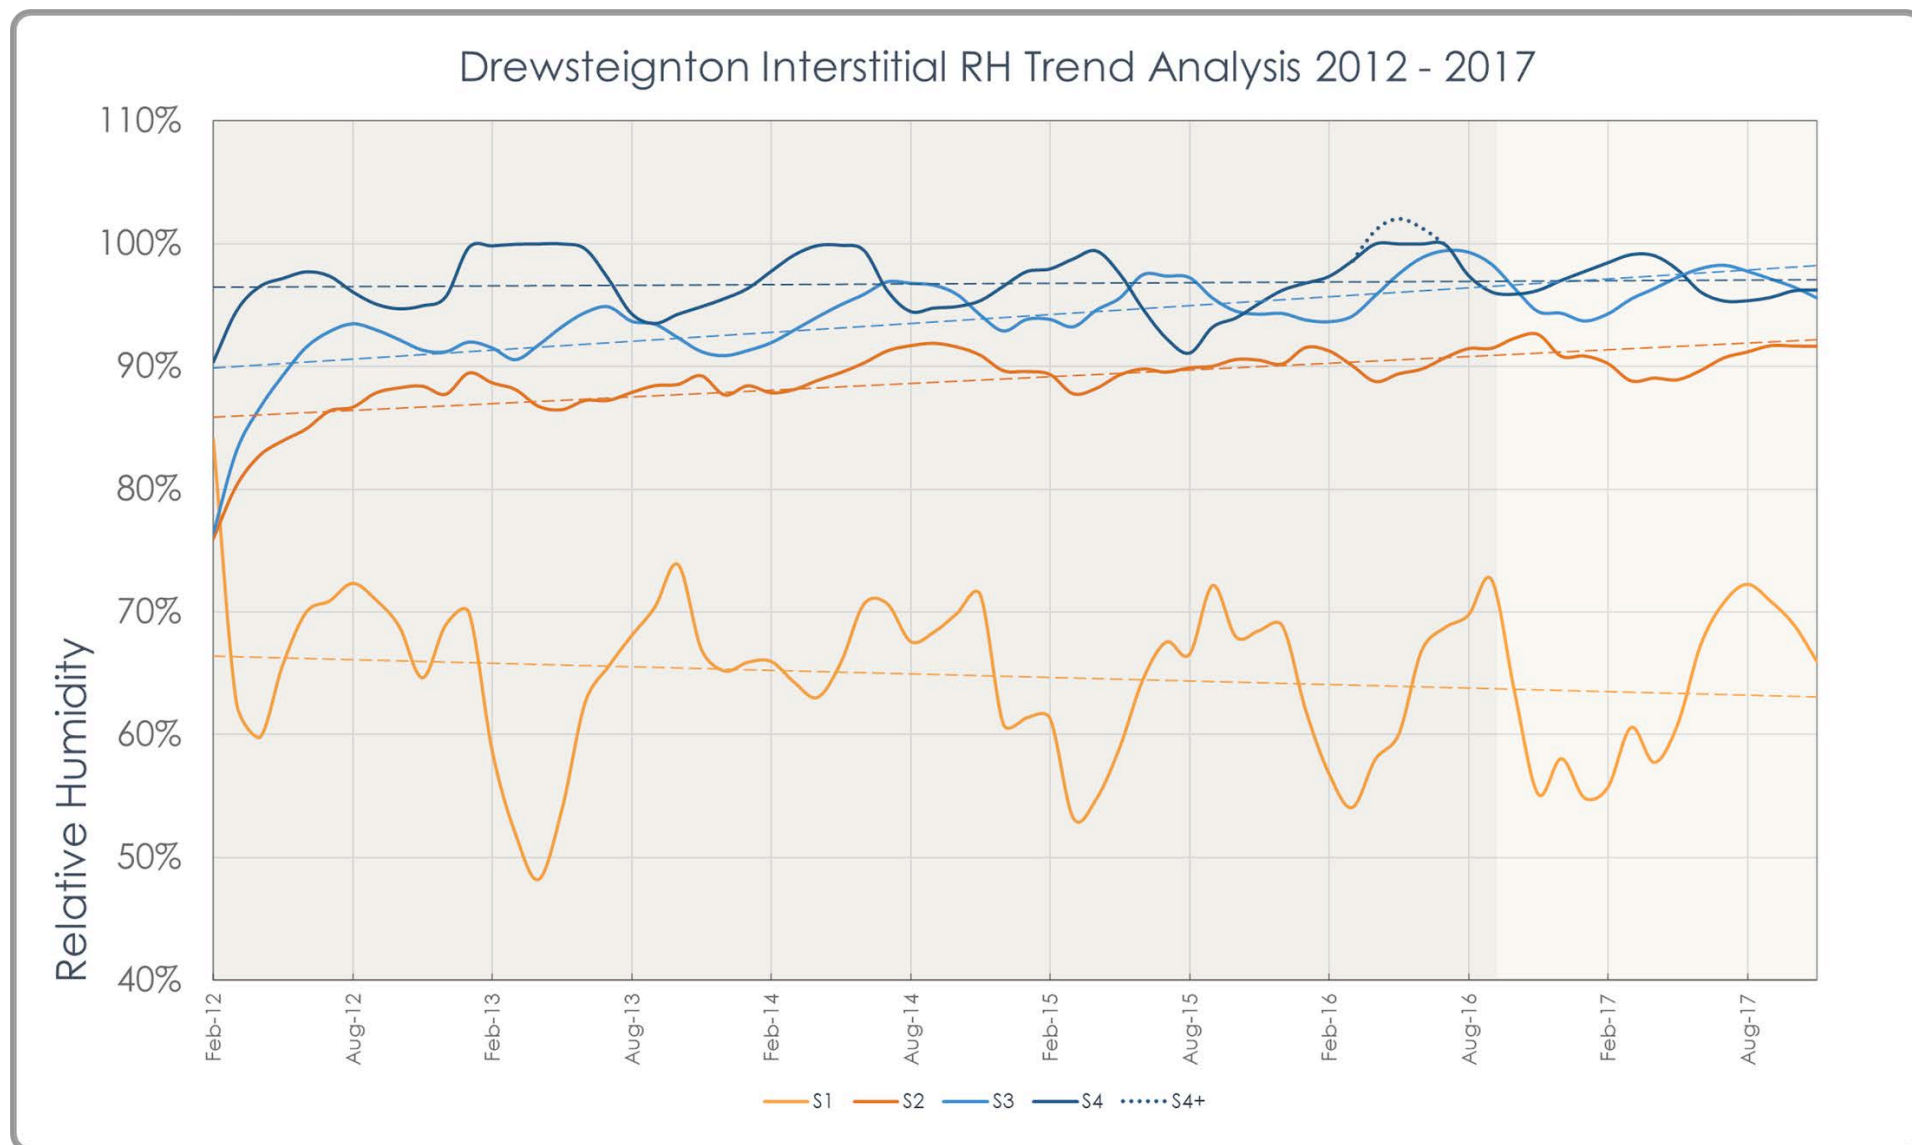
Figure 50. Relative humidity trends over time, Drewsteignton 2012–2017.

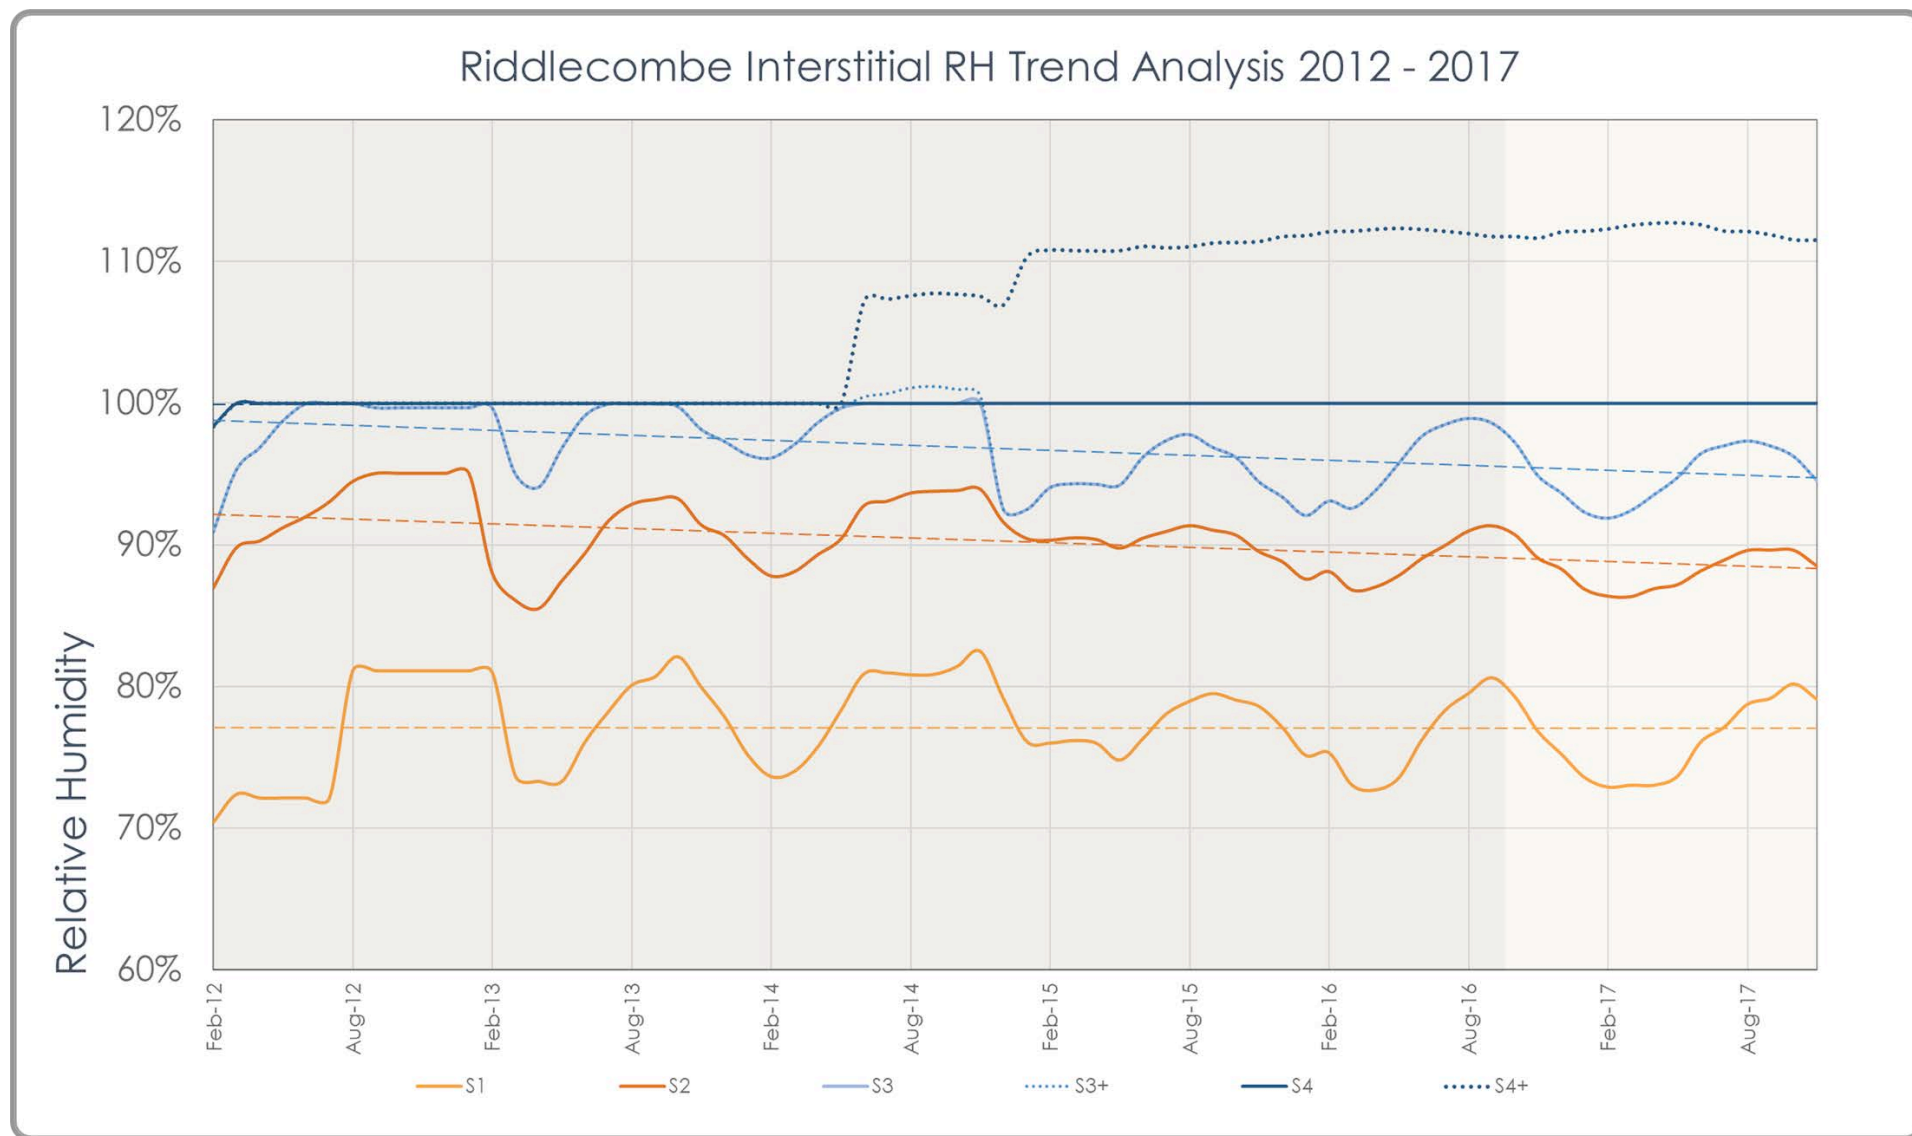
Figure 51. Relative humidity trends over time, Riddlecombe, 2012-2017.

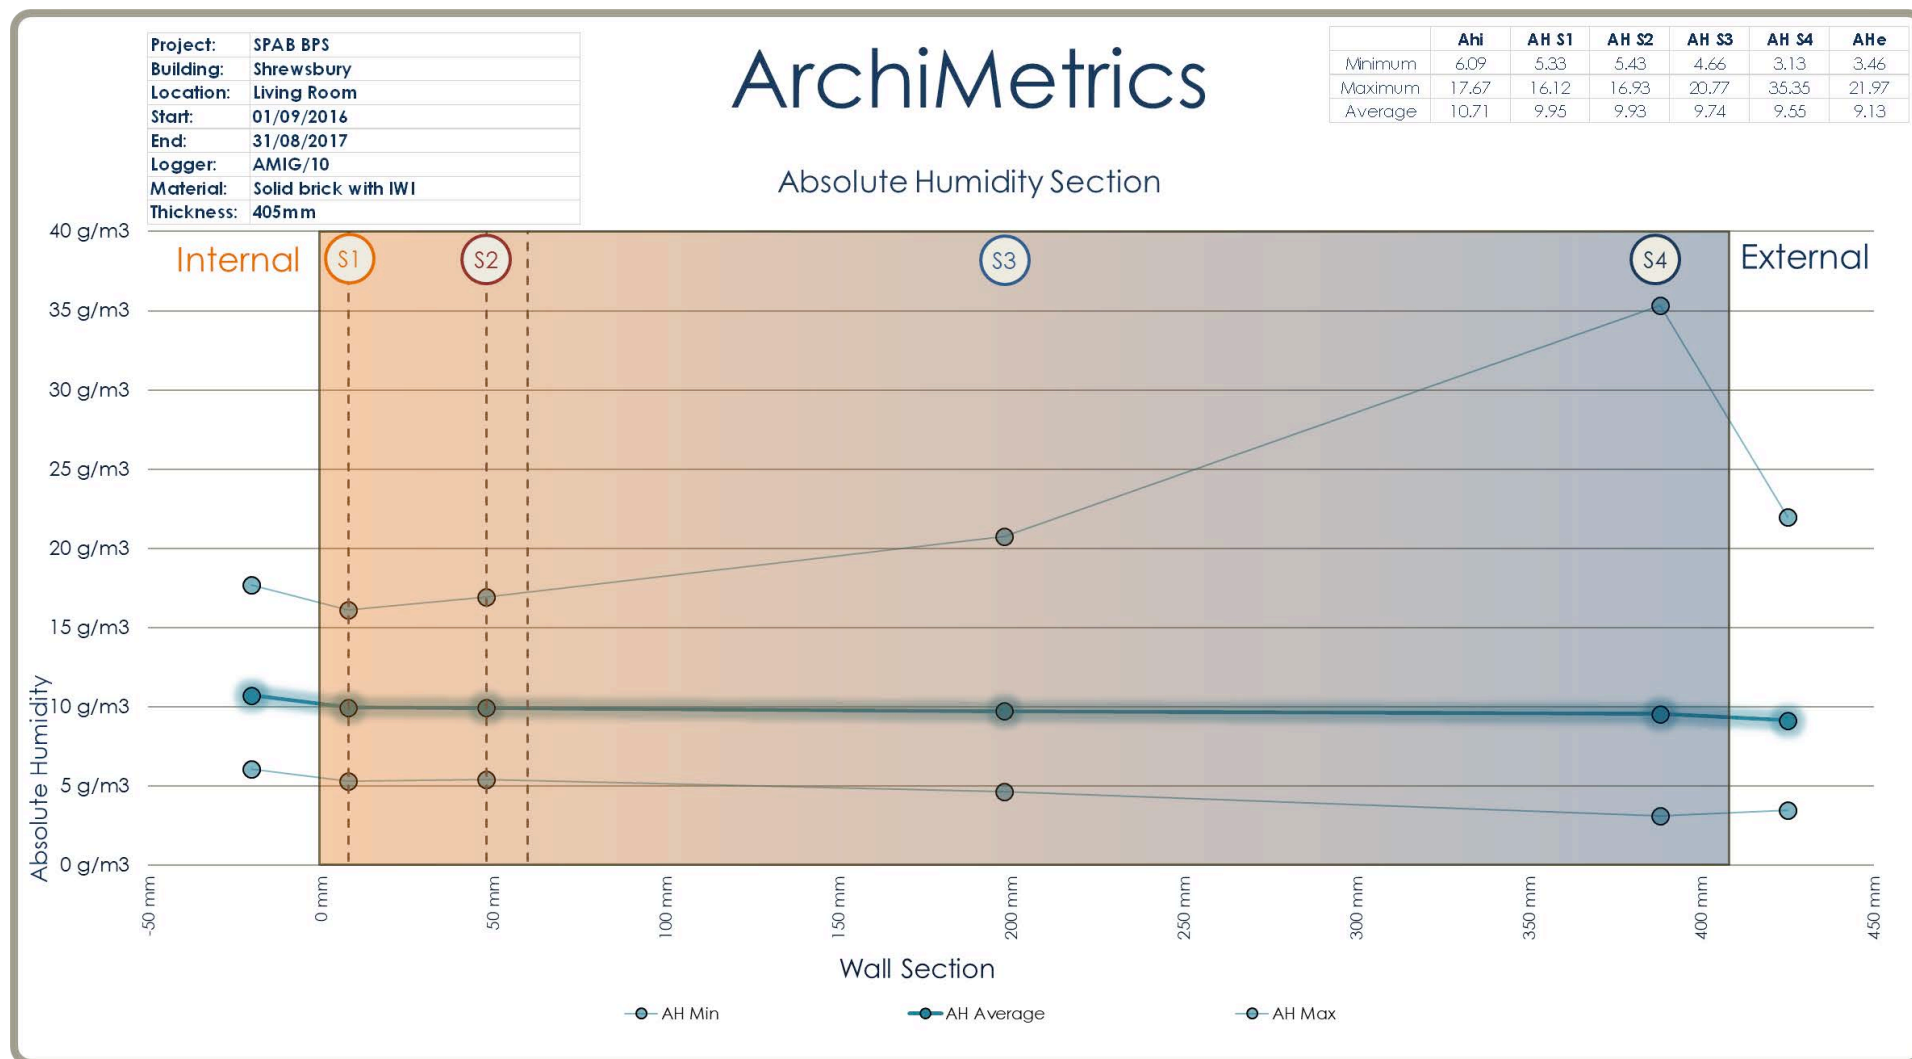
Figure 52. Absolute humidity average Section, Shrewsbury, 2016-2017.
