The SPAB Building Performance Survey 2017

Interim Report

ArchiMetrics Ltd.

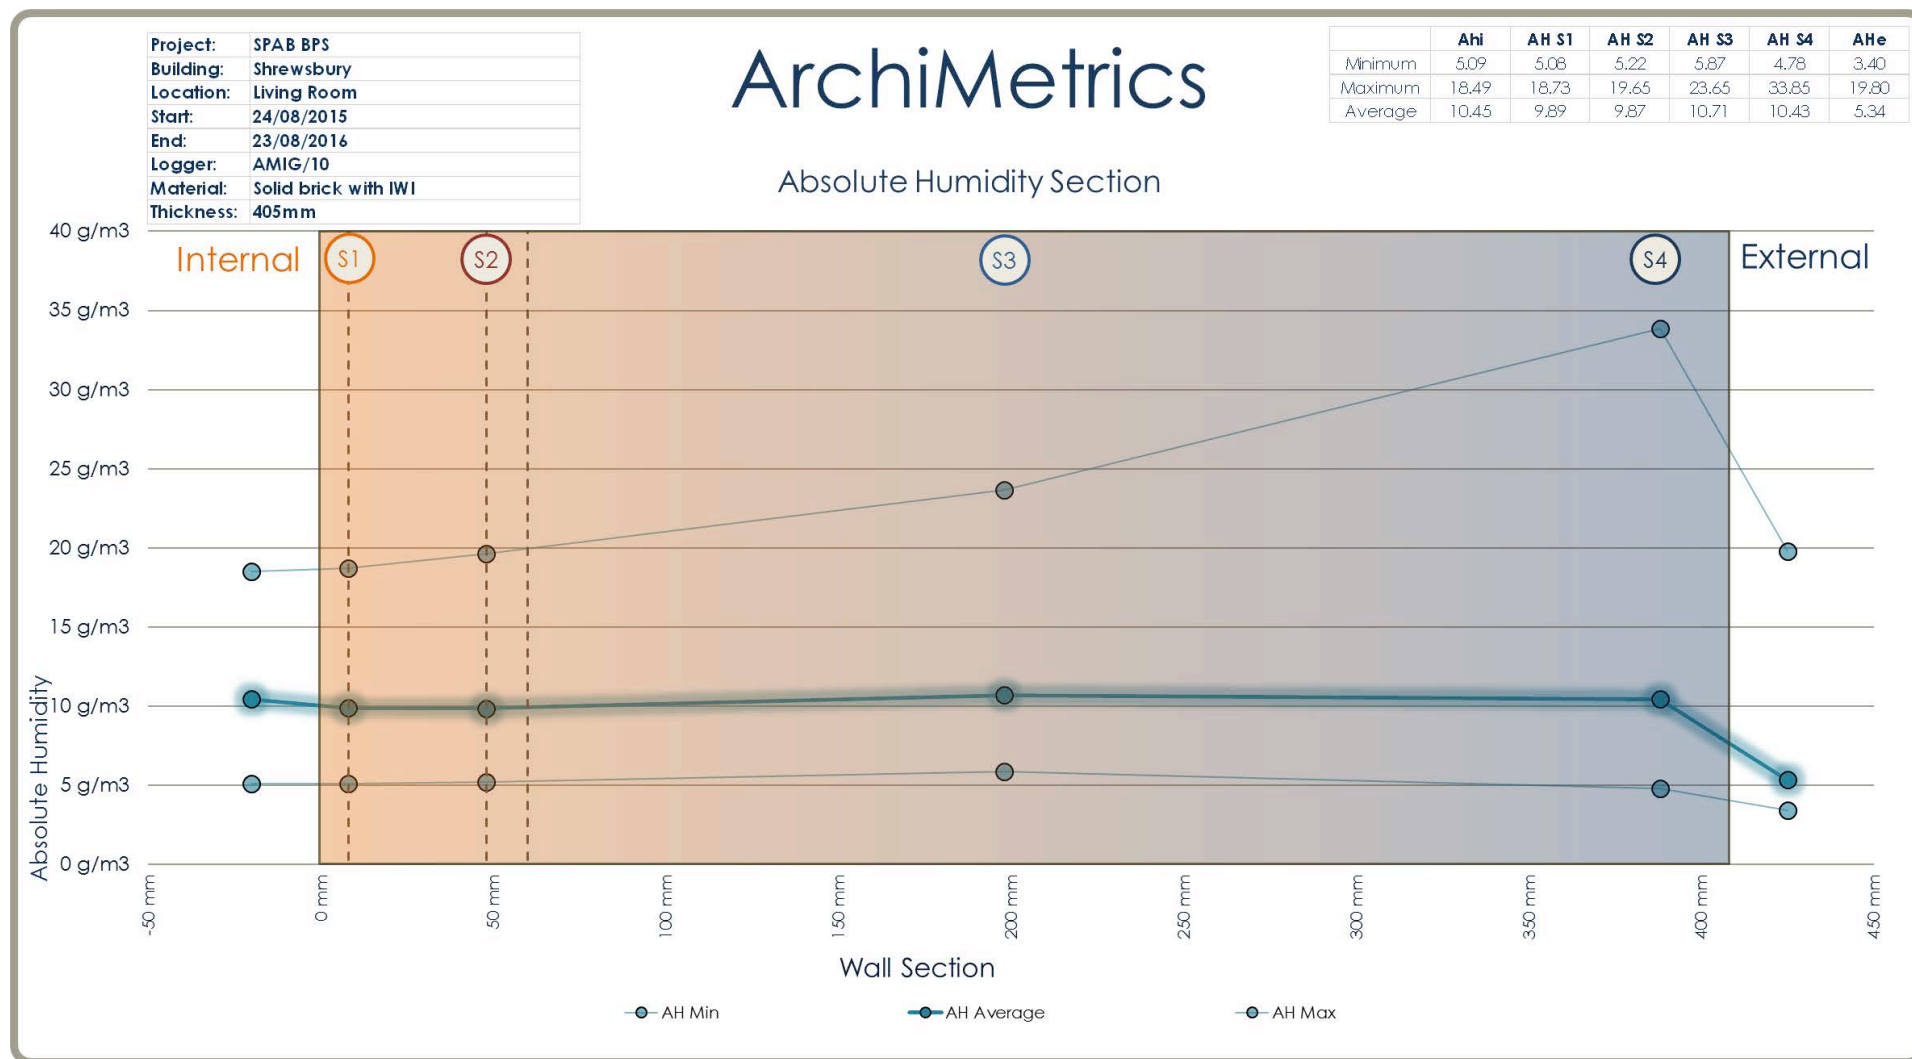
Figure 53. Absolute humidity average section, Shrewsbury, 2015 -2016.

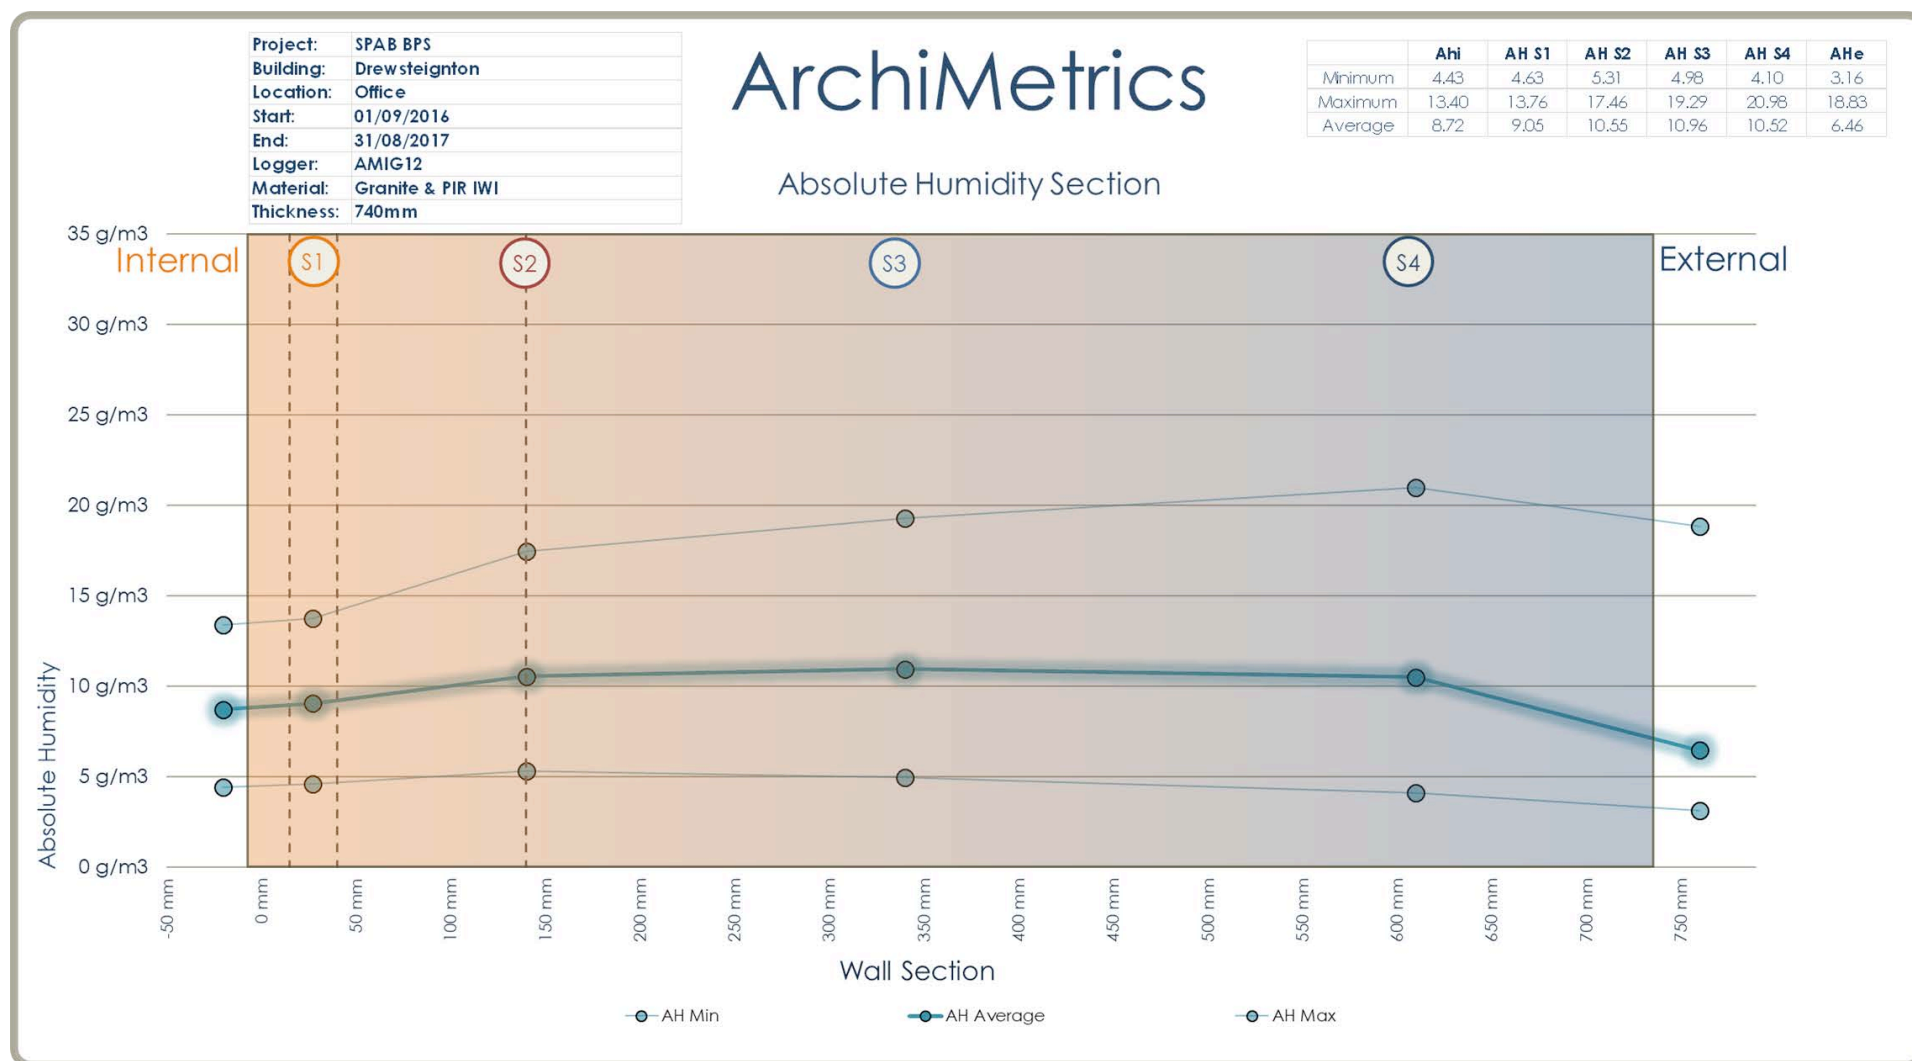
Figure 54. Absolute humidity average section, Drewsteignton, 2016-2017.

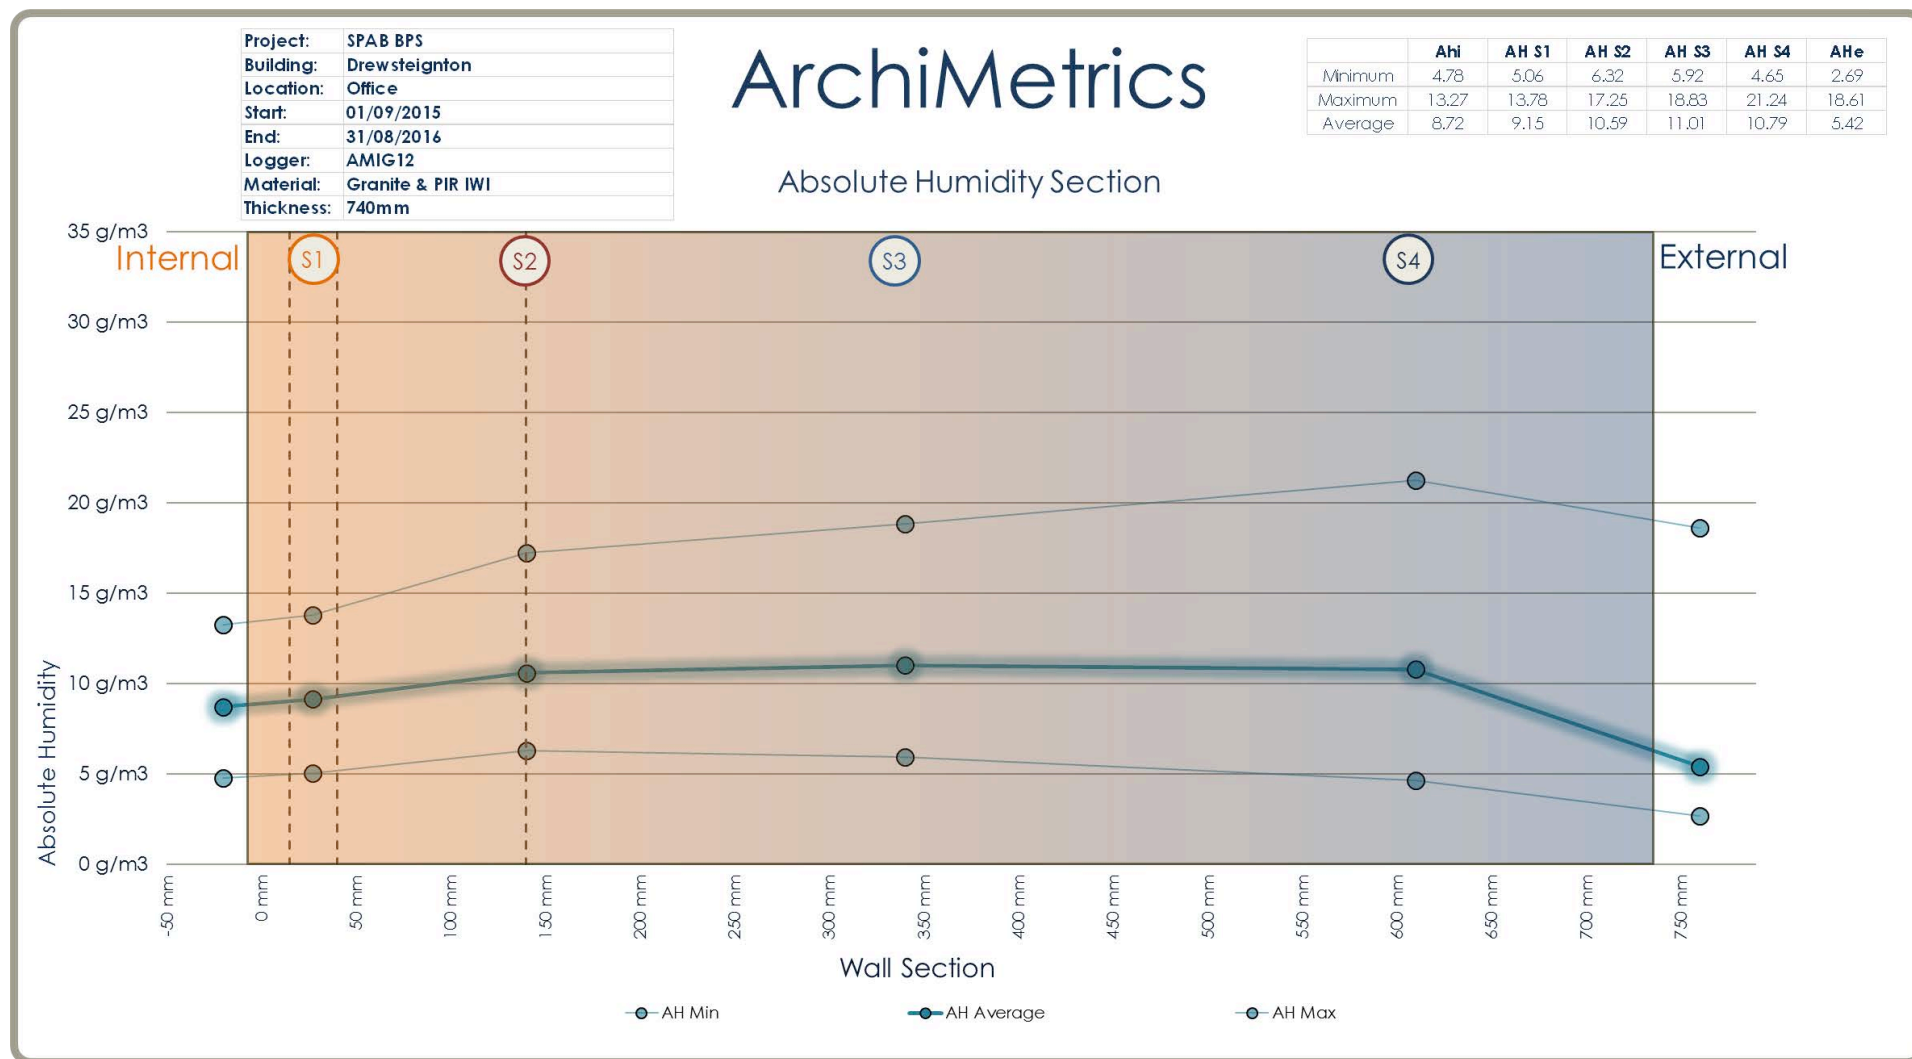
Figure 55.. Absolute humidity average section, Drewsteignton, 2015 -2016.

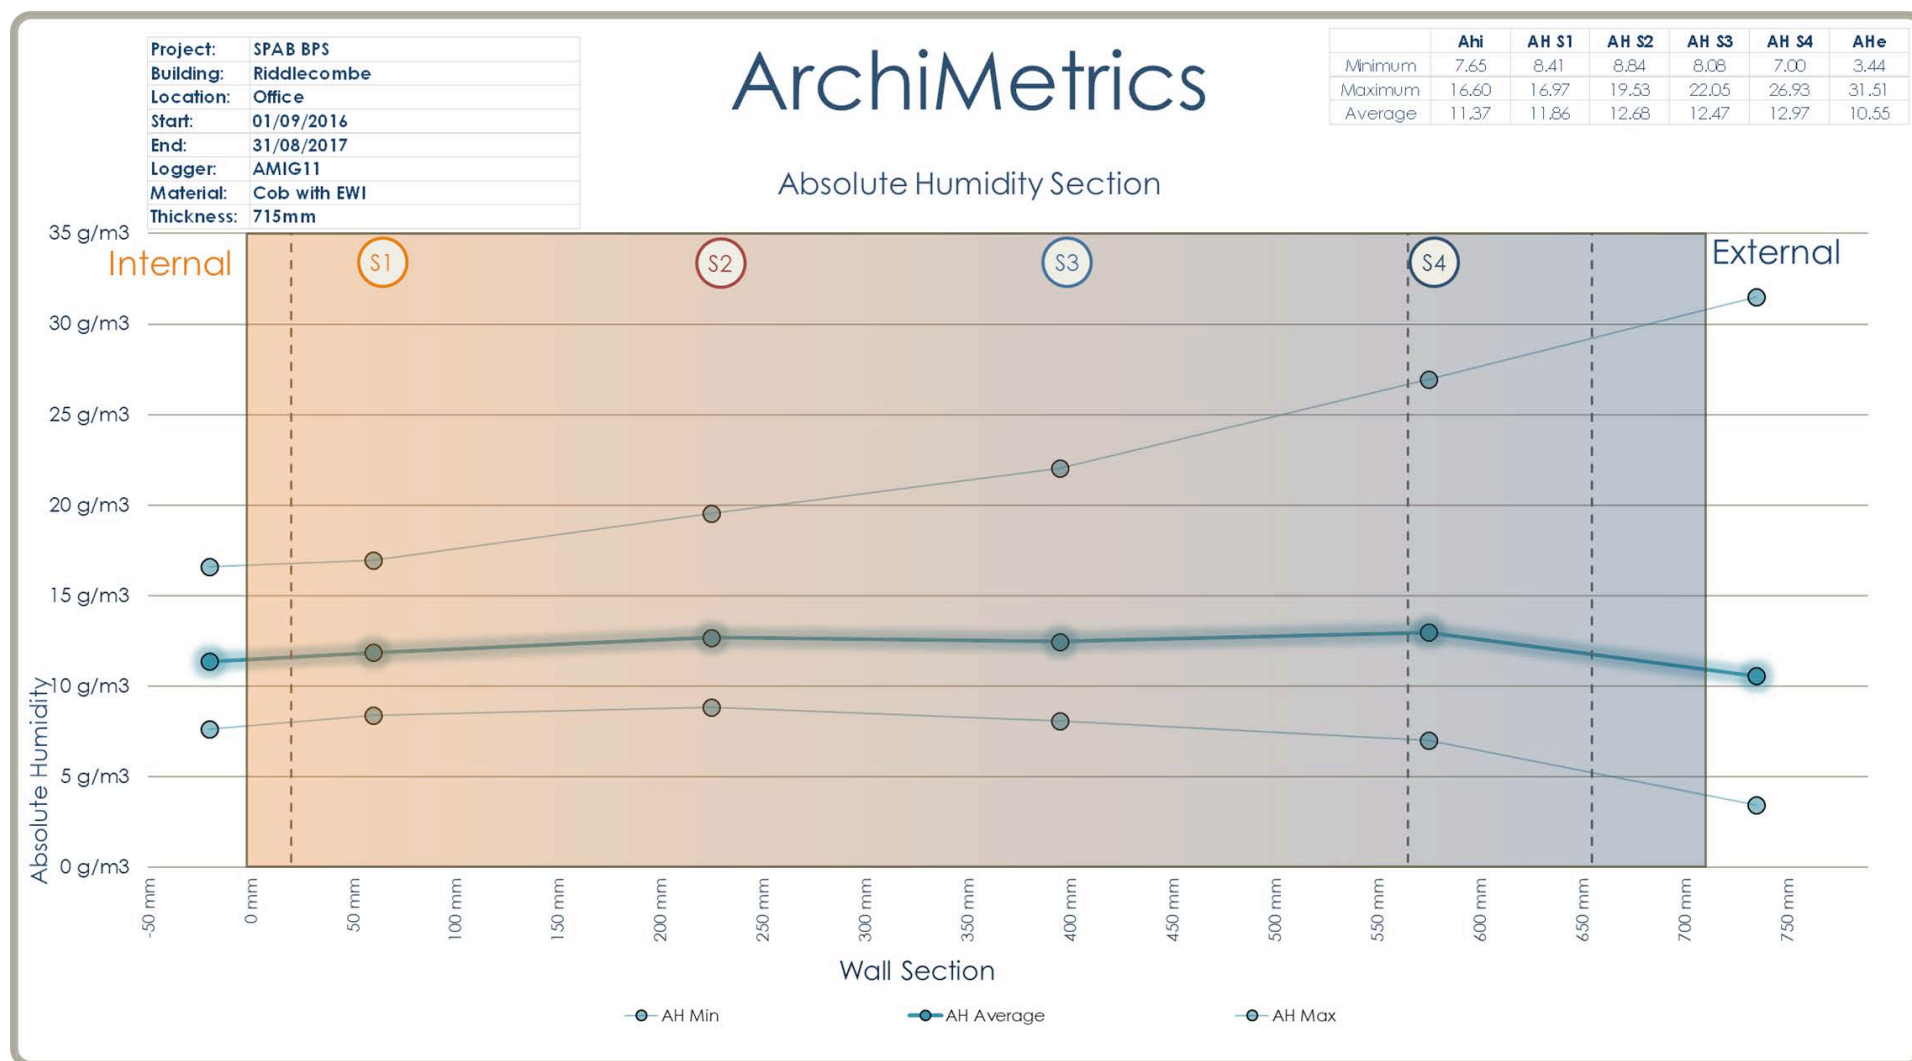
Figure 56. Absolute humidity average section, Riddlecombe, 2016-2017.

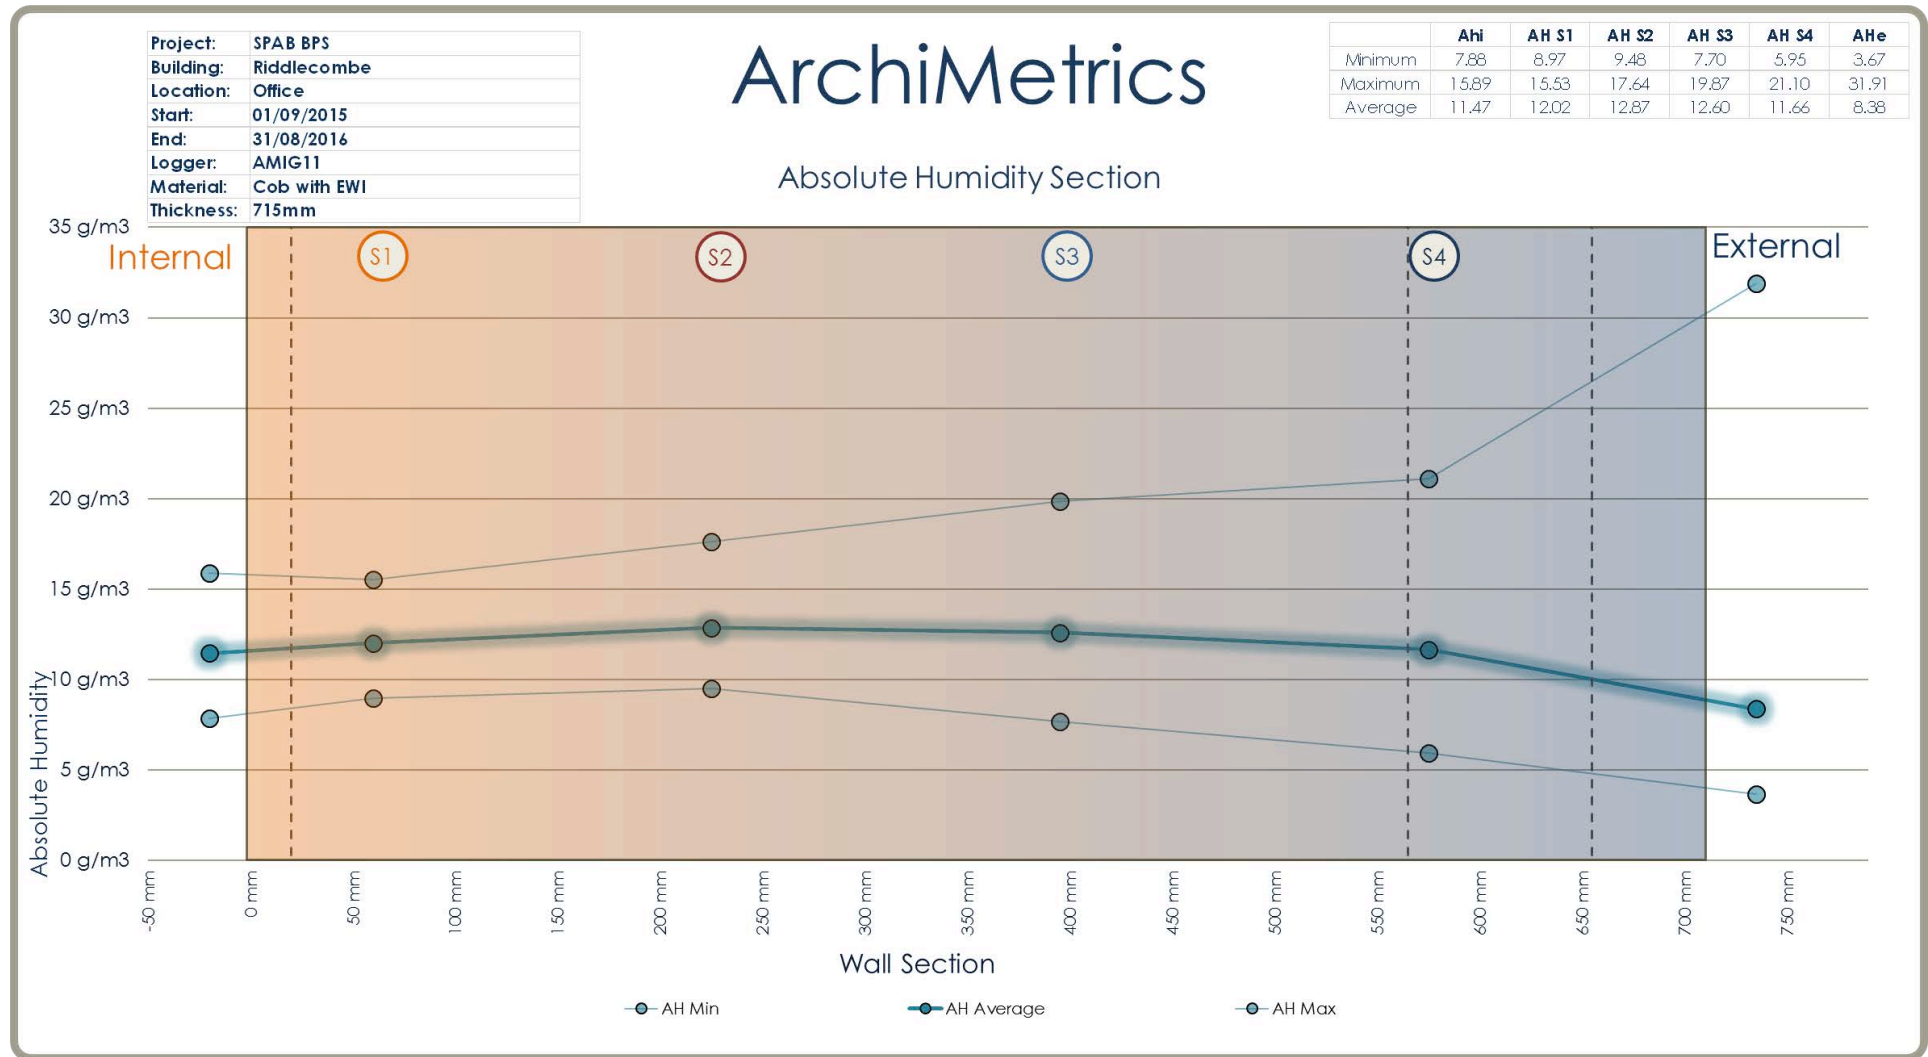
Figure 57. Absolute humidity average section, Riddlecombe, 2015-2016.

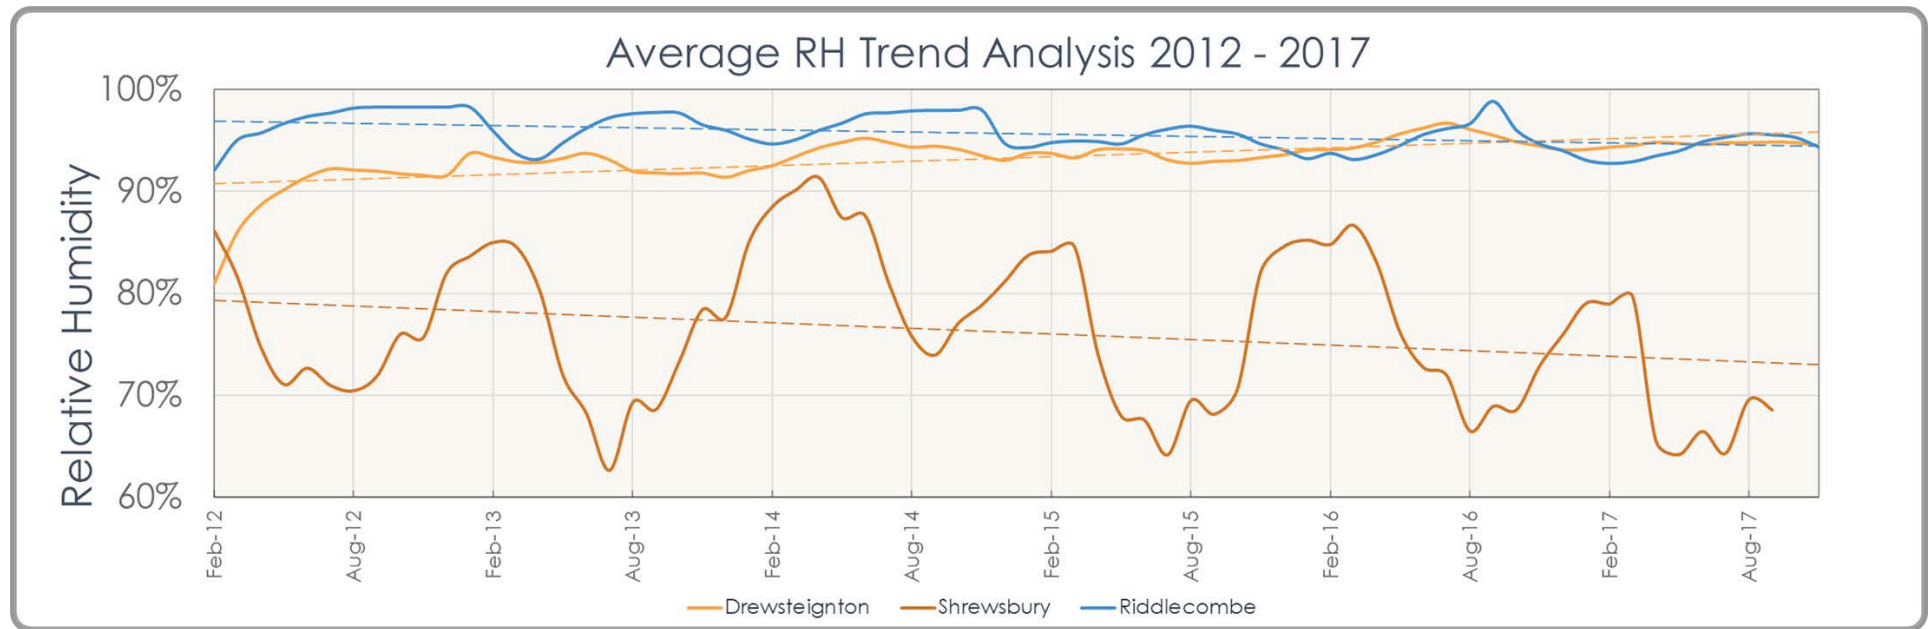
Figure 58. Average RH trend analysis, Shrewsbury, Drewsteignton and Riddlecombe, 2012-2017.
