The SPAB RESEARCH REPORT 2

The SPAB Building Performance Survey Final Report

The SPAB Building Performance Survey Final Report 2019

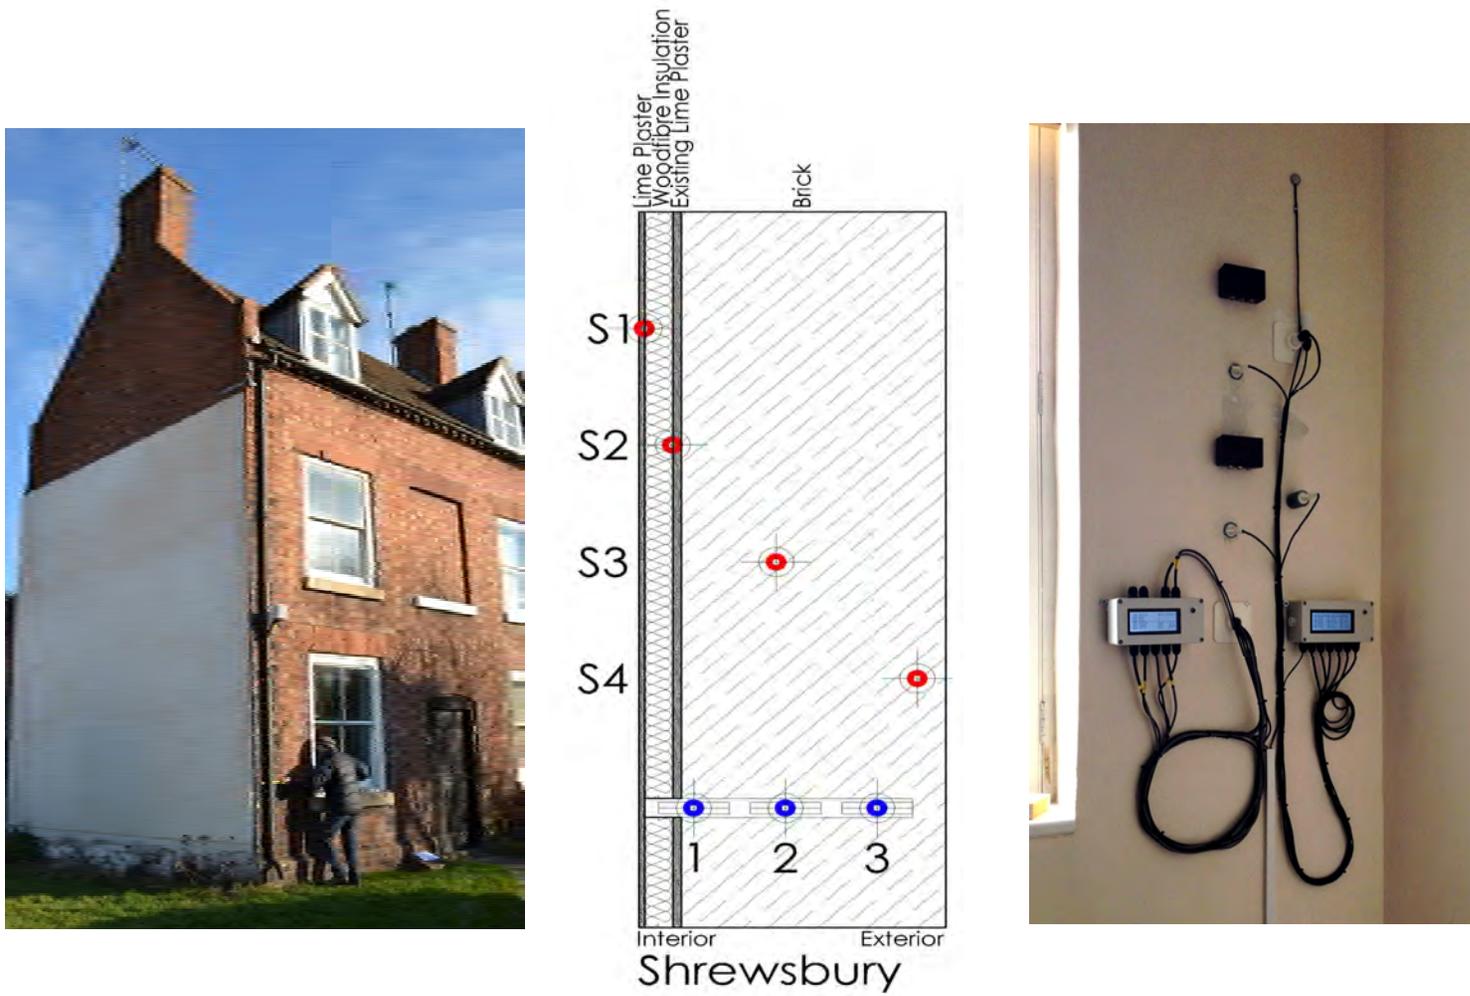
Figure 2. Interstitial hygrothermal gradient and material moisture monitoring, Abbeyforegate, Shrewsbury 2014.

The brick wall monitored in the study is found in a late Georgian building (1820s) located on Abbeyforegate, in the town of Shrewsbury. All the monitored walls are at ground floor level and floor plans showing monitoring locations are provided in Appendix A. The wall at Shrewsbury is south-facing and made of low-fired, relatively soft, porous and permeable brick bedded in lime mortar. It is a brick-and-a-half thick, $\approx 14''/350$ mm, with some areas of pointing in poor condition. As part of the refurbishment of the house in 2012, the wall was internally insulated with 40 mm of woodfibre insulation board with a thermal conductivity (λ) value of 0.039 W/(m K) and finished with lime plaster and silcate paint. Table 1 provides details of the depths of combined RH and temperature monitoring

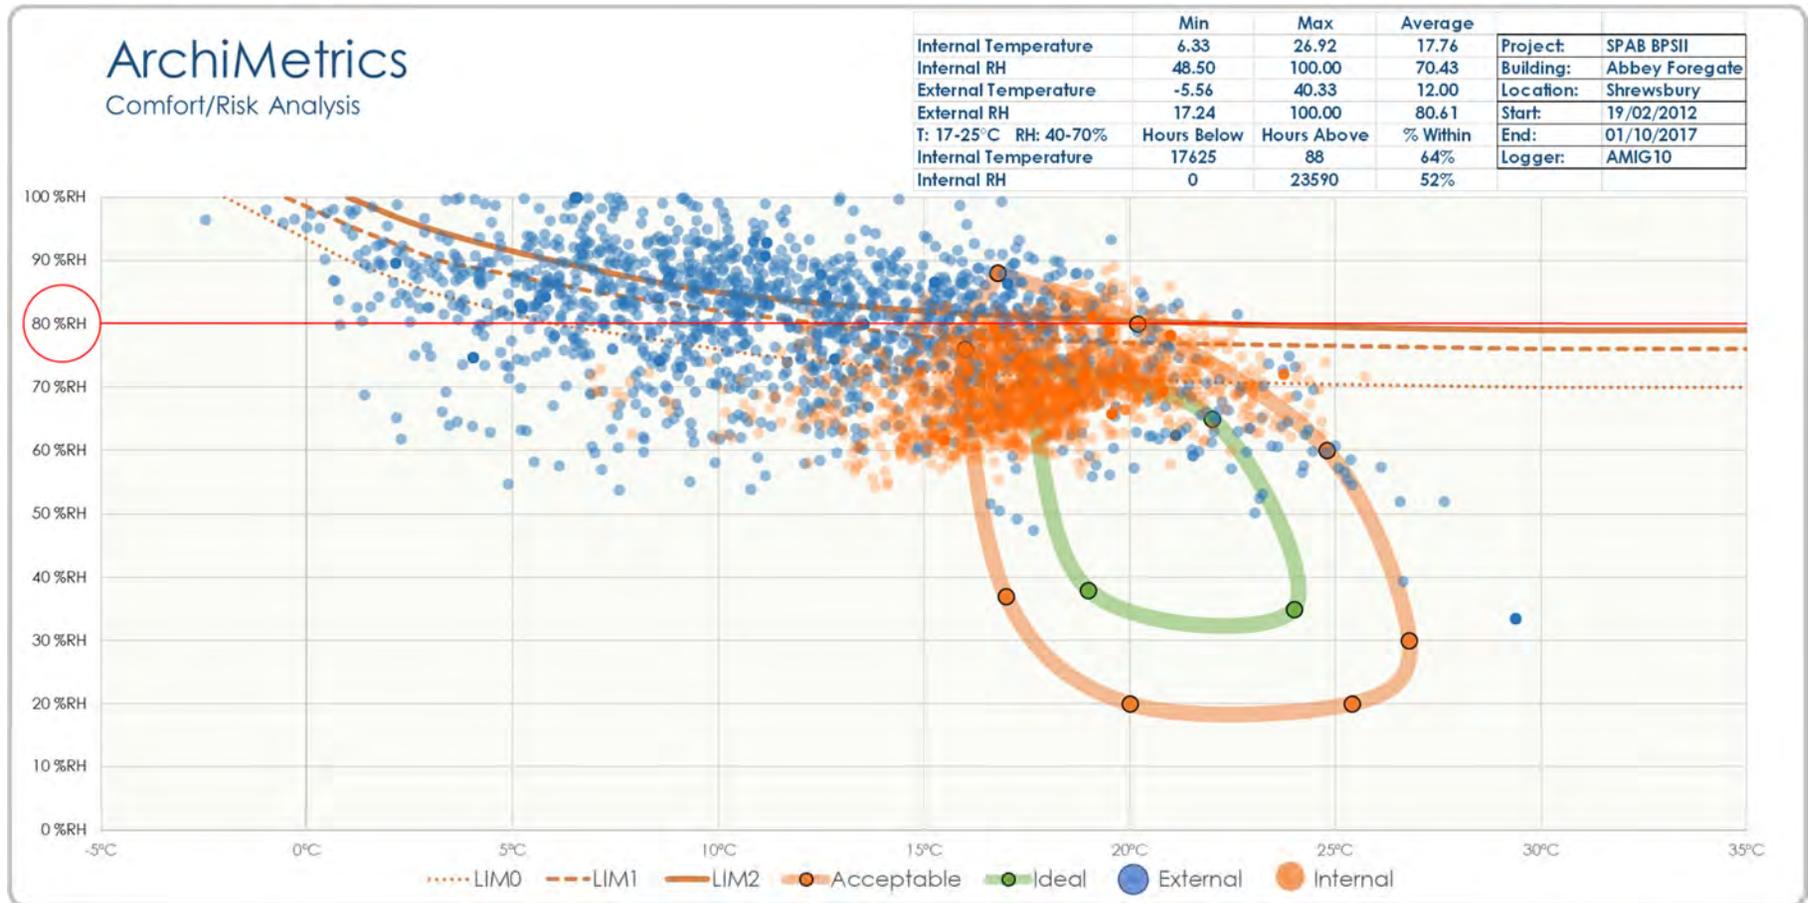
Figure 38. Comfort/risk analysis, Shrewsbury, 2012–2017 post-refurbishment.

The post refurbishment analyses for the rooms, Figures 38, 39 and 40, use nearly a full six years of measured temperature and RH data to map conditions within the rooms. These analyses also include external conditions and details of hours spent above and below 17–25°C and 40–70% RH for the three rooms and the commonly given 80% threshold for mould growth on surfaces is marked in red.
