SPAB CONFERENCE REPORT

The use of Horsham stone slate in historic buildings

Forum convened by the SPAB
Thursday 21 June 2018
The SPAB, 37 Spital Square, London, E1 9DY
Chaired by Philip Hughes, chair of SPAB technical panel

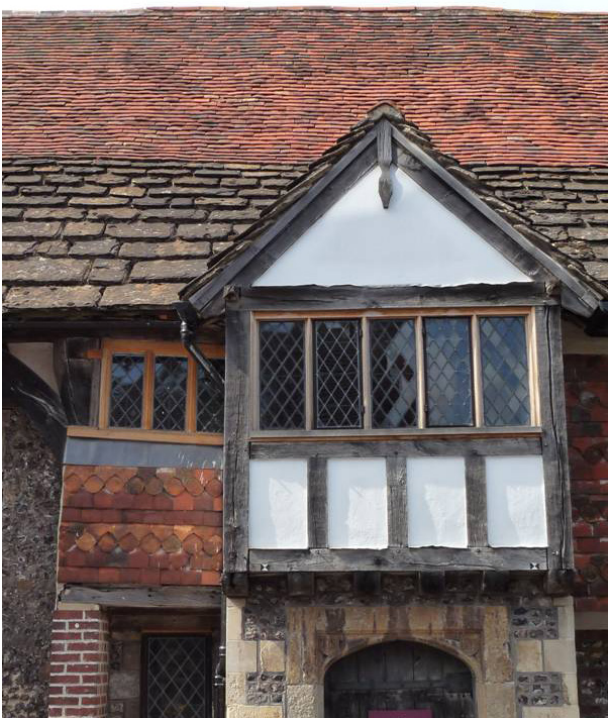
Horsham stone slate in combination with plain clay tiles at Anne of Cleves House, Lewes, East Sussex. Photo credit: Matthew Slocombe.

Combining HSS with plain clay tiles can also be historical in its own right - certain buildings might have been covered in this manner at construction; other roofs have had courses of tiles for a long time, and the proportion of tiles might have increased over time through successive re-coverings. Is it legitimate/desirable for the proportion to increase again if the amount of HSS set aside and capable of re-use, or available from other sources, is reduced? Is it legitimate/desirable to introduce plain clay tiles to a roof now, where there is insufficient HSS available to complete the whole area, given that this has become an established method in the region?

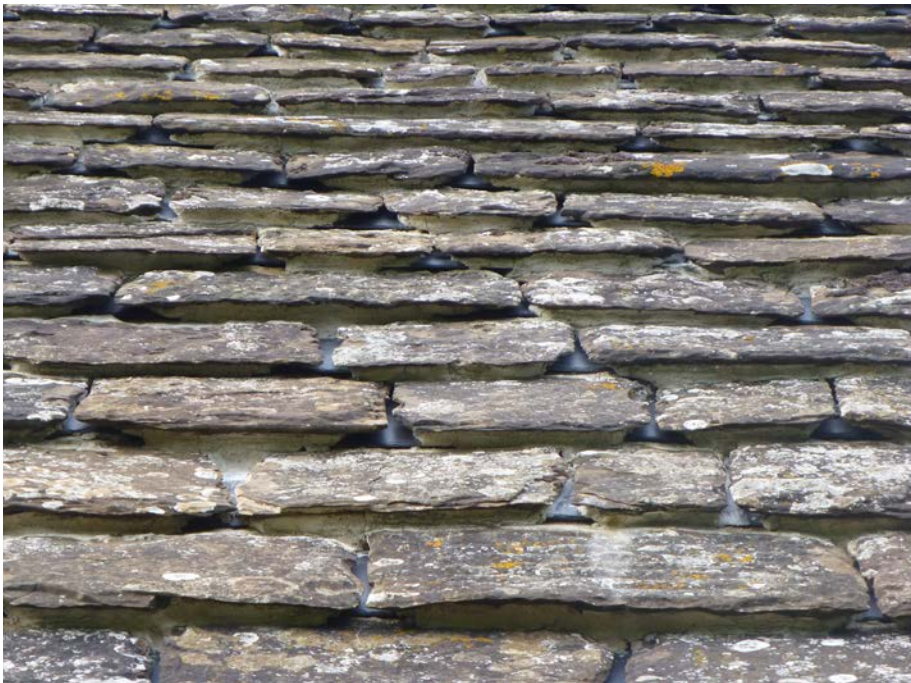
Horsham stone slate single-lapped with Welsh slate soakers at Botolphs Church, West Sussex (view angled to show technique). Photo credit: Rachel Morley.

Usually, in the single-lapped system, the shadow slates are nailed to a narrow batten with the HSS nailed to a more substantial batten to get the soakers to lie flat between the HSS courses. As these soakers bear the weight of the HSS, transmitted through the mortar, it is important both that those slates are durable and that the mortar is able to flex. It was, therefore, of concern that some contractors seemed reluctant to embrace lime rather than cement for bedding mortar (despite, for example, Historic England having devised a straightforward NHL-based specification suitable for roofing, published in its Practical Conservation volume on Roofs). Historic England is currently carrying out detailed research on the curing strengths of NHLs, as there has been a realisation recently that over-hard NHL mortars may be problematic. Many of those present had also been following the current debate around the use of hot-mixed mortars and consequent developments in mortar specification, but there was no consensus on the adoption of hot lime – for HSS roofing or more widely. Richard Jordan reported successful use of hot lime in a number of projects but stressed that highly significant historic roofs or large-scale work were not really the place for experiment. There was broad agreement that finding the ‘right’ mortar for use with HSS was essential to the long-term success of roof projects – further research, and monitoring the performance of recent work over time, would be instructive. A softer mortar could perform sacrificially and enable periodic repointing. The group agreed that whatever mortar is used, it is advisable for one person to oversee mixing for the duration of a project, to ensure consistency and control quality.

The group discussed the choice of slate for soakers in the single-lapped system and there was broad

agreement that whilst Welsh slate might be more expensive, it was of better quality and consistency than other types. However, alternatives to shadow slates were also discussed and the group wondered whether it might be possible to experiment with, for example, a lead under-cloak, or lead with welted edges formed to mimic shadow slates. Some within the group also debated use of a highly durable pitch polymer damp proof course material (such as Hyload). These alternatives would not need to be mortared in, so would allow ventilation of the roof void – and open up the possibility of insulating such roofs safely.

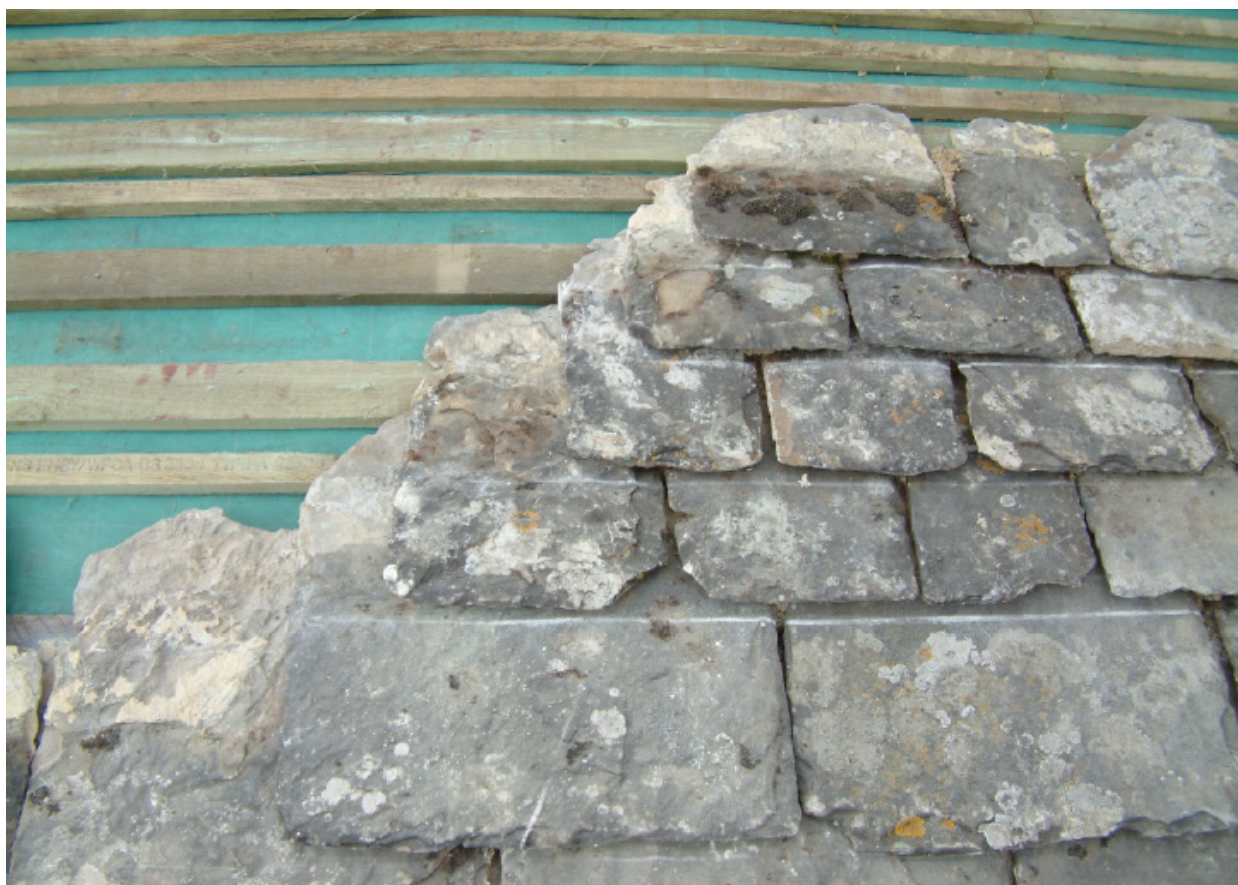
Work in progress at Coombes Church, West Sussex (repaired 2008). Photo credit: Richard Crook.

Architect Richard Crook described his repair of a double-lapped HSS roof at Coombes Church near Lancing, West Sussex in 2008, indicating that it is still possible to use this technique effectively. However, as discussed above, 'compromise' repair or roofing techniques such as introducing courses of plain clay tiles towards the ridge, and use of a version of the single-lapped roofing method using shadow slates, had been in use for some time.
