St Andrew's Chapel, Boxley, Kent

A report on recent archaeological investigations

Site status: Grade II listed building (National Heritage List reference 1185580)

Report by: Graham Keevill, Keevill Heritage Ltd
Client: The Society for the Protection of Ancient Buildings
October 2019

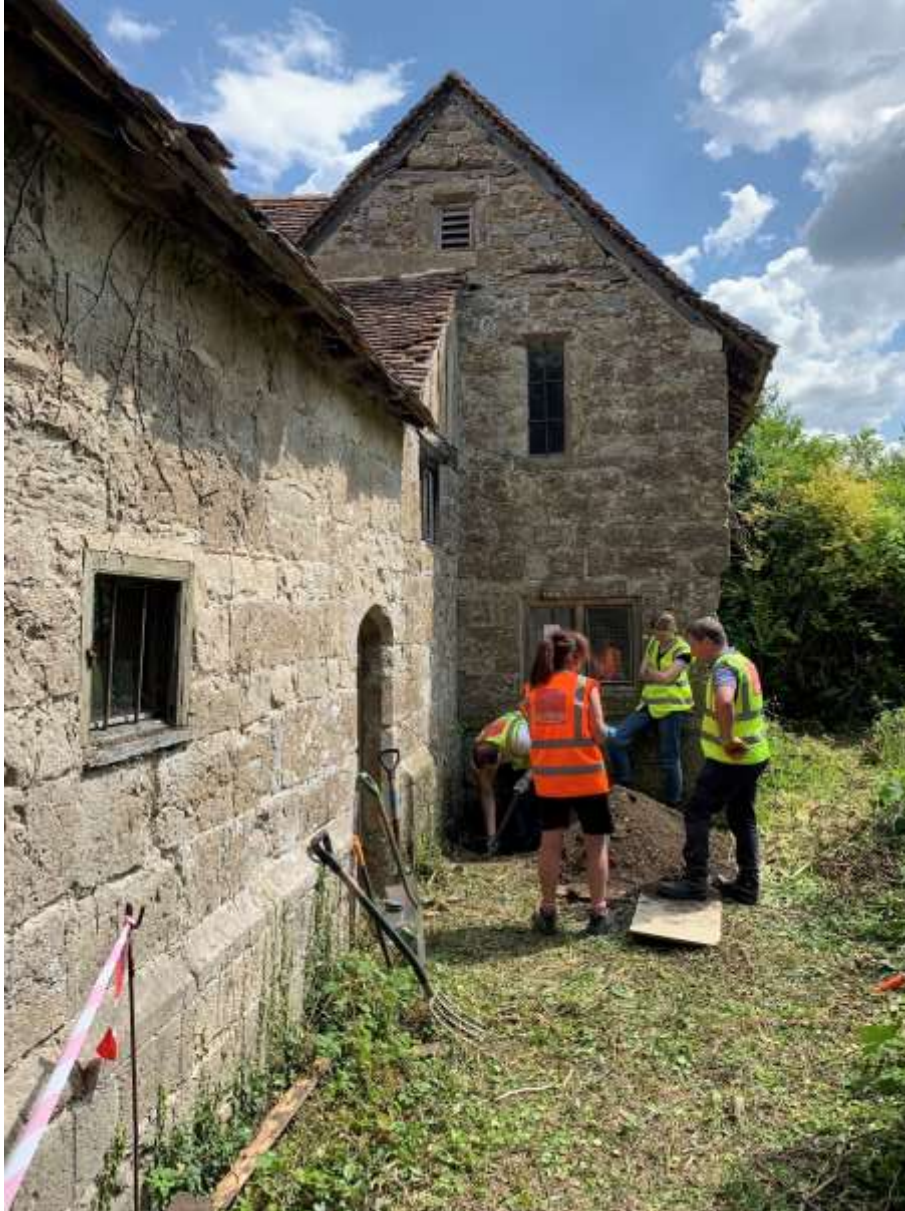
Figure 1: Excavations in progress, July 2019. This shows test pit 3 being excavated by SPAB volunteers. View looking east.

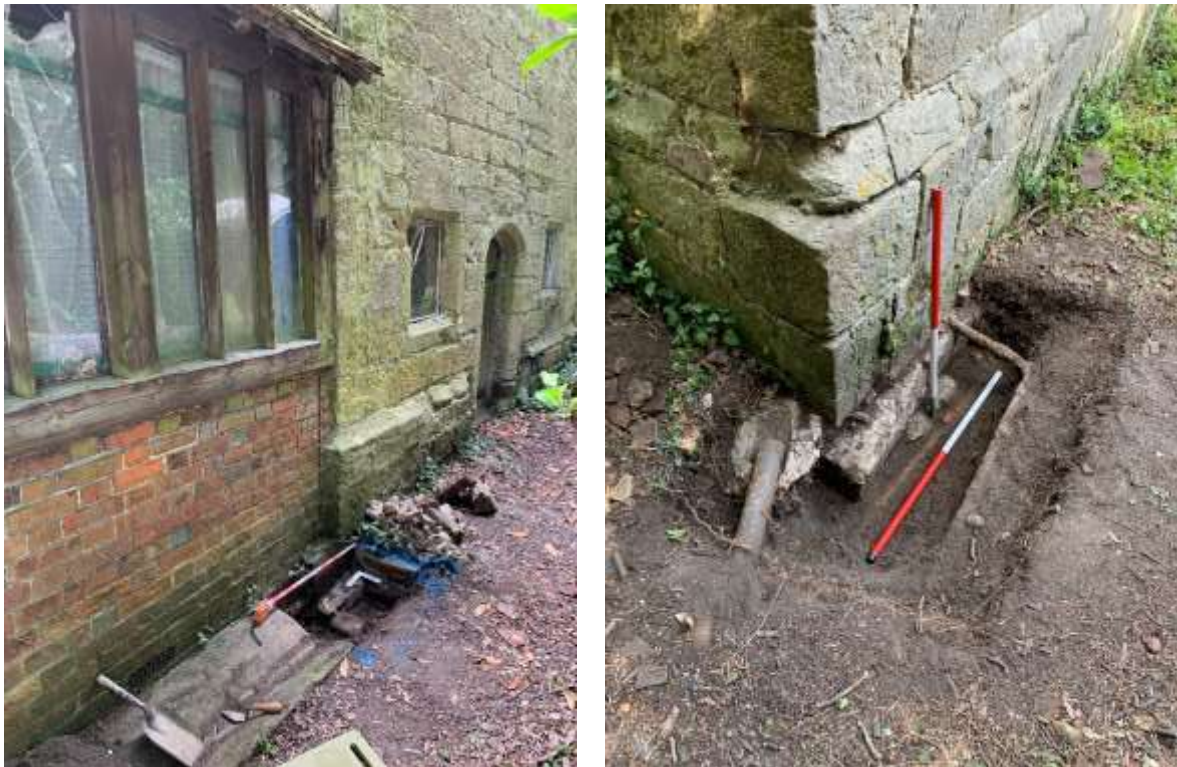
Figure 4: General location photographs of TP1 (left) and TP2.

This excavation was located on the west end of the Chapel, at the junction between the north-west corner of the building and a small single-storey extension added in the late 19th century. The pit was up to 0.75m long north-south (but this included a modern brick and concrete drain pit, which was only partly broken out), 0.5m wide, and 0.4m deep (excluding the drain pit).

TP2 was excavated on the south-west corner of the Chapel, where some structural movement was evident. Most of the pit lay against the south wall, and the part wrapping round the west end was largely left unexcavated because a Victorian/modern downspout catch-pit and drain were found here (**24**, **25**). Removal of these was unnecessary archaeologically, while the condition of the masonry here gave some cause for concern as well. The southern portion of the pit was up to 1.4m long (east-west – it was shorter initially but was extended to expose more of the masonry described below), 0.65m wide, and 0.4m deep.

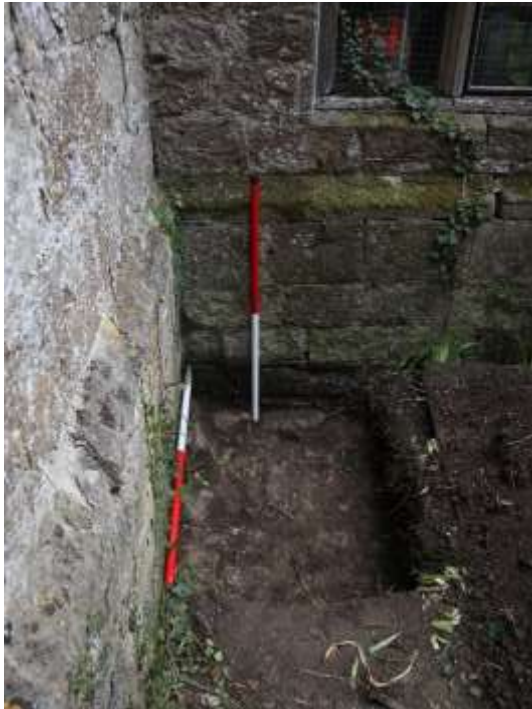
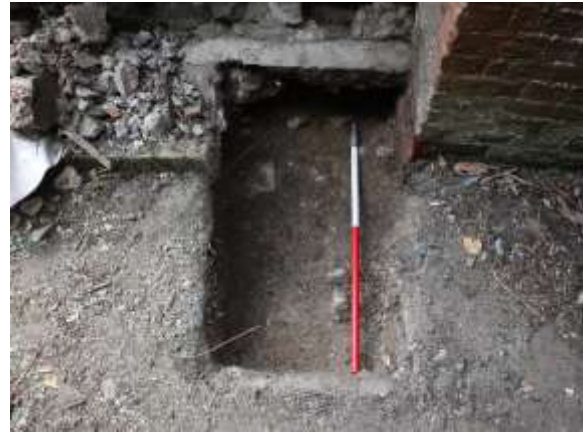
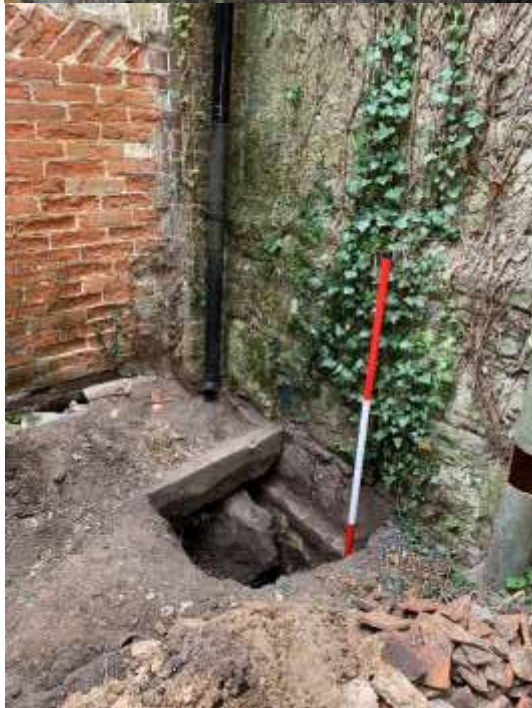
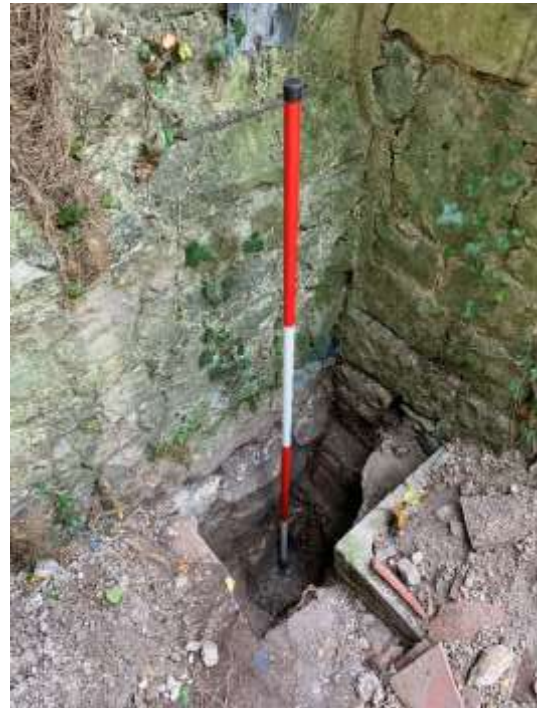
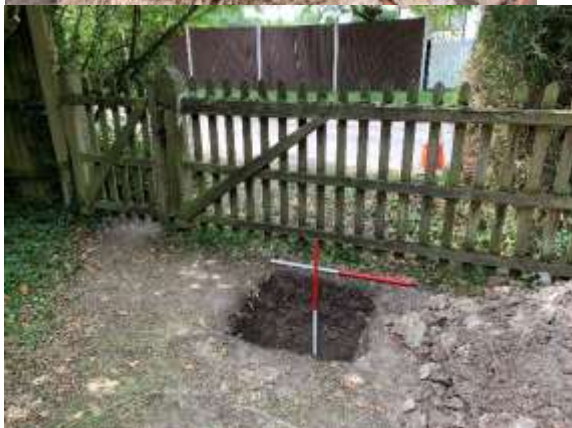
Figure 5: General location photographs for TP3 (top left), TP4 (top right), TP 5 (middle left), TP6 (middle right) and TP7 (left).

This pit was positioned at the junction between the east end of the south wall with the west side of the 'priest's lodging' (see Appendix 1). If the latter was part of the medieval phase, and the former was a post-monastic extension (as per current thinking), the south wall and its foundations should butt up to the wall of the lodging. In fact close observation of the standing fabric suggests that this is not so: the two walls appear quite clearly to be bonded in, and should thus be contemporary. From an archaeological perspective, the relationship between the foundations (if any) under the two walls was crucial. The location was also important to understand how this side of the Chapel operated from a structural perspective. TP3 was 0.9m long east-west, 0.8m wide, and 0.6m deep.

Pit 4 was situated on the south side of the external chimney stack in the east gable of the timber-framed block on the east side of the priest's lodging. The condition of the fabric, existence or

The intention had been to excavate PP5 in the angle between the east wall of the Chapel and the north wall of the adjacent timber-framed block. One of the external concrete drain channels ran along the base of the latter, however, and as with TP4 the obviously poor state of the foundations (if indeed there are any) under the framed section necessitated a change of plan. The pit was therefore moved slightly to the north, and was dug alongside the drain channel instead of through it. The pit was 0.65m long east-west, 0.62m wide, and up to 1.04m deep.

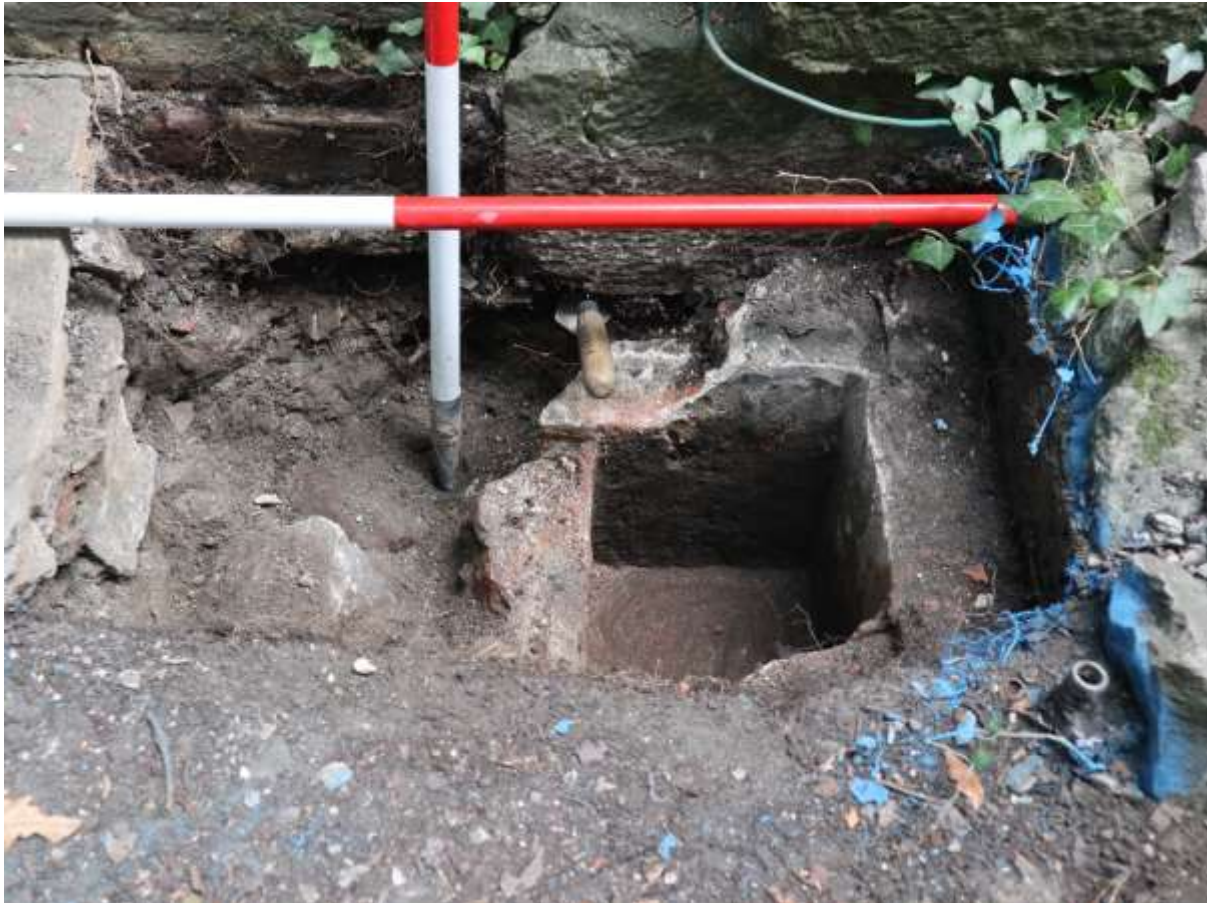
The west wall of the Chapel appears to be an early post-medieval (ie post-monastic) extension. It, and the conjoining south wall, largely consist of massive blocks of ashlar masonry, well coursed but surprisingly thin. The wall was recorded as context **1**, and the bottom course continued below ground for only 0.14m. Oddly, it also extended northwards for 0.2m beyond the north-west corner of the moulded plinth at the base of the wall. It is not clear whether this represented the start of a lost extension, a former connection to a boundary wall, or merely the coincidental result of laying a block that was simply a little too long for its purpose. No evidence of contemporary masonry was seen continuing to the north. Given that the later extension had minimal footings, any such masonry should have survived here. The absence therefore suggests that no such extension had existed. The bottom of the ashlar block was partly obscured by the modern drain pit (**4**), but sufficient of this was broken out to show that the block did not appear to have any further masonry (whether ashlar or otherwise) beneath it. The wall therefore seemed to have been 'founded' in a layer of mid- to dark grey-brown silty clay (**6**), containing some stone and brick rubble in its lower part. This had certainly been cut by the shallow brick rubble footing (**3**) for the Victorian extension; it seems likely that wall **1** had also cut **6**, but this could not be proved conclusively because of the drain pit (**4**). It was clear, however, that there was soil underneath the bottom course of the ashlar, and a trowel could be pressed in here to the full length of its blade (ie 100mm).

Figure 6: TP 1 with the base course of wall **1** showing soil (probably layer **6**) extending under it.

No foundations of any sort could be found under the west wall in TP1, or at the corner with the south wall in TP2. The latter is especially remarkable because one would usually expect the corner of a building to receive a substantial foundation. The two isolated stones found in TP2 certainly do not qualify for that description. The limited nature of the excavations must always be borne in mind, but the evidence seemed clear enough: much of the west end and south-west corner had been built on bare earth with little to show by way of foundations. The situation was more complicated in Pit 8, where an area of stone rubble was found beneath the wall, but there was a gap between the two which was filled with soil. The same was found in pits 3 and 9, although here the masonry could be exposed more fully than in TP 8. In both cases a substantial rubble stone structure was found under, but separate from, the 'south aisle' wall. These structures did not appear to be mortared, and they were very different in character to the well-made and regular foundations under the north and east walls of the Chapel. What do they represent? They appear to have been intended as foundations, but it is far from clear at the moment how this fits in with the late medieval Chapel or the post-Dissolution extensions. It is conceivable that the footings were for a Monastic-phase structure associated with the Chapel – perhaps the priest's lodging proper (as opposed to the block currently identified as such, but evidently post-medieval). It seems less plausible that they were intended for the 'south aisle' all along. Firstly, there is a clear and consistent gape between footing and wall. A

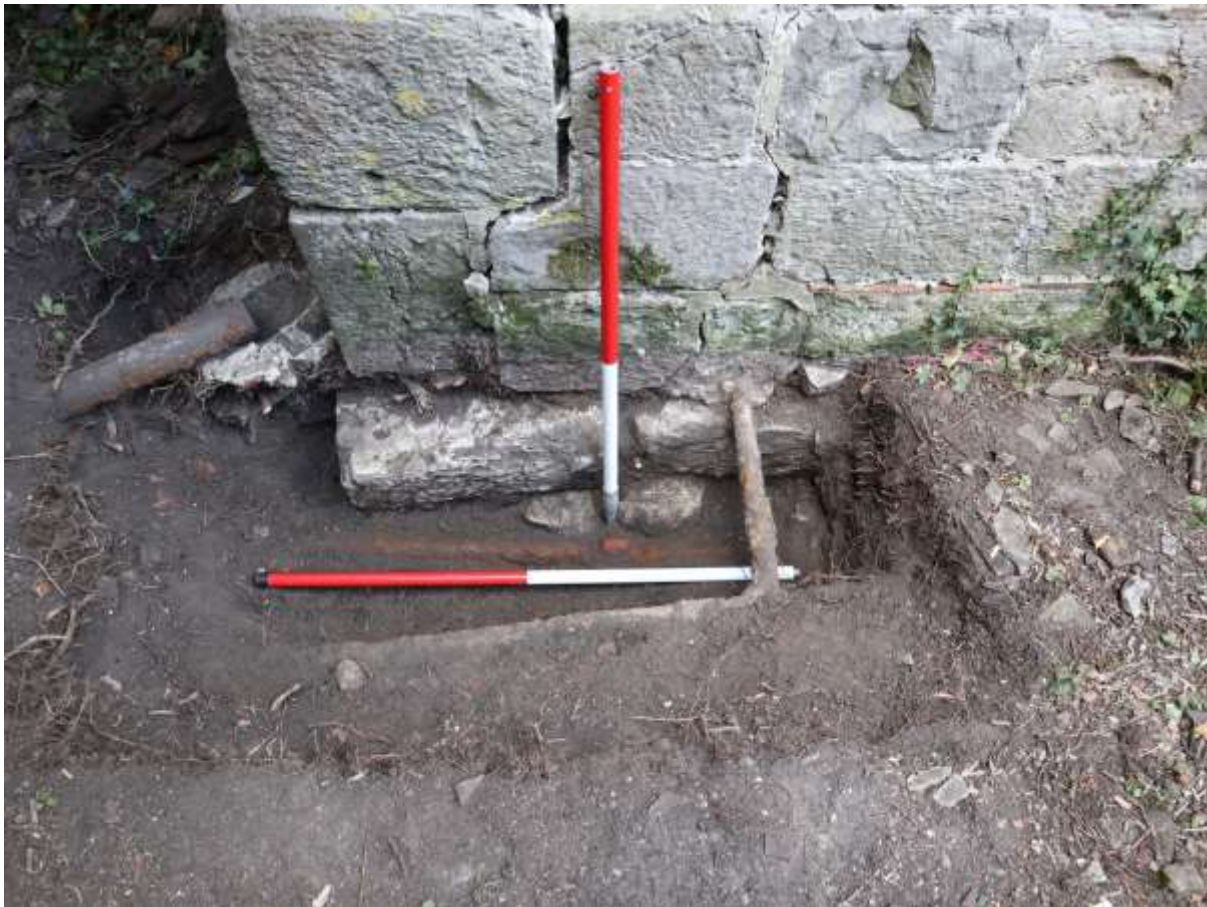
Here the south-west corner of the post-monastic extension was recorded as structure **20**. The lowest visible course of the ashlar masonry continued for 100mm below ground, where an offset course of ashlar (**21**) was found. This extended 60mm beyond the wall face at the east end of the pit, where at least two blocks were present, but the corner block (0.5m long) had been moved outwards to a width of 140mm at the corner. The block also slanted downwards to the corner, consistent with the movement evident in the wall masonry above. Substantial roots (probably of ivy) were evident penetrating the masonry here, and no doubt this contributed to the degree of movement seen. This would also have been facilitated by the apparent absence of foundations under most of the masonry – only two quite small and isolated stones (**22**) were present between the east end of the corner block and the next one to its east. As in pit 1, there appeared to be nothing but soil under the rest of offset **21**. The presence of two Victorian/modern iron pipes (**27**, gas, at shallow depth; and **28**, probably water, at the base of the pit) running roughly parallel with the south wall precluded deeper

excavations, and the nature of the footings could not be investigated further because of this. It seemed clear, however, that the standing building had poor foundations at this point.

Figure 7: TP 2 looking north, with extensive movement in wall **20** and foundation **21** clearly visible. Note the isolated stones (**22**) under the middle of **21**, and the various modern services.

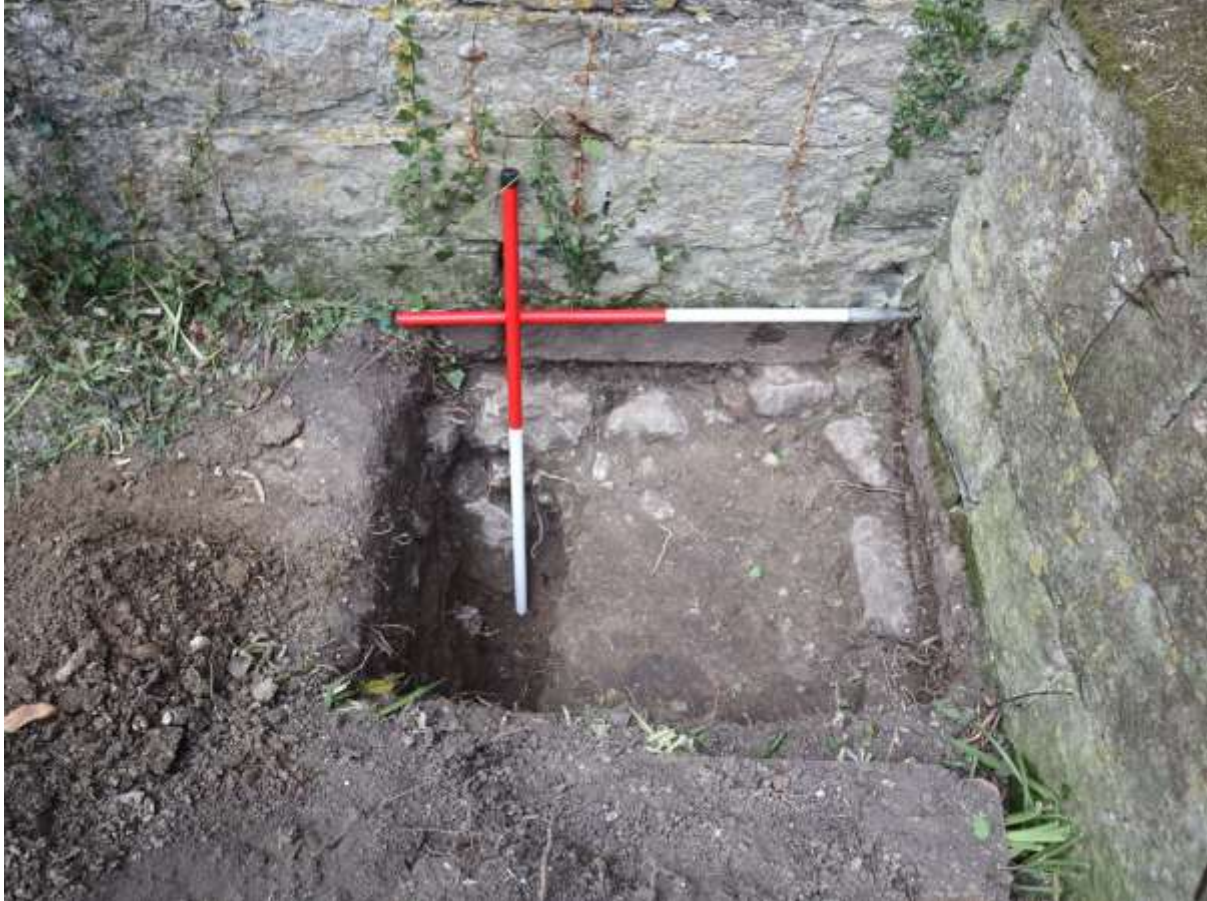
The two standing walls (**29** for the west wall of the lodging, **30** for the south wall of the Chapel) continued below ground for a single additional course each, of identical depths at 150mm. There was nothing here to contradict the impression that the two walls were fully bonded. Unlike pits 1 and 2, however, both wall appeared to have good foundations below them – although these were not necessarily contemporary, for reasons described below. The foundation under wall **29** comprised large, rough blocks of ragstone (**33**). These showed no sign of the careful dressing and tooling evident in the ashlar above. Two courses were visible, the upper one consisting of thin stones: the lower one was not investigated further. Perhaps significantly, there was no direct contact between wall **29** and foundation **33**, at least on the plane of the wall: there was a distinct 30mm wedge of

brown silty clay on top of the foundation, and the wall rested on this. It is possible that this represented some movement in the footing and that it was in contact with the wall further back into the masonry, but it is perhaps more suggestive of a constructional break between the laying of the foundations and the building of the wall above. The question of how long or significant this break might have been is discussed in Section 4.

Figure 8: Walls **30** and **29** (to the right) with their respective foundations. Note the clear gap between wall and footing in each case.

Exactly the same relationship was noted for the Chapel extension's south wall (**30**) and its ragstone foundation (**34**): if anything the soil-filled gap between them was more distinct. A sondage was dug at the west end of the test pit to examine the foundation. At least two courses were present, with a thinner (130mm) upper and a deeper (c 300mm) lower one. The latter was not necessarily the bottom course but a further one beneath it could not be found despite some probing. The nature of this 'footing' is open to some doubt, as no evidence for a foundation trench was evident in the silty clay subsoil (**32**) to its south (this also appeared to abut **33** to the east). Some possible implications of this will be discussed in Section 4.

seasonal break might account for this, but the depth of the gap and amount of accumulated soil suggests something more than this. Equally, why was the foundation not continued for the full length of the south wall if it was built for it? More extensive excavation will be needed in the future to prove the point either way, but at the moment it is suggested (tentatively) that the foundations in pits 3 and 9 (possibly in TP 8 as well) are of the monastic period and belong to a substantial structure – possibly the original priest's lodging. The part of the building currently identified as the lodging appears to be post-monastic, and part of the extension/conversion to secular use of the Chapel as a whole.

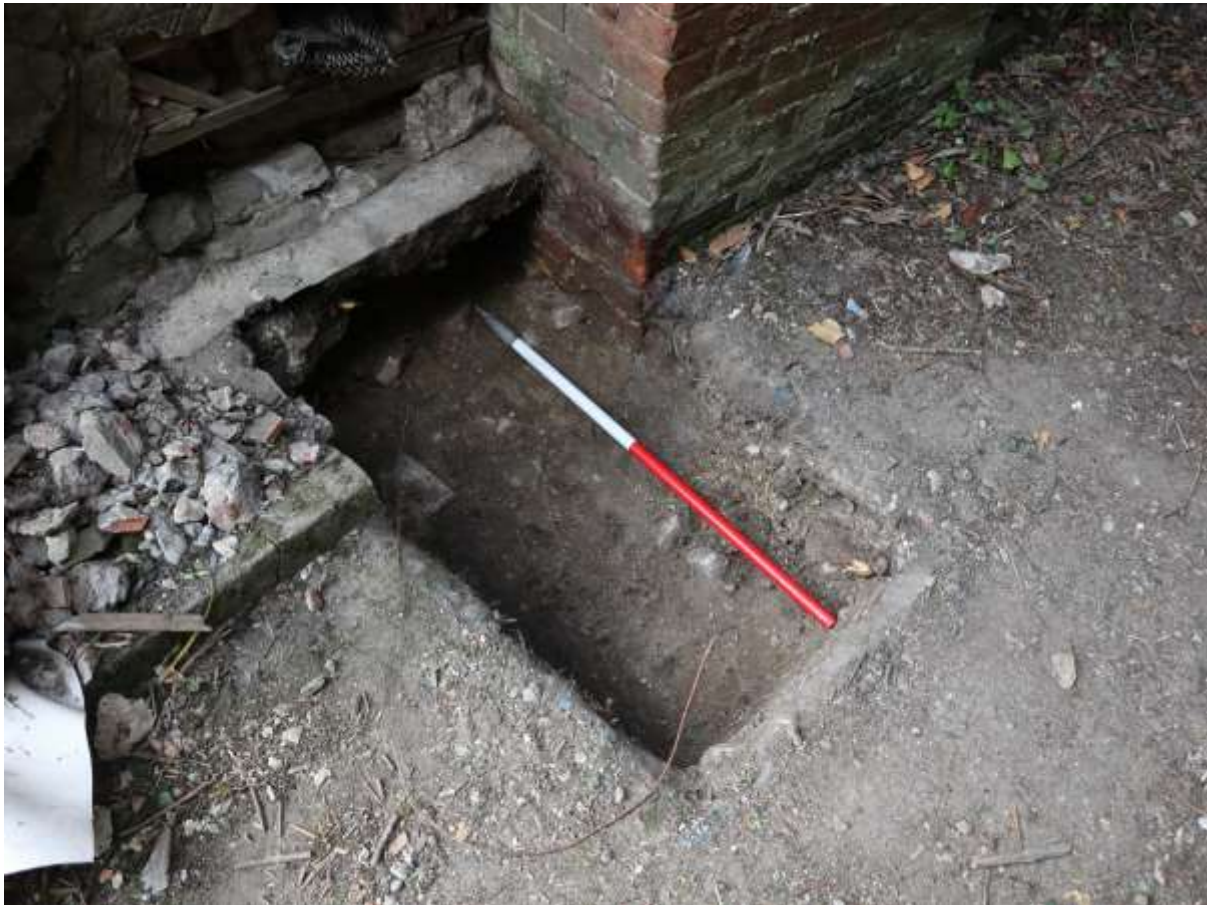
otherwise of foundations, and damp penetration are a matter of concern in this location. It is also of interest archaeologically because of the position of the timber-framed block in the overall building phasing, the possibility that there had been a further bay to the east at some point in time, and for the relationship of the chimney to the rest of the building frame. The pit was 1.14m long east-west, up to 0.68m wide, and was excavated to a depth of only 0.2m to obviate the risk of undermining the poor-quality foundations of the inner frame.

As in several other pits, part of an external concrete perimeter drain (37) had to be cut out for the excavation to proceed. A further edging of concrete (36) inside (ie west of) this was left in situ, however, because it provided support to a thin layer of masonry rubble (35) resting on a layer of small cobbles in clay (42). Only the rubble appeared to be a footing for the in situ base plate of the timber frame. This proved to be a re-used piece, with a good-quality bead moulding suggestive of an original position around a door or window. This ran up to the south side of the brick chimney stack (38), whereas the cobbles and clay continued under the stack (which therefore seemed to be built directly off this layer). The chimney is made from late post-medieval (perhaps early 19th-century) bricks, so it is likely that it had been inserted into the timber frame rather than the latter having been built around the brickwork.

Figure 9: TP4 looking north-west, showing the bead-moulded re-used timber at the base of the framed extension, its poor-quality footings (supported by a remnant of the concrete drain), and the brick chimney stack. The layer of cobbles can just be seen under the stack.

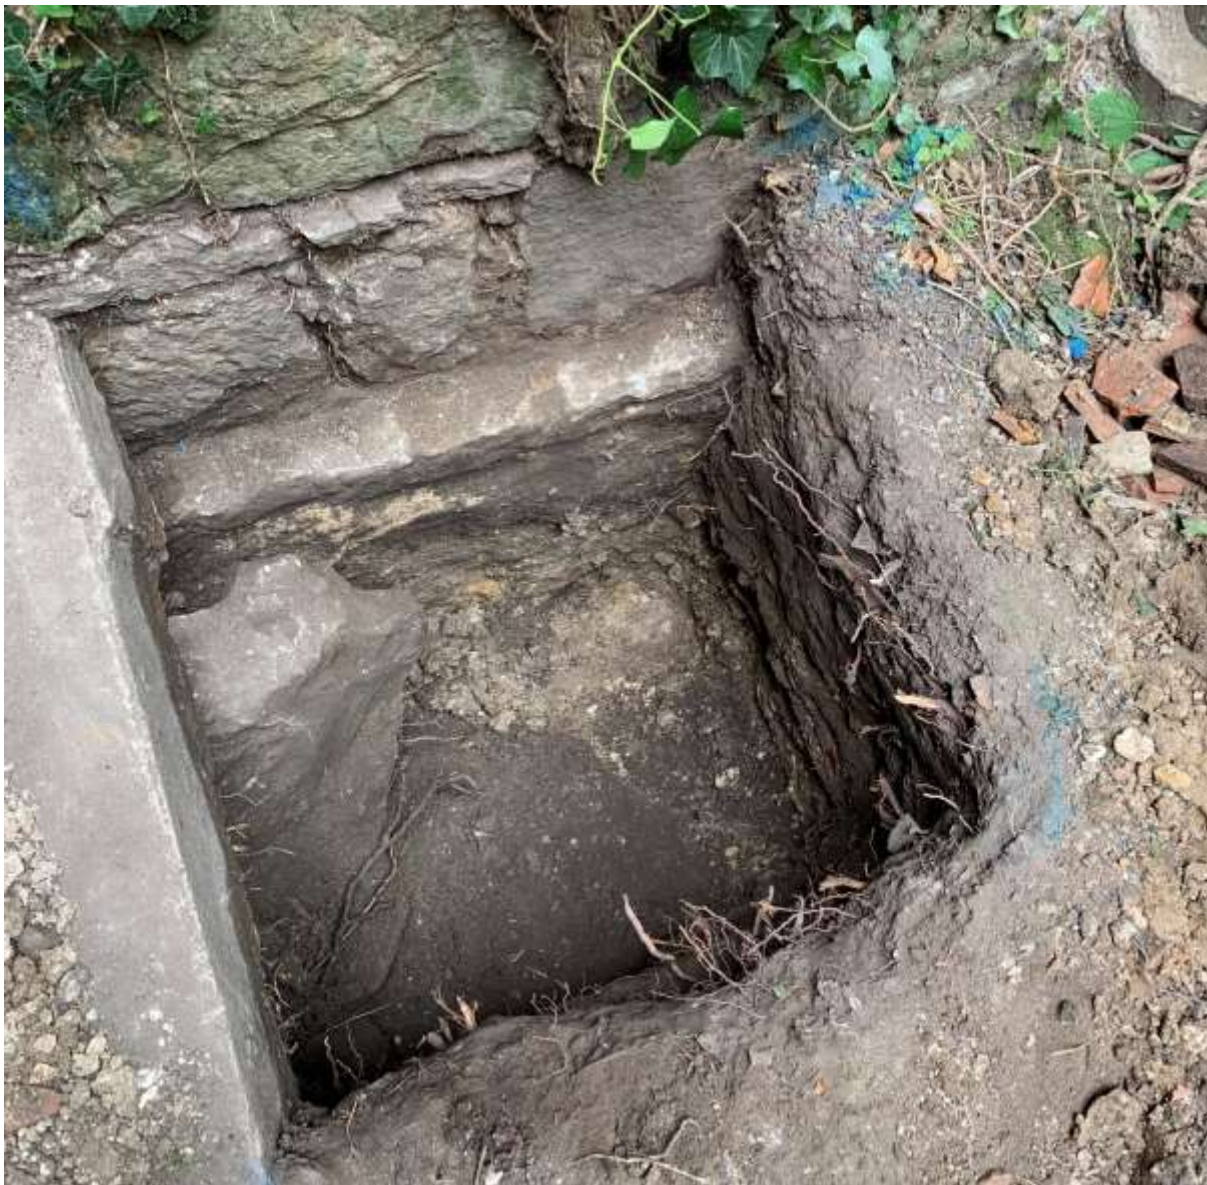
Figure 10: TP5 looking north-west with the in situ and disturbed Gault Formation at the base of the pit, overlain by the offset masonry. Note the massive piece of quarry stone on the left edge.

The bottom 0.44m of the pit was filled with a pale grey to brown marly clay (**47**), gritty but devoid of rubble inclusions. A similar layer was found at the base of TPs 6 and 7 (see below). In all three cases it was identified as a natural/geological deposit, ie the Gault Formation. Three sherds of red

The masonry (44) continued up for a further 0.4m, at which point an 80mm offset was present. The wall above this was recorded as context 43. The stonework beneath the offset comprised massive ashlar blocks in contrast to the semi-coursed rubble of the lower part. This seemed to be consistent with the suggestion that the lower part of 44 was built as the wall's foundation, with the upper part (including the offset) standing above the late medieval ground level.

The foundations of the Chapel were examined in TP5 (east wall) and TP6 (north wall). While there were some variations in form and depth between the two (as described above), the character of the footings was essentially the same. They comprised well-built coursed masonry using stone of similar nature as the standing fabric – ie generally large, quite well-shaped blocks, if not finished to ashlar quality. Both were set on the firm Gault marl geology, the somewhat greater depth at the east end presumably being due to variations in the surface level of the bedrock.³ The foundations had either been trench-built (ie the masonry was set tight against the edge of a trench which had been dug to the exact width required), or within a wider cut: if the latter is the case, the edge lay outside the confines of the two pits (or at least their lower parts). The presence of three very late medieval pot sherds at the very base of pit 5 provides a strong indication (but not quite proof) that the second

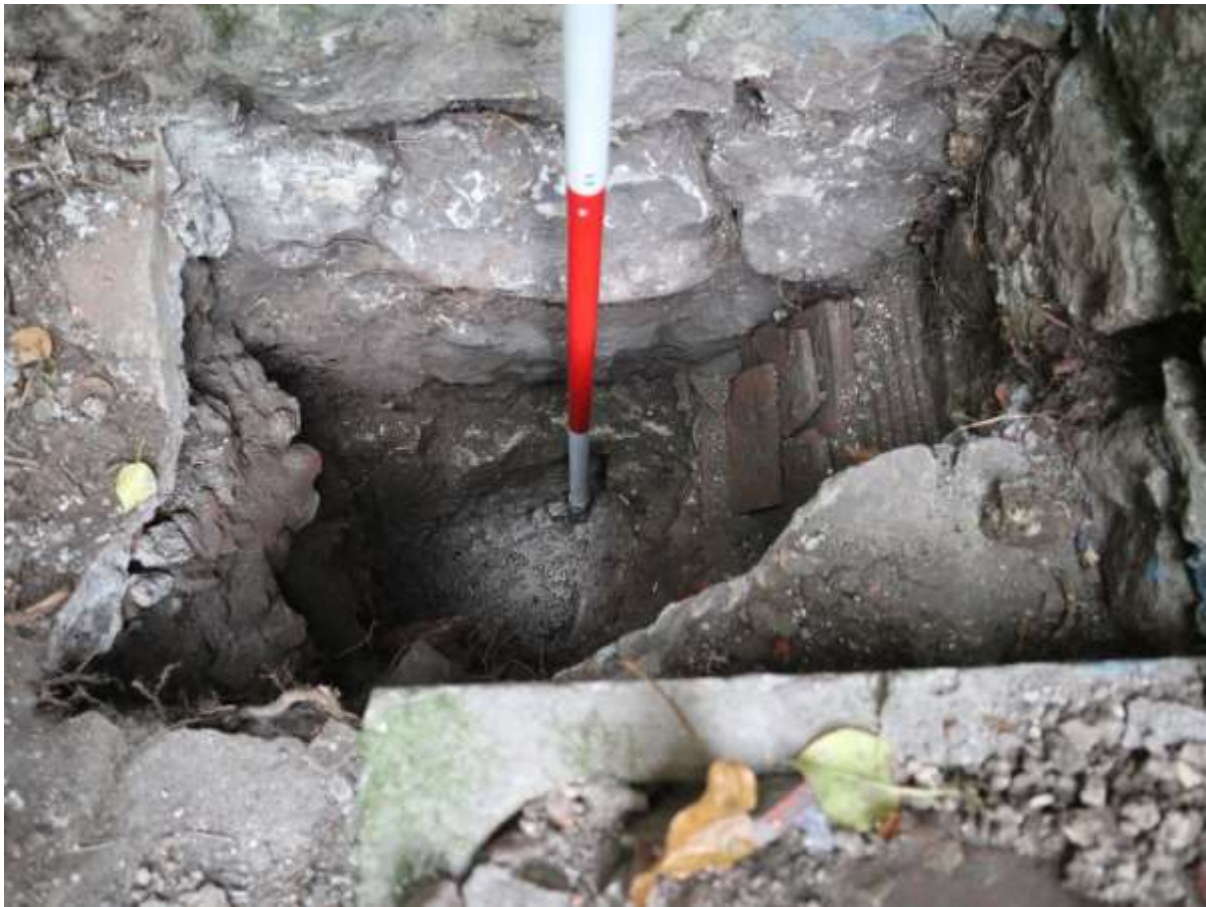
A firm, pale grey to brown marly clay (60) was found at the very bottom of the pit. This appeared to be identical to layers 10 in pit 7 (see below) and 47 in TP5. It is also interpreted as the natural geology, although the limited width of the pit precluded any excavation into it. Significantly, however, the bottom of the north wall (50) terminated directly on the marly clay; the masonry was 0.4m deep, with a 60mm-wide offset at its top. It then continued (49) for 0.5m up to the top of the concrete drain; this section of the masonry had a slight batter, becoming more distinct at ground level, with the standing portion of the Chapel wall then rising vertically off it. Masonry 49 and 50 were abutted by a dark grey-brown silty clay (54); this appeared to occupy the full 0.8m depth of the pit under the concrete drain, but the restricted nature of the excavation made it difficult to be sure of this. Finds (all of 18th/19th-century date and retained on site) were only present in the upper part

Figure 11: TP6 looking south, with the Gault Formation at the base overlain by the north wall of the Chapel. Note the stacked tile footing for the porch, overlaying the offset foundation.

The east wall (**53**) of the small porch built against the Chapel rested on a somewhat unusual footing (**52**). This consisted of a tile layer at its base, resting directly on the offset of **50**. The rest of it was formed from pegged roof tiles stacked on edge in a single layer/course. Wall **53** was built off this.

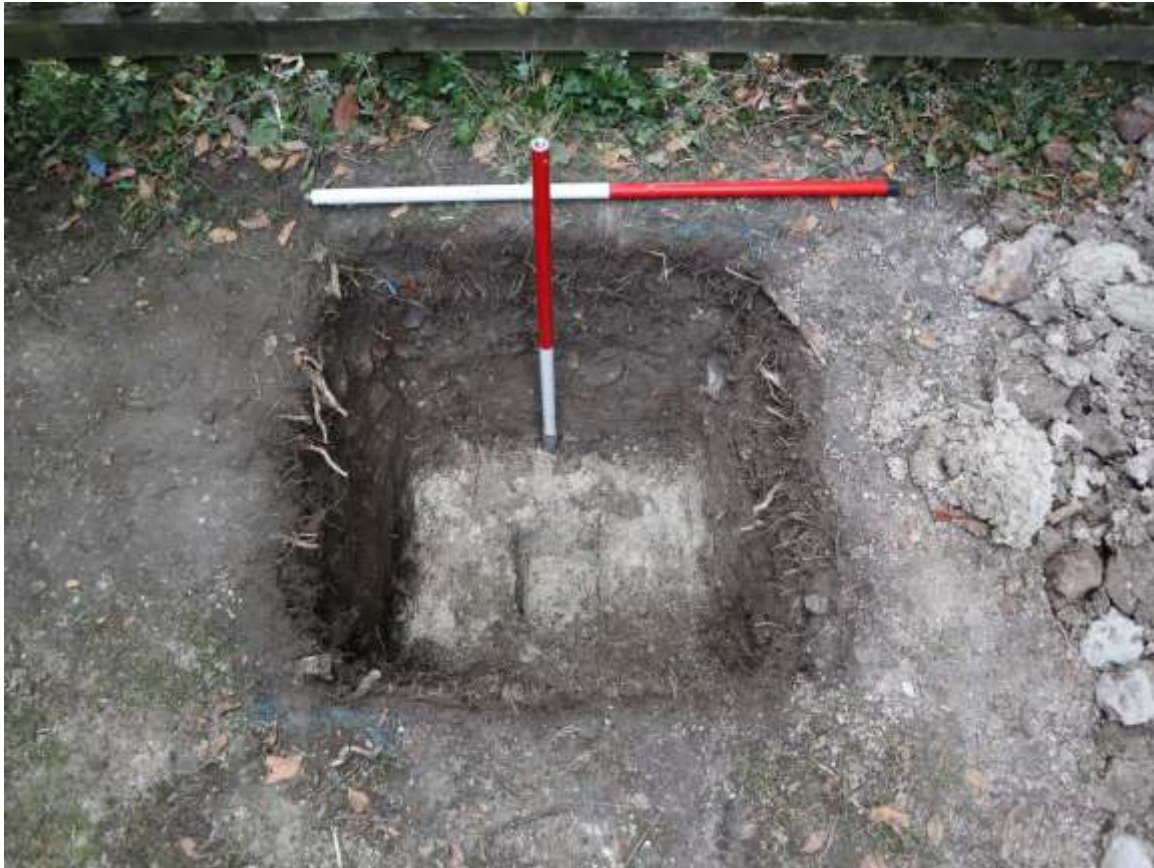
Figure 12: TP7 looking north-west, with the Gault Formation very clearly visible across the base of the pit.

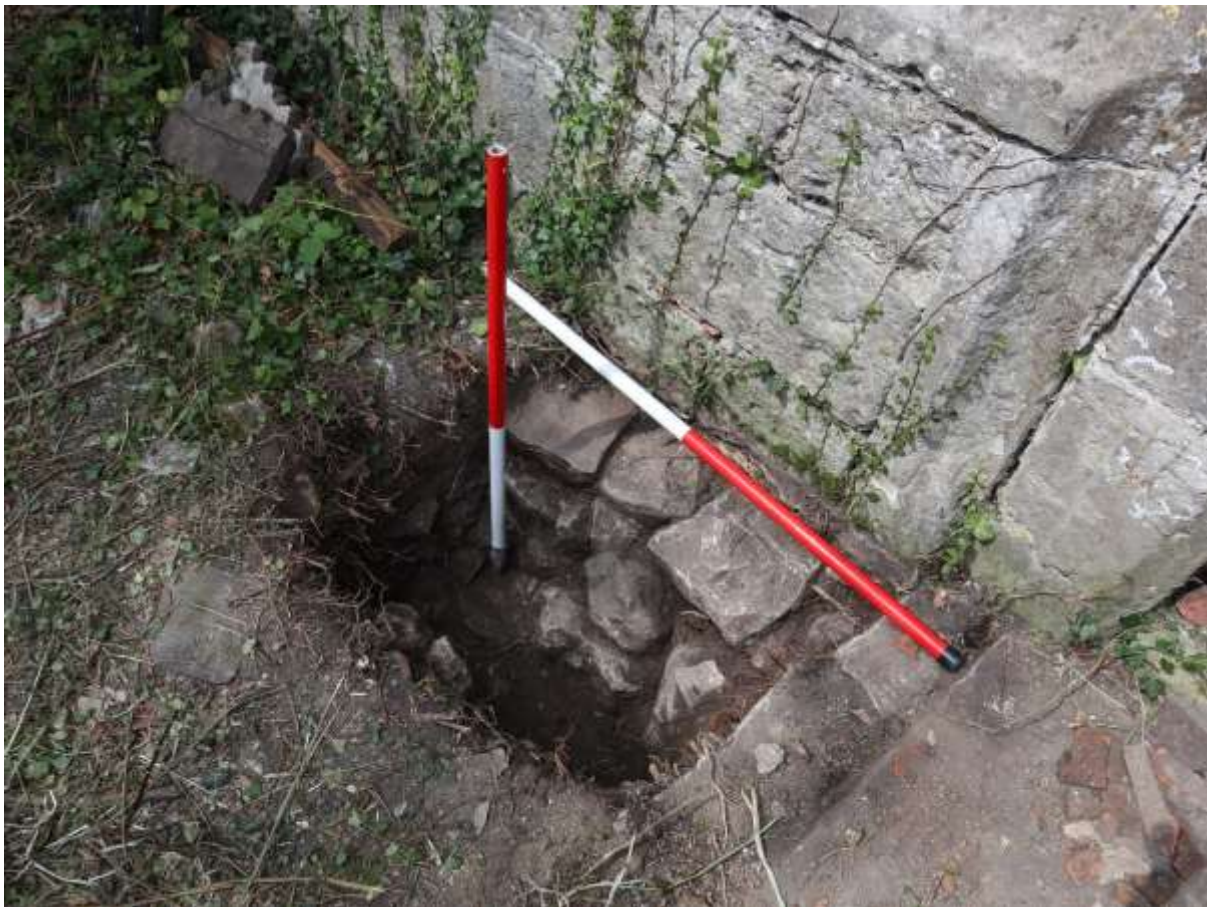
The findings were similar to those in TP3. A substantial structure of uncoursed ragstone rubble (**56**) was found underlying the aisle wall (**55**), but again separated from it by a distinct 20mm-30mm soil-filled gap (**59**). As the photograph below shows, **55** had a somewhat stepped/sloping appearance, but no sign of a construction cut could be seen in the sections running south from the aisle wall. The mid/dark grey-brown silty clay (**58**) which occupied most of the pit (apart from a thin topsoil, **57**, which ran over the top of **55**) therefore appeared to abut the ragstone structure. The finds from this layer were interesting: they were mostly medieval and early post-medieval, though two sherds of English stoneware belong to the 18th or even the 19th century. The earlier finds were all from the lower part of the pit, however, and might therefore suggest that **55** was of late medieval date. An early post-monastic date is also possible.

Figure 13: TP9 looking north-west, with the ragstone rubble structure (foundation?) underlying the Chapel's aisle wall, but seemingly separate from it.

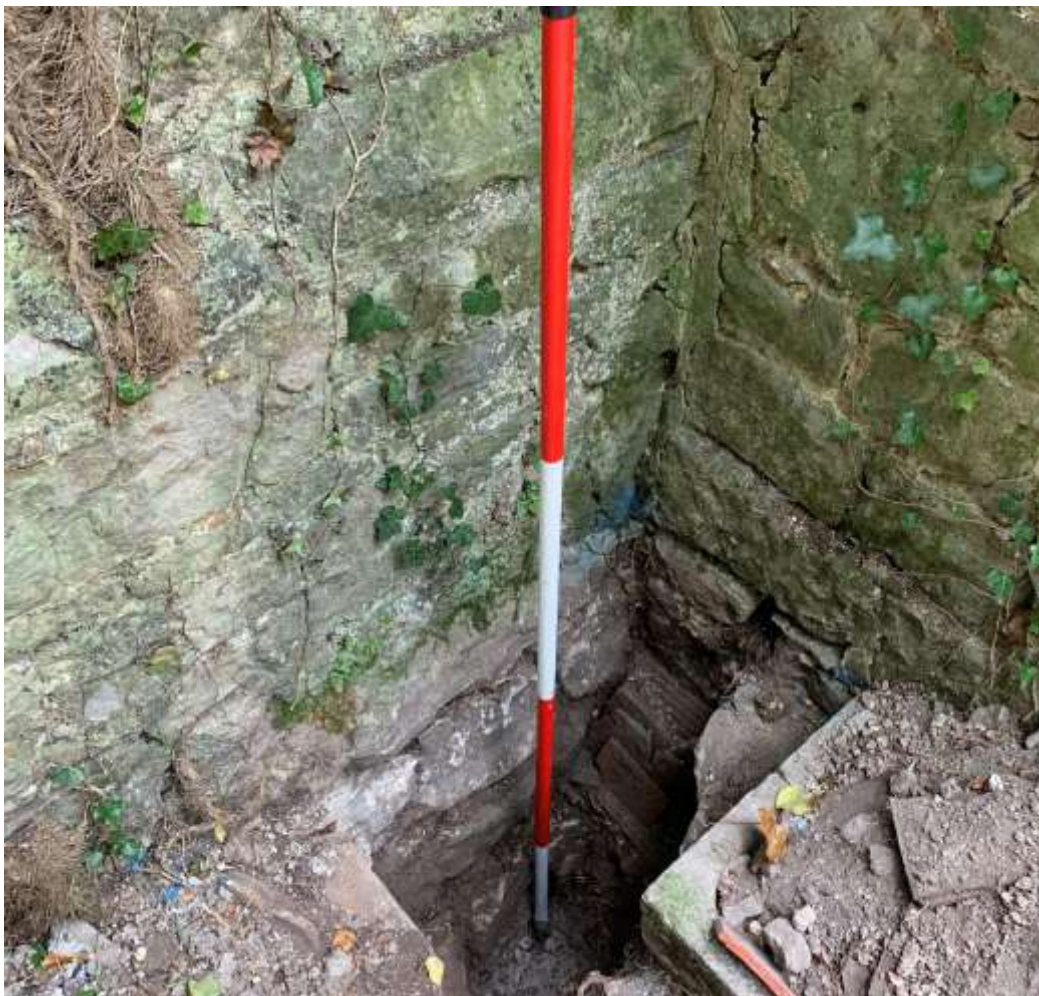
The exposed masonry changed almost imperceptibly from foundation to standing masonry in each of the two pits. The point at which this transition occurred was not easy to recognise, but was clearer in TP5 than in TP6. In the former, an offset was found only 0.2m below the current ground surface; the wall course above this (which had been concealed/buried by the topsoil and subsoil) was of good quality ashlar masonry – which continued for at least two further courses beneath the offset, to 0.6m below ground. The subsoil (clearly of quite late post-medieval date, probably 18th-century) also covered/abutted these courses. The offset and these course are therefore considered to have been standing, visible masonry when originally built. The apparent date of the subsoil seems to mean that they remained visible for around 200 years after the Dissolution. The rest of the stone masonry was foundation, of inferior (but still good) build quality. The very restricted size of TP6 was compounded by the battered upper masonry of the north wall and the offset under this, so that it was impossible to recognise a similar topsoil/subsoil/foundation relationship here, but the character and depth of the masonry was much the same. The slightly battered upper section of wall **49** may be the same as the upper part of wall **44**, and the rough 'chamfer' visible immediately above ground on the north wall perhaps equates to the offset just below ground in TP5 (the ground levels are slightly different at the two pits).

Figure 15: Evidence for what may have been an offset, now badly damaged, at or just above the current ground level can be seen in TP6. Note the way the bottom of the porch wall is 'sloped' against the wall of the Chapel. Note also the moulded chamfered plinth at a higher level in the wall behind the top of the ranging rod.

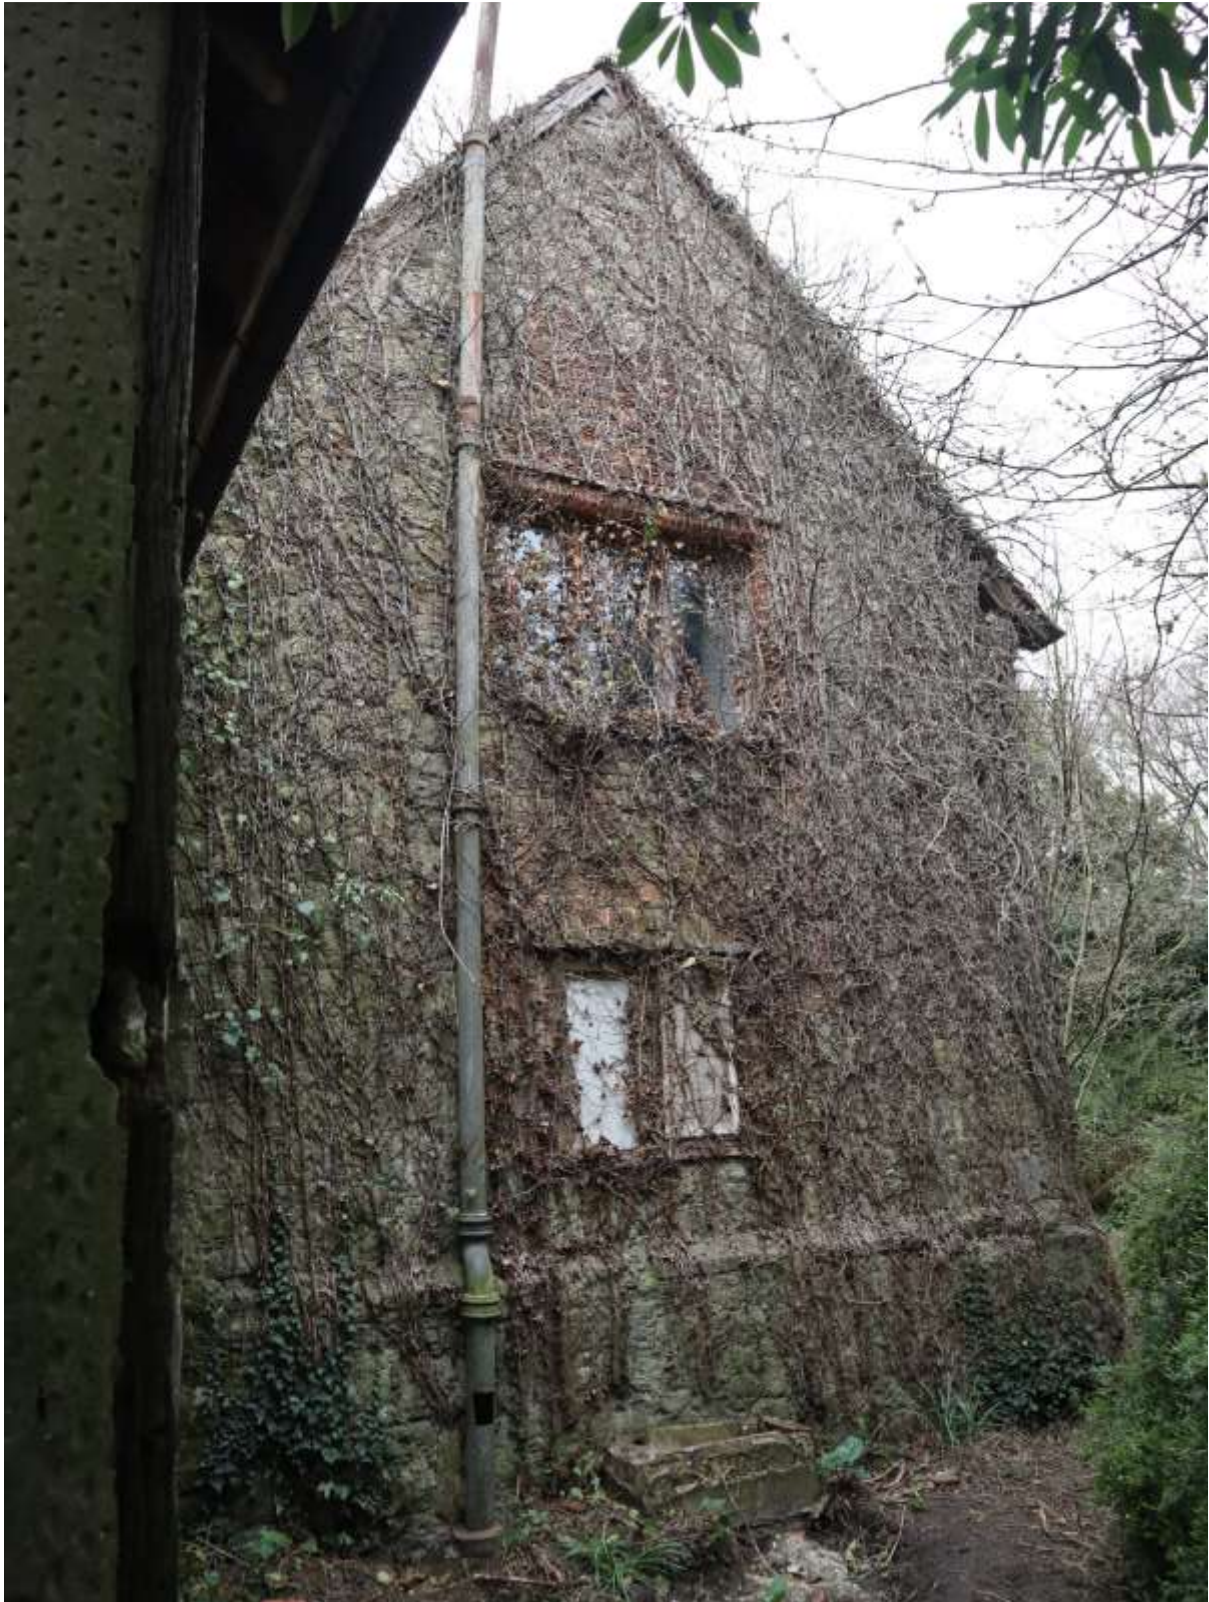
Looking at the built fabric, the east end retains plentiful evidence for the location, size and form of the building's original east window. Though obscured by ivy outside and render inside, this was clearly a large (full-height) lancet (Figure 16). Externally, this can be seen from brick blocking at the point of the arch and across the centre of the window, with the inserted mullioned windows on the ground and first floors largely fitting within the frame of the lancet. Internally, flaking paint and render above the first-floor inserted window also belies the existence of the lancet's head. This substantial window fits well with the assumed ecclesiastical function of the building (though it would not be wholly out of place in a more domestic environment).

Figure 16: The east elevation of the Chapel is still obscured by ivy (now dead), but the arch of the former lancet window can still be discerned through the brick blocking above and below the first-floor window. The absence of such blocking beneath the ground-floor window suggests that its cill is at a similar (perhaps the same) height as the medieval original.
