St Andrew's Chapel, Boxley, Kent

A report on recent archaeological investigations

Site status: Grade II listed building (National Heritage List reference 1185580)

Report by: Graham Keevill, Keevill Heritage Ltd
Client: The Society for the Protection of Ancient Buildings
October 2019

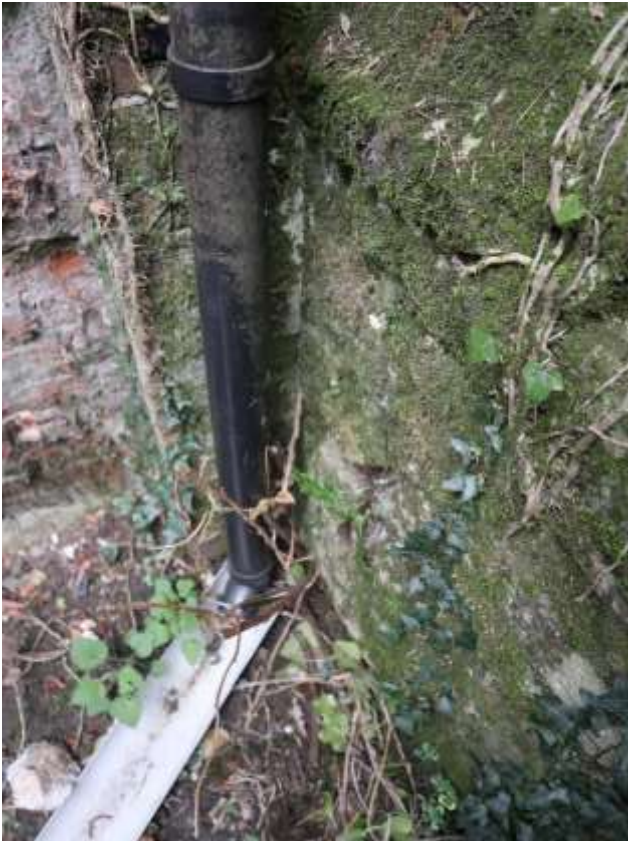
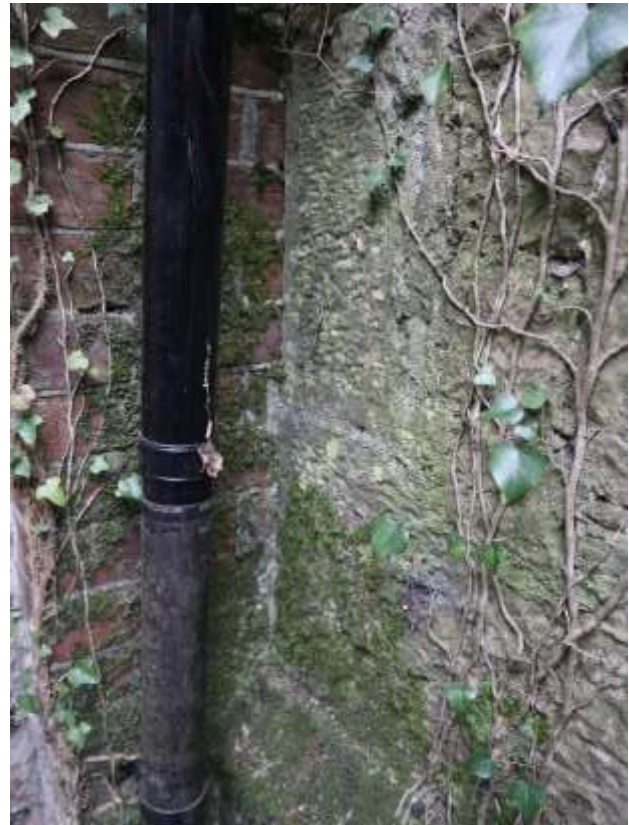
Perhaps the most unusual and complex stratigraphic sequencing occurs at the south-east corner of the Chapel, where the timber-framed section joins the apparently original late medieval building. At low level, the archaeological relationships are clear and seemingly straightforward: the brick infill of the timber-framed extension clearly abuts (and is therefore later than) the moulded chamfered plinth of the Chapel's east wall. Immediately above the plinth, however, the relationship is reversed: the carefully dressed ashlar blocks of the east wall all finish in a clear straight joint, butting up to a brick pier rising off the plinth (Figure 17). At face value, this suggests that the upper masonry of the east wall post-dates the timber framed section. Clearly this is illogical, but it still needs to be explained. The first relevant observations are that the brickwork of the is quite late (probably early 19th century), while it also cuts into the brick panelling in the timber frame to the east. Thus the pier seems to have replaced something earlier. Even so, this does not remove the clear evidence that the ashlar masonry was built against something structural rising from the moulded plinth. Stepping back for a moment, we may note that the 'priest's lodging' to the south of the Chapel is bonded in (and so appears to be contemporary) with its 'south aisle'. The 'aisle' is an addition, probably post-dating the Dissolution. The timber-framed bay to the south-east of the Chapel appears to have been added to the lodging. If these relationships are correct (and they all appear to be), it must logically follow that the timber-framed bays are later than the Chapel itself. This does not preclude the former existence of an earlier building in this area, however, and this might make sense of the unusual relationship at the south-east corner of the Chapel. It is at least possible that a large post rose from the corner of the moulded plinth, and formed the start of an earlier timber-framed structure running to the east, to the south, or both, contemporary with the Chapel. This would make sense of the straight edge in the masonry of the east wall.

Figure 17: The relationship between the east wall of the Chapel and the brick pier at its junction with the timber framed extension to the east. The left-hand photograph shows the lower part of the pier clearly butting against the moulded plinth of the east end, but the right-hand image shows equally clearly that the fine ashlar blocks of the Chapel abut the brickwork!
