# 5. Scaffolding

## OHP scaffolding

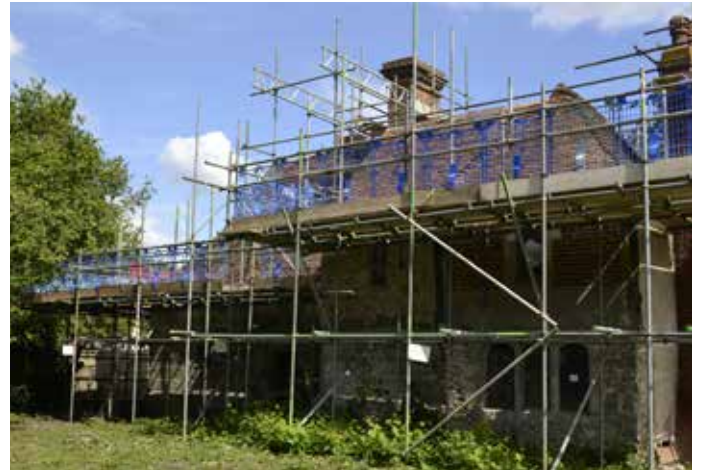
At the Old House Project, scaffolding was necessary from the earliest days of the our ownership. Localised repair was needed to a leaking roof valley, and where overhanging trees had dislodged tiles. For this, our experts at Ashford and Cranbrook Roofing were able to use freestanding scaffold towers for access.

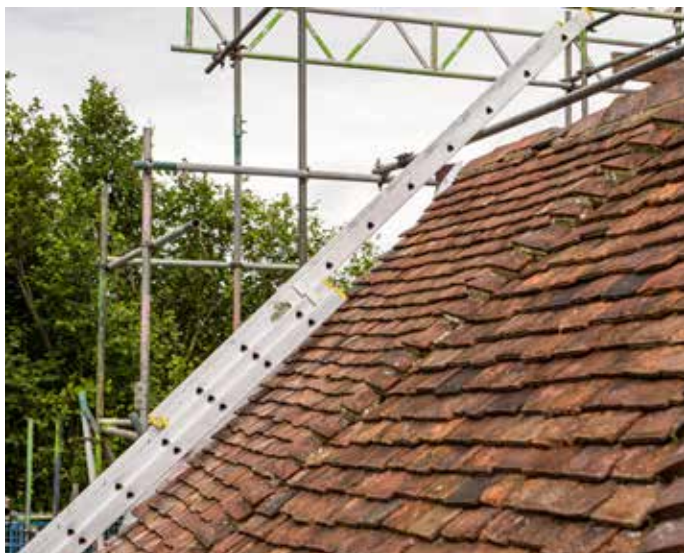
The OHP scaffold was devised to facilitate the roof and chimney repair work we intended, but also to allow access for training and public engagement.

analysis of the roof timbers by Dr Martin Bridge (funded by Historic England). Visitors could observe these works without intruding on their progress.

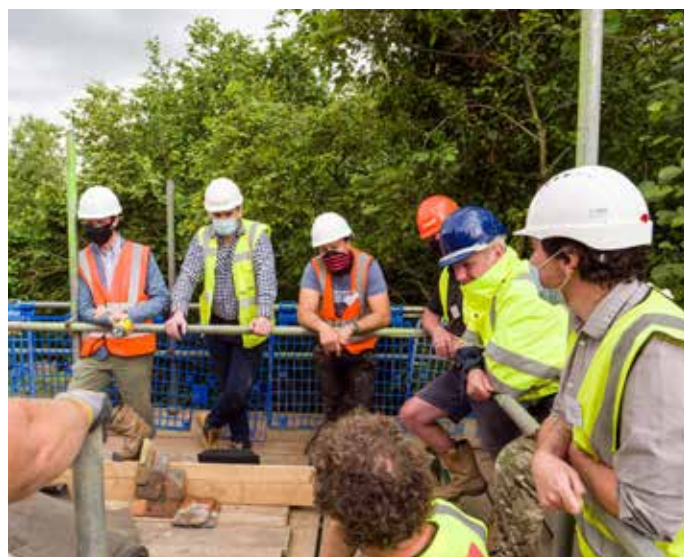
Weald Scaffolding, a firm used regularly by Ashford and Cranbrook Roofing, were asked to do the work. They were interested in the OHP and proved willing to meet our requests, even though some had not been asked of them previously. For public and educational access we specified that they should provide some areas of double-width scaffold. This was especially necessary since social distancing restrictions, related to Covid-19, applied at the time, but it also allowed space for group access. Building-in this provision is useful for any conservation or building project with an educational or community focus. Work that could

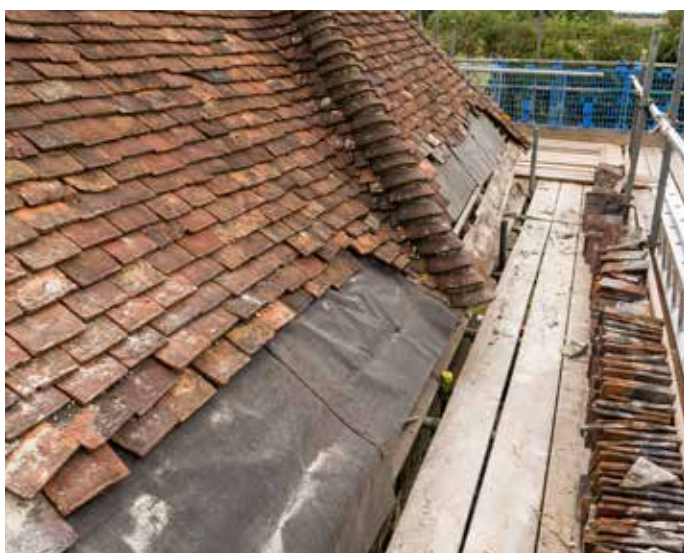
through the building (temporary protection is strongly advised where scaffolding must be taken through a building before erection), through breakage of historic glass, or where scaffold tubes lack end caps resulting in damage where the metal of the tube abuts masonry or timber. In addition, special thought needs to be given to anchorage of a scaffold to avoid the need for fixings to be drilled into historic masonry. By doubling-up the scaffold width at the OHP, greater stability was easily achieved, allowing the structure to be completely self-supporting.

be observed from the scaffold included the roof covering repair by Ashford and Cranbrook but also carpentry repair to the underlying roof structure by John Russell's expert carpentry team, chimney repair and repointing by brick specialists Mathias Restoration Brickwork and dendrochronological

Our particular need with the work to St Andrews was to allow access for roof repair without causing unintended damage or disturbance to the many Kent peg tiles that were in good condition. The scaffold was designed to include a tube running horizontally at ridge level. This allowed a ladder to

be run from the working platform at eaves level to the ridge without resting on (and risking breakage of) the existing and historic handmade tiles. This idea was novel and surprised the scaffolders at first, but they embraced it readily and it seemed to work well for our roofers.
