The Magazine of the Mills Section of the
Society for the Protection of Ancient Buildings

no
170

January 2022

Mill News

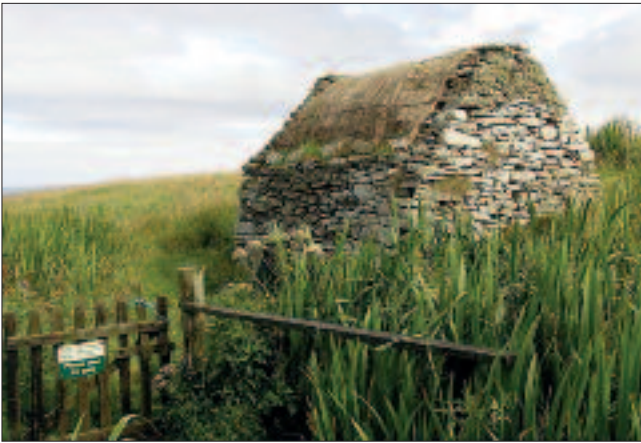
Fig. 3. The restored Southvoe Mill on the Burn of Wiltrow at the Croft House Museum, Southvoe, Dunrossness in 2007. Picture courtesy of Robbie Work.

It was said³ of this group of three mills on the Burn of Wiltrow that in 1977 the middle mill was ruinous, the upper one was still thatched, but converted to a shed. The lowest mill had been restored in 1970 in connection with the nearby Shetland Croft House Museum. Apparently, it was an excellent restoration and remained in good order (see Fig. 3) until about six years ago. Now dilapidated, a new access path has been installed and restoration work is planned⁴.

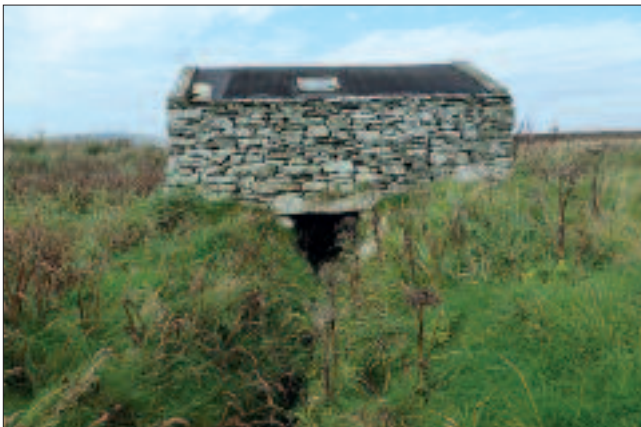
Fig. 4. The restored mill at Troswick, Dunrossness in 2011. The original roof has been replaced with a tarred felt covering. Picture courtesy of Derek Mayes

Nine individual mills were built on the Clumlie Burn, of which seven survive as upstanding remains dispersed along a single short stream. The lowest mill was restored in 1904 and again circa 1929. The original roof has been replaced with a tarred felt covering (see Fig. 4). The mill has been in continuous use and is in good working order⁴.

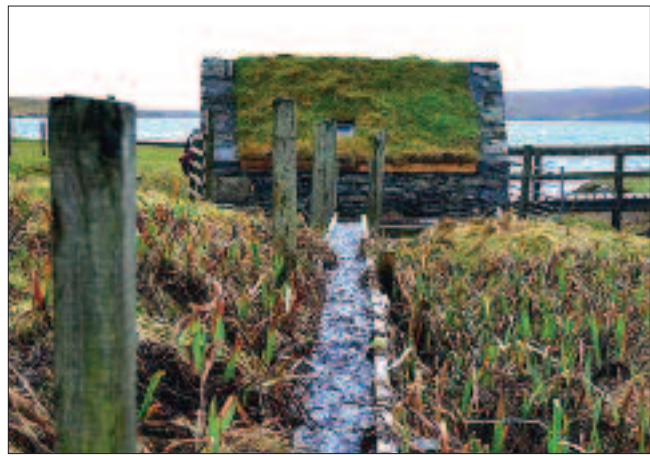
Fig. 5. The restored mill, at Trondra in 2013. Picture courtesy of Tommy Isbister.

“When I first restored the roof of the mill it was thatched, but some years later this was replaced with Norwegian-style grass which needs much less maintenance. There was only the original runner stone left, the bedstone had been lost when it had been used for a boat mooring. Every maker of millstones had different ways of shaping them, they were all about the same diameter, but were often different in the concavity, so they had to be made by the same person. A pair of matching stones were eventually obtained from Northmavine.” Tommy continued *“millstones were made from what was known as ‘millgrutt’. I think this is mica schist, there are several places in Shetland where they could get the rock slabs big enough for the purpose.”*

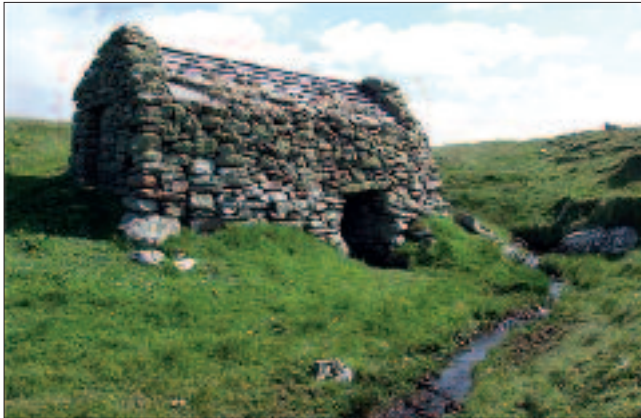
Fig. 6. One of the mills at Huxter in 2012.
Picture courtesy of nz_willowherb.

I found satellite images of four mills here, the lowest group of three small mills are built along a steeply flowing burn before it falls into the sea. The mills stopped being used during the 1940s and were recorded in 1977 as ‘a very fine group of three mills’³. Some restoration work was carried out in the 1980s by the Sandness Conservation and Heritage Group. Further work was undertaken by members of the Sandness History Group in 2009. Again, the mills have fallen into disrepair. The buildings are on common grazing land and none of the restorers actually owned them⁴. At present they are mainly unroofed but still have the supports in place and stand to their full height⁸. One of the mills is shown in Fig. 6. The mill nearest the sea is the listed building.

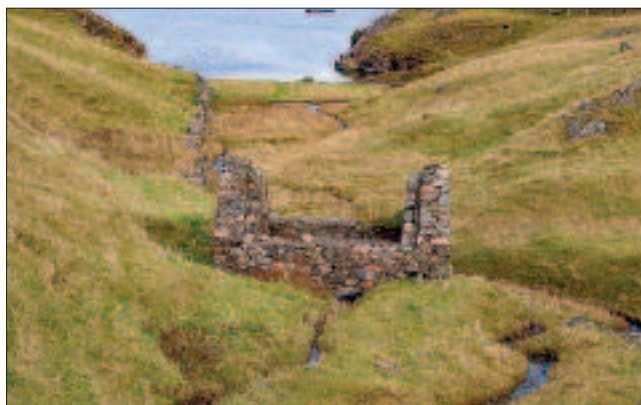
Fig 7. The mill at Uyea Sound (Vementry), in late 2019.
Picture courtesy of Richard Lewis.

The mill is sited on the burn from Hostigates Loch. The mill was restored in 1946 and possibly again in the 1960s. It had an eight-paddle tirl with inclined paddles driving a pair of 38in (0.96m) millstones. However, in 1977 it was reported that the thatched roof was decaying and the runner stone had been removed. By 1996 it was said to be roofless. Fig. 7 shows the mill in 2019.

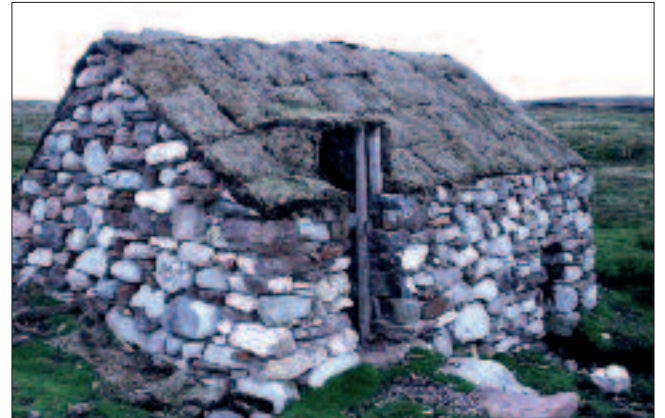
Fig. 8. The reconstructed mill at Tangwick, Northmavin in 2008.
Picture courtesy of Stan Darling.

The mill is not far from the Tangwick Haa Museum. This is actually a reconstruction of the 1829 original mill and built on the same site. Utilising local stone, it uses the original millstones found on the site. Restored in 2007/2008 by Hillswick, Eshaness Area Regeneration and Development Association (HEARD). Currently it is in a fairly good condition.

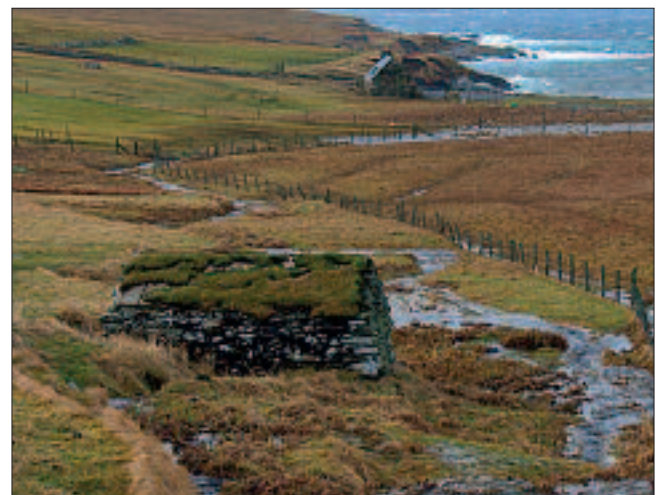
Fig. 9. Kirk Knowe Mill at Westing on Unst in 2011.
Picture courtesy of Mike Pennington.

This restored mill on the Burn of Bighton, had a turf thatch over corrugated-iron roof and a window opposite the door. In 1997 it had a timber shute feeding a tirl in the lower house; the millstones were in-situ in the upper

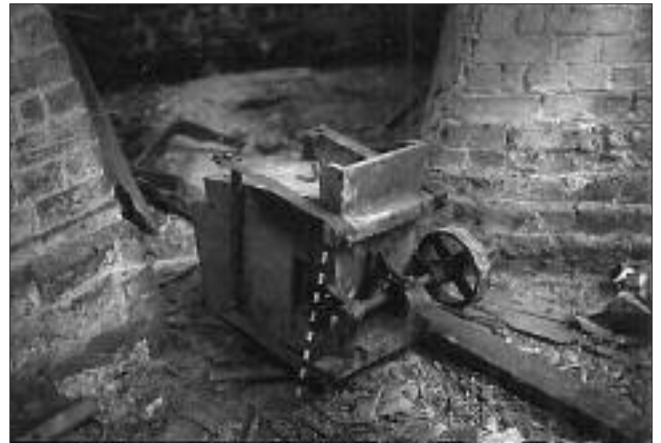
The 1967 photograph of the mystery object at Chinnor Windmill.

This was done by examining the photo in detail, helped by correcting off the 3D viewpoint and lens distortions, by morphing the image in different ways so as to 'show rectangular parts as rectangular', meaning that details of these faces became clearer.

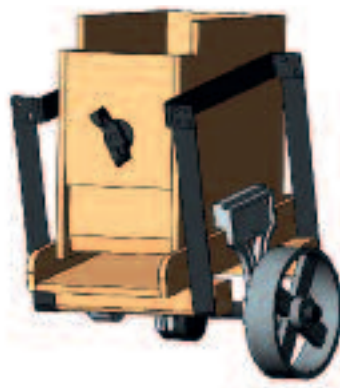
Feeder exit view.

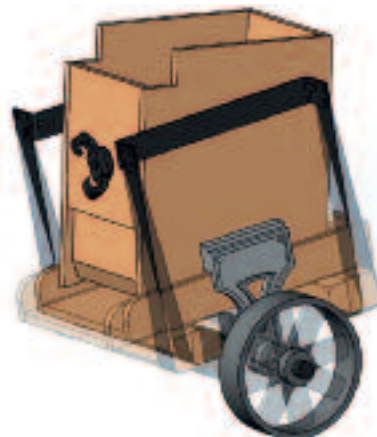
Illustration of the vibratory feeding movement of the chute oscillating on its four supporting leaf springs, created by the pulley-driven eccentric.

To function correctly as a feeder, we can infer details which were hidden from the photographer – you can just make out a wing nut presumably for clamping in place an adjustable gate and of course the base of the ‘box’ must be missing to allow feed onto the vibrating chute!

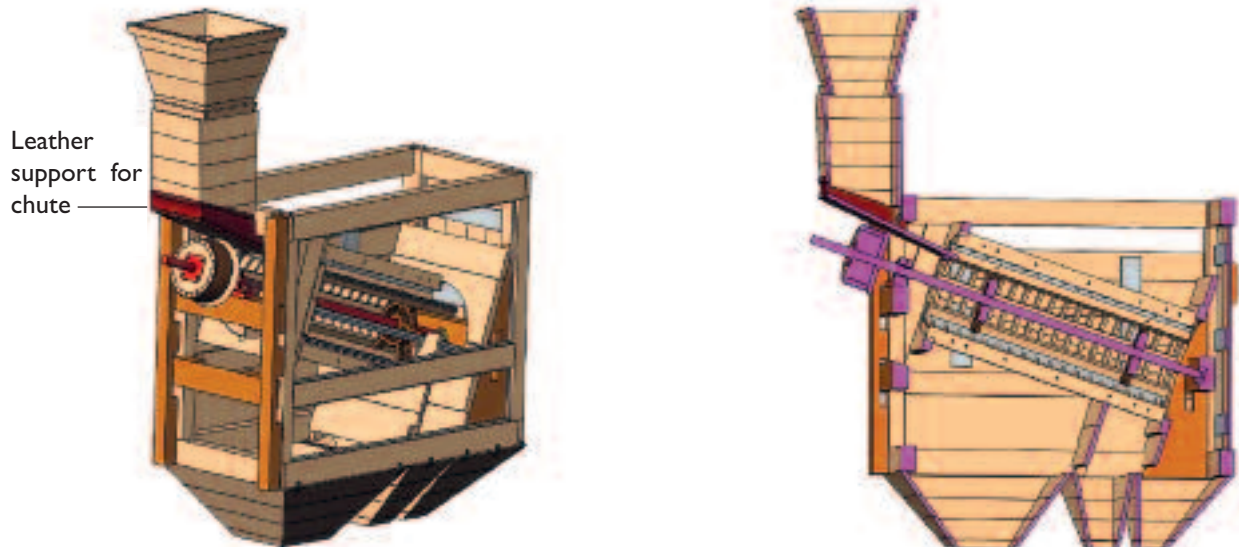
Drawing of the dresser at Pitstone Windmill, which was moved from Chinnor Windmill.

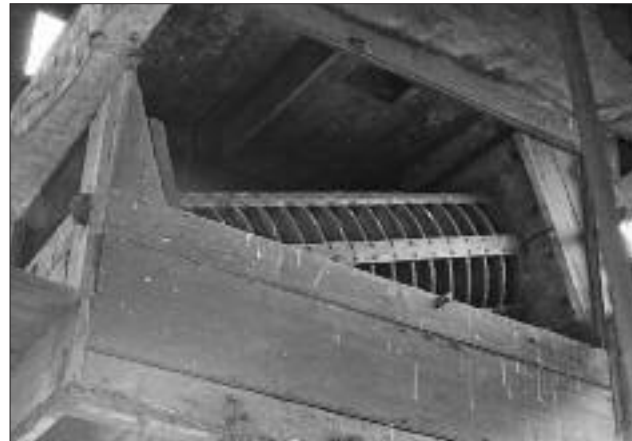
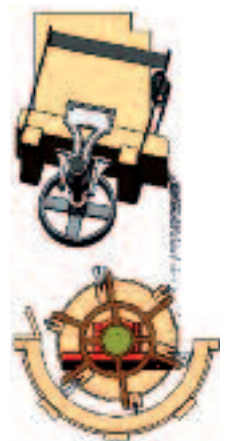
The Pitstone dresser when installed at Chinnor (left) and the possible vibratory feeder (right).

Chinnor did have a flour dresser on the bin floor, which survives to this day having been relocated to Pitstone Windmill, but the installation at Pitstone has a grain feeder already fitted in the form of a leather-supported chute agitated by protrusions on the rotating dresser shaft (see drawing on page 8).

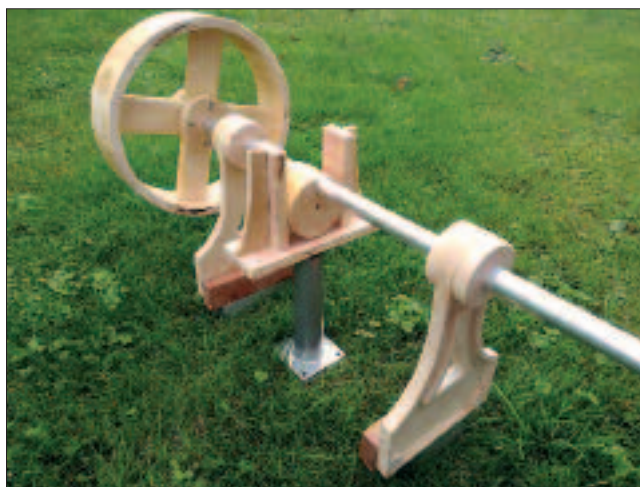
Wooden pattern for the cast parts of the feeder.

The use of castings suggest that the feeder was 'bought in' rather than of local manufacture, but unfortunately we're really not much further forward. Perhaps Mill News readers will have suggestions of what other piece of equipment our feeder might have been used to feed, or perhaps will recognise the castings or method of chute suspension from equipment in other mills? Maybe the style of the castings is typical of a particular agricultural machinery supplier, so we could have a go at establishing the feeder's provenance.

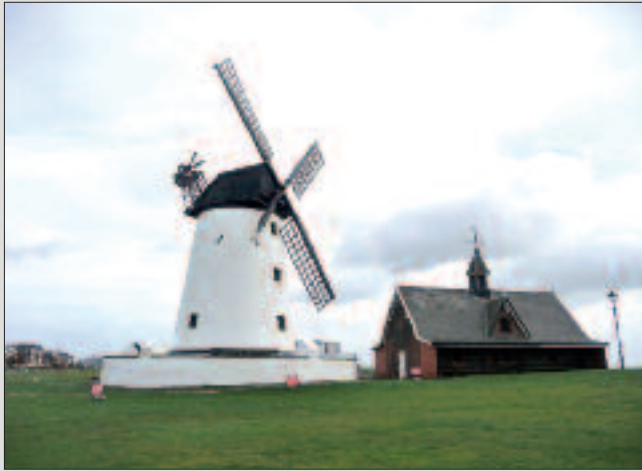
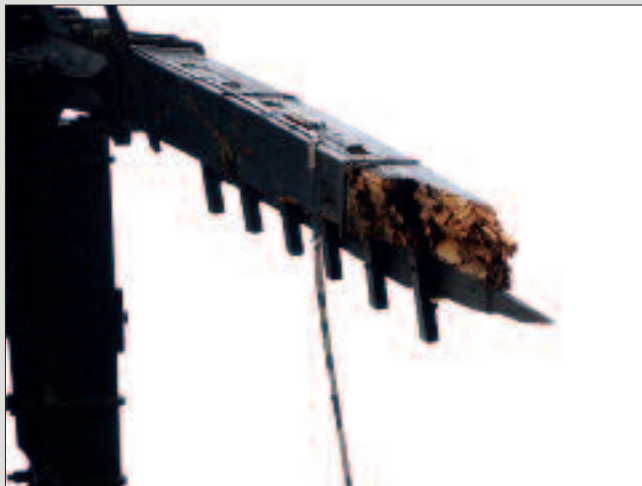
In 2019 Woodchurch Mill in Kent lost a sail in high winds and the whole of the fan stage also blew off. The repairs to this are going to cost quite a lot of money. Fortunately Ashford Borough Council are looking into the repairs.

In October 2021, Lytham Windmill in the North West, owned by Flyde Borough Council, also lost a sail and skeleton fan blades. The damage in high winds was caused apparently just three months after the mill was repaired following previous gales. It is believed that Lytham will be using their local millwright, who will be sourcing new wood for the repairs.

In both cases the stock failed a quarter of the way down from the centre point.

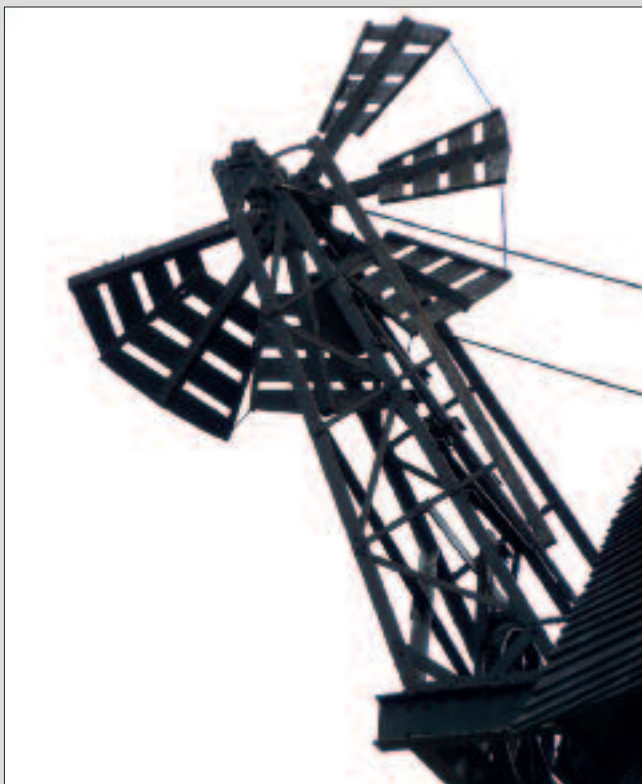
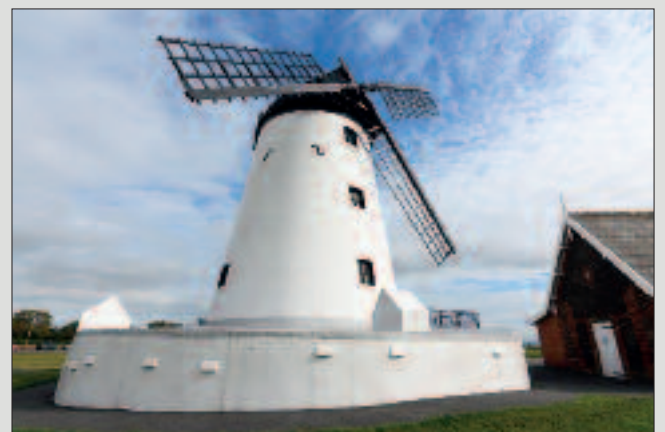
*This column: the wind damage at Lytham Windmill.
Pictures – Margaret Croker.*

*Lytham Windmill after removal of the damaged sail.
Picture – JPIMedia.*

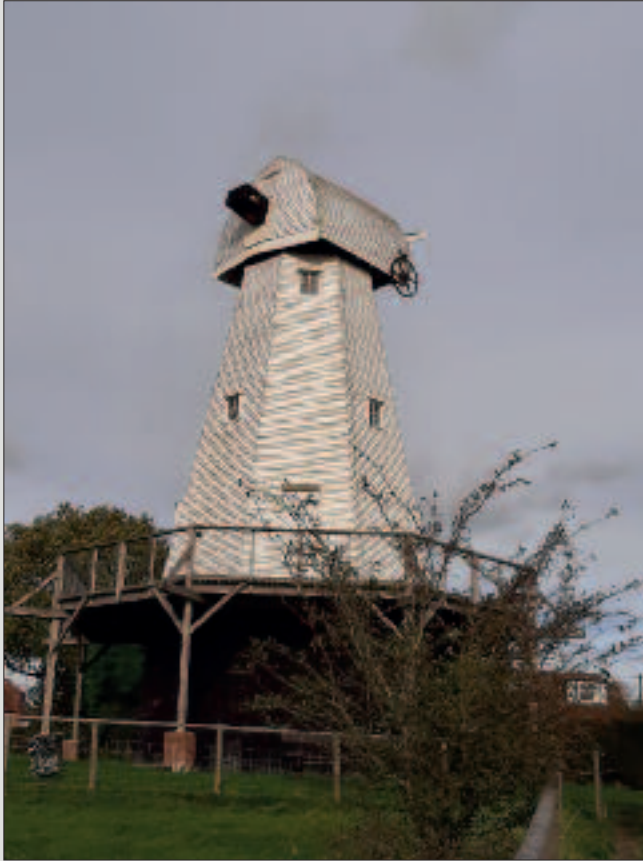
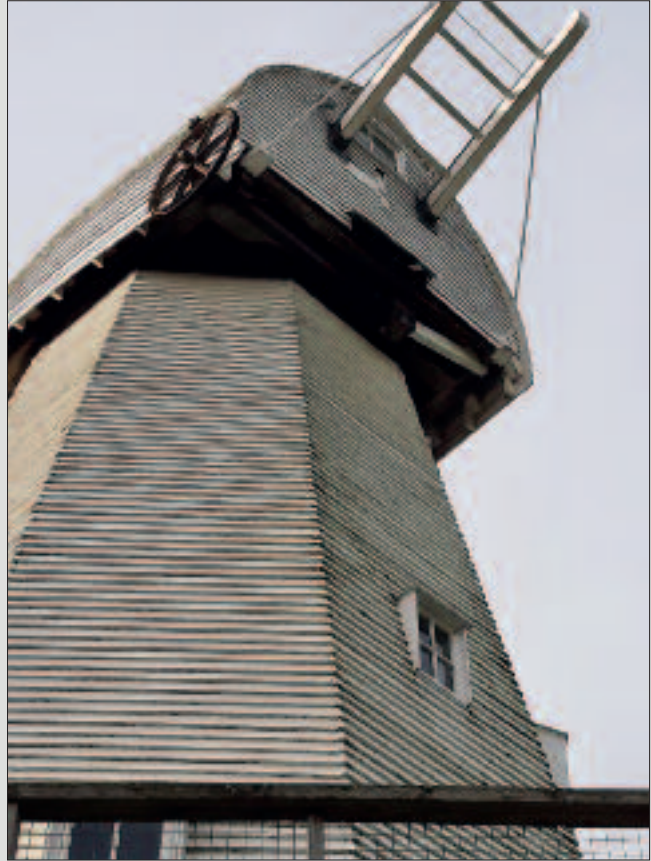
*Woodchurch Windmill without sails or fantail following damage by high winds in 2019.
Pictures – Carole Leith.*

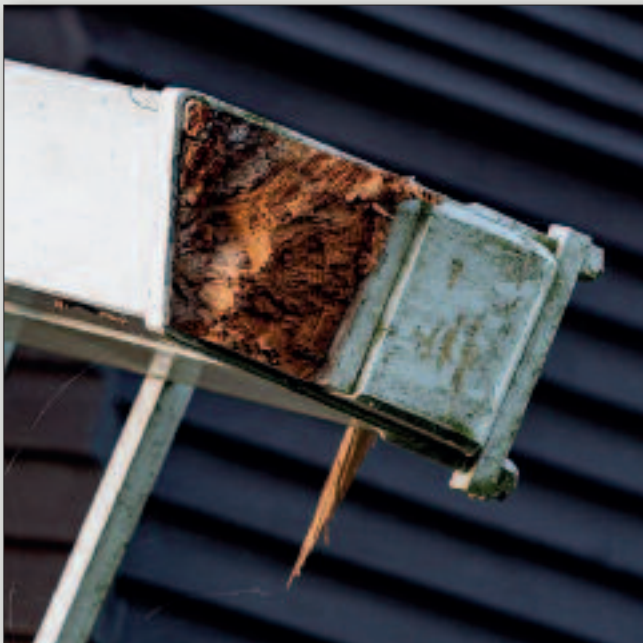
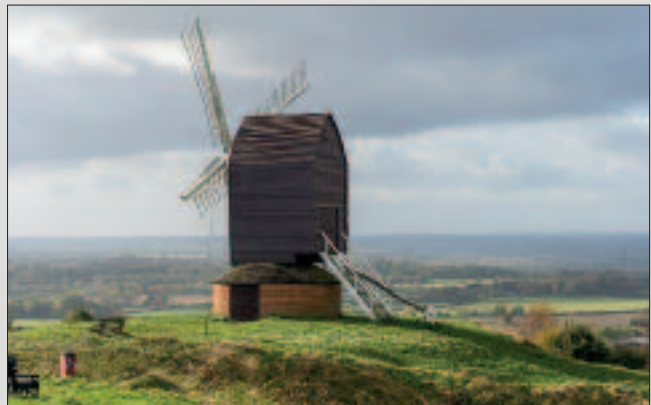
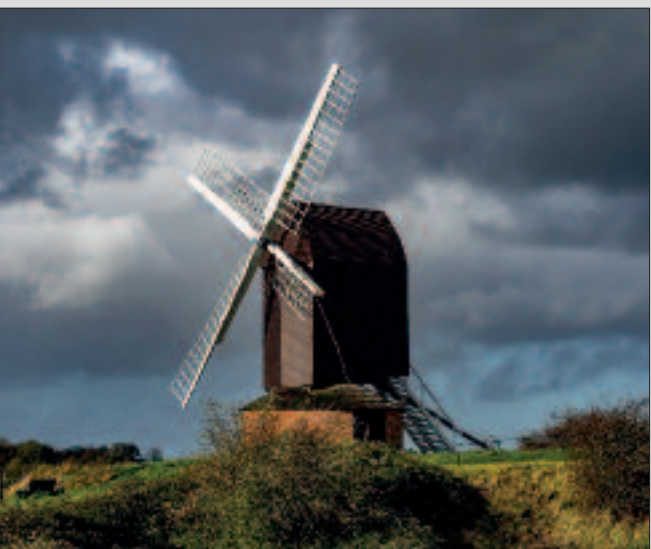
*The broken sail at Brill Windmill.
Pictures – Tim Andrew*

We now hear that Brill Windmill in Buckinghamshire has also suffered the loss of a sail recently.

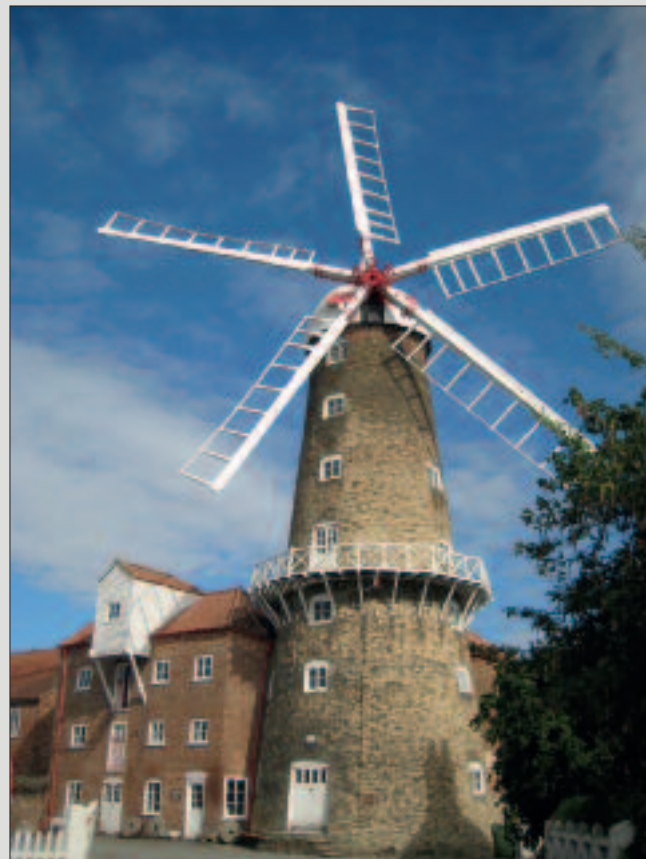
*Maud Foster Windmill, Boston.
Picture – James Waterfield.*

'The Maud Foster Mill in Boston built in 1819 is undergoing work to put it in good order. The first thing has been to repair and re-canvas the cap roof, followed by painting of all the exterior woodwork and ironwork, with assistance from the Mills Repair Fund. The next work as time and resources permit will be to refurbish the turning gear and the shades (shutters) in the sails. Surprisingly, in a good wind, the mill will still grind flour, albeit in smaller quantities.'

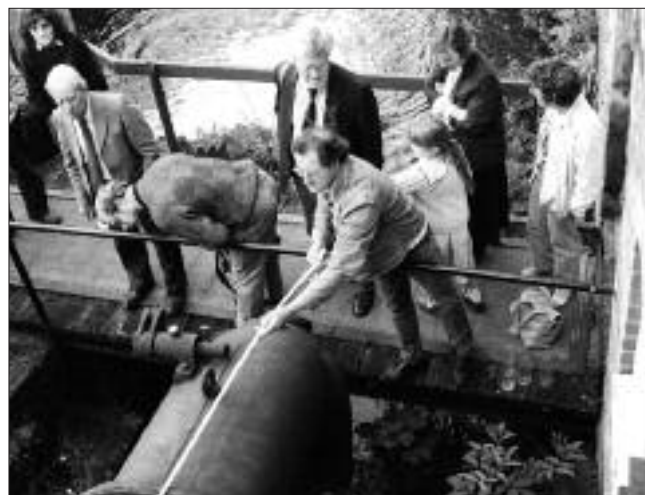
*Alan measuring a turbine during the 1988 SPAB tour in Surrey.
Picture – ?.*

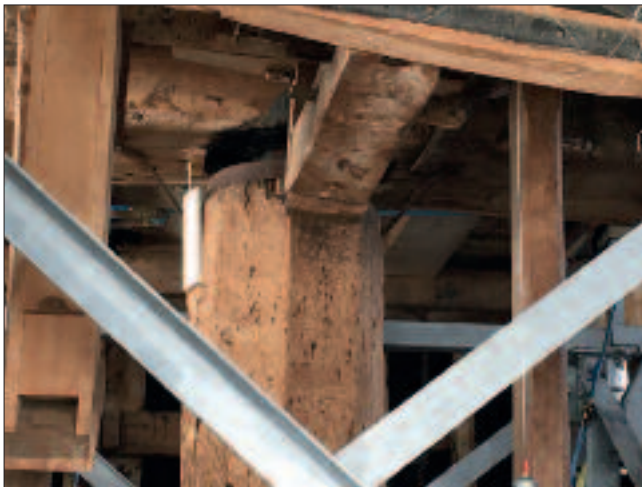
*Main post with the top of the post exposed.
Picture – Mildred Cookson.*

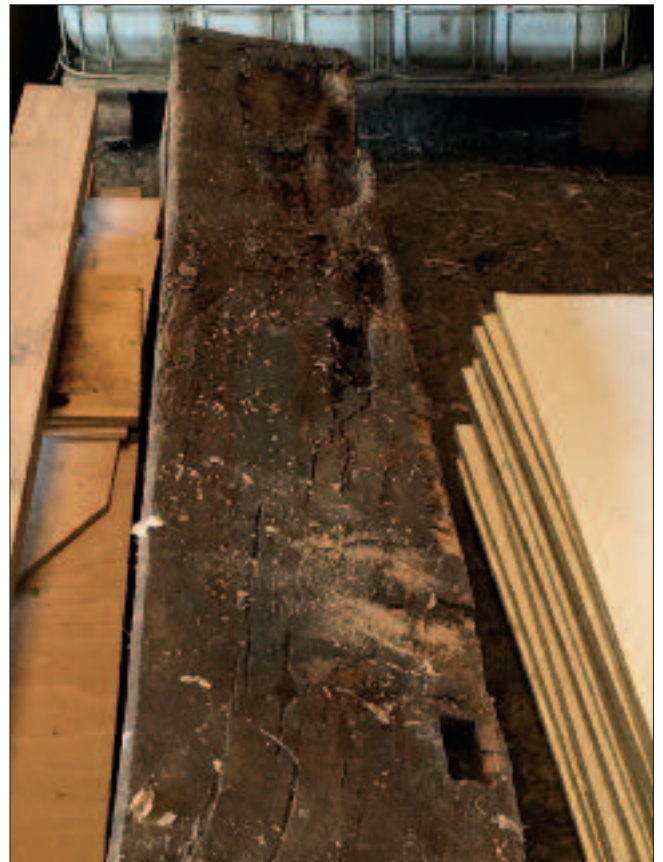
*The old weather beam.
Picture – Mildred Cookson.*

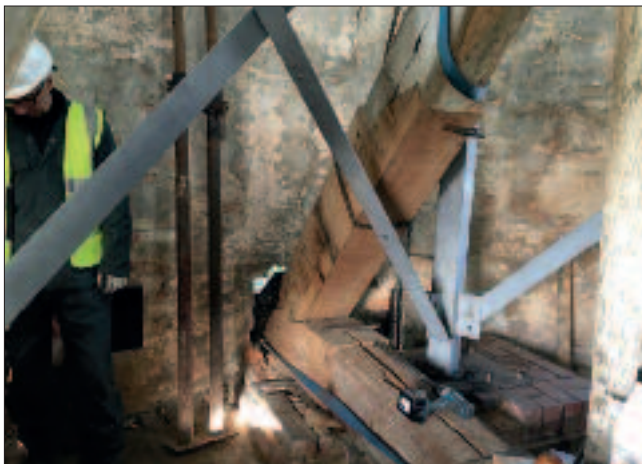
*Quarter bar and cross-tree repair.
Picture – Mildred Cookson.*

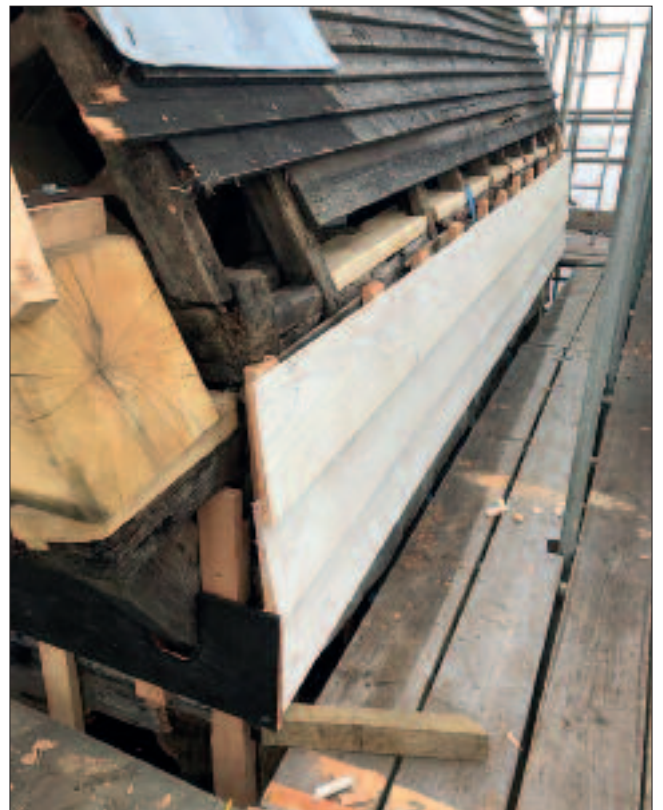
*New weatherboarding going on.
Picture – Dorothea Restorations.*

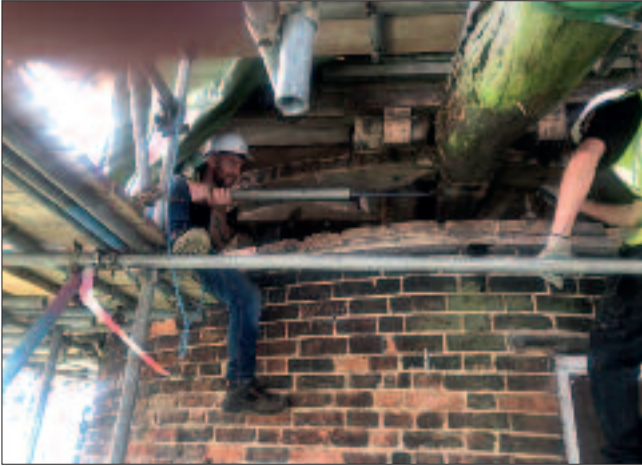
*Removing the old tail pole.
Picture – Dorothea Restorations.*

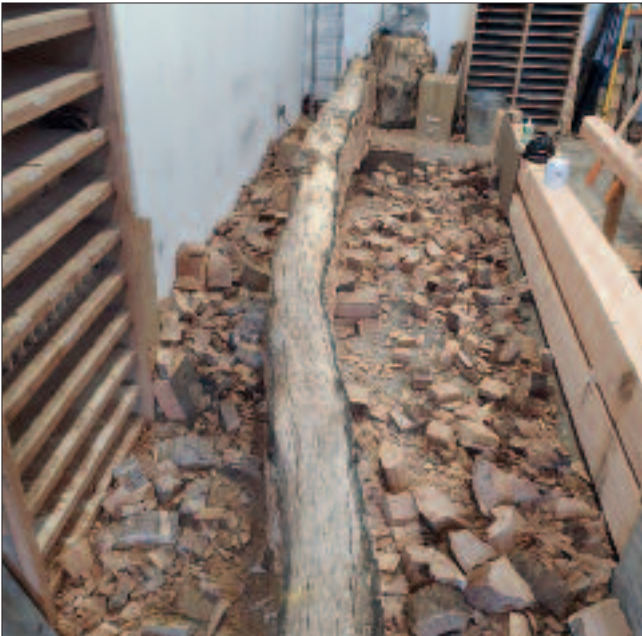
*Timber for the new tail pole.
Picture – Dorothea Restorations.*

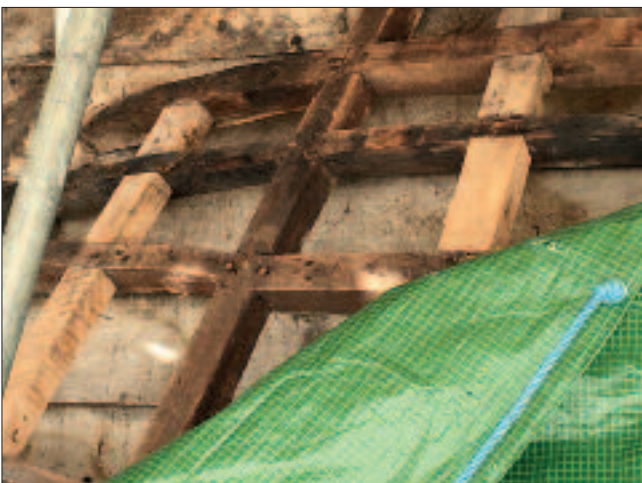
*Timber repairs to roof of the roundhouse.
Picture – Mildred Cookson.*

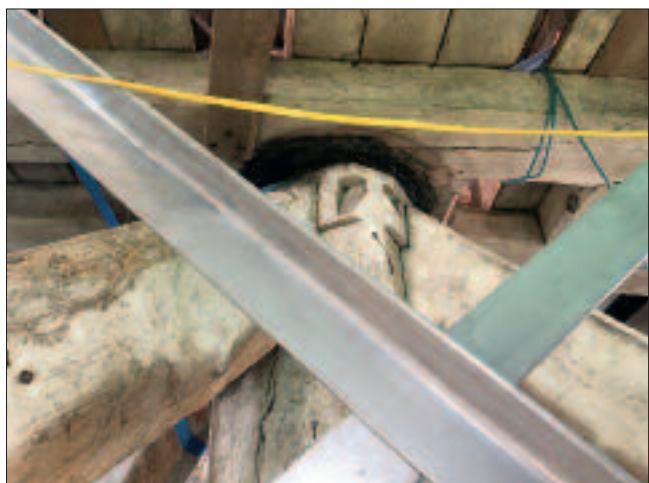
*Top of the post after the dendro core extracted.
Picture – Mildred Cookson.*

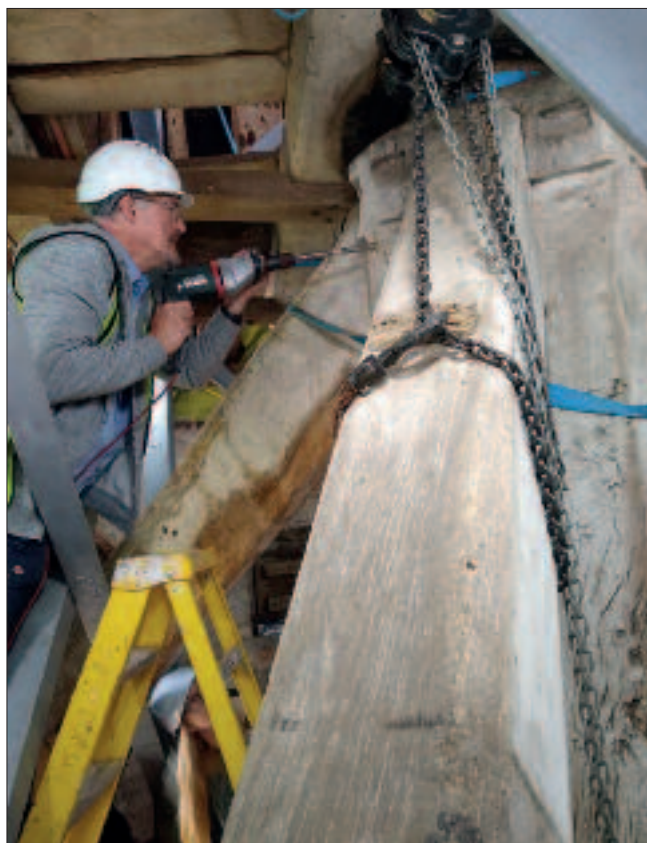
*Martin Bridge drilling the core taken from the main post.
Picture – David Holmes.*

Main post – this was previously cored but a reading was not forthcoming – the core was taken in a logical position at the widest part of the post below the buck – it may be worth trying a similar position on another face. It may also be worth going lower on the post to avoid possible rot – but the lower section is very knotty.

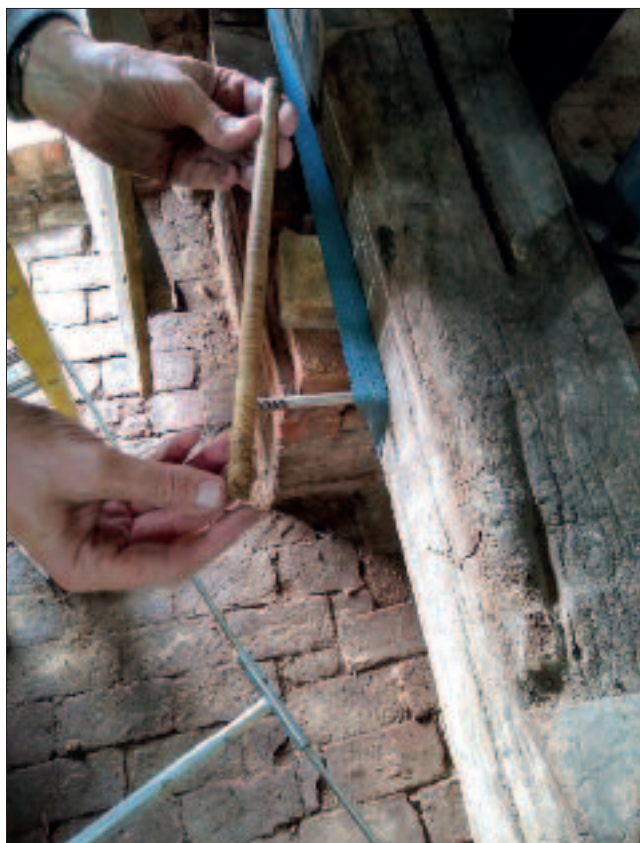
*The core sample taken from the main post.
Picture – David Holmes.*

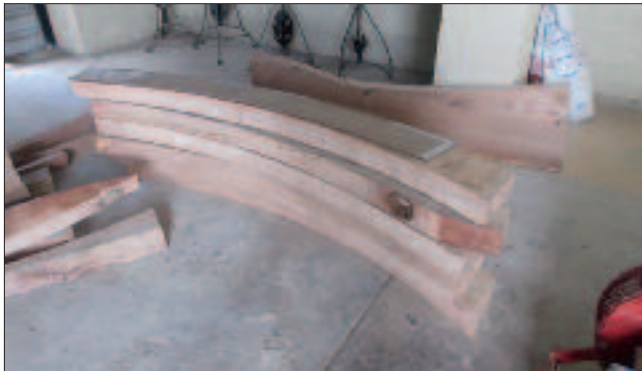
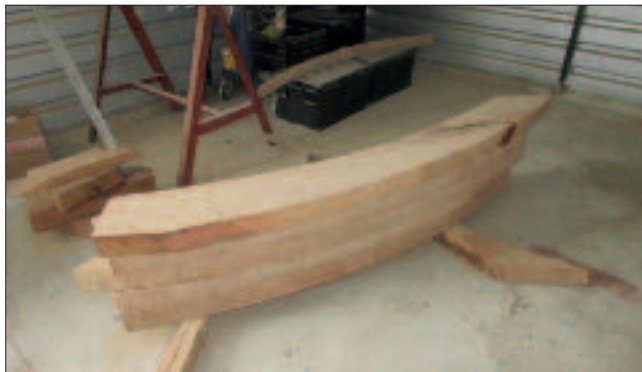
Some of the segments of the curb rings which Mike has been cutting.

Mike, here in Grabouw, is busy with the curb rings. He's been on holiday for two weeks but is back now, so I expect lots more progress on that front! He'd thickened and cut many of the arcs before he left;

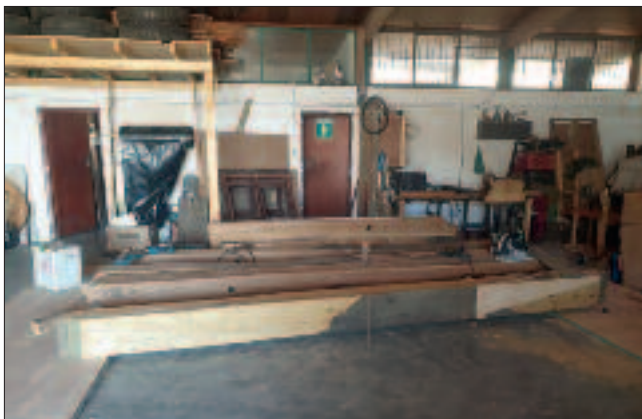
Jon has been busy lengthening the Bilinga beams for the sheers.

In Cape Town, Jon is busy with the cap frame. The two long sheers needed scarf joints to make them long enough. He is attaching the outriggers to them with tenon joints and making the fancy 'ogees' at the ends. He's busy with the tail beam which supports the heavy stone bearing at the back of the wind shaft;

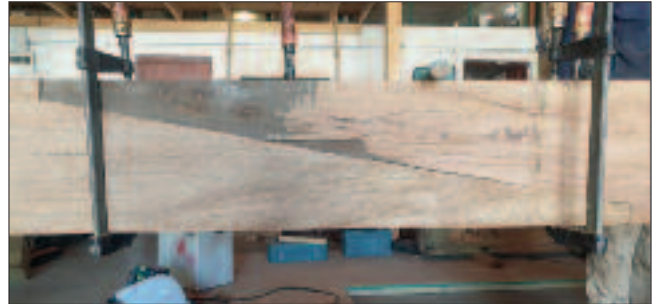
One of Jon's scarfs in the massive sheers, made from old Bilinga wood which he had.

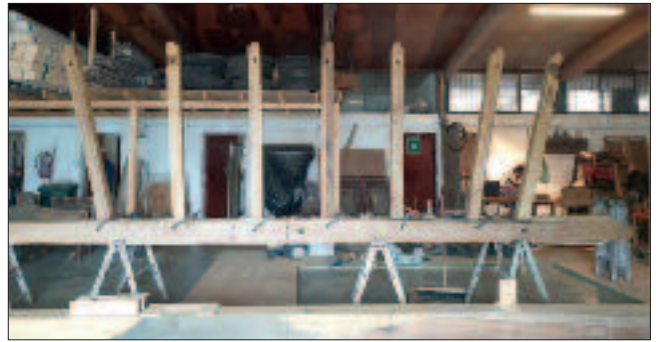
One sheer has its outriggers fitted. The four bolt holes for the clamps at the scarf can be seen. The second sheer is in the foreground. The outriggers will be cut to length when we have worked out how long they must be, and finished with fancy ogees.

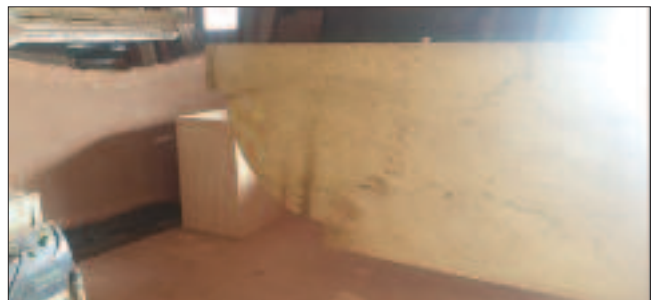
An ogee at the end of a sheer, or maybe the Burgemeester?

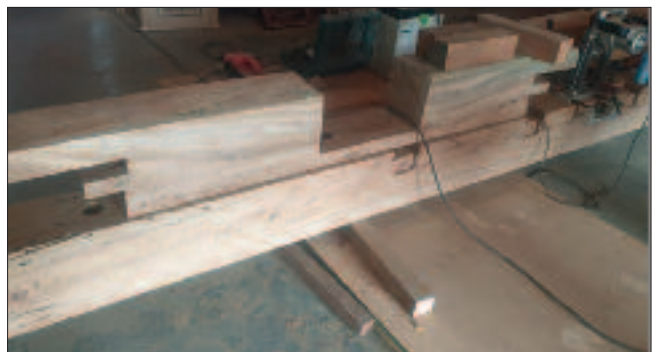
The beginnings of the tail beam, which will be beefed up, back and underneath.

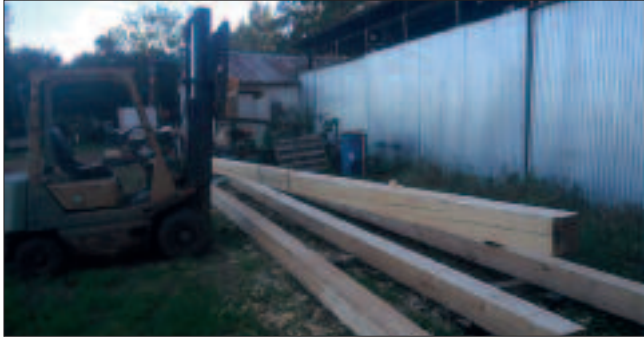
Selecting the straightest pair of spruce beams for the long stretcher.

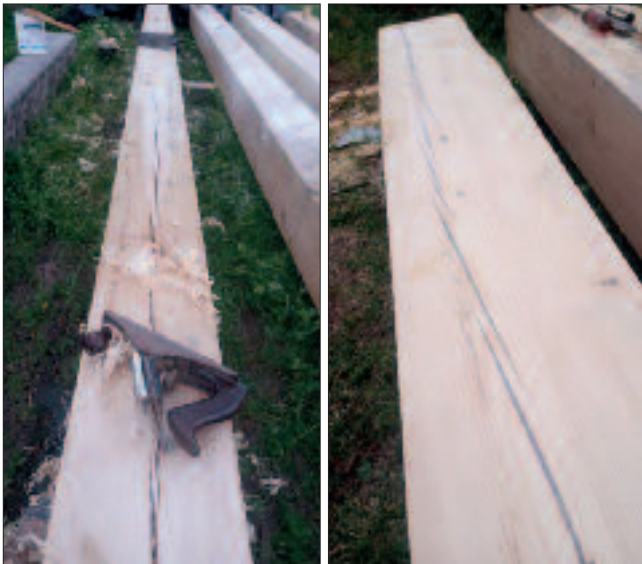
Filling the 'sbakes' in the spruce beams for the stretchers with epoxy resin.

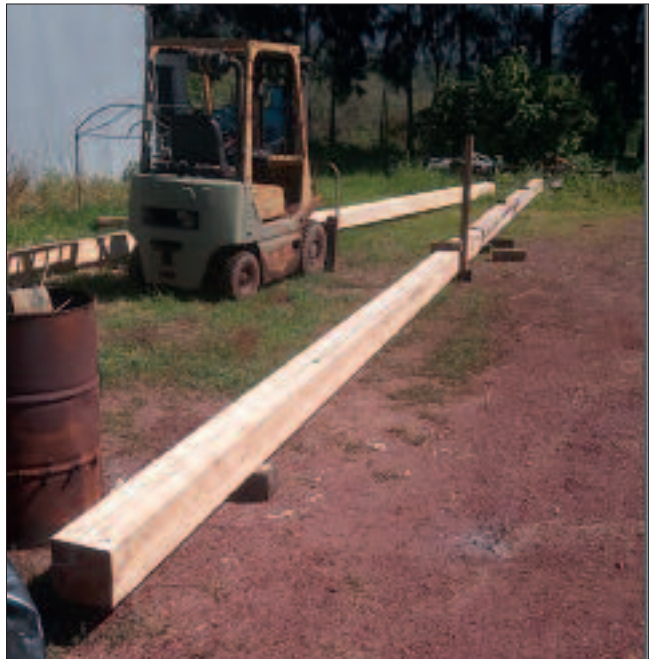
Two 8m beams laid end to end. Now they must be joined!

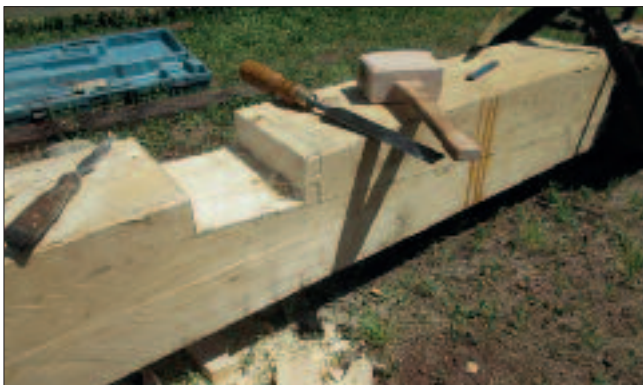
Scarf marked out, many downward cuts then the offcut chiselled off, then more. I cut the second one 33 times over the 900mm overlap.

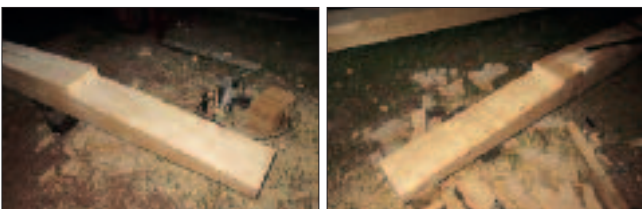
The first 'table' finished and the second 'table' roughed out.

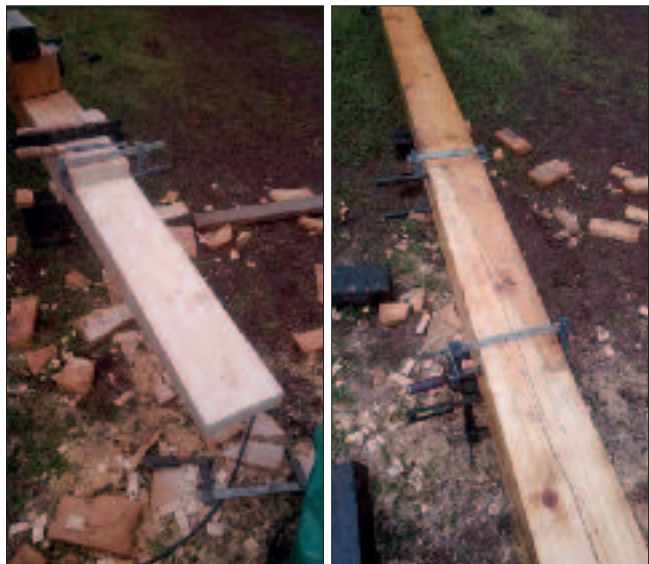
Left: Second 'table' finished – will they fit together?

Right: Now to drill the holes and hope they come out in the right place!

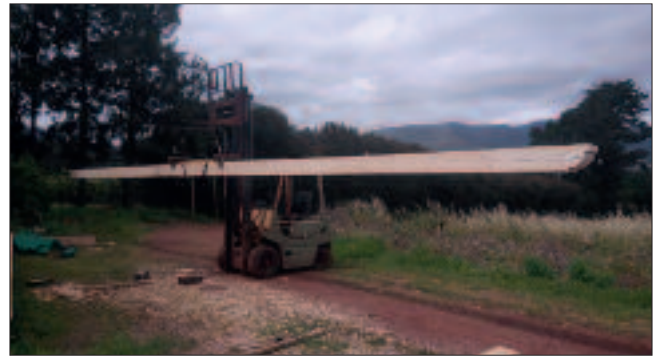
This is the long stretcher which I've made, hanging from the forklift in the middle. It's spruce, 12m long and 200mm square.

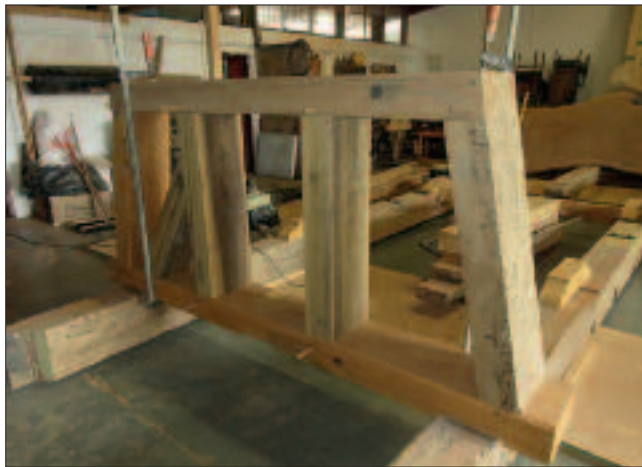
The Dutch call this 'Het voorkeuvelens', the front gable, perhaps? The middle two uprights which will hold the neck bearing in place are Stinkwood! Jon made it as if it was going to stand vertical, but it must lie over at 10 degrees, so he will deepen the dovetails be's made in the sheers and Burgemeester at the front.

I had to give him the news that I hadn't realised that the front framework which he's just completed needs to lie over backwards at 10 degrees, but he quickly saw a way to correct that without spoiling work that he'd already done.

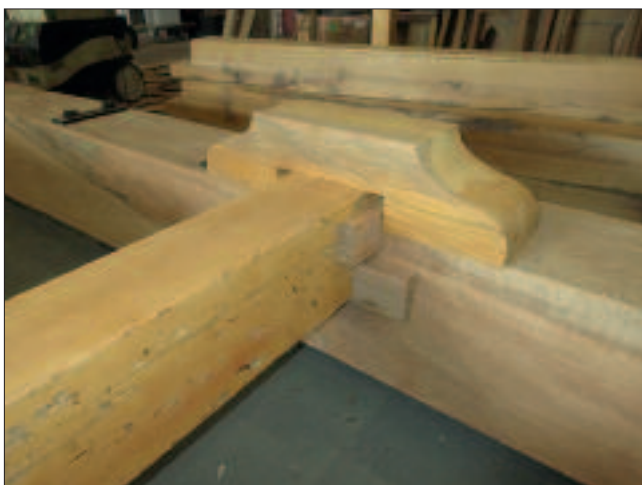
The bridges have been made to hold the sprattle beam, which must also be able to move laterally and fore-and-aft, by adjusting the wedges.

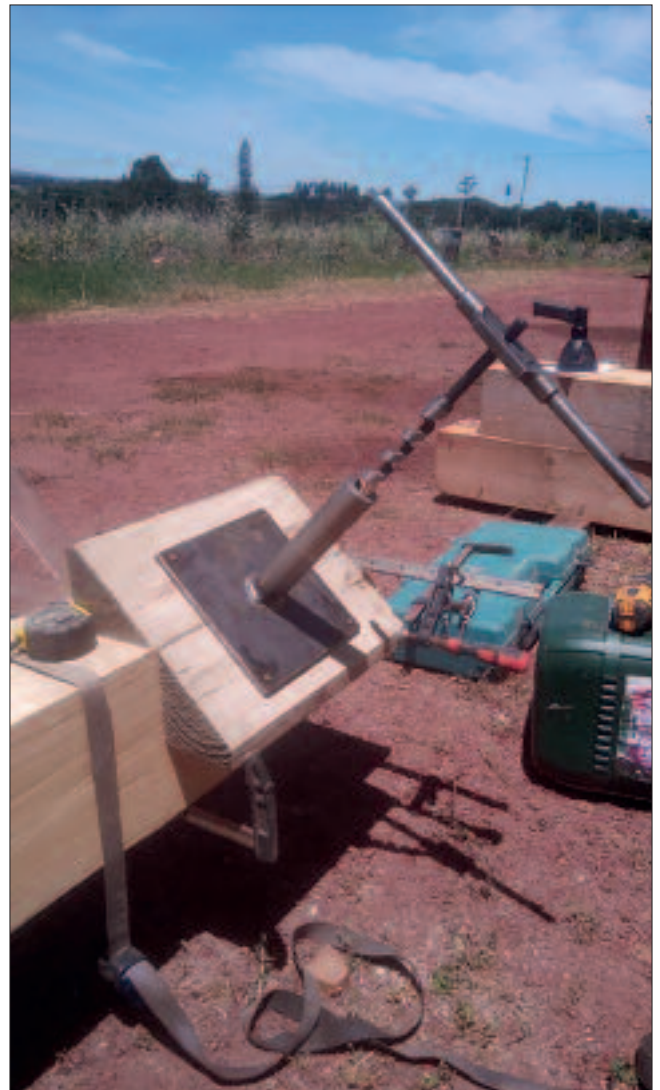
Each end of the long stretcher had to be drilled at 45 degrees for the bolt which attaches to the long brace which reaches down to the bottom of the tail pole at the back. Nervous moments, but it came out at the right place!

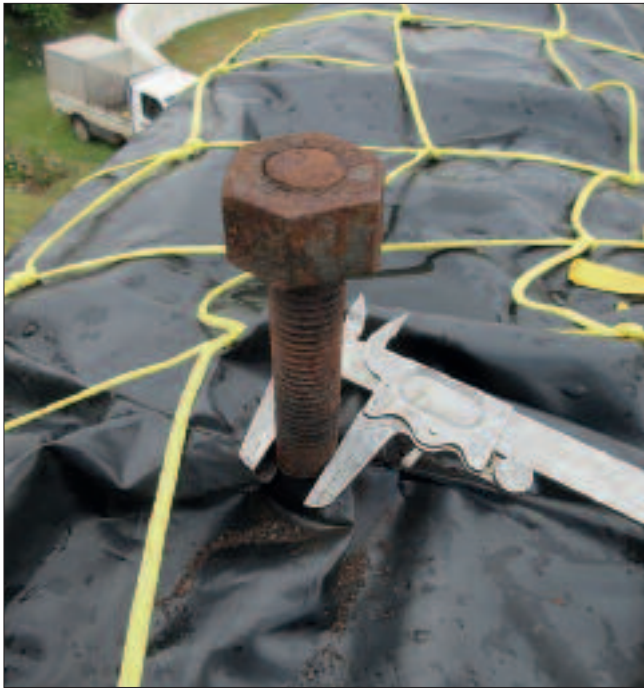
The studs on the top of the tower are 3/4in diameter. I will have two discs machined to make measurements more accurate.

We also needed to do some measurement on the top of the tower, so I brought a ladder. We did some checks and planned how to do the 32 measurements between the eight studs so that we can drill holes in the curb ring in the right places. There were some very enthusiastic hoots and waves from passing vehicles!

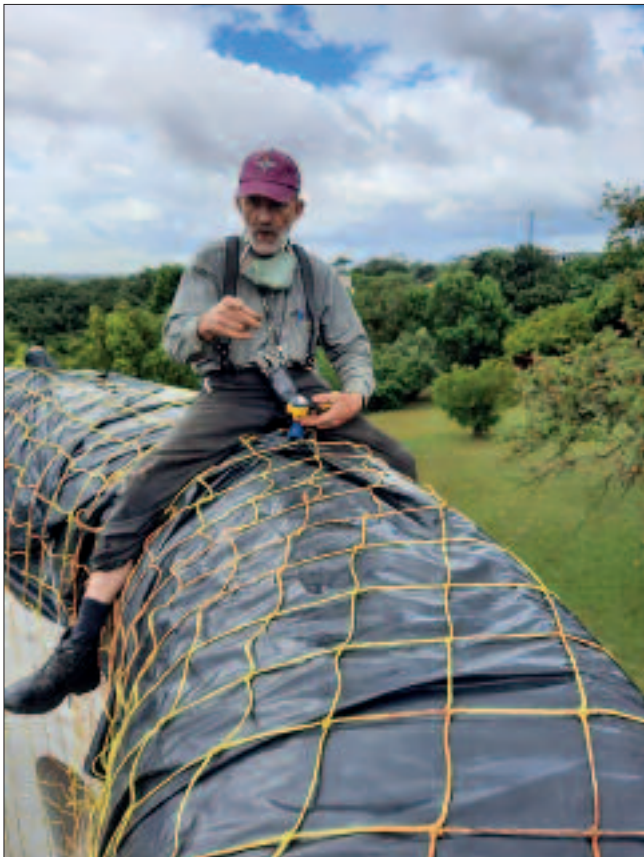
Jon and I will do the measurements from stud to stud, 32 times like this!

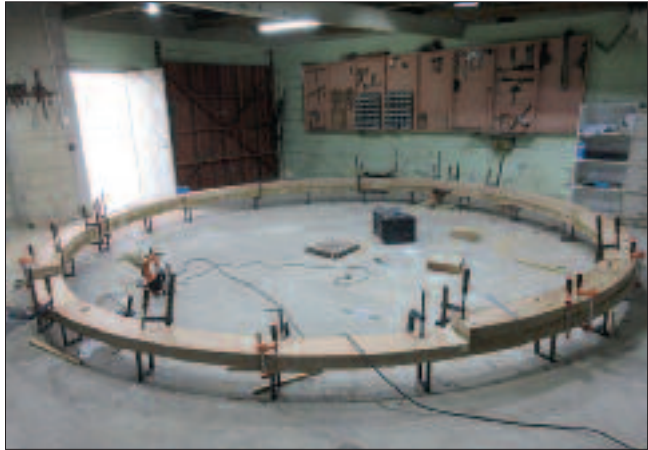
Two more arcs to add to make up the second layer. Mike will machine the outside surface, then the wrought-iron band can be fitted. Then the inside surface must be machined very accurately round. He must then make another ring which rotates inside this curb, which will be fixed down on the tower with the studs.

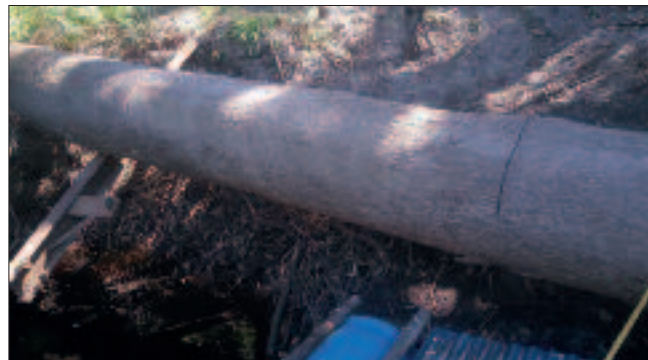
High and dry! It's a eucalyptus, but we're not sure which! Hopefully, this will be our wind-shaft.

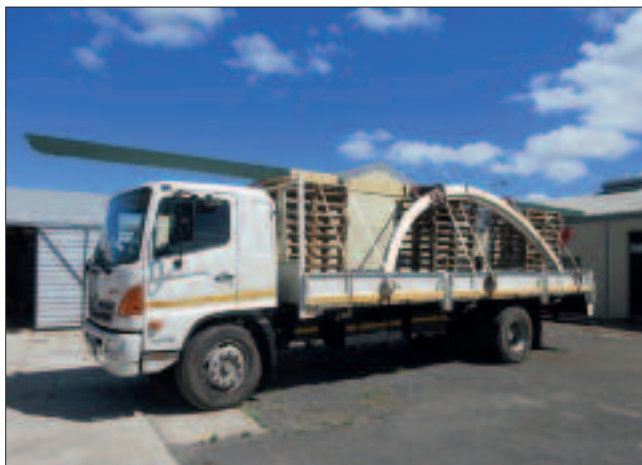
At Mike's to collect the rafter-support ring.
