The Magazine of the Mills Section of the
Society for the Protection of Ancient Buildings

no
170

January 2022

Mill News

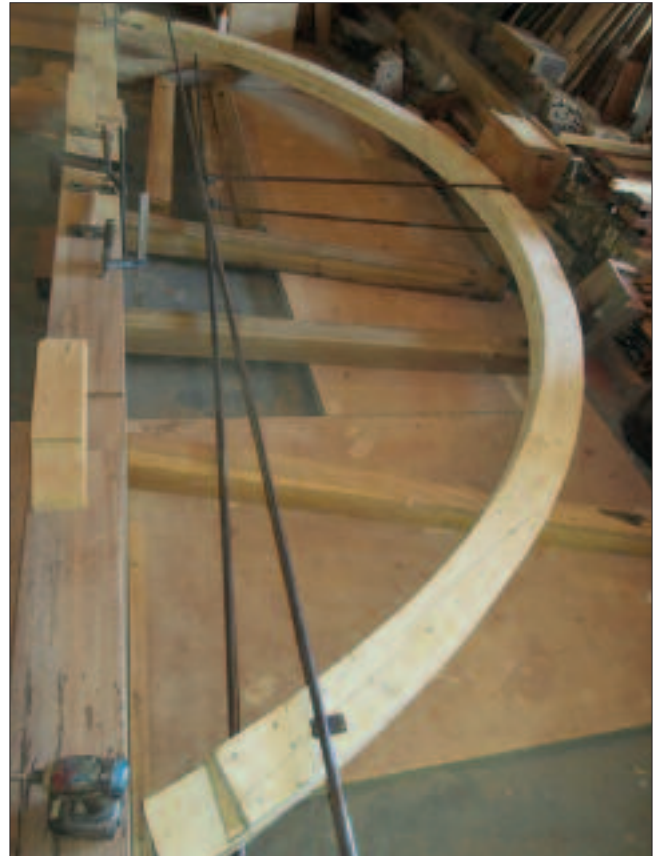
Mike attached metal rods to the half-rings to hold their shape. Most of the material here is sliced offcut from the big beams, kindly done by Abie at Somerset Timbers.

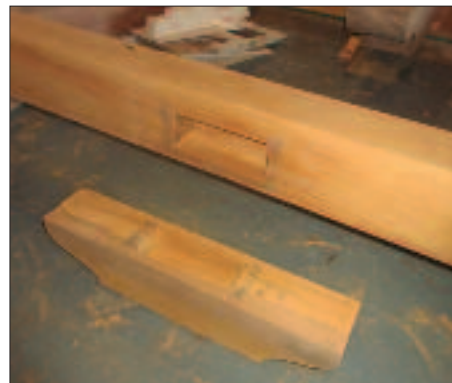
This is the sprattle beam and the bridge, both cut out for the half-bearings for the pintle bearing at the top of the vertical shaft. Jon will use African Blackwood, which has even better properties than Lignum Vitae.

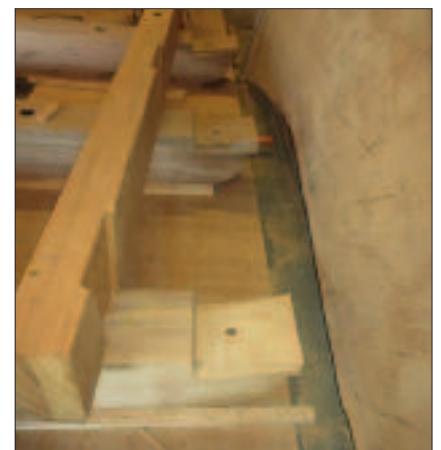
The dovetails have been modified in the sheers and Burgemeester so the front gable can lie over at 10 degrees.

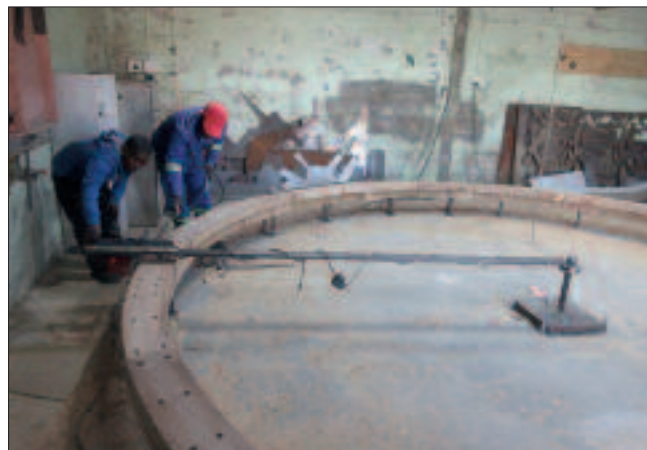
Sizing the curb ring.

The rough but accurate finish will be cleaned up with a belt sander.

He will iron out any problems before tackling the inside surface which must be very accurate and smooth. He will simply slide the rig off the bar and turn it around.

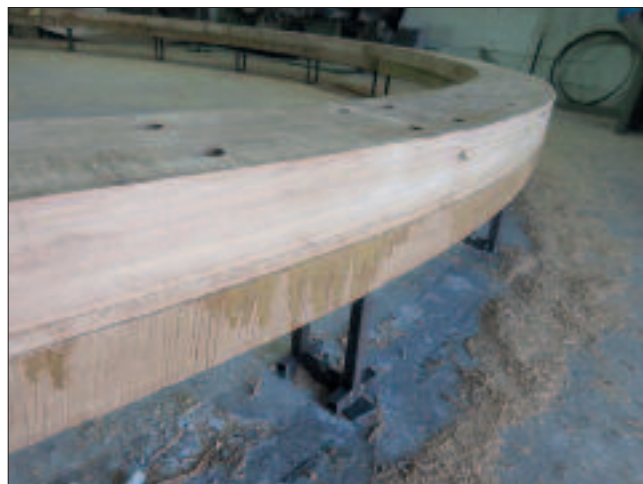
The curb ring after sizing.

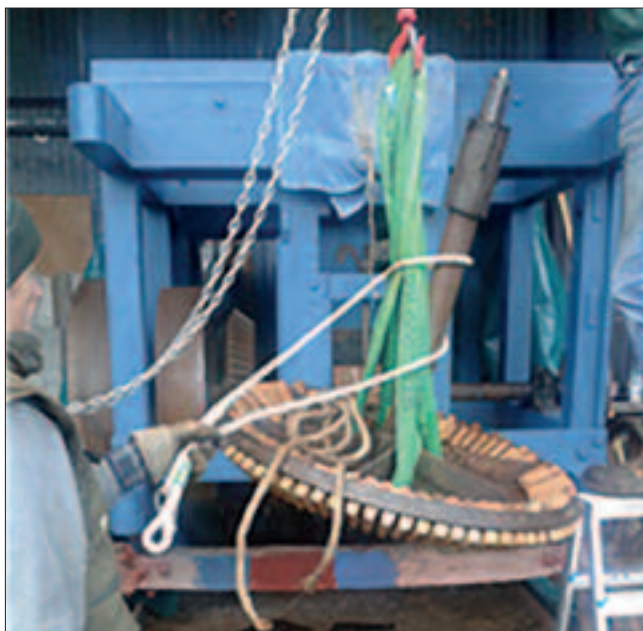
The crown wheel being lifted into place. Trial traces of Prussian Blue and Venetian Red are visible on the rear axle.

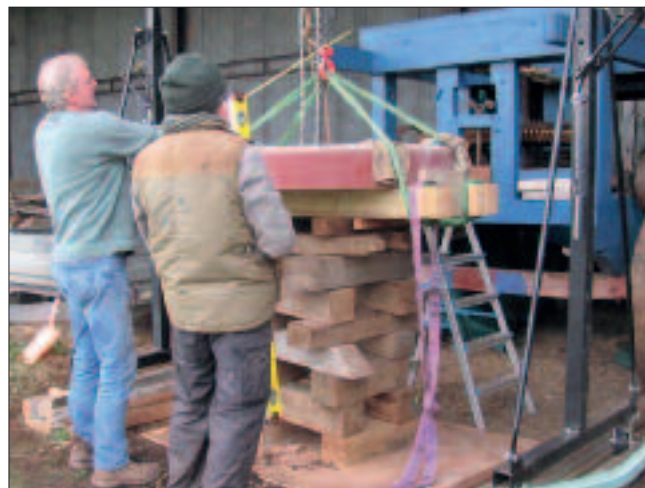
Raising the stones– one block at a time.

With the bedstone in place we now needed to lift the runner stone into position. This is, of course, much more difficult as we needed to get the bar to fit neatly on to the cockhead.

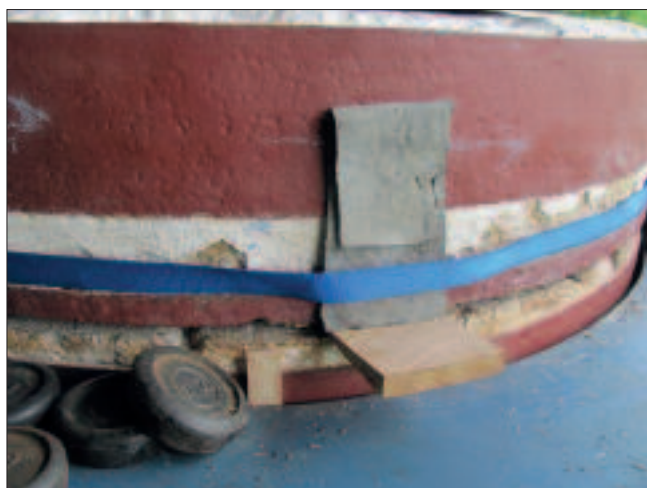
Using sheet lead and strapping to identify balance points.

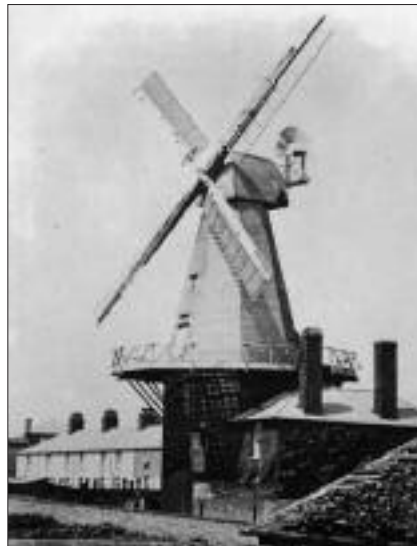
Fig. 1: Regent's Place Mill, Ashford, in working order pre-1872.

The houses on the north side, visible in Fig. 1, have now gone, but the terraces on the opposite side of the street survive. The original walled Mill Lane, which led west from Hemsted Street, was widened to form an extension of Regent's Place soon after the mill and its brick base were removed. The mill house remained standing for at least another 50 years.

Figs. 1 and 4 show the mill as it stood before dismantling and as rebuilt at Badlesmere. There are subtle changes – eg. side clamps on both middlings instead of just one. On the whole, however, the rebuilt mill is very similar to the original, although the dark colour of the weatherboarding suggests it was tarred and not painted in its new location.

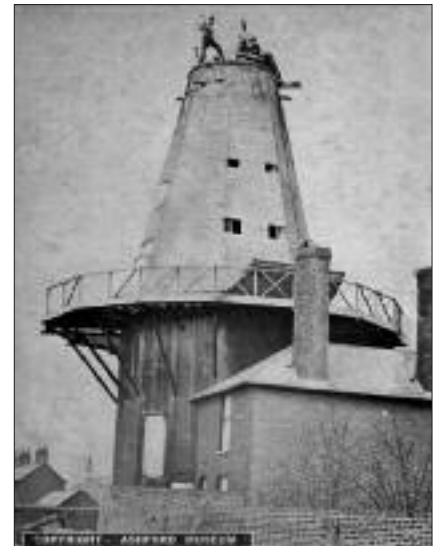
Fig. 2: Dismantling Regent's Place Mill.

Dismantling and re-erecting an existing windmill was clearly just as economical as building a new one from scratch, even at this late date. The sequence of dismemberment is interesting. Fig. 2 shows the mill with the windshaft, sweeps and cap roof already removed. Part of the roof has been lowered whole and lies on the

The photograph also shows square holes cut into the wall panels at the positions of the main floor beams. Early removal of the beams would have created a large internal void through which large parts such as the brake wheel and spur wheel could have been lowered.

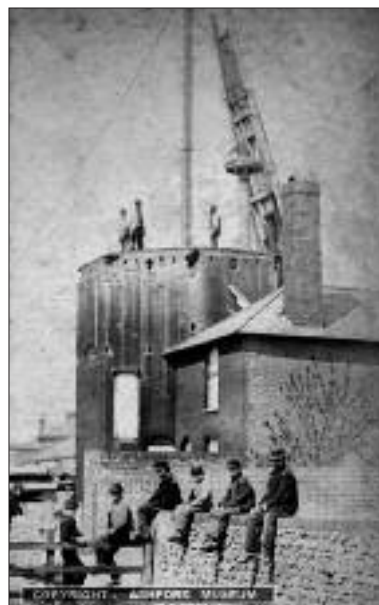
Fig. 3: Dismantling at an advanced stage.

Fig. 3 shows the dismantling at an advanced stage. The reefing stage has been completely removed and large holes in the brickwork indicate the former positions of main beams, joists and struts. A long timber, probably a sail stock or 'middling', has been set vertically and tensioned with ropes to act as a derrick pole. The pole is being used to remove the last of the side panels, which has *continued* >>

The mill would have been similar to Cranbrook in terms of its internal layout. The third (stage) floor would have been the meal or spout floor with the overdriven millstones on the fourth floor and the bins on the fifth. This is confirmed by the detail of the remaining wall panel in Fig. 3; the fifth

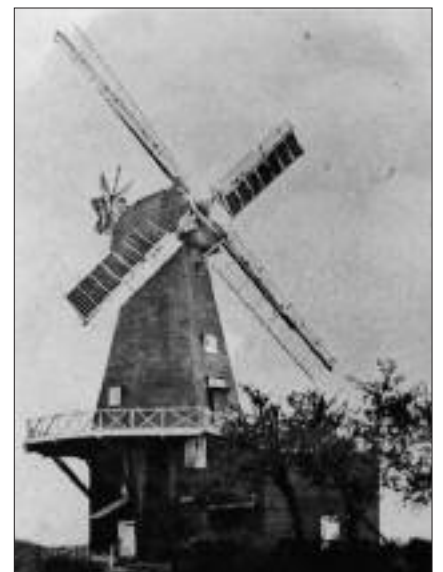
Fig. 4: Regent's Place Mill as rebuilt at Boundsgate Corner, Badlesmere.
