KURG at Boxley Abbey: 13-15 July 2020

Introduction

Kent Underground Research Group (“KURG”) was invited by the Society for the Protection of Ancient Buildings (“SPAB”) to participate at their working party at Boxley Abbey on 13-15 July 2020.

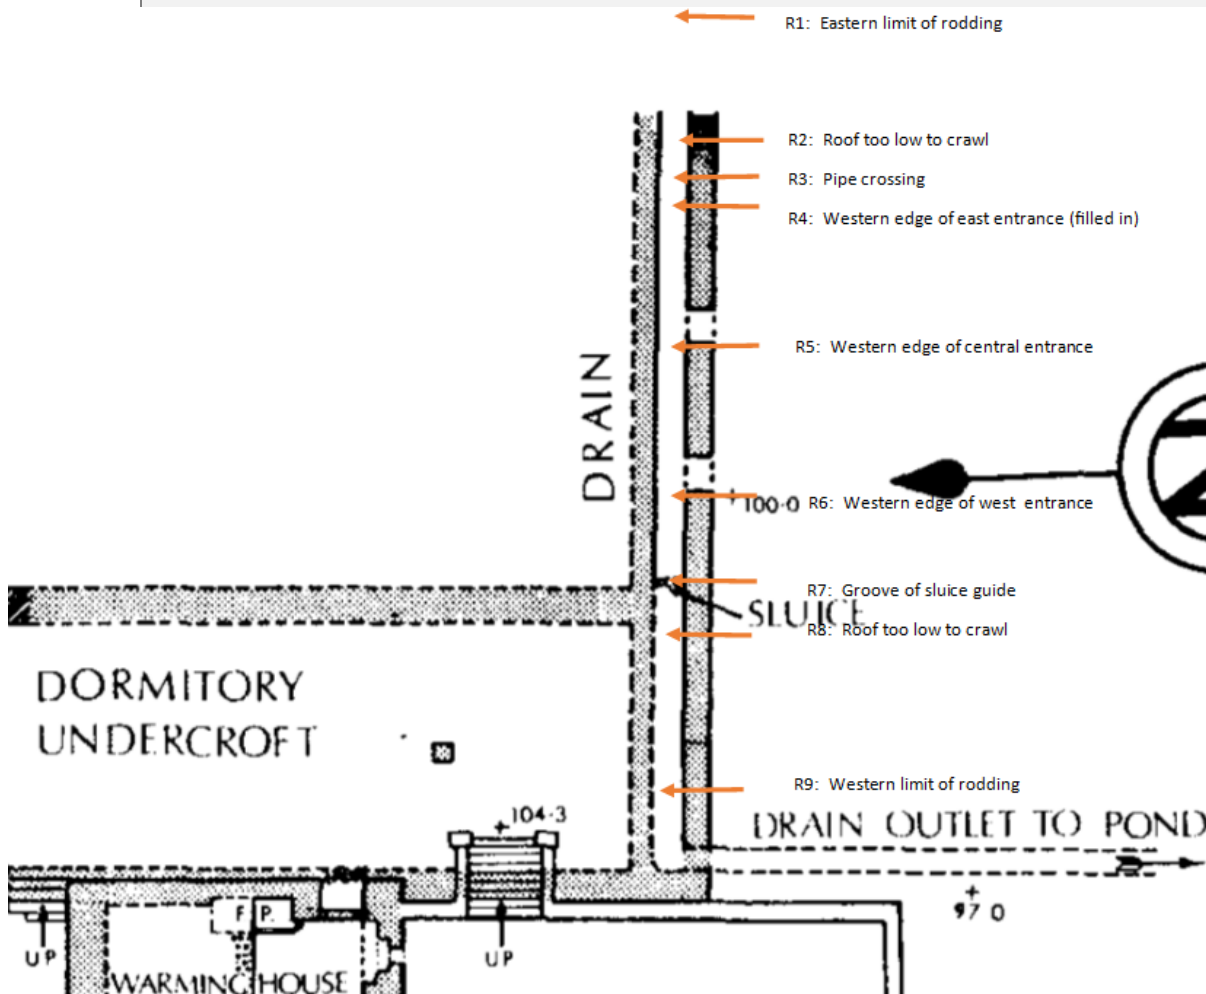
Point	Description	Distance from point R7 (metres)
R1	Eastern limit of rodding	21.2
R2	Roof becomes too low to crawl (east)	17.0
R3	Pipe crossing reredorter	15.0
R4	Western edge of east entrance (now filled in)	14.6
R5	Western edge of central entrance	8.2
R6	Western edge of west entrance	3.1
R7	Groove of sluice guide	0.0
R8	Roof becomes too low to crawl (west)	1.0
R9	Western limit of rodding	7.4

Locations of measuring points shown on an extract of the plan in the paper by Tester in *Archaeologia Cantiana LXXXVIII*. The walls of the reredorter continue further east (to the top of the plan) than is shown. The positions of R1-9 shown are only approximately to scale.

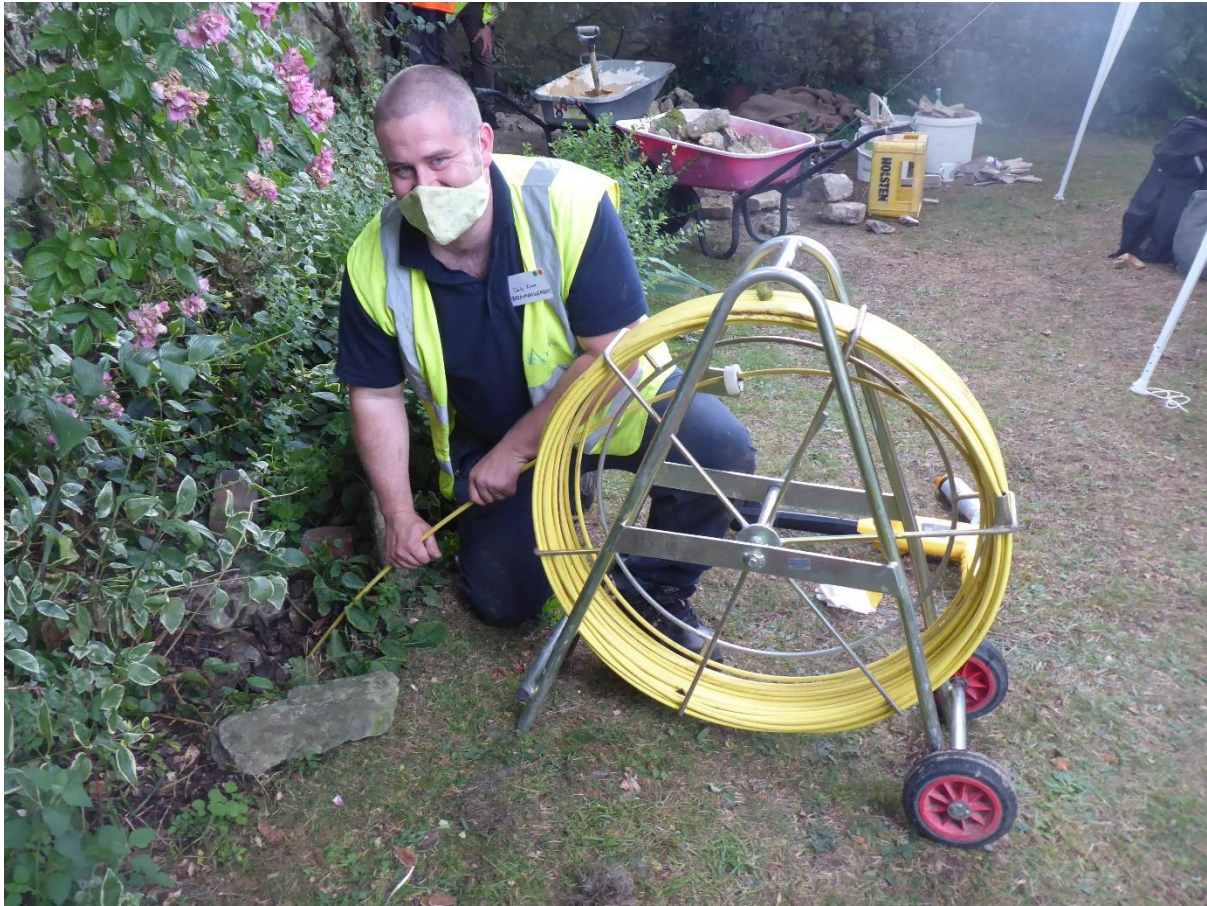
Limited investigations have been made by us to investigate these possibilities. We understand that a brief GPR investigation by Terra Measurement near the top of the steps up from the current Rose Garden gave complex signals with no obvious line of such a drain. In the Rose Garden itself near the foot of the steps is a small drain that leads downwards and slightly to the south. Various attempts with sondes on drainrods and fibreglass reel did not lead to progress of more than a metre, although its location is suggestive of a linkage to the reredorter.

Dale Rose of Terra Measurement investigating the small drain in the current Rose Garden.

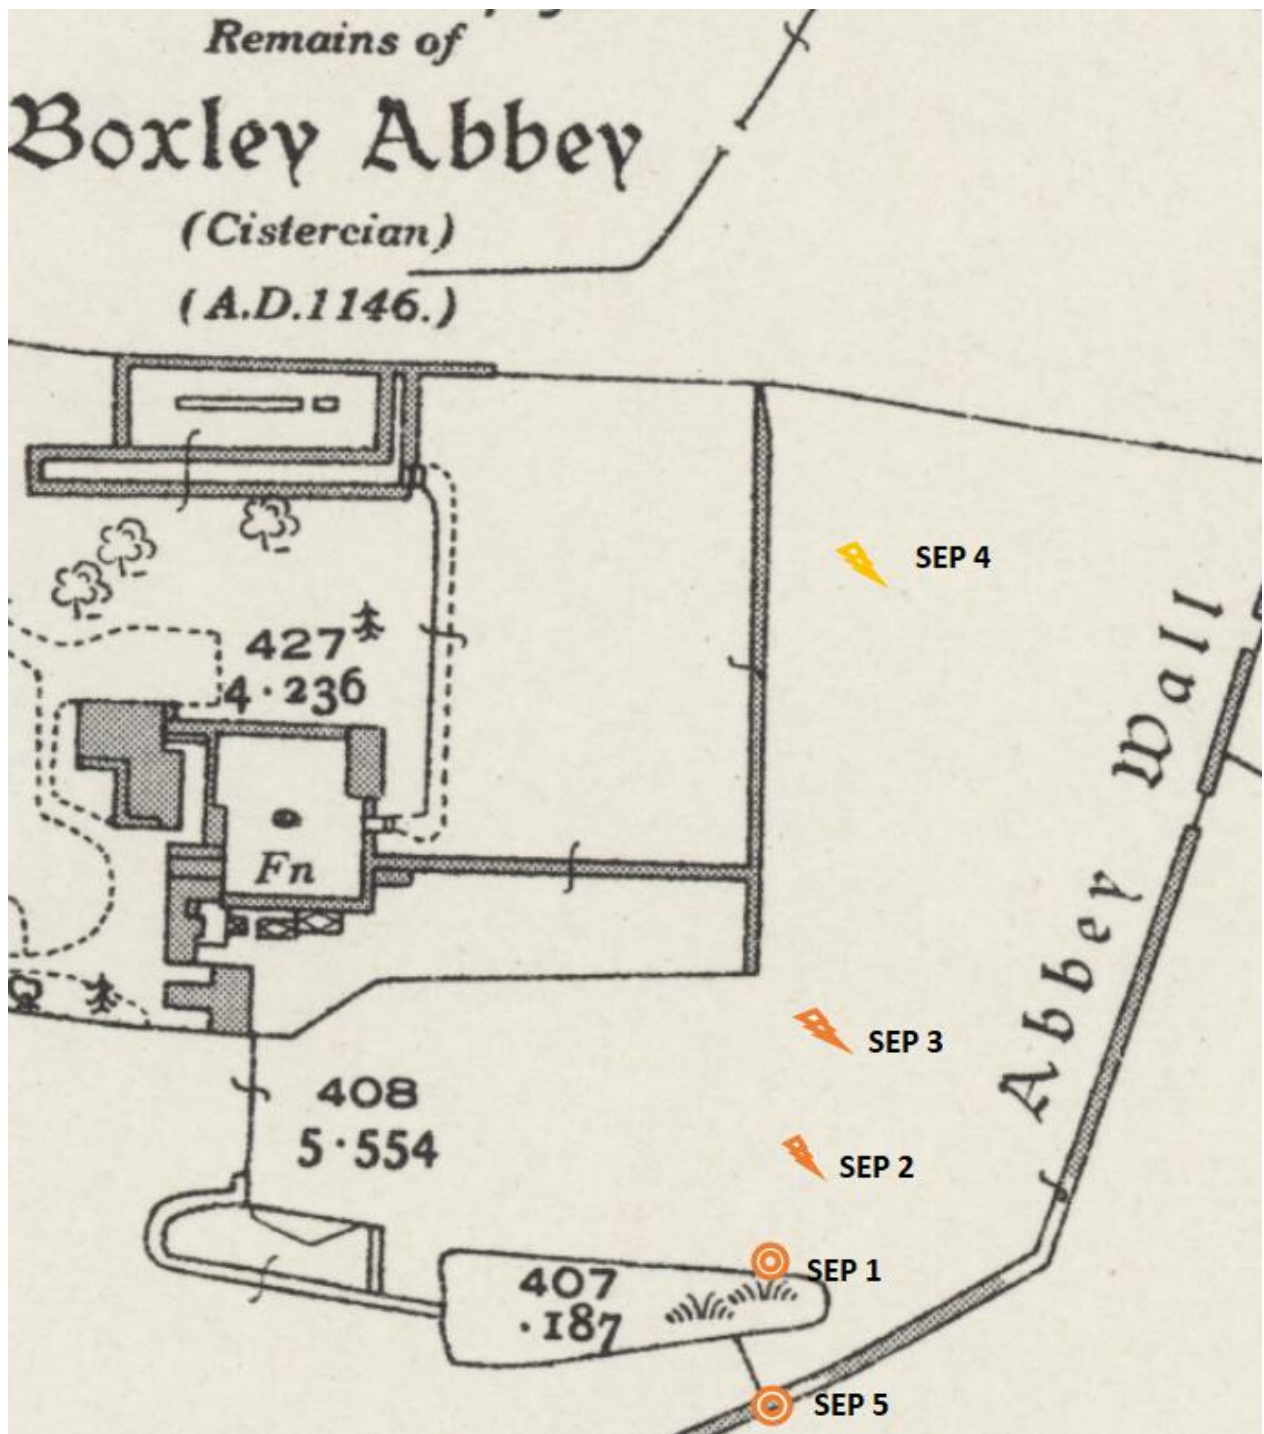
Locations superimposed on a 25 inches to 1 mile map revised 1936/7 and published 1946 (not reproduced to scale here).

With a sonde on drain rods threaded into the drain, the position of SEP 2 was located approximately 20-25 metres away, with the limiting factor for progress being the number of drain rods rather than any blockage. A sonde on fibreglass reel reached to SEP 3 before some form of blockage prevented the sonde being threaded further. The depth of the sonde was measured as around 1 metre. It is understood that Terra Measurement managed to find further signals with the use of GPR up to SEP 4. It should be noted in this context that the area inside the abbey wall north and east of SEP 1 is heavily wooded and GPR is only feasible along a length of grassy path that runs north-south just

outside of the inner wall. The 1801 survey shows the drain turning to the east at a point near to SEP 4, but due to the undergrowth and woodland, this could not be verified.

Taken together, this tends to support the 1801 survey, with the open drain being replaced by a buried ceramic land drain and with a more direct line in the approach to the south east pond.

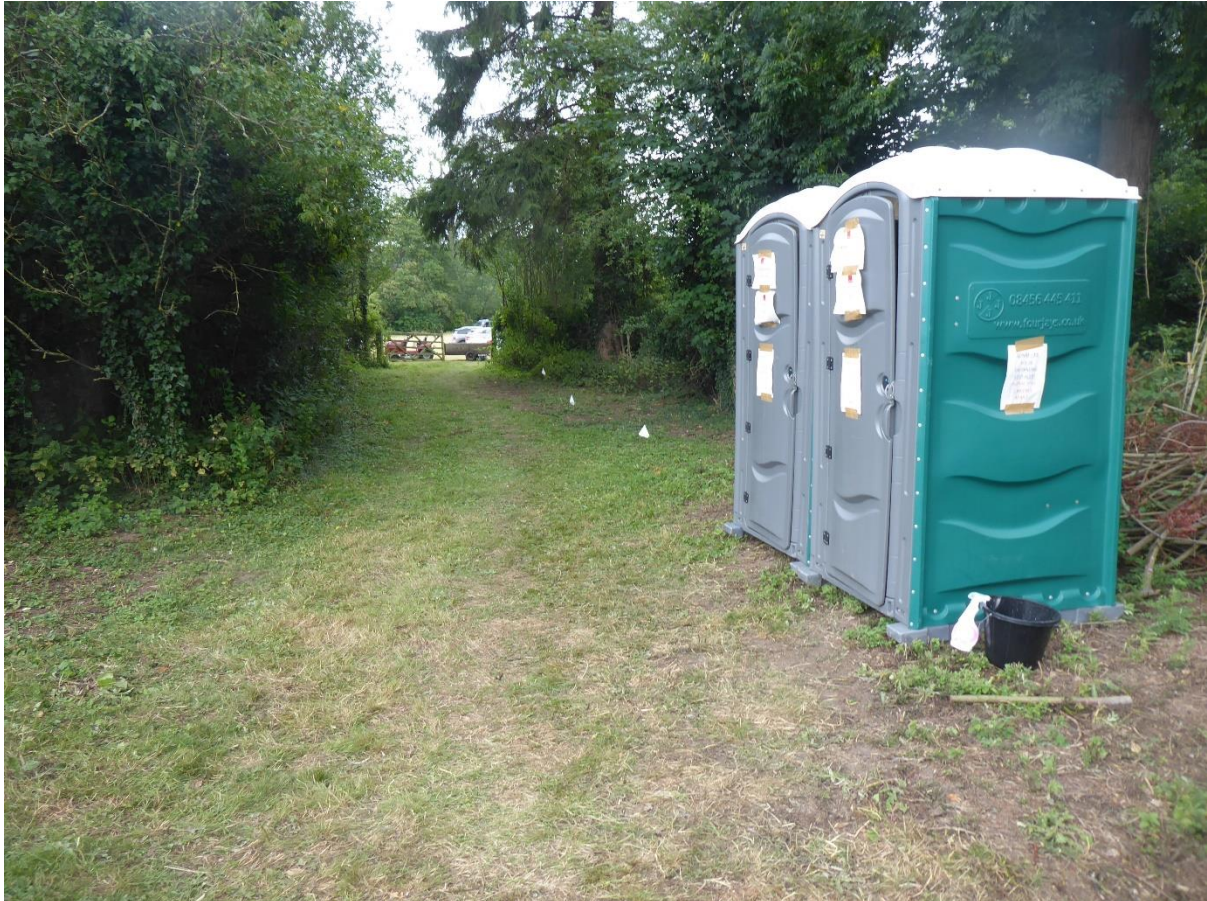
A line of Terra Measurement's white flag markers running along the path beyond the portable toilets.

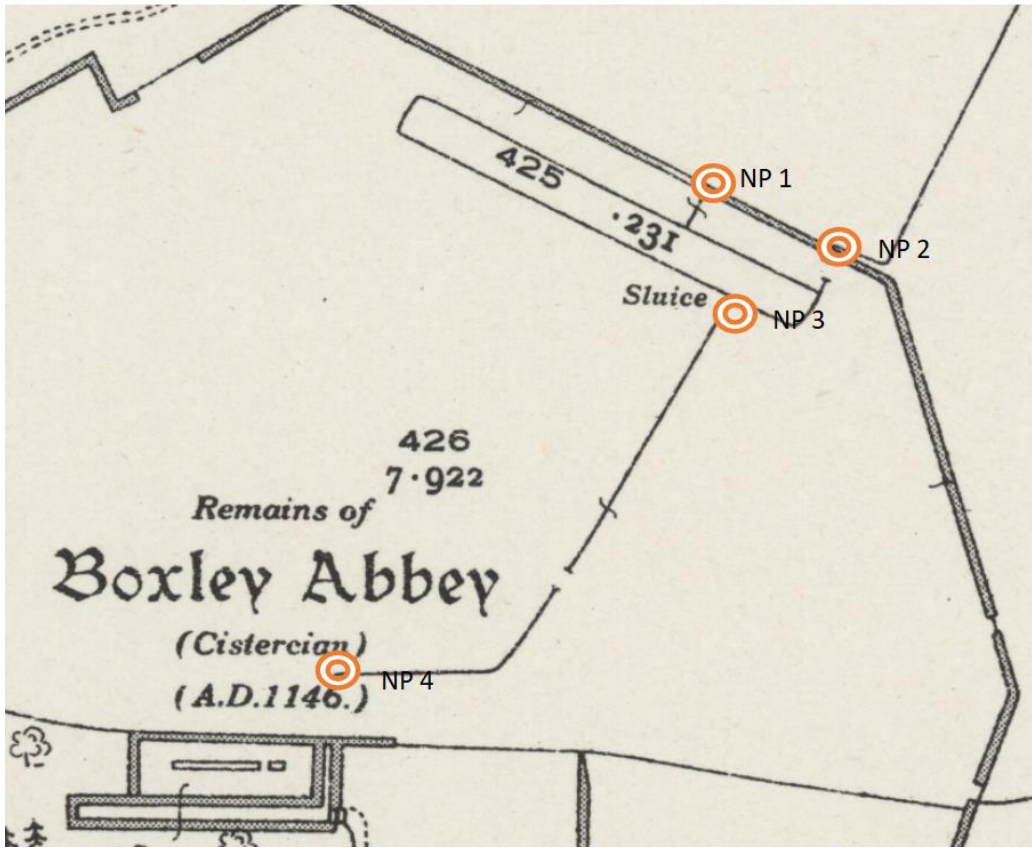
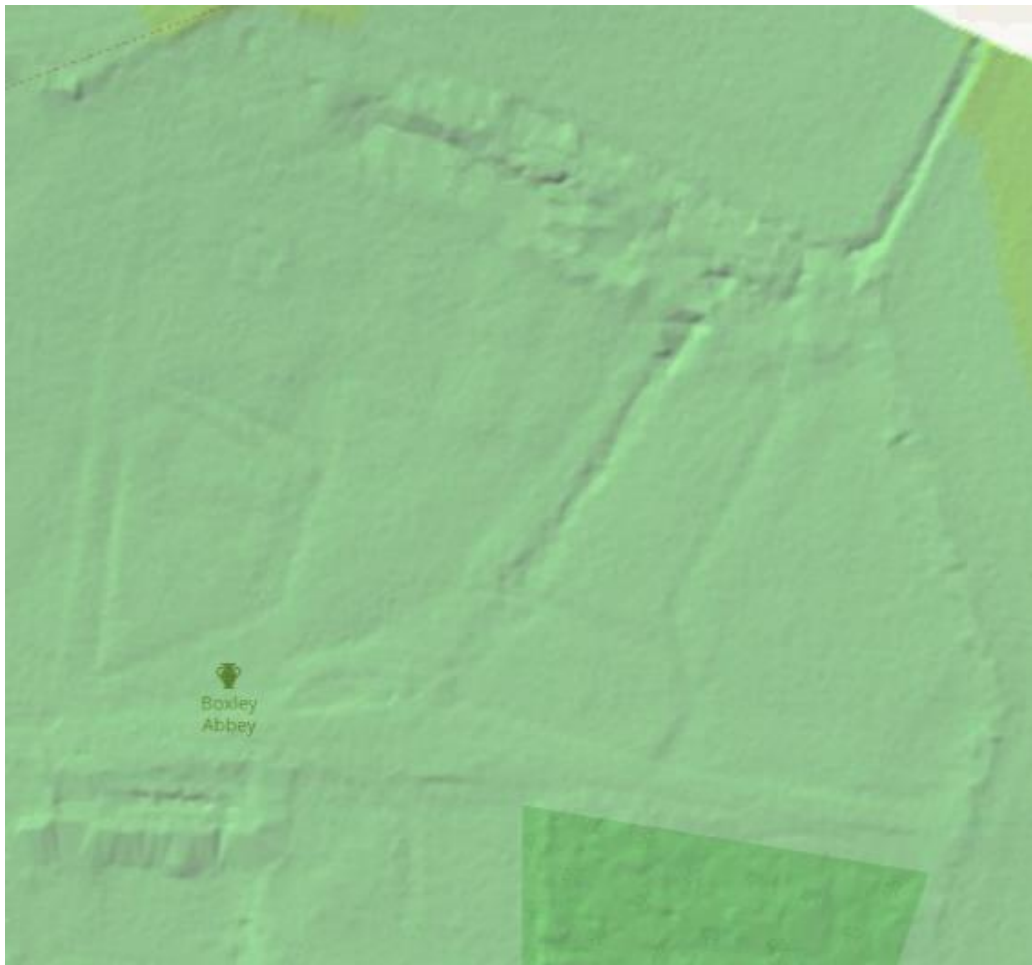
The north pond was found to have two inlets running under the abbey wall. These are both shown on the 1946 map, but the western inlet seems to be omitted from earlier maps. Both inlets are currently active, although in July 2020, it was the western inlet at NP 1 that had the larger flow. The eastern inlet at NP 2 seems to be consistent with both the 1801 survey and the 1946 map. Interestingly, the 1801 survey appears to show an islet that may have been caused by sediment from the eastern inlet and in practice in July 2020 the eastern end of the pond is largely silted up, whereas the western end has open water.

In July 2020, the sluice and dam at NP 3 was heavily overgrown, however, visible brickwork in the dam included bricks that seem likely to date from after 1801, even though the shape of the pond appears similar in both the 1801 and 1946 maps. It therefore seems likely that the newer bricks represent maintenance rather than a major change in the structure.

The drain running from the east in the 1801 survey no longer exists on the ground in 2020. It is possible that there is an underground land drain, but the vegetation growth and the cars parked over the area made it difficult to investigate.

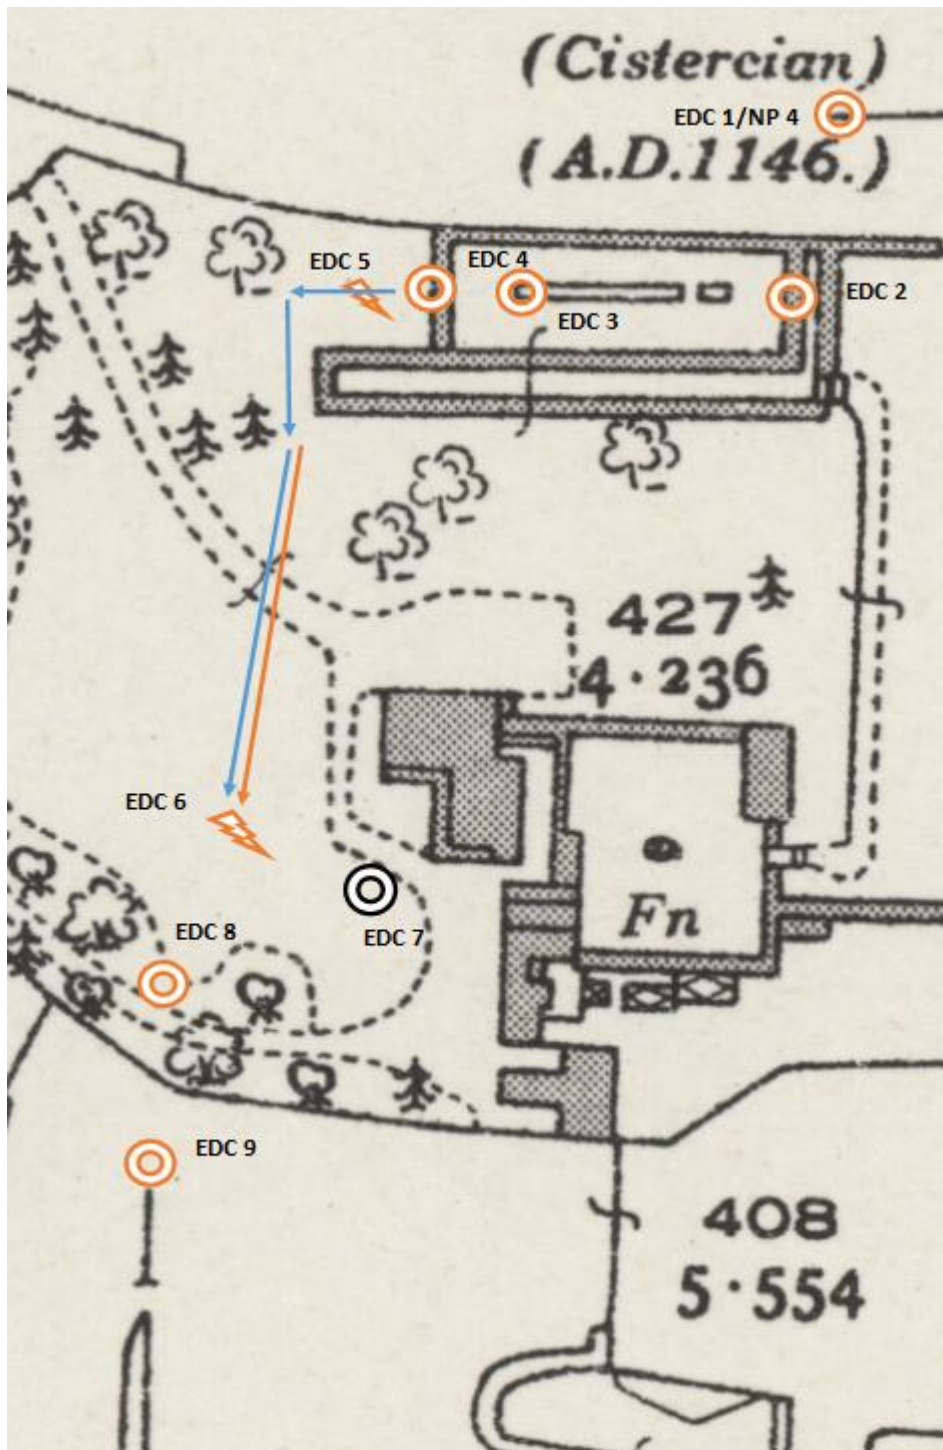
The entrance at EDC 4 was investigated using a sonde on the end of both drain rods and glass fibre pipe. In both cases, no progress was made beyond EDC 5. This may be caused by dislocations in the pipe or a sharp corner in the channel. Coming from the other direction, the access point at EDC 8 was investigated using a sonde on the end of a glass fibre pipe to reach EDC 6 (at a depth of around 0.8 metres), but could not progress further. To try to find the line of the flow from EDC 5 to EDC 6 two methods were used:

- Firstly using GPR, a length of channel across the drive and under the trees beyond was found. This is shown as the orange line in the map below. Closer to the stone walls of the terrace at the EDC 5 end, the readings were not conclusive.

- Secondly using a metal detector. Rather strangely, this proved to pick up the line intermittently all the way from EDC 5 to EDC 6, showing that the channel went around the stone walls of the terrace at the EDC 5 end, rather than underneath them (the blue lines in the map below). It is not clear to us why a metal detector was working in this instance. It is not a confusion with electricity or telephone cables, as these service lines were found separately. It is possible that the channel is in ceramic pipe with a metallic glaze, or with large amounts of iron oxide in its construction or deposited by water flow and this is sufficient to cause an induced magnetism. However, the signals were clear on the known run from EDC 4 to EDC 5 and for some of EDC 6 to EDC 8. One feature to note is that on the western end of the structure on the approach to EDC 5 at the end of the terrace walls, the metal detector tended to show two separate lines around a metre apart.

In a final test, the dam in the penstock at EDC 1/NP 4 was breached (by removing a small green football that blocks an overflow pipe), sending all of the water through the western drainage channel. This eventually caused the flow through EDC 2, EDC 3, EDC 4 and EDC 8 to dry up. We can assume, therefore that the eastern and western drainage channels are separate in normal conditions.

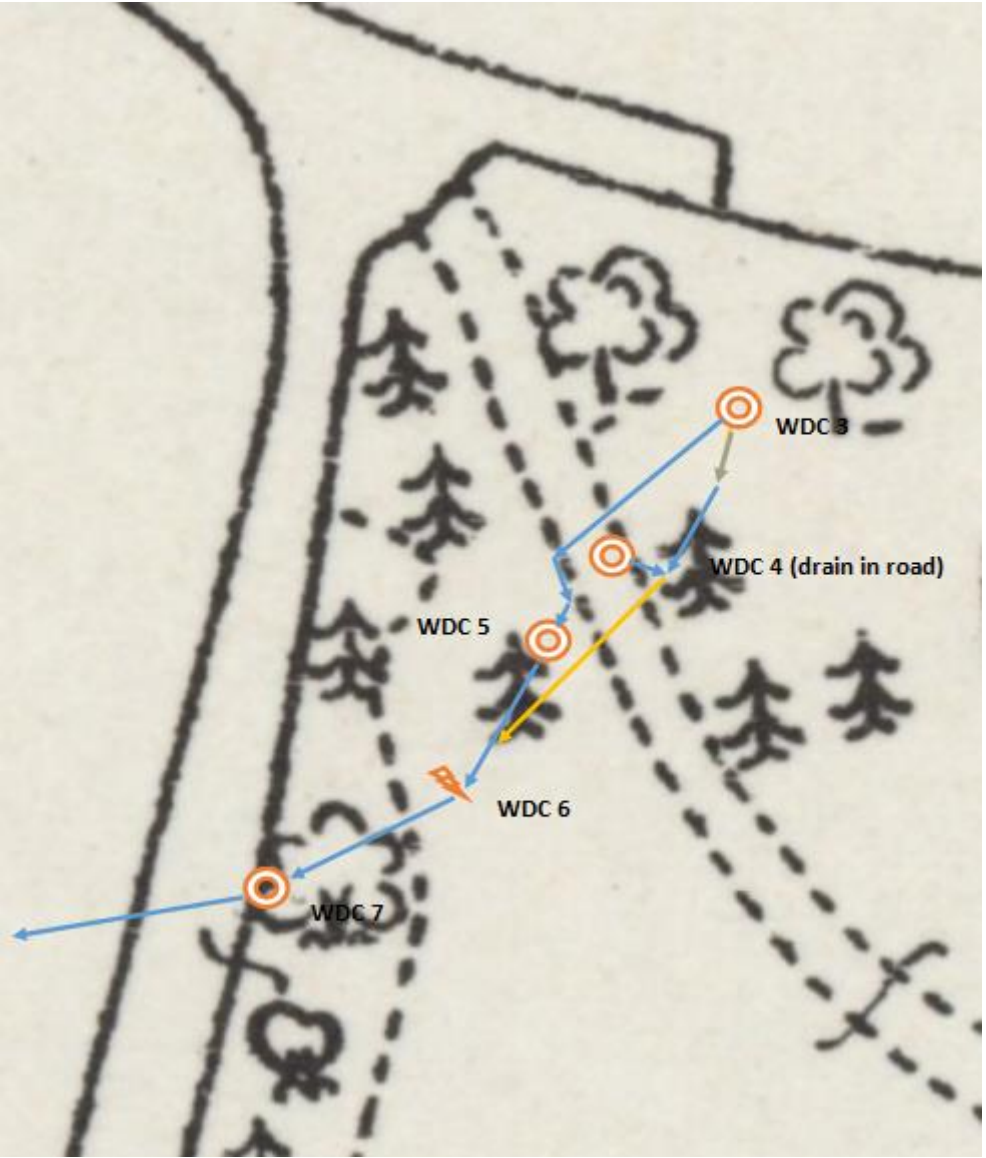
As noted in the previous section, a blockage in the black plastic pipe between WDC 3 and WDC 5 caused water to be forced up from WDC 3 and run over the surface to the road drain at WDC 4. This was damaging the ground and the road surface. During a visit in the very wet February of 2020, water was also then running over the ground beyond the drive and down the track through to the Hospitium.

We found that we were able (through much use of drain rods) to clear the black plastic pipe between WDC 3 and WDC 5. The blockage was caused primarily by a brick (apparently Georgian era) that had been brought into the pipe – presumably by water flow. On clearing the blockage, water no longer flows across the surface. However, the rather tight “S” bend of the black plastic pipe, relatively low incline, together with its corrugated nature and relatively small diameter relative to flow will mean that it is likely to be prone to blockage in future.

In the diagram below, blue lines show the line of proved pipe. Yellow lines show assumed lines of actual flow and grey shows assumed lines where flow probably once occurred. The places where the two lines cross the drive (albeit – assumed in the case of water from WDC 4) are clearly visible as patches on the tarmac surface.
