THE SPAB RESEARCH REPORT 2

The SPAB Building Performance Survey 2013 Interim Report

OCTOBER 2013.

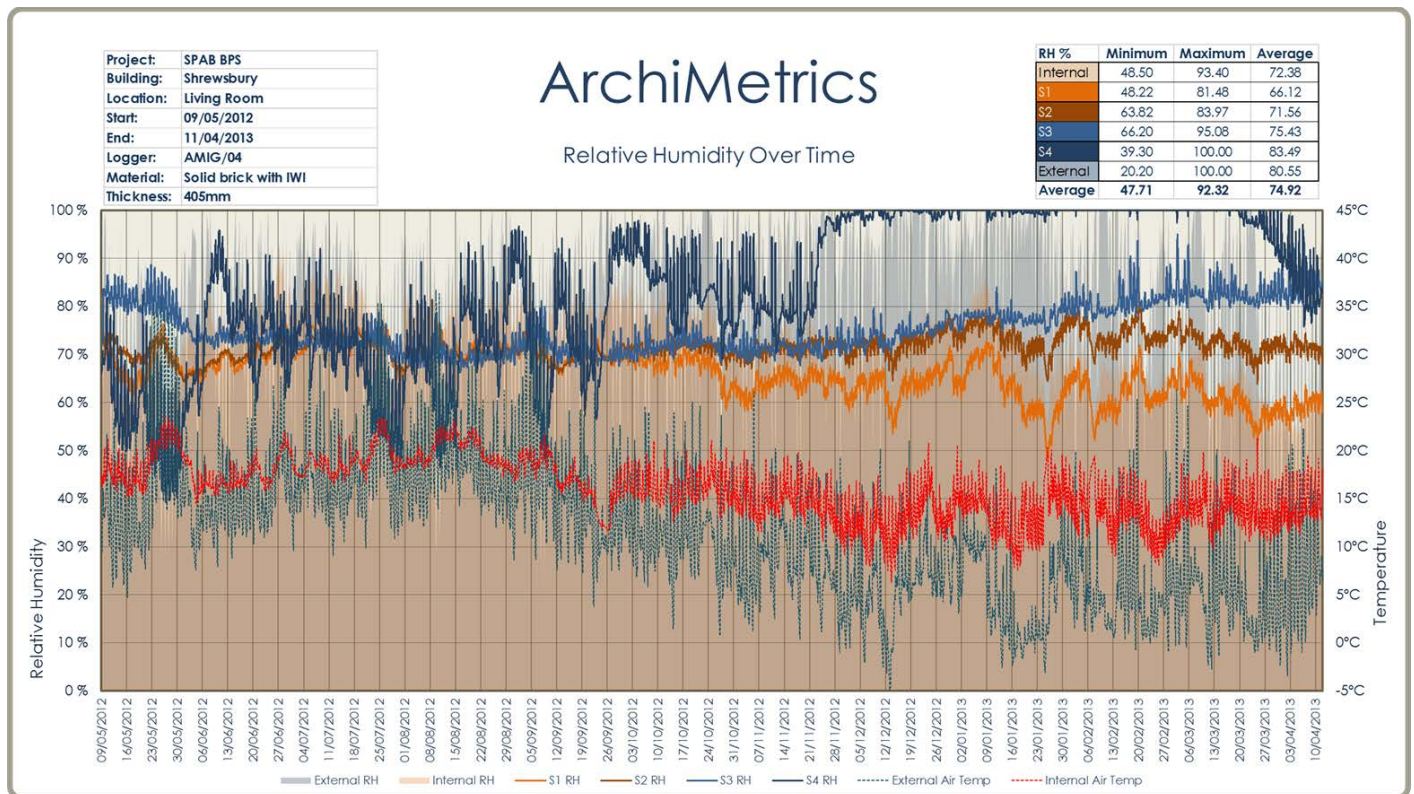
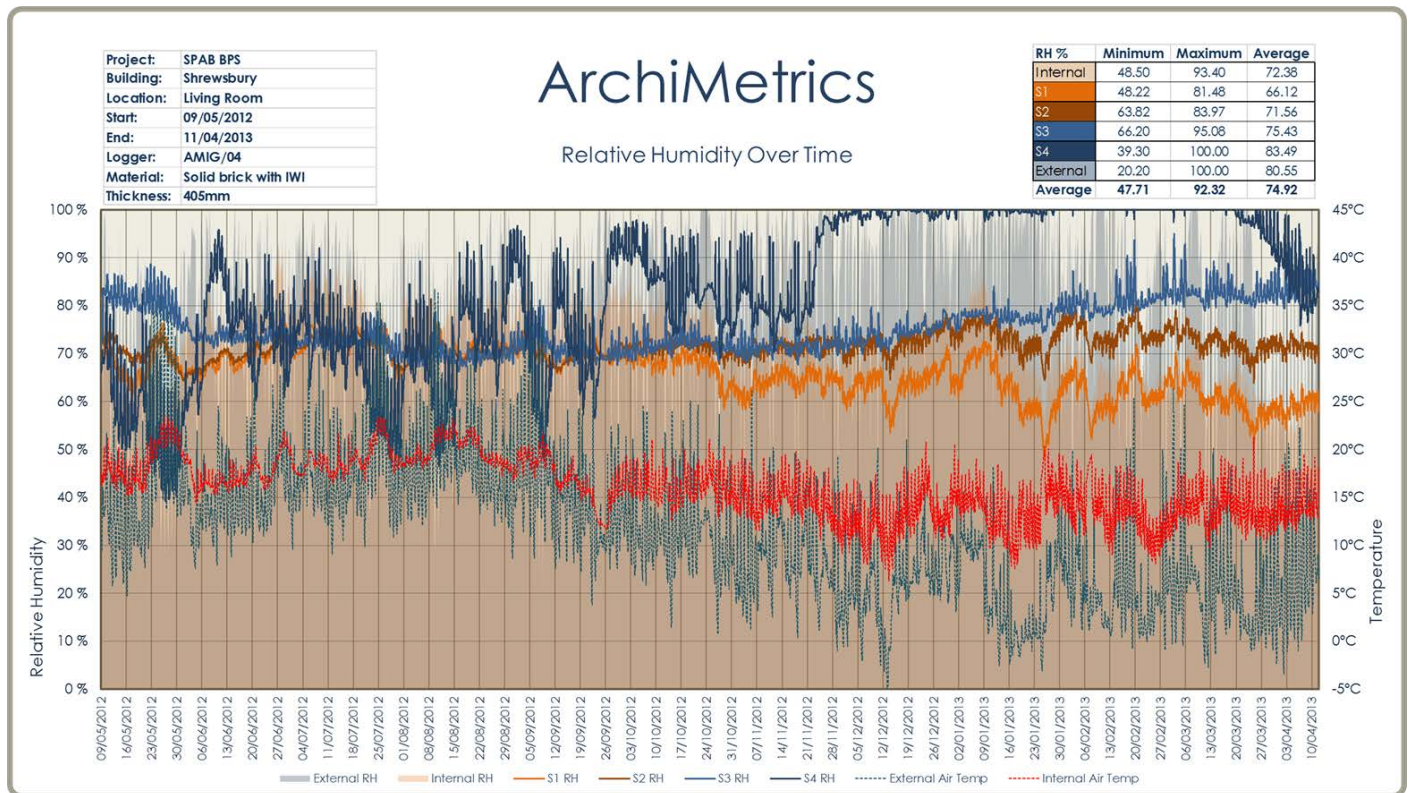
Figure 6: Relative Humidity over time, Abbeyforegate, Shrewsbury 2012 - 2013.

Another characteristic shared by the walls at Shrewsbury and Skipton (Figures 6 and 7) in comparison with those at Drewsteignton and Riddlecombe is seen in the nature of the gradients plotted for each of the interstitial sensors which in turn communicates something of the qualities of these walls. The %RH responses measured at Shrewsbury and Skipton are that much more volatile than those plotted for the Devon buildings indicating walls that are more open and porous in structure and therefore subject to greater and more rapid changes in condition. Both these walls are south-facing, however extremes of temperature do not seem to be a determining factor in this behaviour as the wall at Riddlecombe is also south-facing. Therefore it is more likely to be a reflection of the amount of air that is passing in and around the structure. It has been observed that the pointing of the brick wall at Shrewsbury is in quite a poor state of repair, and the wall at Skipton is a rubble core construction with considerable voids both these lead to the opportunity for multiple air pathways within the body of the wall. The walls at Drewsteignton and

With the exception of sensor 4, %RH responses throughout the wall section are very steady despite the open and porous nature of the wall and on average remain below 80%, the threshold often given for the formation of mould fungus. Neither do they, overall, exhibit a rising trend of %RH throughout the wall section as a whole, unlike those measured at Drewsteignton and Riddlecombe. Readings from sensor 2, installed between the woodfibre insulation and the brickwork are particularly interesting in this regard as these are particularly stable, only varying between 63.82 - 83.97 %RH throughout the whole period, with an average value of 71.56%. It might be suggested that this steady %RH response may be as a

consequence of the hygroscopic properties of the woodfibre board which, via its moisture buffering capabilities, might serve to even out fluctuating humidity responses in this part of the wall.

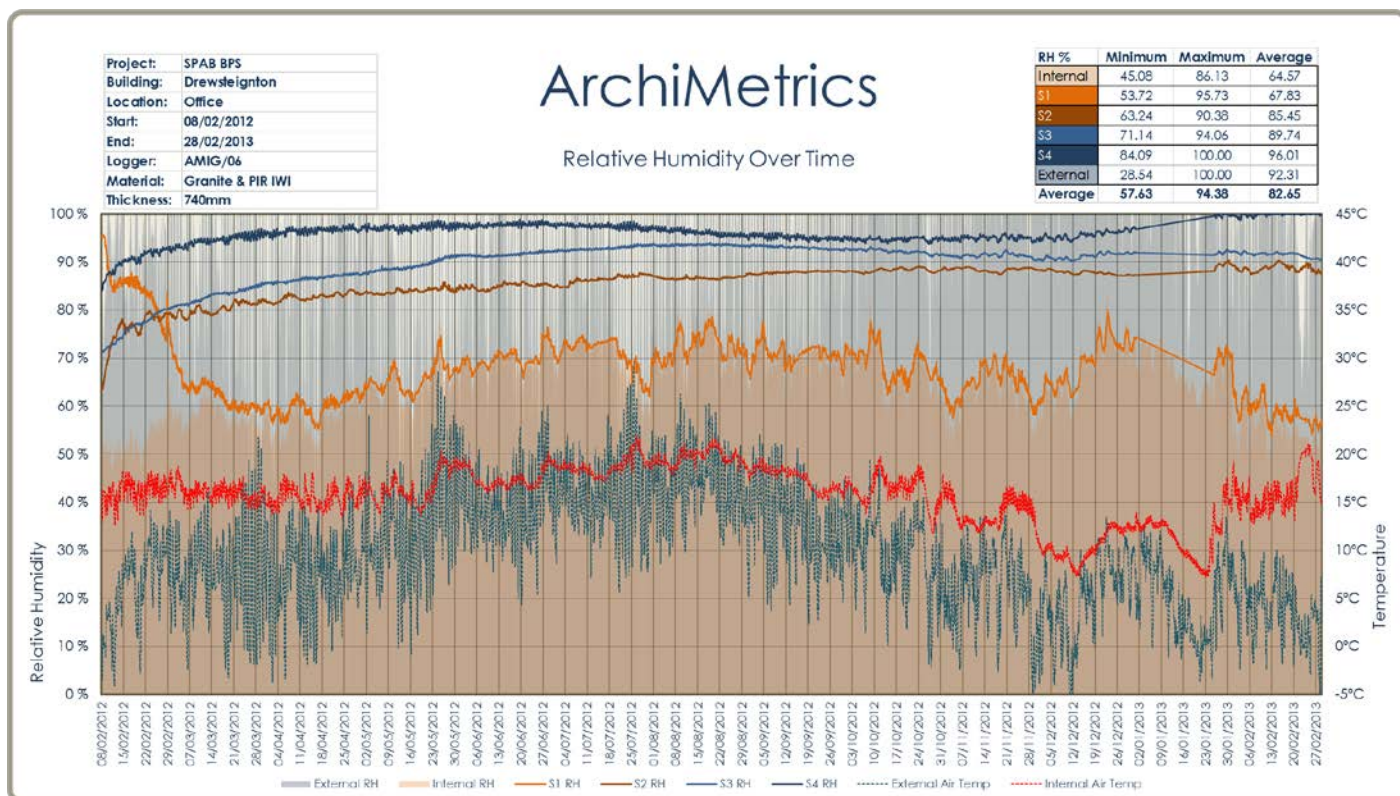
Figure 8: Relative Humidity over time, Mill House, Drewsteignton 2012 - 2013.

The walls at Drewsteignton and Riddlecombe (Figures 8 and 9) also share another feature, that is both these locations exhibit a trend of rising %RH over the reported monitoring period (12 months for Drewsteignton, 6 month at Riddlecombe). This is particularly clear in Figure 9 when measurements of %RH at sensor 4, the sensor closest to the external side of the wall at Riddlecombe, reaches 100% RH within a matter of weeks from the commencement of the graph and is followed, sixteen weeks later by sensor 3 and all four gradients have a mostly upward trajectory for the entire duration of the graph. At Drewsteignton, Figure 8, the trend is less obvious and there is also a period of time over the summer where measurements of %RH decline at sensors 3 and 4, however, over the full reporting period the predominate trend is one of increasing %RH with the exception of measurement from sensor 1 positioned in the air gap behind the plasterboard drylining of this wall which tracks internal room %RH conditions. Towards the end of the graph for Drewsteignton, in January 2013, sensor 4 reaches 100% RH. There is however a significant difference between these two walls in that peaks of %RH occur in opposing seasons suggesting two different and possibly opposing driving forces for this behaviour. By and large, and this can be seen in the other walls in this study (Figures 6 and 7) %RH increases and peaks during the winter when colder external temperatures cause the %RH to rise particularly within the colder, external side of the wall leaf. However, at Riddlecombe the rising trend, including peaks at 100%, occurs over the warmer summer months and it is thought that this may be due to vaporisation or sweating behaviour from the cob material that has a high moisture content due to the failing external cement render that previously covered the building and water introduced into the wall as part of the re-rendering process. (This phenomenon is explored in more detail in the individual report on Riddlecombe in Appendix A, pps. 102-121). Continued measurements of this wall into the winter period, 2013-14, should be able to shed more light on the high %RH measured in this wall and whether this is a seasonal and ultimately diminishing trend or a cause for concern over the longer term. However, measurements of %RH at Drewsteignton reveal a trend of rising %RH that occurs over a 12 month period, when normally perhaps one might expect any rise in %RH as a result of colder temperatures to be reversed during the warm summer. Both Drewsteignton and Riddlecombe also show higher interstitial %RH values where average %RH values measured at sensors 2-4 in both walls all exceed 80% the value often quoted as the threshold for mould growth conditions. In contrast, only measurements from sensor 4 exceed 80% RH in the walls at Shrewsbury and Skipton, averaging 83.49% and 81.43 respectively whereas averages for sensor 4 are much higher at Drewsteignton, 96.01% and at Riddlecombe, 99.82%.

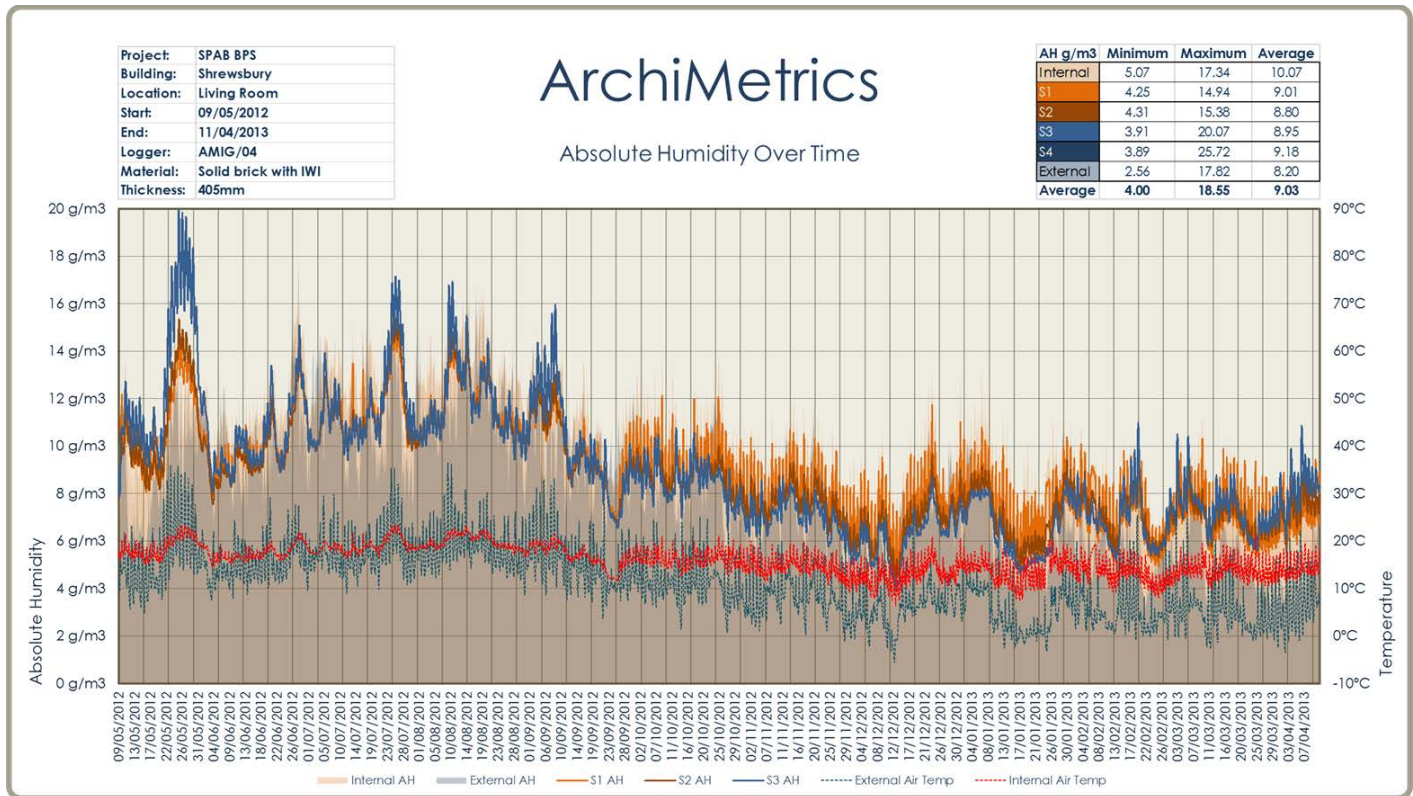
Figure 10: Absolute Humidity over time, Sensors 1 - 3, Abbeyforegate, Shrewsbury 2012 - 2013.

All four Figures (10-13) show the same general pattern of behaviour, that is to say that as atmospheric absolute humidity increases in the warmer summer months (due to the ability of warmer air to contain more vapour) a similar rise in absolute humidity occurs within wall fabric. Following this logic we can also see that weights of vapour within the walls are at their highest in proximity to a source of heat. During the summer the highest weights are recorded towards the exterior side of the wall, at sensor 4 and diminish in proximity to this heat but in winter this hierarchy is reversed and with the onset of central heating sensor 1 tops the range of absolute humidity readings through the wall section. This behaviour is particularly visible in the walls at Shrewsbury and Skipton (Figures 10 and 11) but less defined at Drewsteignton, Figure 12,

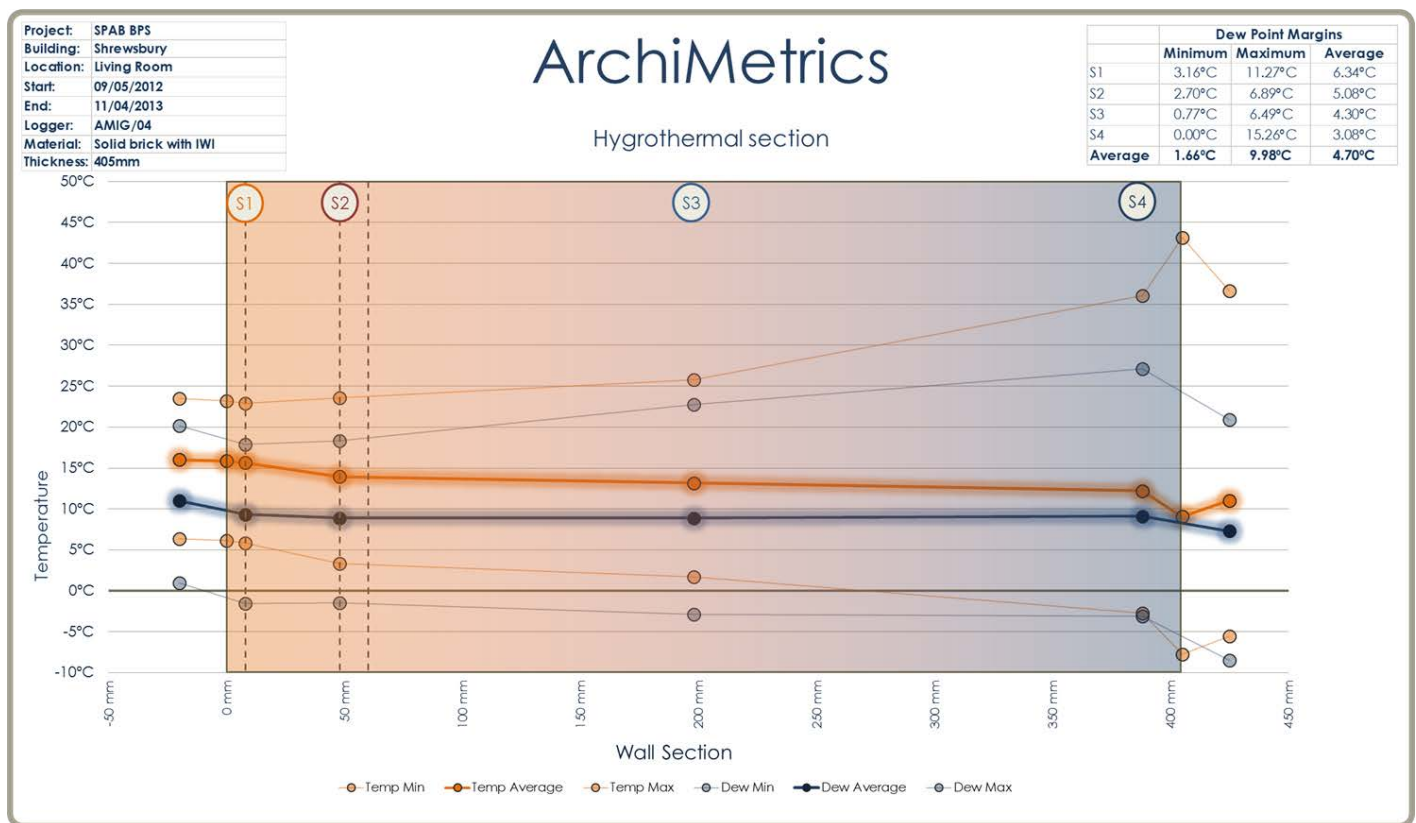
Figure 18: Hygrothermal Section, Abbeyforegate, Shrewsbury May 2012 - April 2013.

dewpoint gradient narrows towards the colder external side of the wall as colder temperatures cause an increase in %RH. However, in Figures 18 and 19, Shrewsbury and Skipton, there is a gap between these two gradients showing that, over an annual cycle, on average, a temperature drop of roughly 3°C is required before saturation point is reached at sensor 4. Therefore possibly there is no significant risk of extended periods of condensation within these two walls. This is in contrast to the wall at Drewsteignton, Figure 20, where temperature and dewpoint gradients at sensor 4 are seen to be in close proximity to one another, the margin of difference being 0.57°C. As well as the wall at Riddlecombe, Figure 21, where at sensor 4 and sensor 3 they are affectively coincidental with margins of 0.03°C and 0.54°C respectively. This would seem to suggest that these walls, which were also found to both exhibit the trend of rising %RH, may be at greater threat from condensation over the long term.

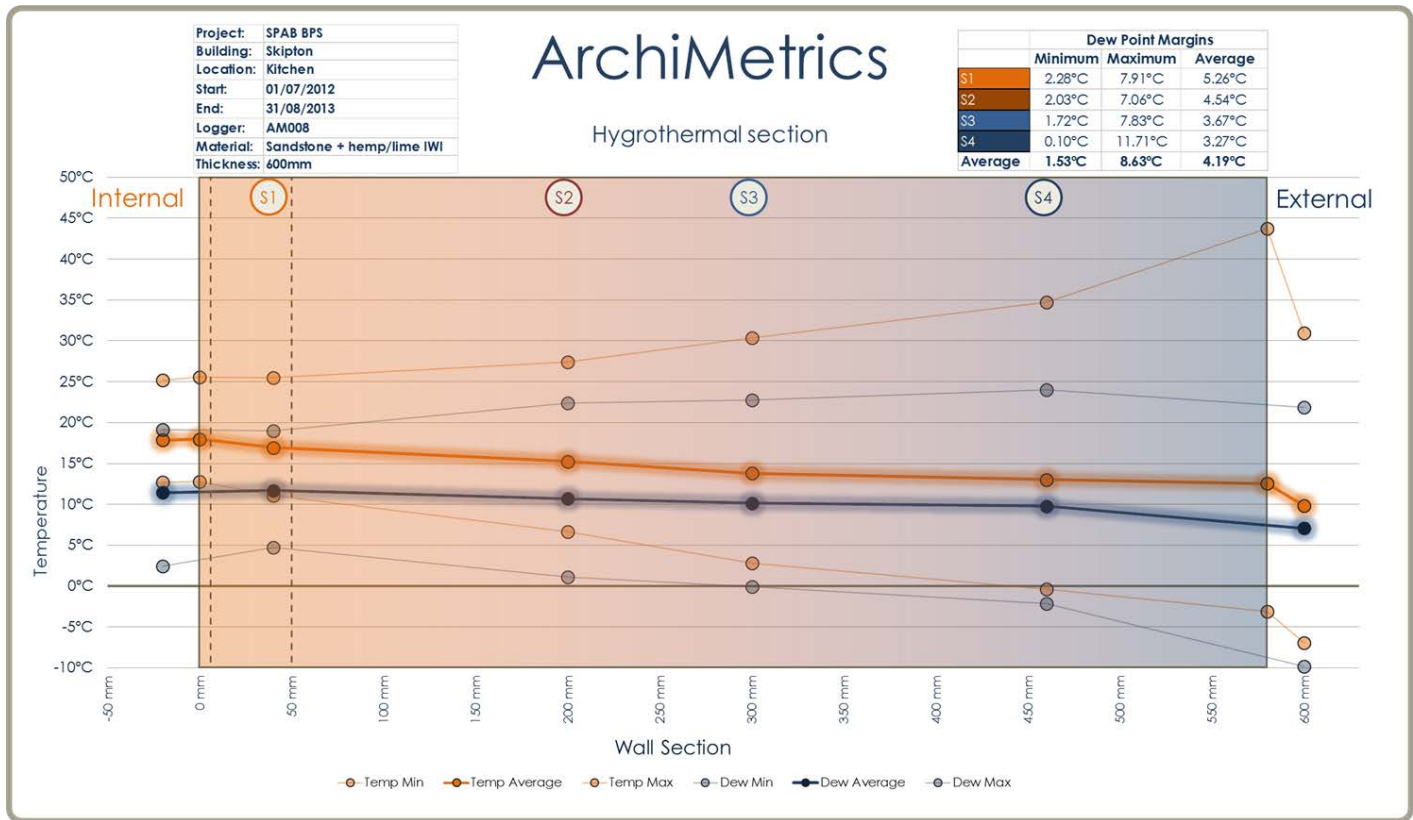
Figure 19: Hygrothermal Section, White House Farm, Skipton, July 2012 - August 2013.

Figures 18-21 provide plots of temperature and dewpoint gradients for the four wall sections under examination in this report. In the temperature gradients for the walls that have been insulated internally (Shrewsbury, Skipton and Drewsteignton) it is possible to see the different thermal resistance of this layer, compared with that of the masonry part of the wall, reflected in the steeper gradient which passes through the insulation. The pitch of this gradient reflects the degree of impact this insulating layer has had on the overall U-value of the wall post-refurbishment i.e. it is at its steepest at Drewsteignton, Figure 20, where the addition of 100mm PIR resulted in an measured 87% decrease in heat loss through this wall. The gradients are less pronounced at Shrewsbury and Skipton where the thinner 40mm addition of IWI resulted in reductions of 69% and 38% respectively. Beyond this insulating layer these internally insulated walls all share another characteristic which is a flattening of the temperature gradient as it passes through the remaining masonry part of the wall, here walls at Drewsteignton and Shrewsbury only seem to have a 1-2°C temperature difference across their masonry sections, whereas the wall at Skipton looks to have a slightly greater difference of between 4-5 °C, once again as a reflection of the different proportions of heat loss reduction that have occurred in these walls. The temperature gradient within the masonry section at Skipton also differs from that of Drewsteignton and Shrewsbury in that at these locations the flattened gradient also follows the same pitch between sensor positions indicating a similar rate of heat loss throughout this part of the wall section. As has been observed elsewhere the wall at Skipton is a rubble core construction and as such is more diverse in its materials and contains considerable voiding particularly at the centre of the wall. In pre-refurbishment measurements the affect of this rubble core and alterations in thermal conductivity/resistivity as a result of the wall's disparate construction was seen in changes of pitch between measurement points particularly the measurement that straddled the rubble core. This characteristic is still visible, if somewhat muted by the flattened temperature gradient, in Figure 19 post-refurbishment.

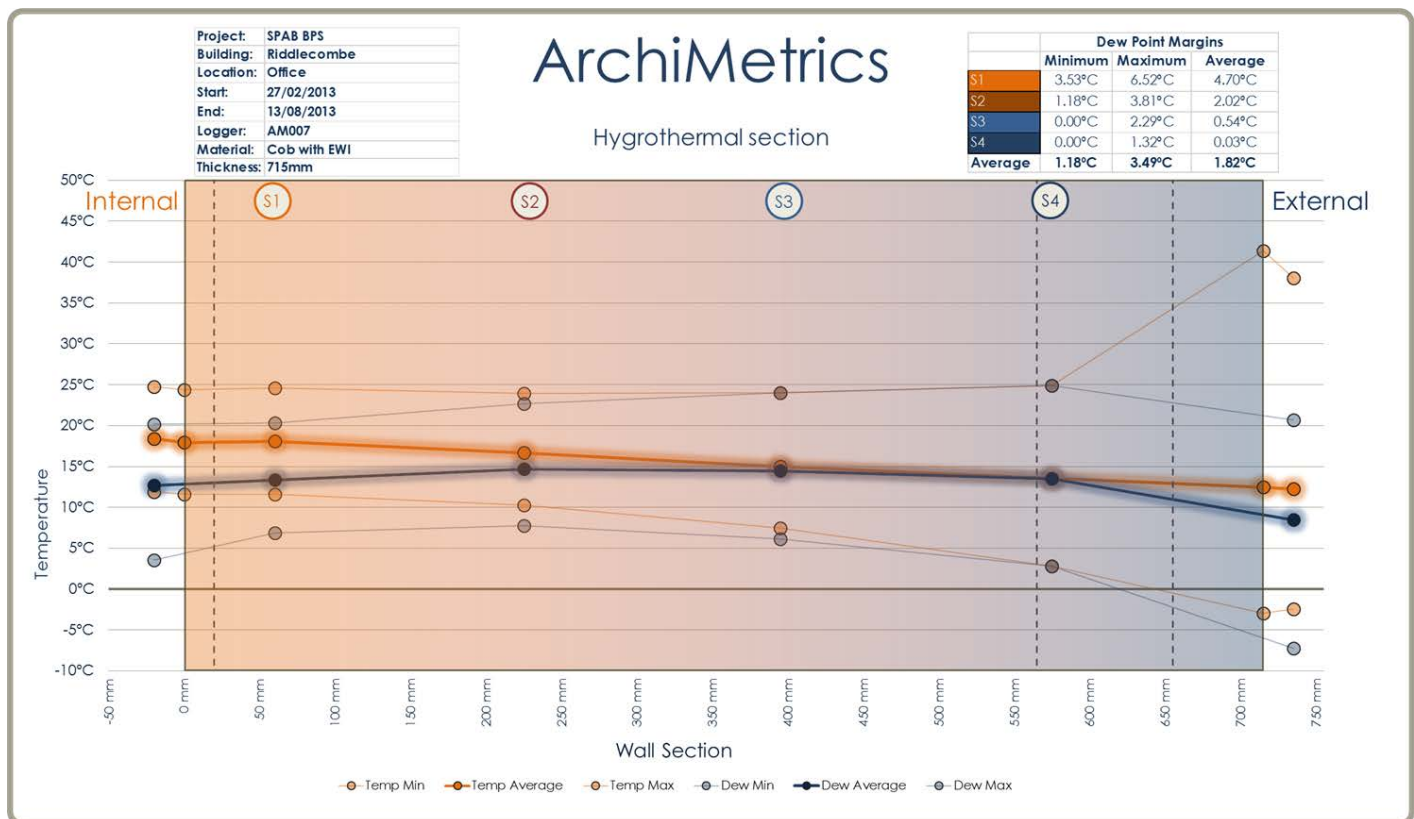
Figure 21: Hygrothermal Section, The Firs, Riddlecombe February - August 2013.

The dewpoint gradients plotted for these walls derive from measurements of %RH and show the nominal temperature drop required for dewpoint to occur at certain points within the wall. For Shrewsbury, Skipton and Drewsteignton these gradients are, more or less, flat and sit around 10°C. At Riddlecombe, which is found to have higher levels of vapour within its structure, the average dewpoint gradient is raised above 10°C and is convexed and peaks within the centre of the wall echoing the section plot of average absolute humidity found in Figure 17. For all four walls the margin between the temperature gradient and the

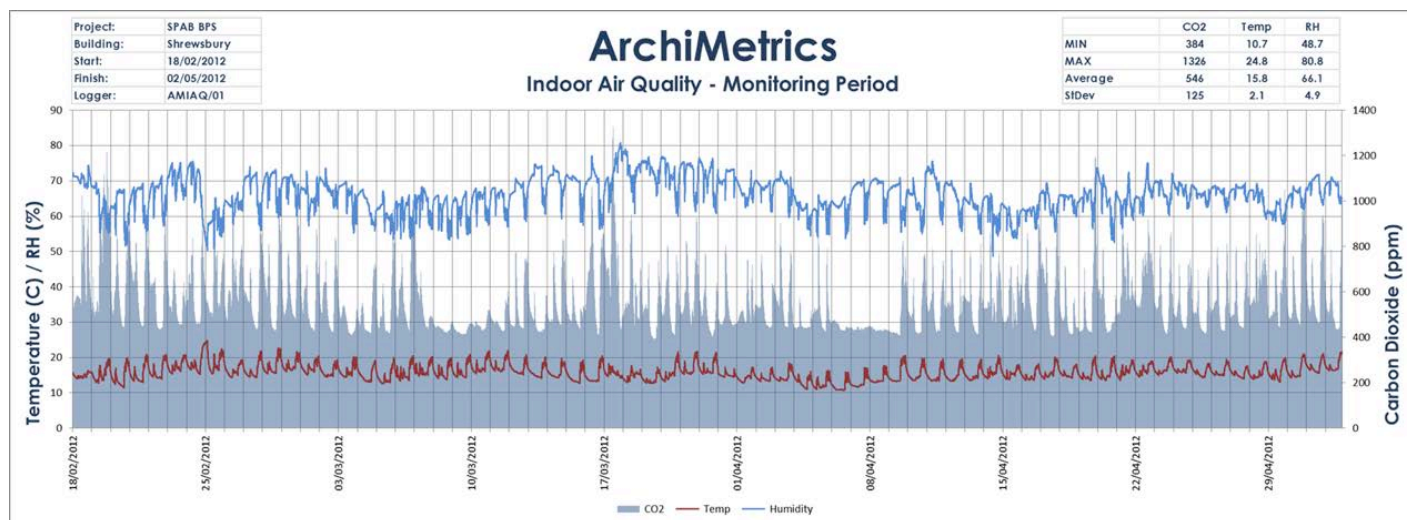
Figure 26. Indoor Air Quality (CO₂, temperature and RH) Abbeyforegate, Shrewsbury, 2012.

Figures 26-29 provide plots of CO₂, temperature and %RH for the four houses post-refurbishment. Figures 27-29 cover roughly a 3 week monitoring period whereas the graph for Shrewsbury, Figure 26, is for a longer two and a half month period. Table 5 provides averaged values for indoor conditions within the four buildings pre- and post-refurbishment, the data in the table is averaged over a 2-3 week period for all locations for comparative purposes.

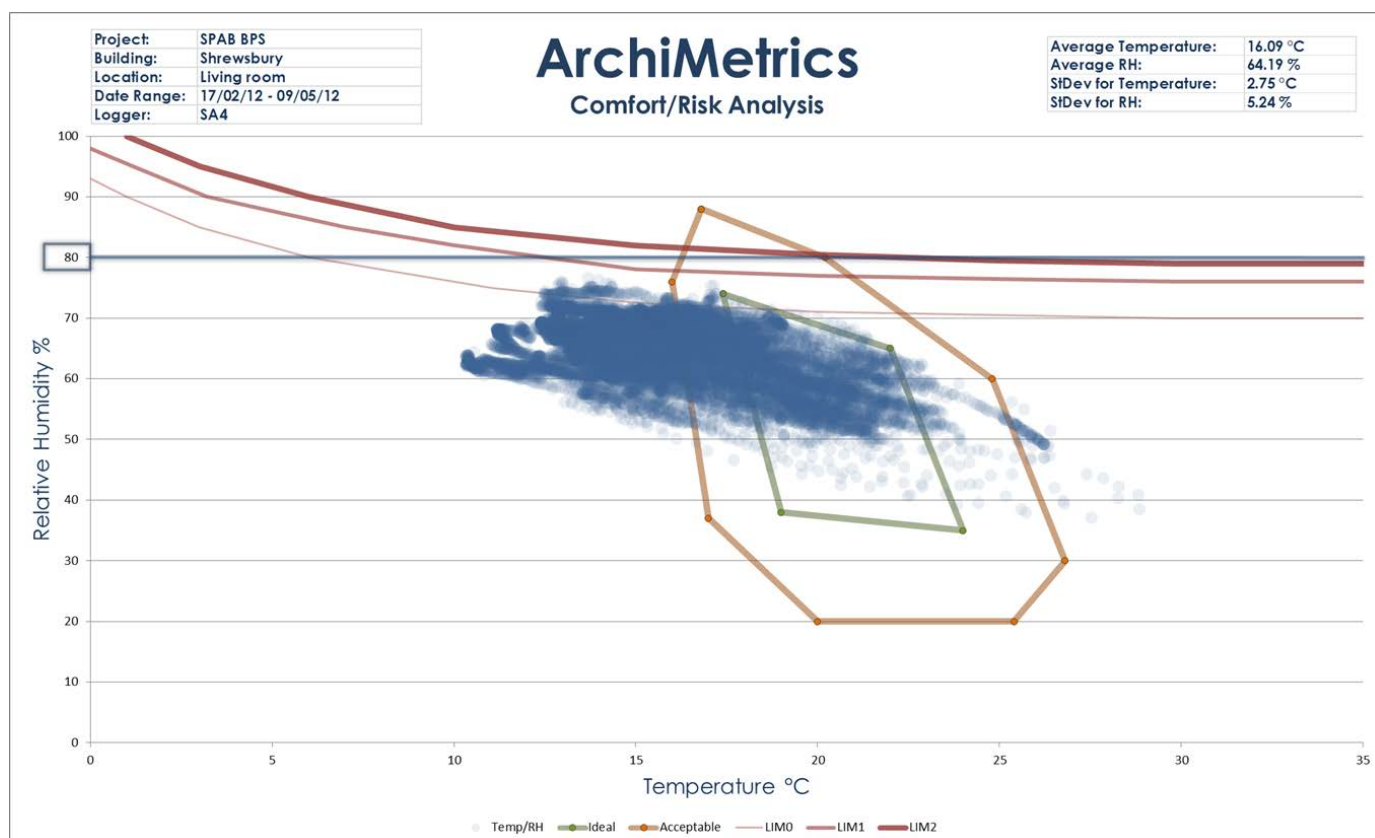
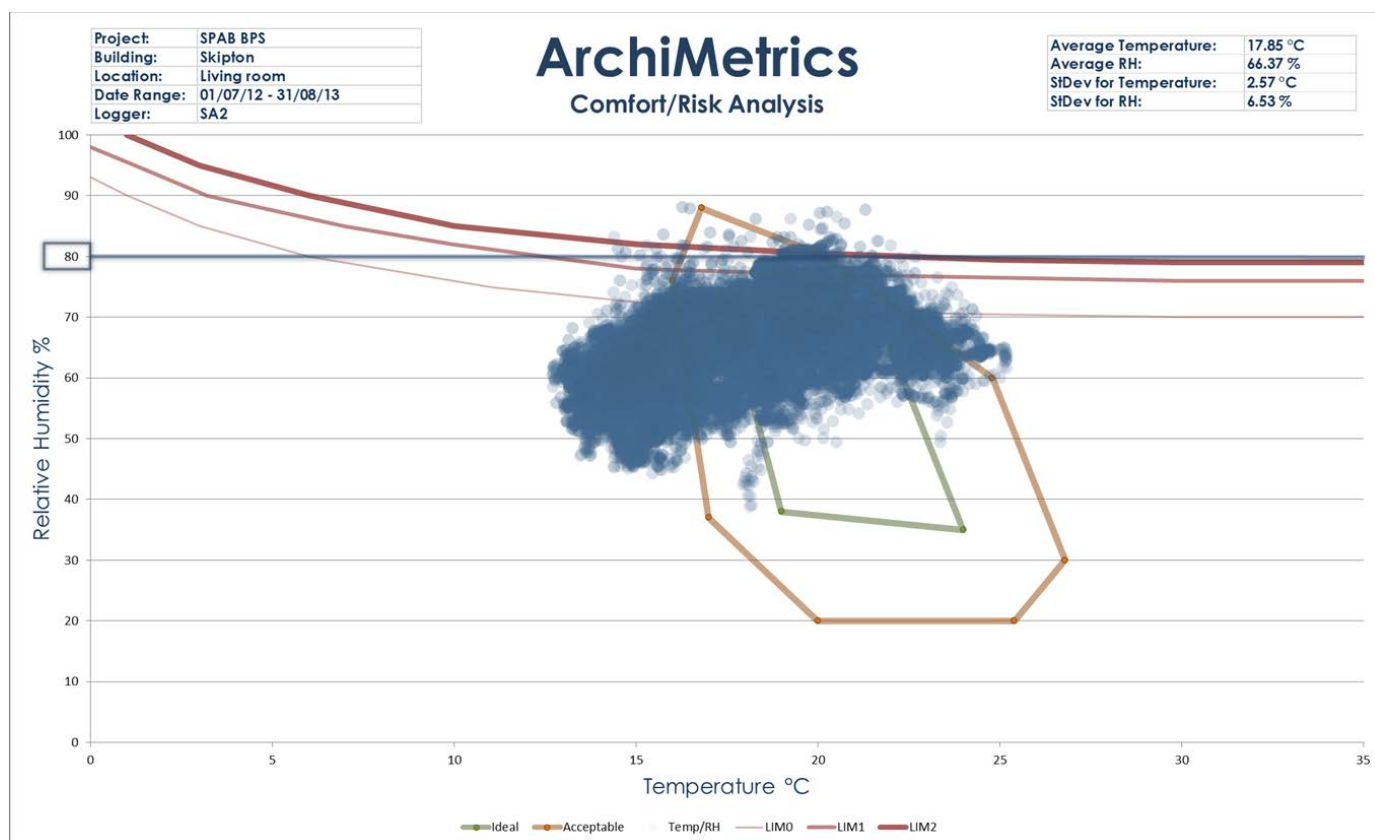
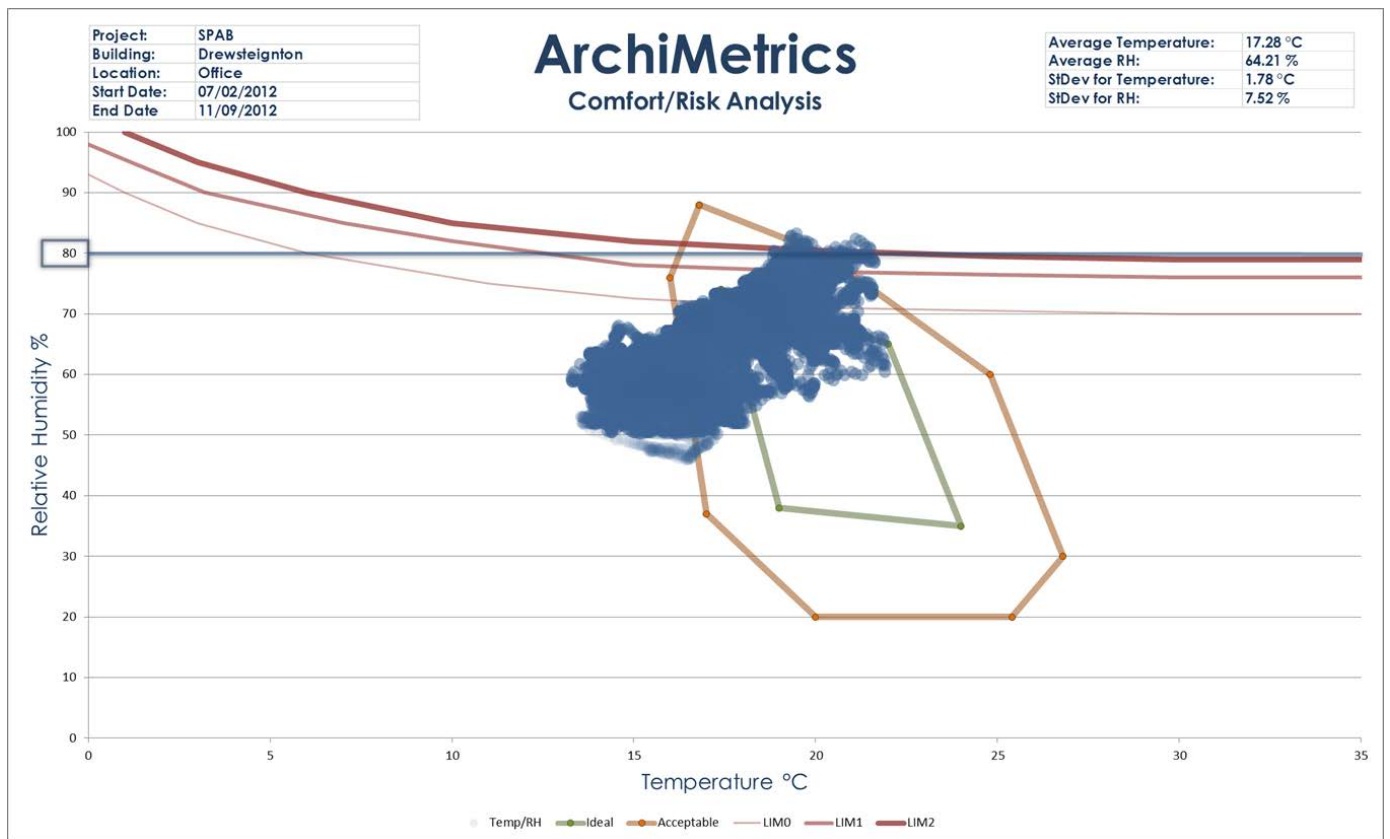
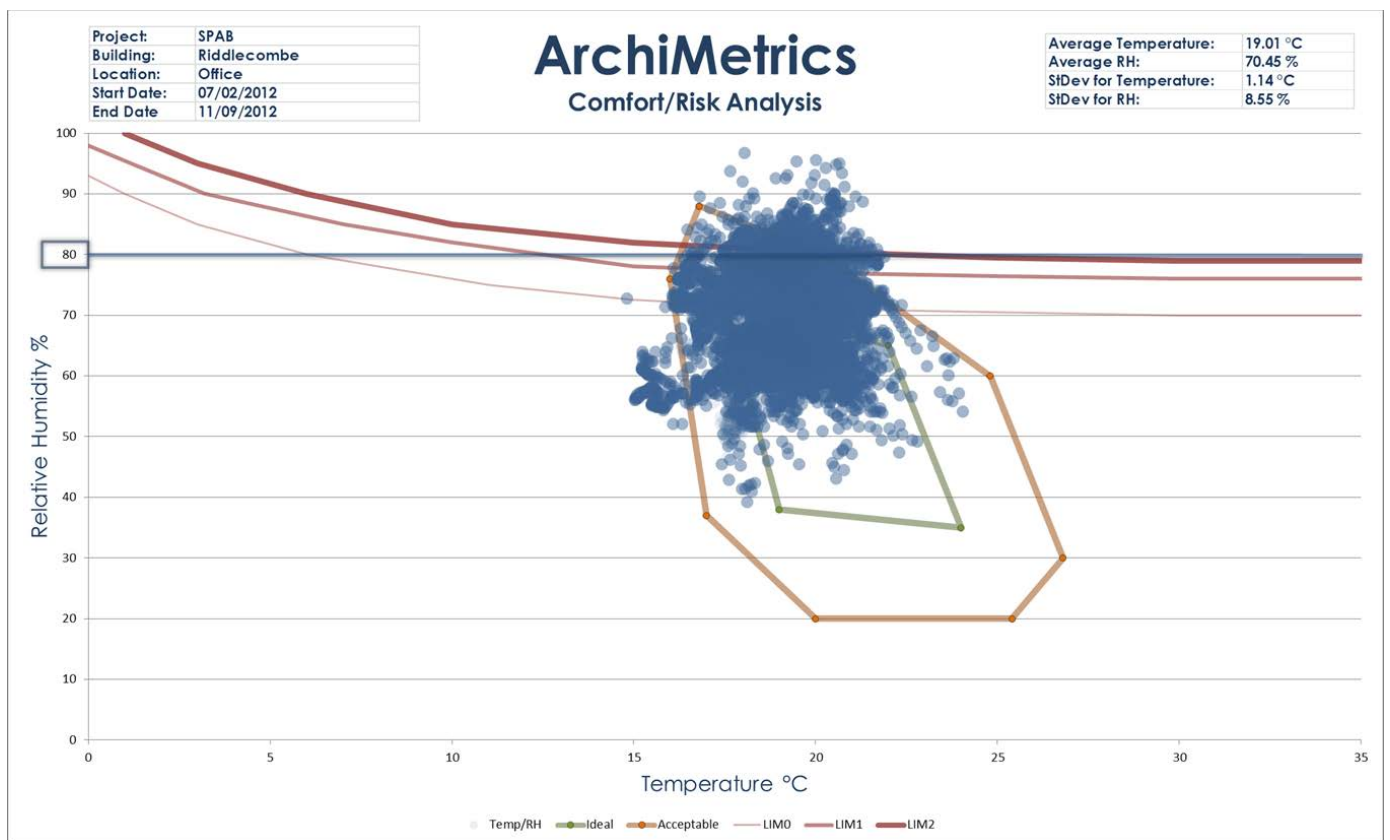
Previously, in 2011, measurements of room %RH in any of the properties under survey rarely crossed the limiting isopleths given for mould growth, where LIM0 represents an optimal substrate, LIM1 being biodegradable materials and LIM2 representing porous materials ⁶. In Figures 30 - 33, post refurbishment we now find a proportion of measurements that intersect with these isopleths although Shrewsbury it would seem remains at very little risk. At the other three properties all three isopleths are crossed by a number of measurements although at Skipton and Drewsteignton this is a very small proportion overall. At Riddlecombe, the location that records high levels of interstitial %RH, indoor conditions also have the highest quantity of room %RH and this is reflected in a greater proportion of indices which cross and surmount all three LIMs. However, it should be noted that there is no indication of mould growth on the internal surfaces of the walls at Riddlecombe, perhaps due to a mould retarding limewash finish, although there is some indication that conditions for such a thing may be favourable.

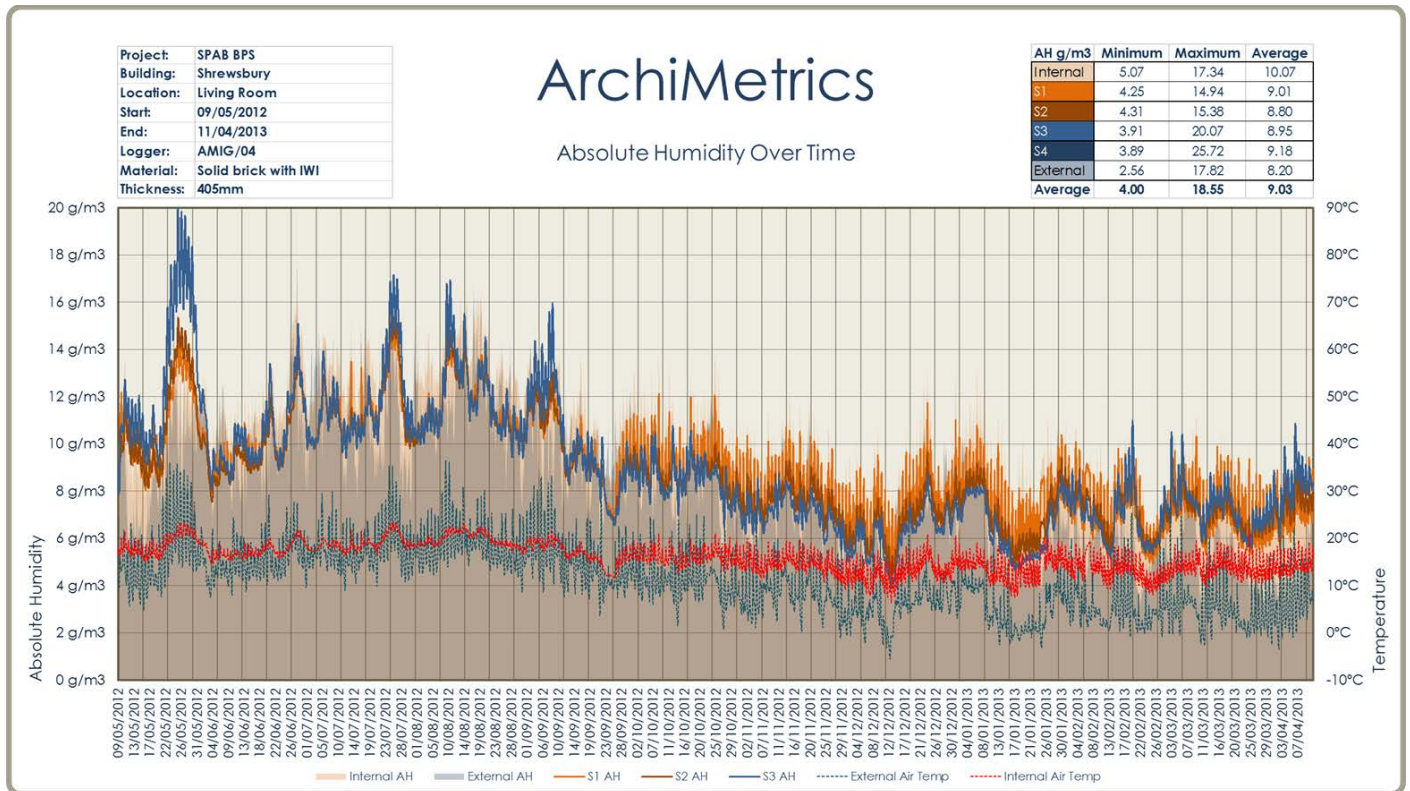
Figures 39 and 10 show plots of absolute humidity over time for the insulated brick wall at Shrewsbury (Figure 10 is given for clarity to show plots from sensors 1 -3 which are obscured by the plot from sensor 4 in Figure 39). These show that humidity rises within the wall, tracking ambient conditions, over the warmer summer months as warmer temperatures enable more vapour to be held in the air. Once again the same volatility is seen in responses at sensor 4 (Figure 39) as a result of its position in close proximity to the external environment leading to rapid cycles of wetting and drying. In general the weight of vapour through the wall is quite evenly distributed and is on average lower than that found for the granite wall at Drewsteignton. Figure 10 shows two distinct summer and winter phases where greater quantities of vapour are recorded towards the exterior side of the wall over the summer but once the interior space of the house becomes heated during the winter months the weight of vapour is higher toward the internal side of the wall. The winter months therefore show the expected pattern with regard to vapour flow where vapour diffuses through the wall from an area of high pressure to one of lower pressure. Figure 39 (including sensor 4) also illustrates an interesting phenomenon which occurs during a period of very cold temperatures between 13th and 21st January. The gradient for sensor 4 becomes uncharacteristically

static and shows the exterior wall face to be the driest point of all four sensing positions. This period also coincides with high %RH, 100%, measurements at this location (Figure 6). This is during a period of snow fall in the area, when the vapour carried in the atmosphere is very low but despite this, due to the extremely low temperatures, dewpoint is frequently reached. Therefore whilst this part of the wall is 'dry' from a vapour point of view it is also at dewpoint and therefore likely to be 'at risk' from a small amount of liquid condensation.

Figure 10: Absolute Humidity over time, Sensors 1 - 3, Abbeyforegate, Shrewsbury 2012 - 2013

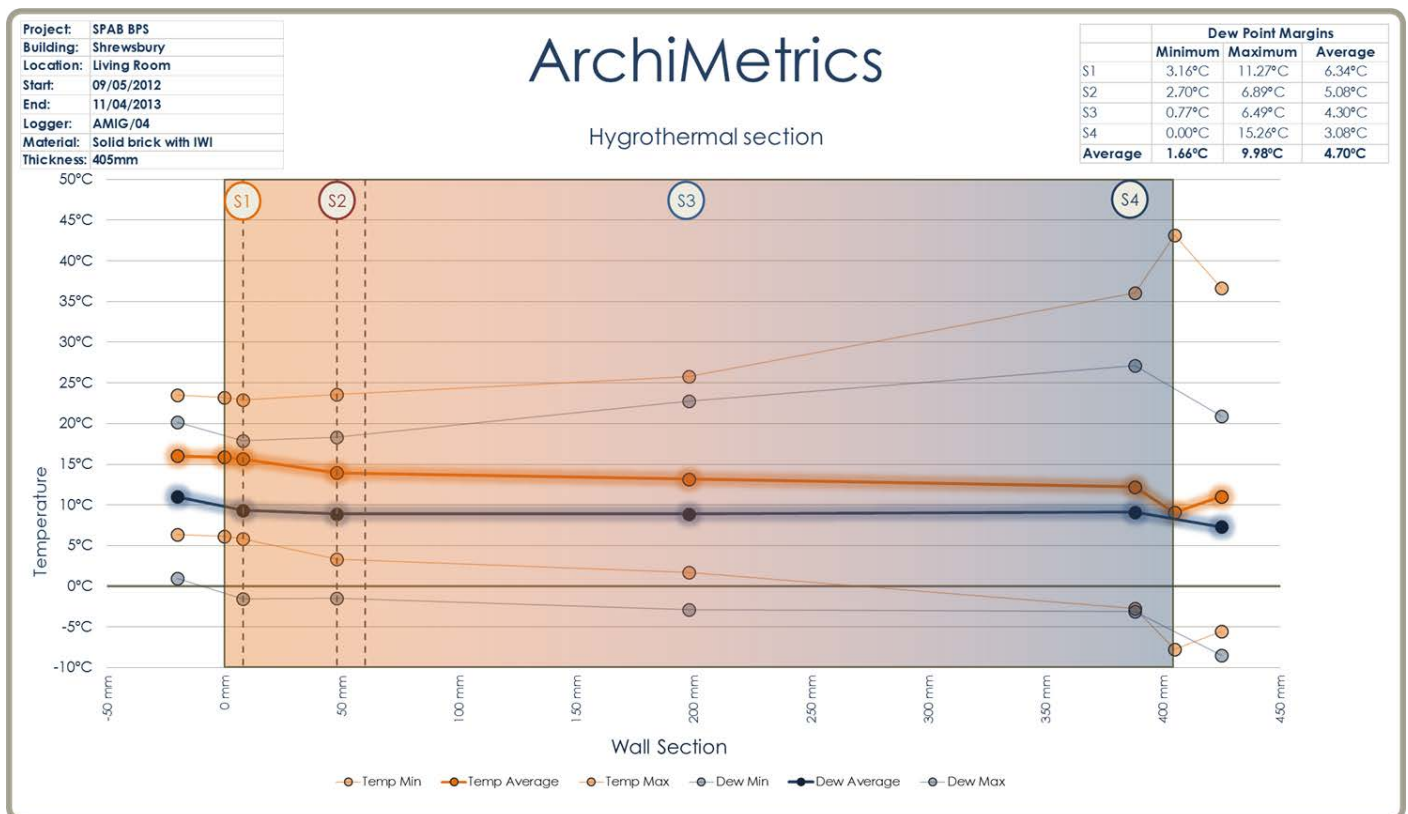
The dewpoint behaviour of the wall averaged over the reporting period is illustrated in Figure 18. This shows that the narrowest dewpoint margin (that is the temperature drop required for dewpoint to occur at a certain point) is understandably located towards the coldest part of the wall element at sensor 4, the average °C margin here being 3.06°C. The average dewpoint margin calculated from data from all four sensors in the wall for this period is 4.70°C. Prior to refurbishment, the average dewpoint margin for the wall section was 5.49°C and 3.96°C specifically at the 4th sensor. Therefore, the addition of 40mm of woodfibre internal wall insulation has not resulted in a significant reduction in these dewpoint margins despite lowering the quantity of heat transferred into the wall during the cold winter heating season. The plots of maximum temperatures recorded over the period are also of interest. These show the affect of solar radiation on the south-facing wall resulting in periods of reverse heat flow in the wall fabric. This reverse heat flow will be of benefit on sunny days during the winter heating season as the transmission of heat from the interior to the exterior will be slowed by the warming of the external fabric by solar radiation.

Figure 18: Hygrothermal Section, Abbeyforegate, Shrewsbury 2012 - 2013.

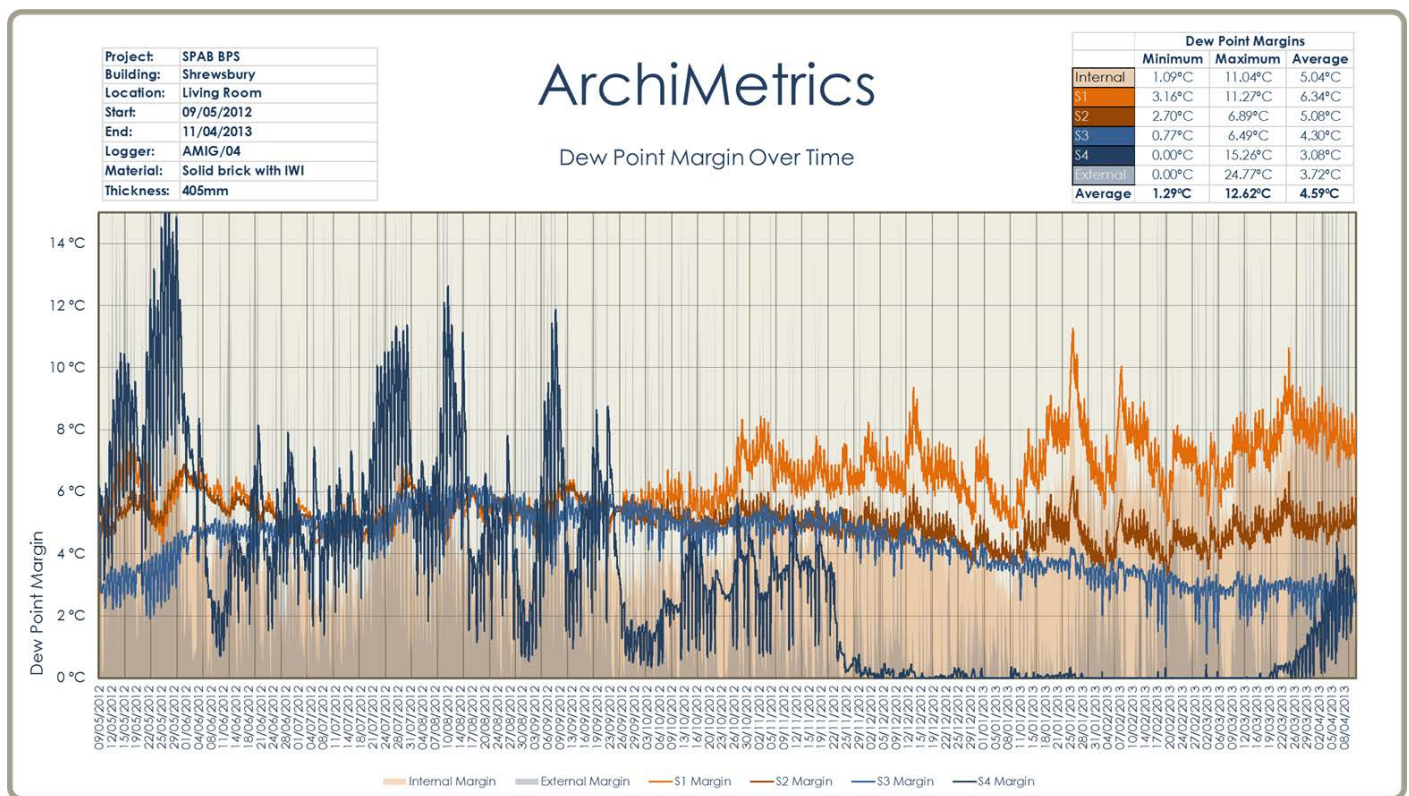
Figure 22 presents a plot of dewpoint margins over time for the wall at Shrewsbury. Like the previous Figures, Figure 6 for %RH and Figure 10 for absolute humidity, this graph shows responses at sensor 4 to be quite volatile and distinct from the more closely group plots from sensors 1 -3. This is not surprising as dewpoint is a factor of quantity of vapour and the surrounding temperature therefore the plots shown from sensors in Figure 22 have a direct relationship with vapour and %RH and mirror the findings shown in Figures 6 and 10. This is most clearly seen in the plot for sensor 4 between the period 22nd November 2012 - 19th March 2013 where the dewpoint margin is around or at 0°C and corresponds, naturally, with the findings of 100%RH over the same period at sensor 4 indicating the likelihood of condensation. However, whilst this may seem alarming and might suggest that the external wall face is at the risk of some frost damage during periods of extreme cold, the risk of condensation needs to be reviewed over an annual cycle. The previous Figure, Figure 18, showed that over the reporting year on average the dewpoint margin at sensor 4 was 3.06°C, for this to be the case there must have been periods of time over the 12 months where this part of wall was well below 100% and free from condensation and that on average this is the predominant condition of the wall. It should also be remembered in this context that sensor 4 is positioned very close to the external wall face (20mm back) situated within quite open and porous materials. Therefore, it is not surprising that extremes of temperature and weather will have a profound affect at this location and that extremes of cold leading to condensation will also be tempered by

extremes of heat resulting in a dewpoint margin overall that suggests the wall is at little risk from prolonged condensation. With regard to the risk of prolonged condensation, the behaviour deeper within the interstices of the wall is of more interest as here, away from the direct influence of internal or external conditions, the opportunities for the dispersal of vapour may be decreased. In this respect, and has been previously noted in the discussion concerning %RH over time, the wall at Shrewsbury appears to be functioning well with levels %RH below risk thresholds and this is reflected in Figure 22 in the 'healthy' dewpoint margins recorded for sensors 1 - 3; 6.34°C, 5.08°C and 4.30°C respectively.

Figure 22: Dewpoint Margin over time, Abbeyforegate, Shrewsbury 2012 - 2013.
