THE SPAB RESEARCH REPORT 2

The SPAB Building Performance Survey 2013 Interim Report

OCTOBER 2013.

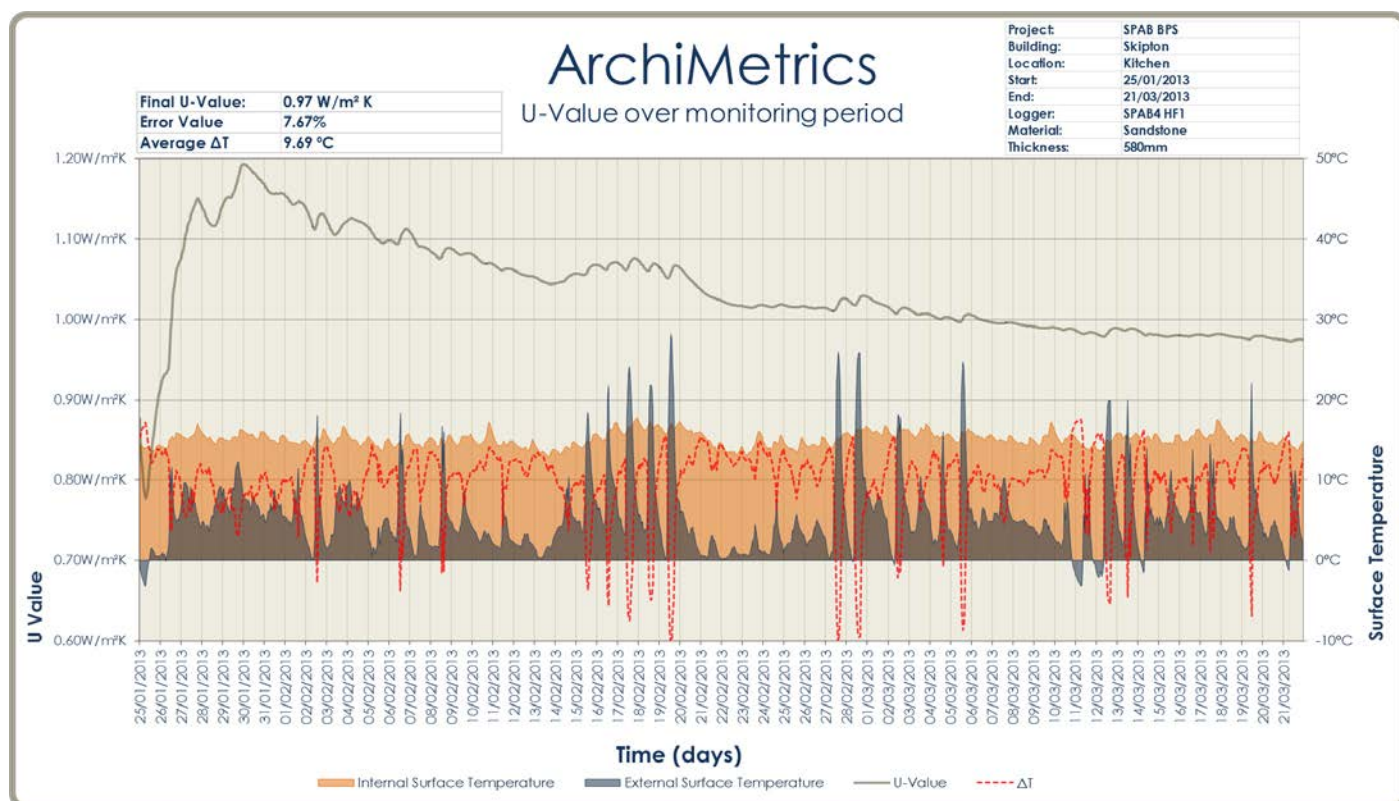
Two U-values were measured from the wall, one lower down at 1000mm above finished floor level and another higher up at 1500mm (Figures 43 and 44). The lower measurement resulted in a U-value of 0.97 W/m²K and the other, slightly higher up the wall, produced the figure 1.04 W/m²K. Percentage error figures have been calculated for both U-values; the 0.97 W/m²K U-value has an error of 7.67% and therefore a potential range of 0.90 - 1.04 W/m²K while the U-value 1.04 W/m²K has an error percentage of 7.58% and a range between 0.96 - 1.12 W/m²K. As can be seen from these two ranges the U-values 0.97 W/m²K and W/m²K sit within the upper and lower end of one another's potential U-value range as determined by their percentage errors and therefore may be considered as consistent. The average of the two measured post-refurbishment U-values is 1.00 W/m²K.

Figure 43. U-value over time (lower) White House Farm, Skipton, Jan. - March 2013.

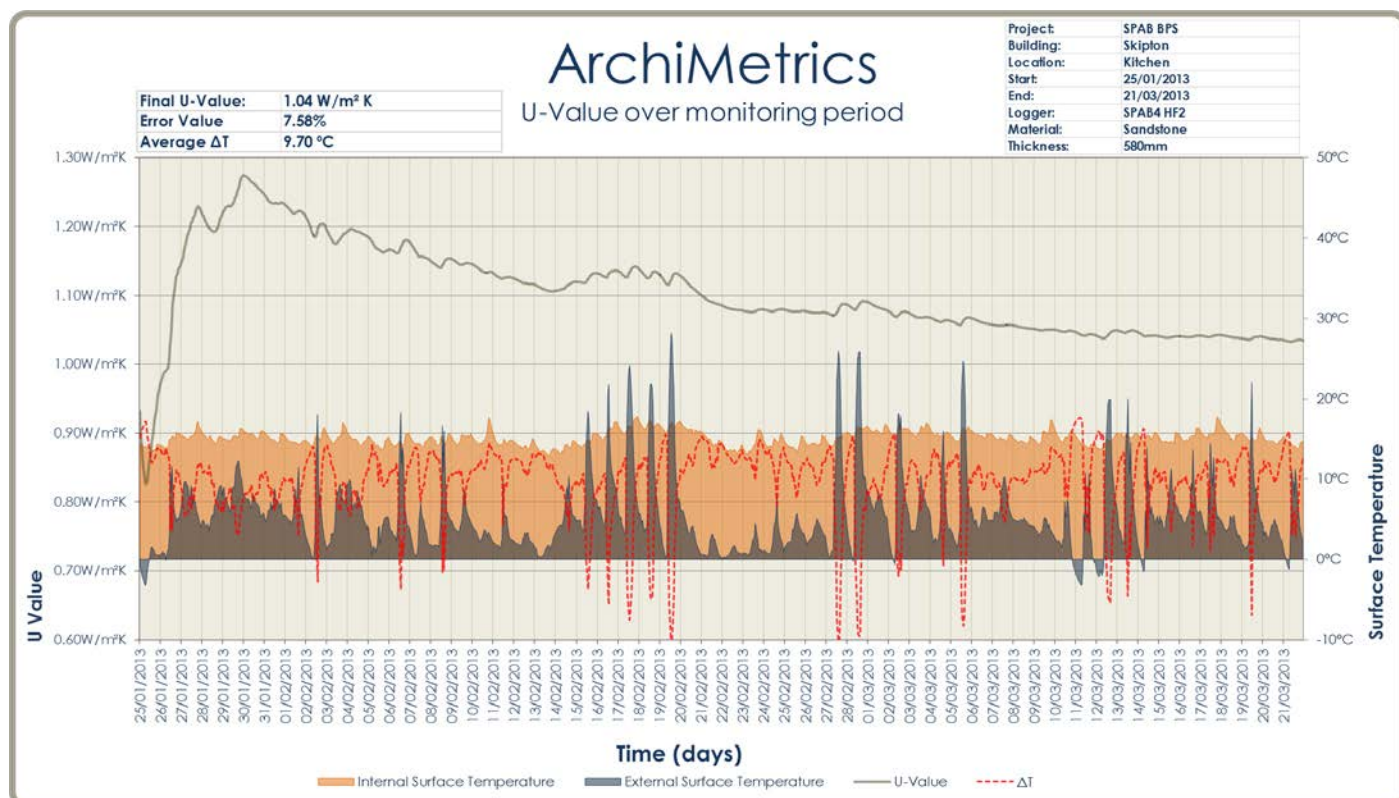
Figure 44. U-value over time (upper) White House Farm, Skipton, Jan. - March 2013.

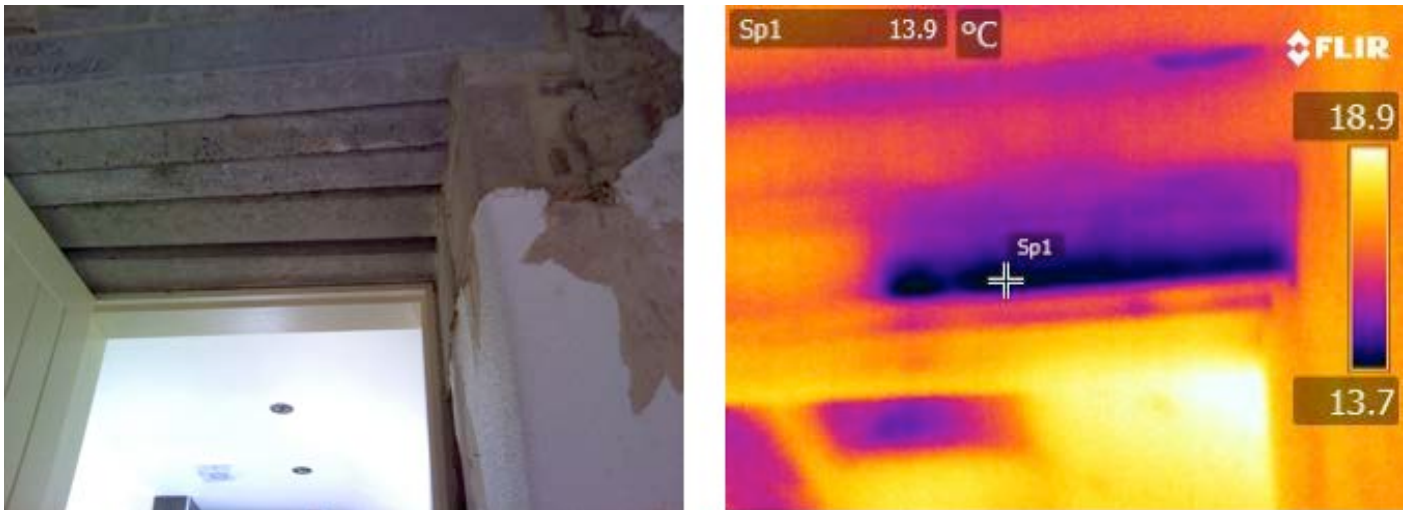
Figure 45. White House Farm, Stirton, Skipton - doorway into bathroom from main bedroom.

The main area of ingress in the property is around the top, sides and base of the unfinished doorway between the main bedroom and bathroom, Figure 45. However the following general points can also be observed:

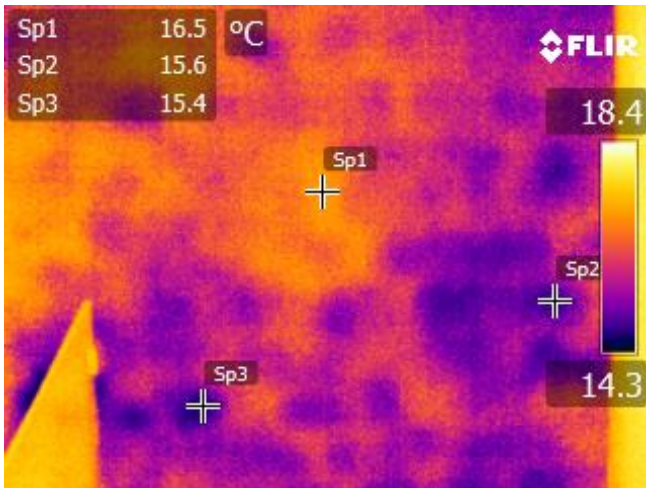
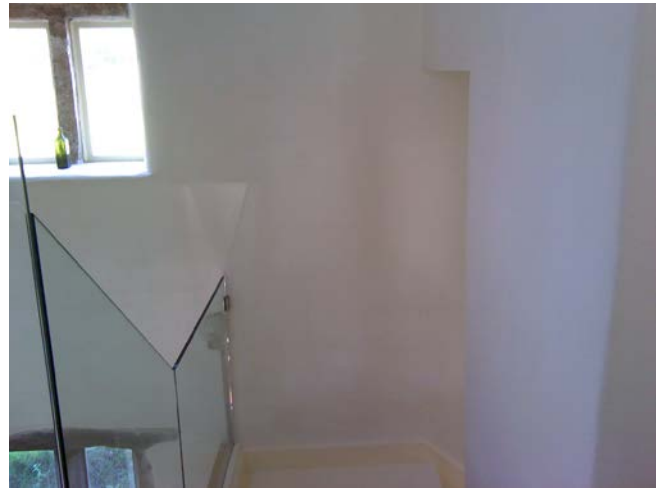
Examining the older building fabric, it is possible to see the underlying external wall structure (Figure 46). It should be noted there is approx. 1°C temperature difference between the coolest and warmest parts of this wall area.

Figure 46. White House Farm, Stirton, Skipton – North exterior wall on staircase.

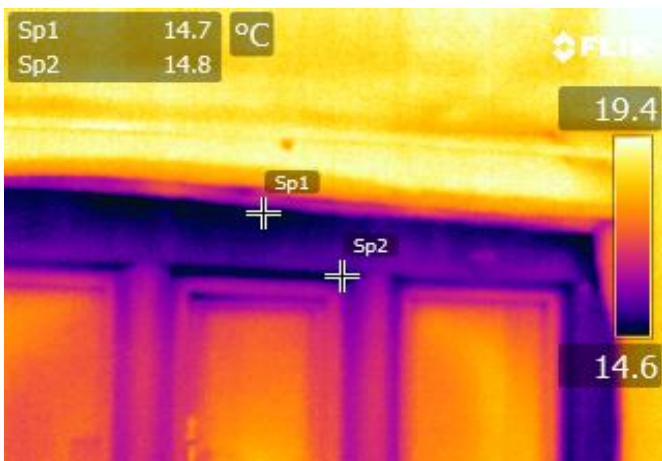
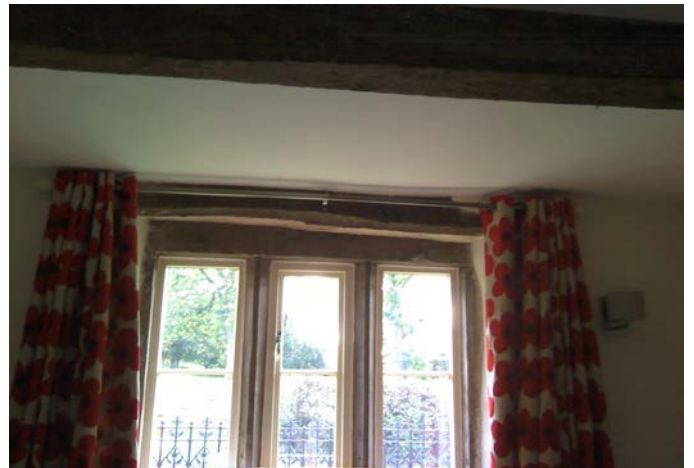
The stone mullions show they are the main thermal bridges and the key leakage points displayed in the older portion of the dwelling are around beams, missing pointing at sills and around window / roof light casements (Figures 47 - 49). In some areas, where floor coverings are not fitted, ingress can be seen between floorboards (e.g. on the staircase).

Figure 47. White House Farm, Stirton, Skipton – Thermal bridging on mullion and air ingress around lintel (NB. lower portion of window mullions are subject to solar gain).

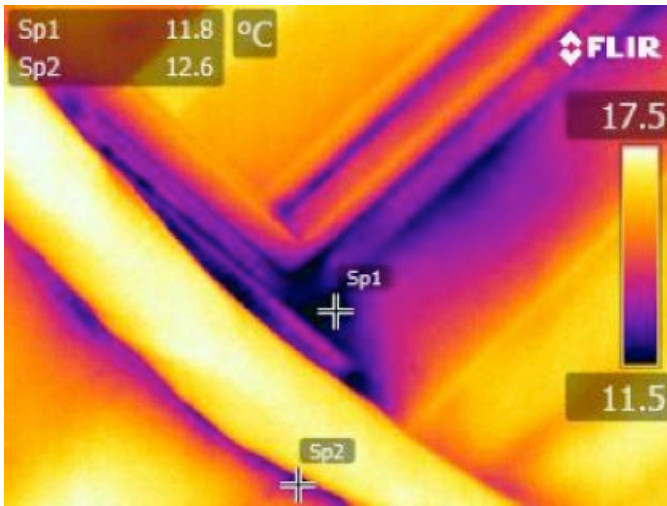
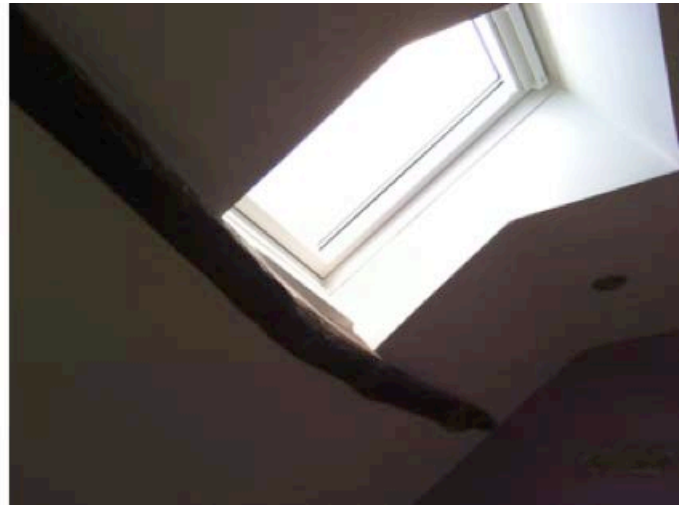
Figure 48. White House Farm, Stirton, Skipton – north facing ceiling in bathroom air ingress around roof light and beam.

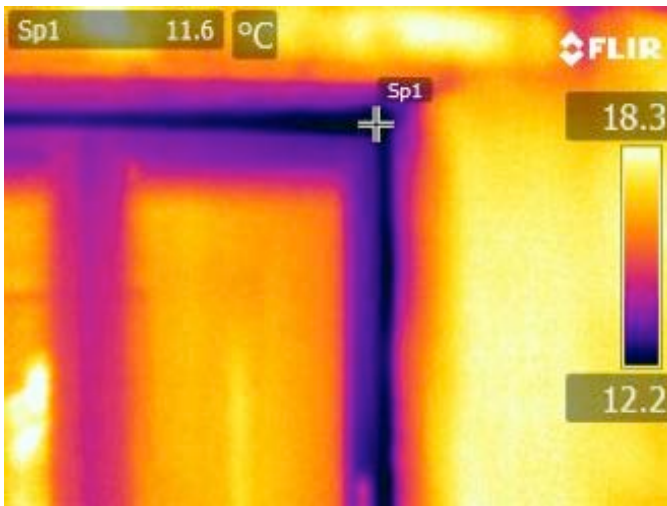
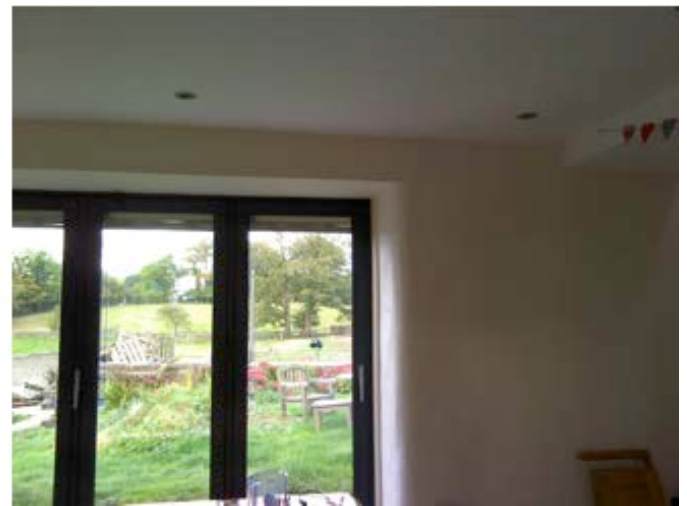
Figure 49. White House Farm, Stirton, Skipton – north wall in kitchen showing ingress around new door casement

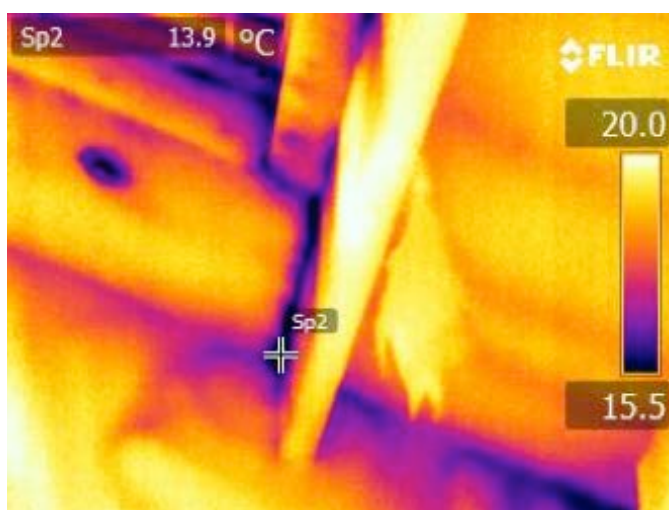
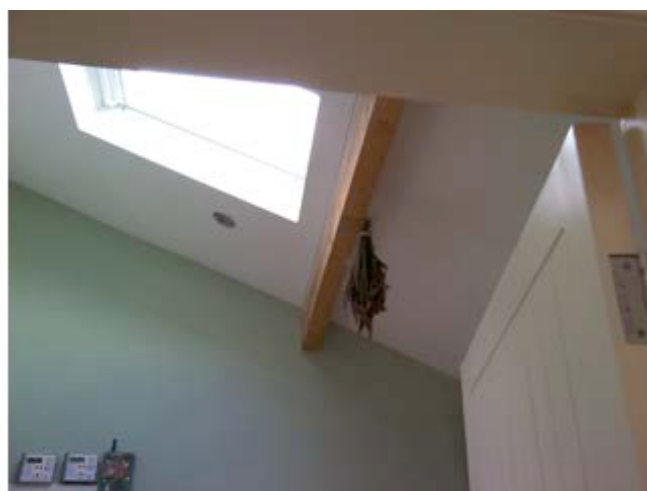
Ingress around beams and window frames is evident in the extension (Figure 51) with the window in the first floor bedroom showing ingress through its opening sections (Figure 52).

Figure 51. White House Farm, Stirton, Skipton – ingress around roof light casement, beam, wall joint and light fitting in Utility Room.

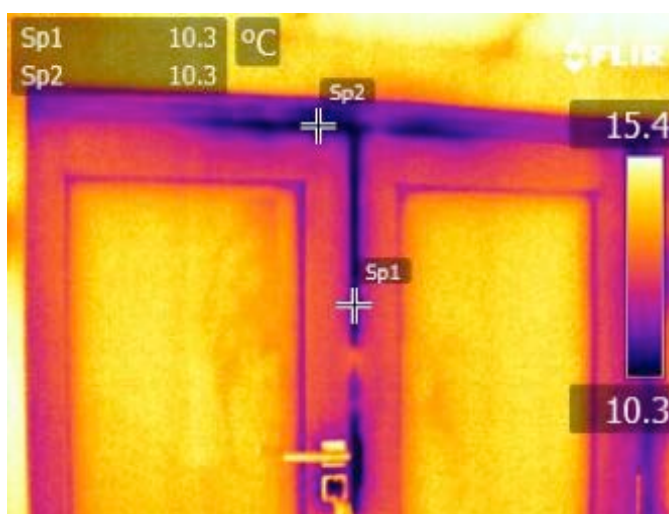
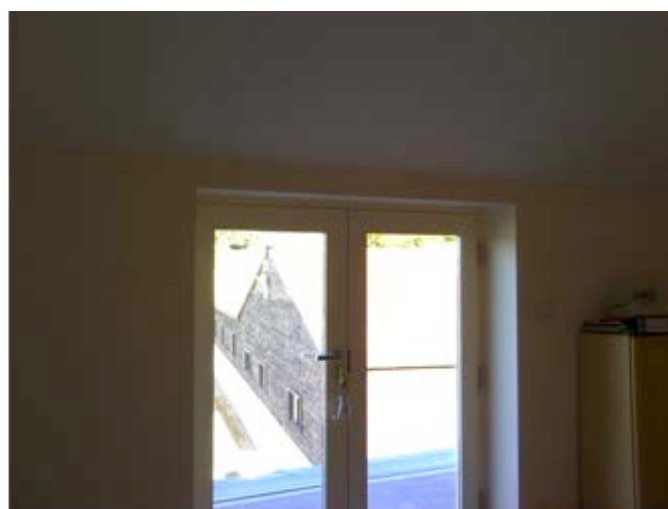
Figure 52. White House Farm, Stirton, Skipton – ingress through opening section of north facing window in first floor bedroom in addition.

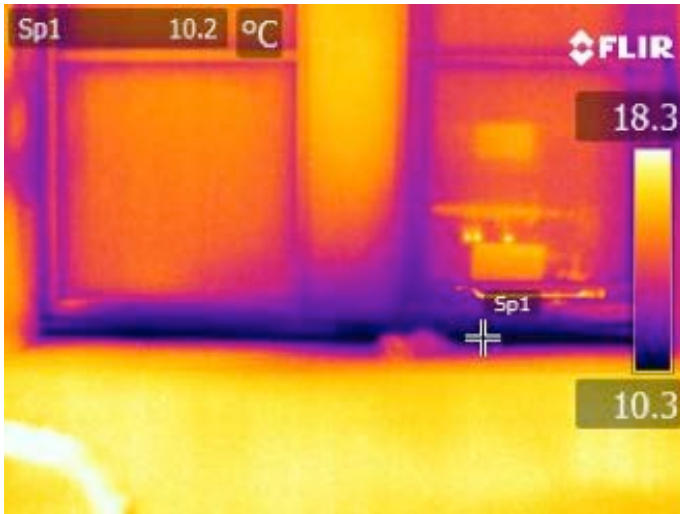
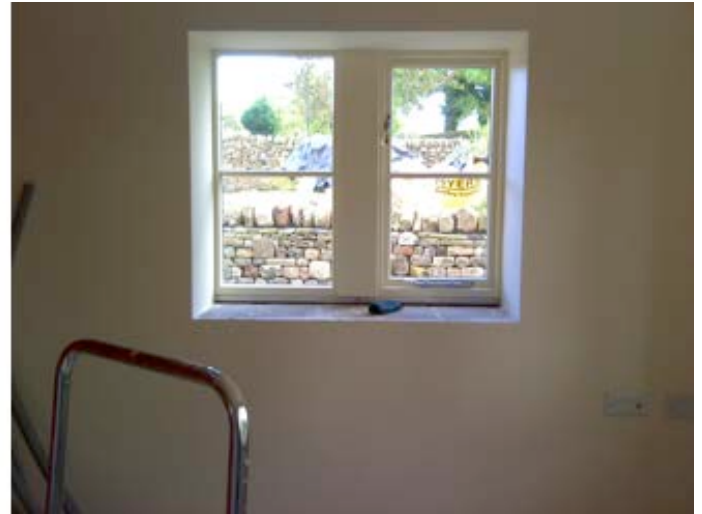
The sills in the extension are yet to be fitted and so ingress is displayed in this area (Figure 53).

Figure 53. White House Farm, Stirton, Skipton – ingress at base of window on east wall (no sill fitted).

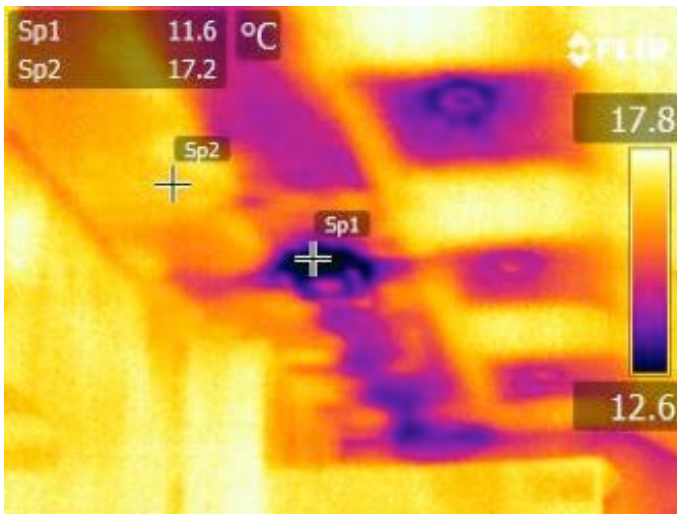
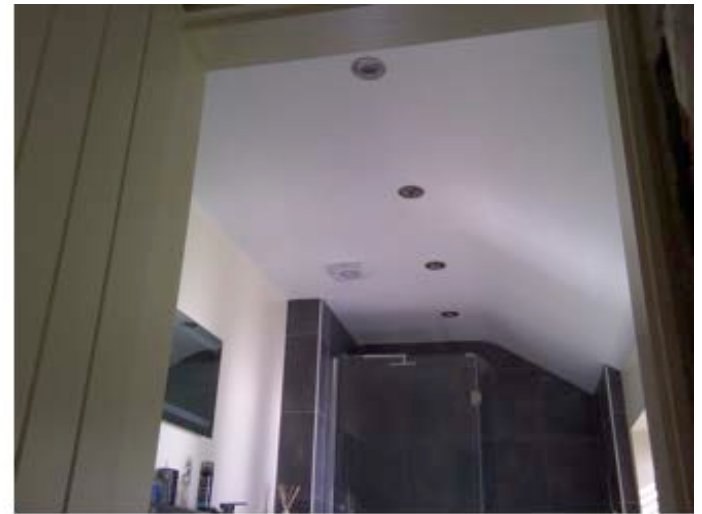
There is also evidence of missing or reduced insulation in the first floor en-suite shower room (Figure 54).

Figure 54. White House Farm, Stirton, Skipton. Reduced insulation in the ceiling of the first floor en-suite shower room.

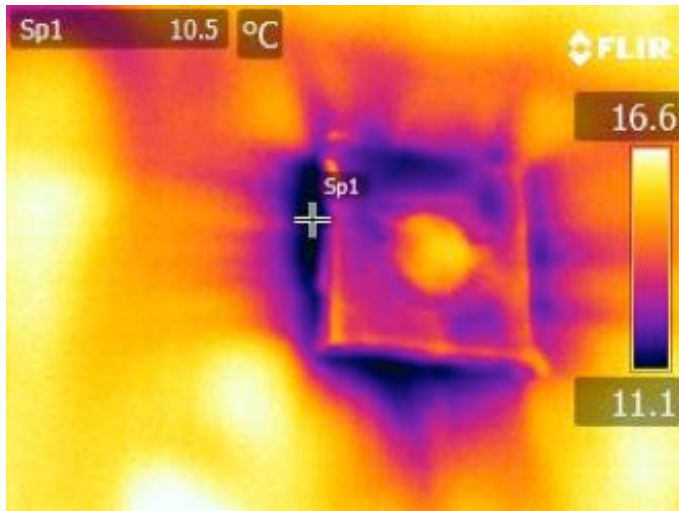
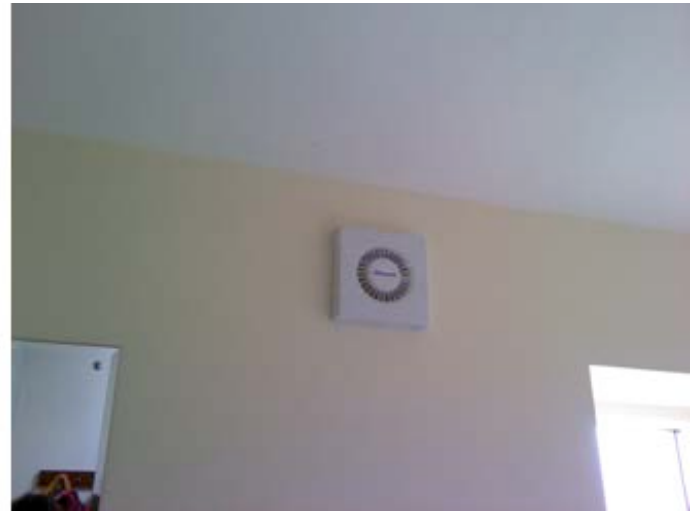
- Though extract fans are taped over during the test, every installed fan showed a poor connection between the base of the cover plate and wall, Figure 55. There are 5 extract fans fitted in the property.

Figure 55. White House Farm, Stirton, Skipton. Ground floor cloakroom extractor fan showing poor connection between the base of the cover plate and wall.

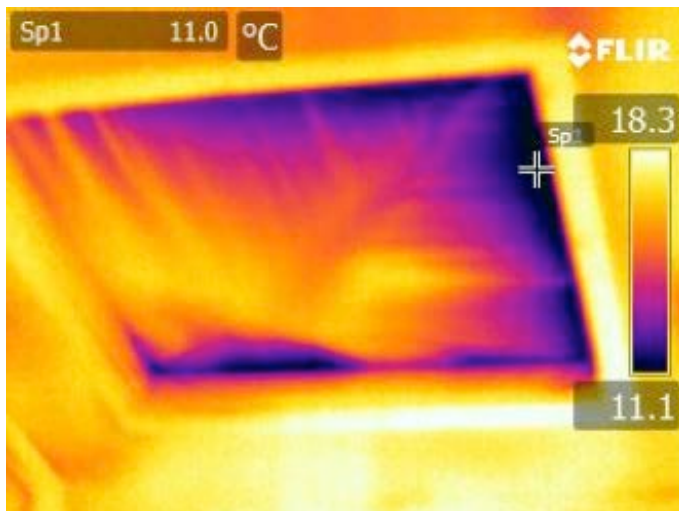
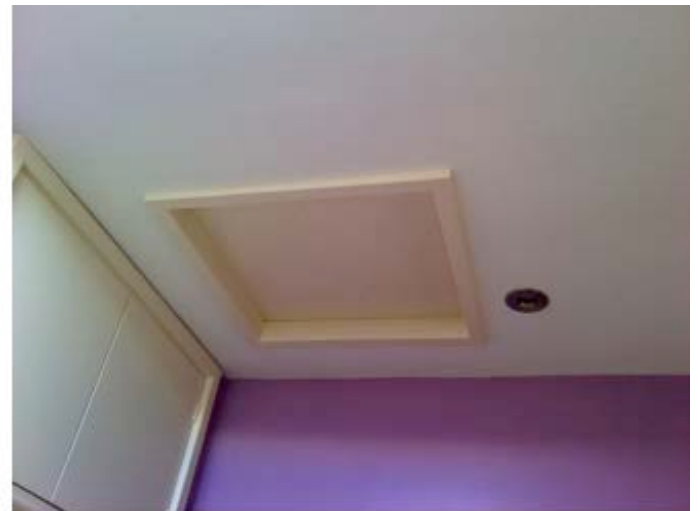
- There was significant ingress around the two loft hatches in the older part of the building (Figure 56).
- Ingress is present around most of the recessed light fittings, together with the fuse box.

Figure 56. White House Farm, Stirton, Skipton. Ingress around loft hatch in main bathroom.

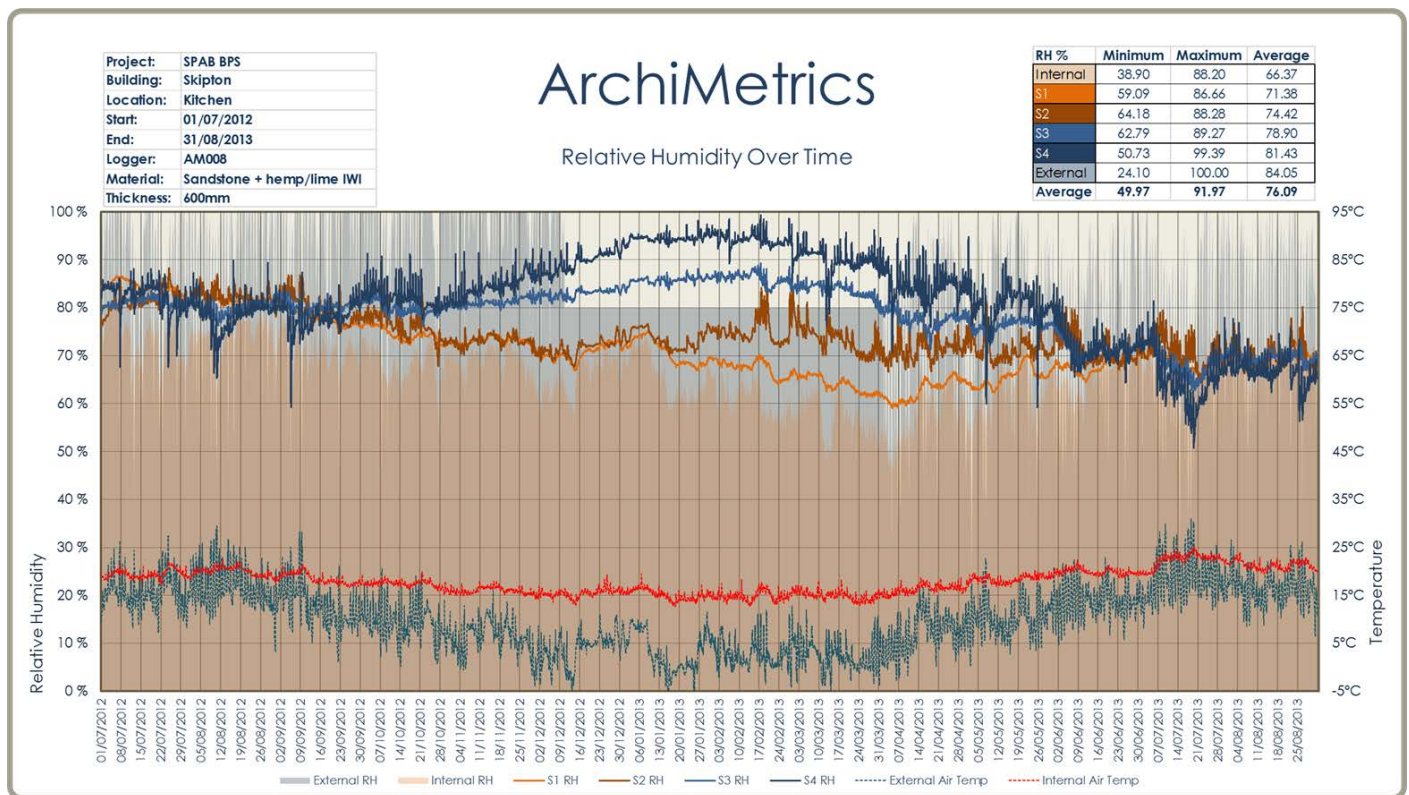
Figure 7 shows plots of %RH from the four sensors located within the wall at Skipton along with internal and external temperature and relative humidity conditions over time. In general, the graph follows a pattern seen elsewhere (Shrewsbury) of two distinct summer and winter arrangements of %RH distribution through the wall. %RH indicates the proportion of vapour held within air at a certain temperature in relation to saturation or dewpoint and is a temperature dependent quantity. During the warmer spring and summer months levels of %RH at all four wall sensors are more aligned as the temperature difference across the wall is less acute due to similar internal and external temperatures. Moving into winter however, internal and external temperature difference becomes more polarised leading to an increase in temperature difference through the wall and hence greater differentiation in the %RH measured by the four sensors through the wall section. By and large, lower %RH is found towards the warmer internal side of the wall and %RH increases in proximity to colder external conditions. The average %RH values calculated for each of the sensors in the wall at Skipton, is shown in the Table at the top right-hand side of Figure 7.

There are a number of other features of the %RH over time graph for Skipton which are of interest. There is a decreasing trend in %RH over the reporting period July 2012 - August 2013. This may reflect a general improvement in weather conditions between the two years, where 2012 was noted to be a particularly wet and cold year compared with that of 2013. In Figure 7 plots of external temperature and %RH show warmer and drier conditions from spring 2013 onward which in turn most likely lead to reduce %RH within the majority of the wall fabric. However, the %RH profiles of sensor 1 and sensor 2, positioned towards the internal side of the wall, may be less driven by external conditions. Here we also see a decline in %RH through the monitoring period which may be more related to the drying of the hemp and lime plaster internal finishes. The drying of these finishes, from haptic observation, has taken place over an extremely long period of time. It was not possible to carry out certain tests at the property in the winter of 2012 because finishes were still wet and the degree of drying has been noticed during regular visits to the property. The relationship between %RH measured at sensor 1 and sensor 2 also undergoes a change during the week beginning 13th January 2013. Until this date conditions at both sensors seem closely matched, if more volatile at sensor 2, and roughly track internal conditions. However after this date a margin of difference appears between the %RH measurements at sensors 1 and 2. This coincides with a period of extremely low external temperatures where the internal/external temperature difference is at its greatest. This may cause a more differentiated temperature gradient through the wall section and an alteration of the predominant influences on %RH behaviour at sensor 2 which is now more driven by external conditions than internal ones.

A further feature of Figure 7 are the sudden rapid drops of %RH recorded at sensor 4, 120mm back from the external wall face. These occur during periods of low external %RH and indicate that this part of the wall is well coupled with external conditions

Figure 7. Relative Humidity over time, White House Farm, Skipton, 2012 -13.

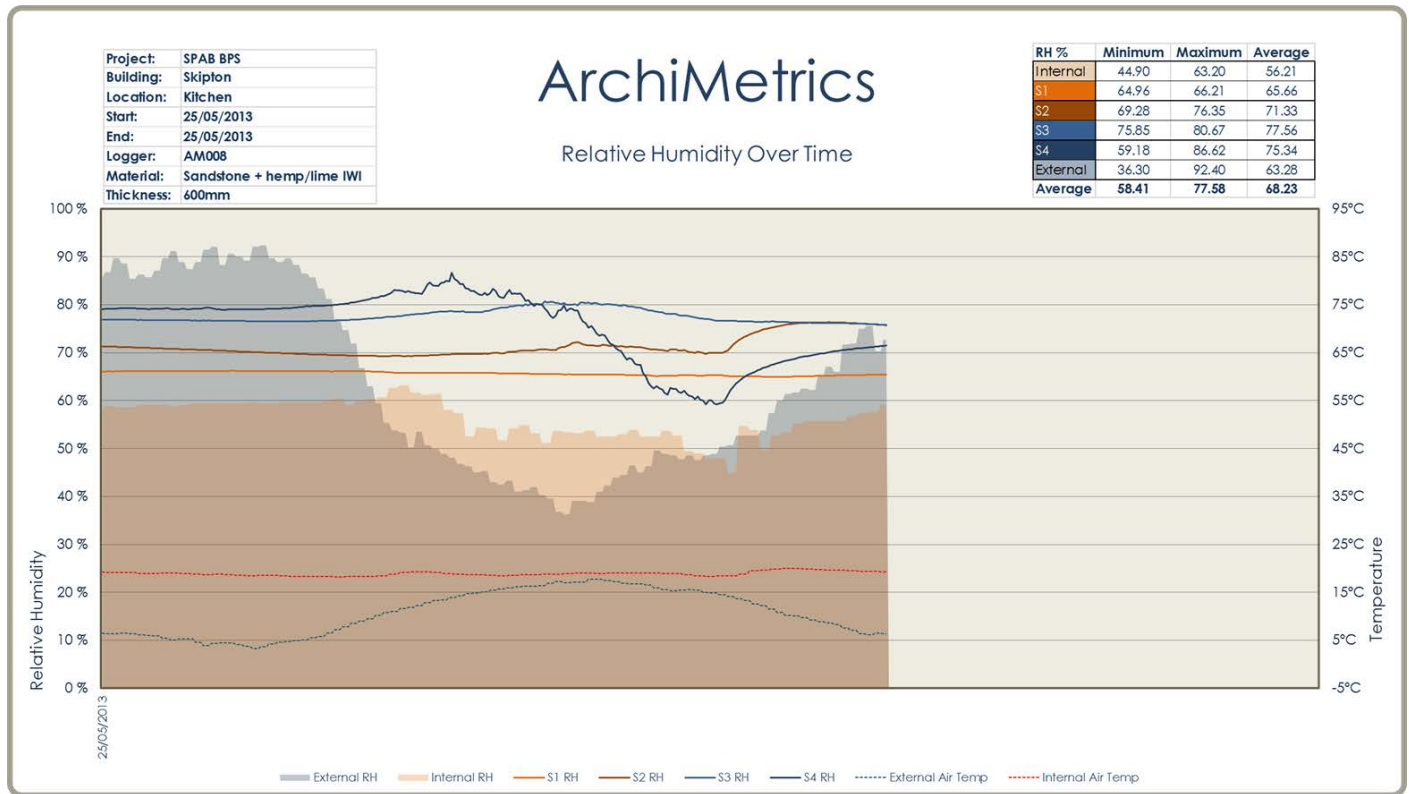
A detailed examination of one of these rapid drops in %RH is provided in Figure 59. As temperature increases through the day the external relative humidity falls and this decline is echoed, albeit with a slight time lag of about two hours, by the %RH conditions measured at sensor 4. Interestingly the same dramatic response is not seen at sensor 3 which sees a gradual rise and decline in %RH replicated in miniature at sensor 2 which then rises quickly to meet the gradient of sensor 3, a trajectory that runs in parallel with sensor 4 at the end of the day. This detailed section may show the competing influence on %RH behaviour within the wall under different conditions. Rises in %RH at sensors 2 and 3 may be in response to increased external temperatures and therefore indicate sweating or vaporisation, similar to that seen at Riddlecombe, taking place at these locations. At the end of the day sensors 4 and 2 seem to share a driving influence which causes %RH to rise, perhaps increasing external %RH and declining external temperatures. Responses at sensors 4 and 2 share a volatile characteristic which is interesting as they are some distance apart from one another within the wall and normally volatility of response declines in proximity to internal conditions whereas here responses at sensor 3, closer to the external wall face, are generally more muted than those at sensor 2. The wall at Skipton is a rubble core construction with many internal voids and fractures, during installation the core of sensor 3 become blocked by dust and rubble as a result of this relatively unstable internal construction, it is proposed that responses at sensor 3

are dampened by this debris whereas the cores of sensor 4 and 2 are more open to the influences of the external environment. What is also clear in Figure 59, however, is that whilst, by and large behaviour in the wall is affected by external conditions, 40mm back from the internal wall face %RH conditions are extremely static and in this way more in line with internal temperature conditions and perhaps reflect a buffering of internal %RH by the presence of hemp within the lime plaster finish.

Figure 59. Relative Humidity over time, 25th May 2013, White House Farm, Skipton.

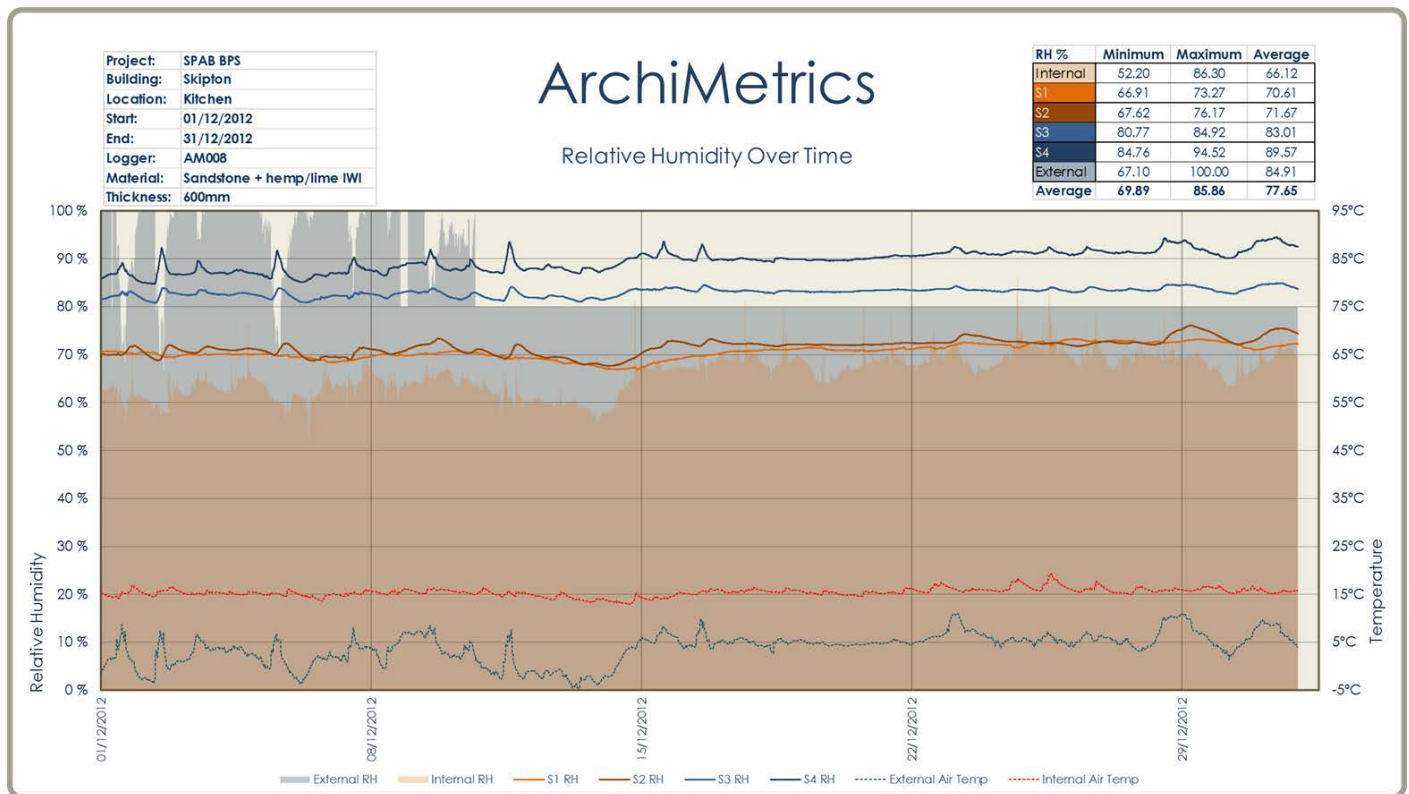
Another detail, this time for December 2012 Figure 60, shows a different relationship between the %RH responses of the interstitial sensors at Skipton. In this month responses at sensors 4 - 2 are similar and can be mapped over the external temperature profile, where peaks in temperature provoke peaks in %RH albeit of decreasing quantity in relation to the thermal profile through the wall section (driven by the wintertime internal high/external low temperature difference). These peaks in %RH once again indicate vaporisation of wet material due to this increased heat. Levels of %RH at sensors 3 and 4 are quite closely grouped, however, the volatility of responses does not decline through the wall section, as might be expected, as responses become more muted as measurements are taken further away from the driving external conditions. Instead, sensor 2 occasionally exhibits more significant changes in %RH than that of sensor 3 and in this way is more aligned with that of sensor 4. As was noted in the 2011 edition of this report, the wall at Skipton is a rubble core construction and as such contains plenty of voids. In this way it differs to another stone wall in this study, that at Drewsteignton, where the form of construction is very homogenous and compact with little voiding. As was noted in the previous paragraph, the loose rubble construction at Skipton allows for a great deal of air transfer through the wall therefore conditions

at a particular sensor position will be highly dependent on these air pathways and may alter depending on weather conditions including wind speed and direction. It is possible therefore, that while %RH at sensor 2 is lower as it is warmer here, due to its position towards internal heated conditions, there is more air exchange taking place with the outside so we see more extreme changes in %RH conditions overall. Whereas, perhaps sensor 3 is more isolated from direct contact with external air and so responses are similar to that of sensors 4 and 2 but more muted.

Figure 60. Relative Humidity over time, December 2012, White House Farm, Skipton.

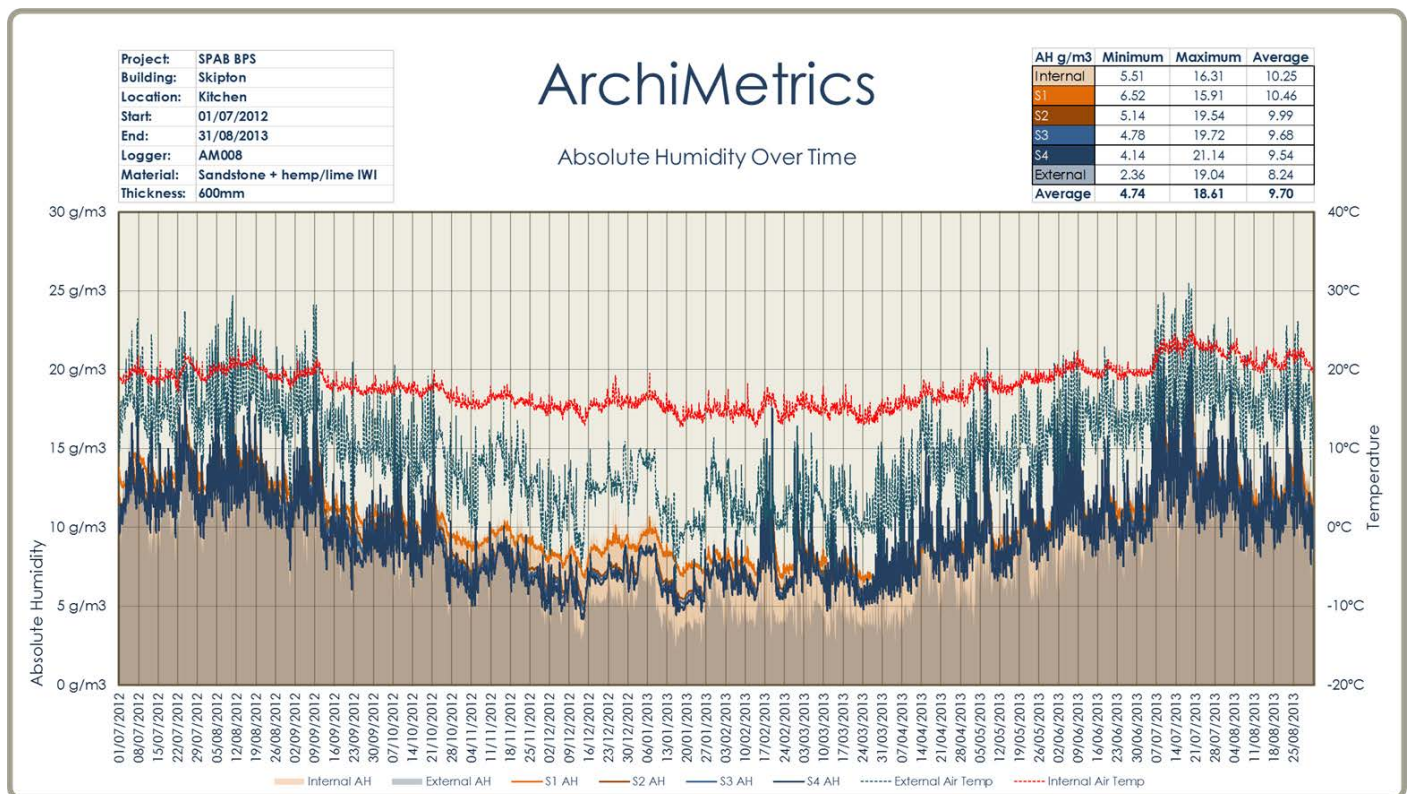
Figure 11: Absolute Humidity over time, Sensors 1 - 4, White House Farm, Skipton, 2012 -13.

Figures 11 and 61 show plots of absolute humidity over time for the refurbished wall at Skipton (Figure 61 is given for clarity to show plots from sensors 1 - 3 which may be obscured by the plot from sensor 4 in Figure 11). Graphs of absolute humidity over time for all four buildings in the Building Performance Survey (and elsewhere) show the same basic trend; that interstitial absolute humidity increases in the summer along with atmospheric humidity. Unlike the plots of %RH in Figure 7, which are temperature dependent, the plots of absolute humidity, which is a measure of the weight of vapour by volume (g/m^3) do show a volatility of response at each sensor position which is in proportion to that sensor's proximity to external conditions. Thus, sensor 4 shows the greatest fluctuations of vapour quantities driven by changing external conditions e.g. increased temperatures result in higher absolute humidity and similar but less pronounced and increasingly diminished responses are seen at sensors 3 and 2. Indeed, responses from all the three sensors placed in the masonry element of the wall are closely coupled and this is particularly

clearly seen in the graph over the winter months, October 2012 - February 2013, in Figure 11. Over the winter it can also be seen that measurements of absolute humidity become more dispersed between the sensors and that in terms of weight of vapour the interface between the hemp/lime plaster and the masonry is the 'wettest' part of the wall presumably as a result of the internal, centrally heated air driving moisture arising due to occupancy into the wall surface combined with the vapour buffering capabilities of this internal finish. The same pattern is found over the same months in the monitored wall at Shrewsbury, which also has a hygroscopic surface finish, but not Drewsteignton. The other occasion where levels of absolute humidity at sensor 1 are slightly greater and seem somewhat distinct from those measured within the masonry section is early on in July 2012, Figure 61. Is it that here we can see the drying of the hemp lime plaster layer, in a similar but much less distinct way to that of the gypsum skim on plasterboard at Drewsteignton (Figure 8) causing relatively high levels of vapour over this time?

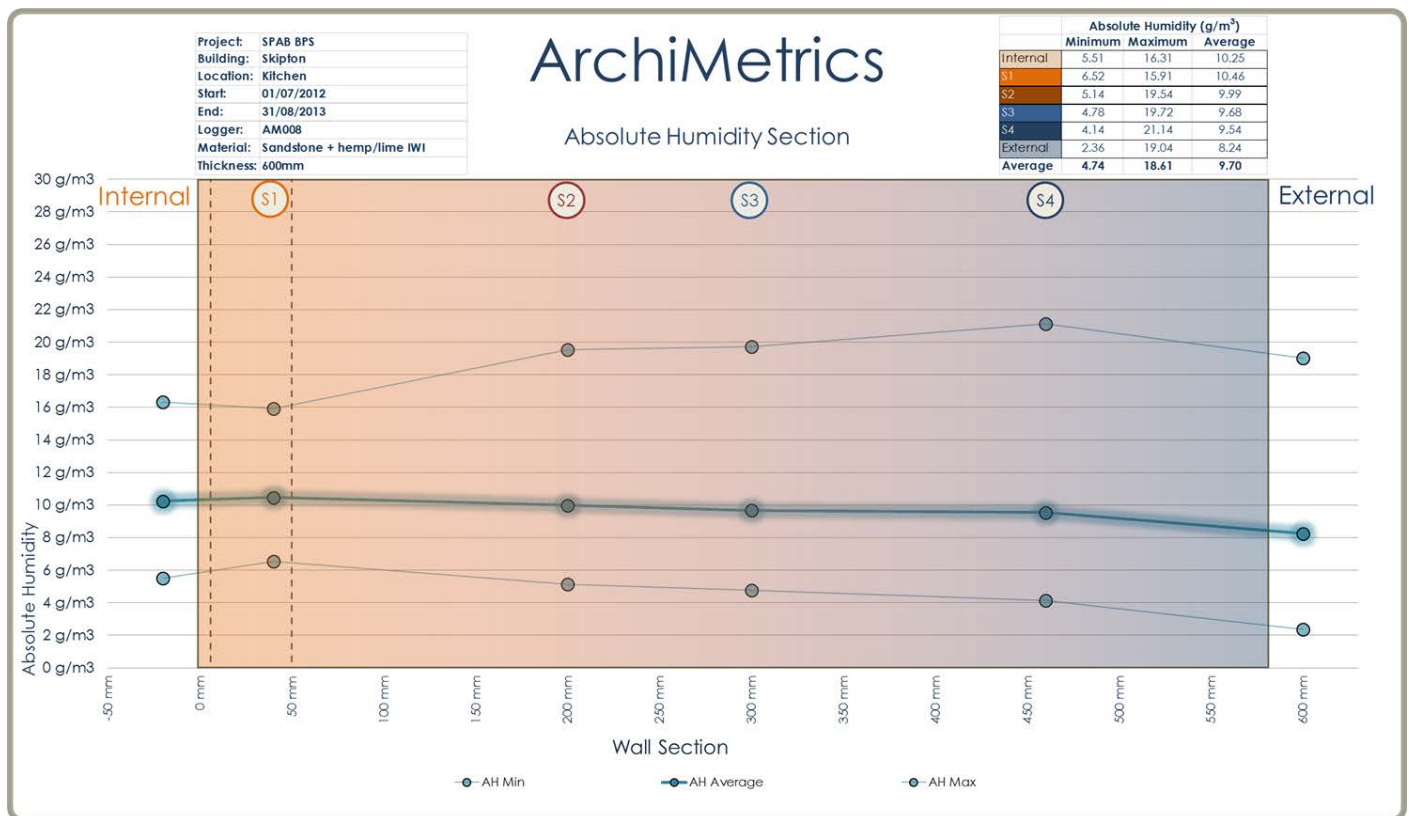
Figure 15: Absolute Humidity Section, White House Farm, Skipton, 2012 -13.

The absolute humidity profile of the wall at Skipton is also provided in the form of a section graph, Figure 15, which plots the average g/m^3 of water vapour either side of and through the wall. This graph shows a steady fall in the measured averages of absolute humidity at each of the four sensors in the wall, from sensor 1 at the internal leaf to sensor 4 and the external atmosphere. This decline from the interior side of the wall to the exterior contrasts with other walls in this survey, Shrewsbury and Drewsteignton (Figures 14 and 16) where average absolute humidity values peak at sensor 4 at the exterior of the wall and decline towards the interior wall face and may reflect the influence of the wet internal hemp/lime finishes drying over the reported monitoring period.

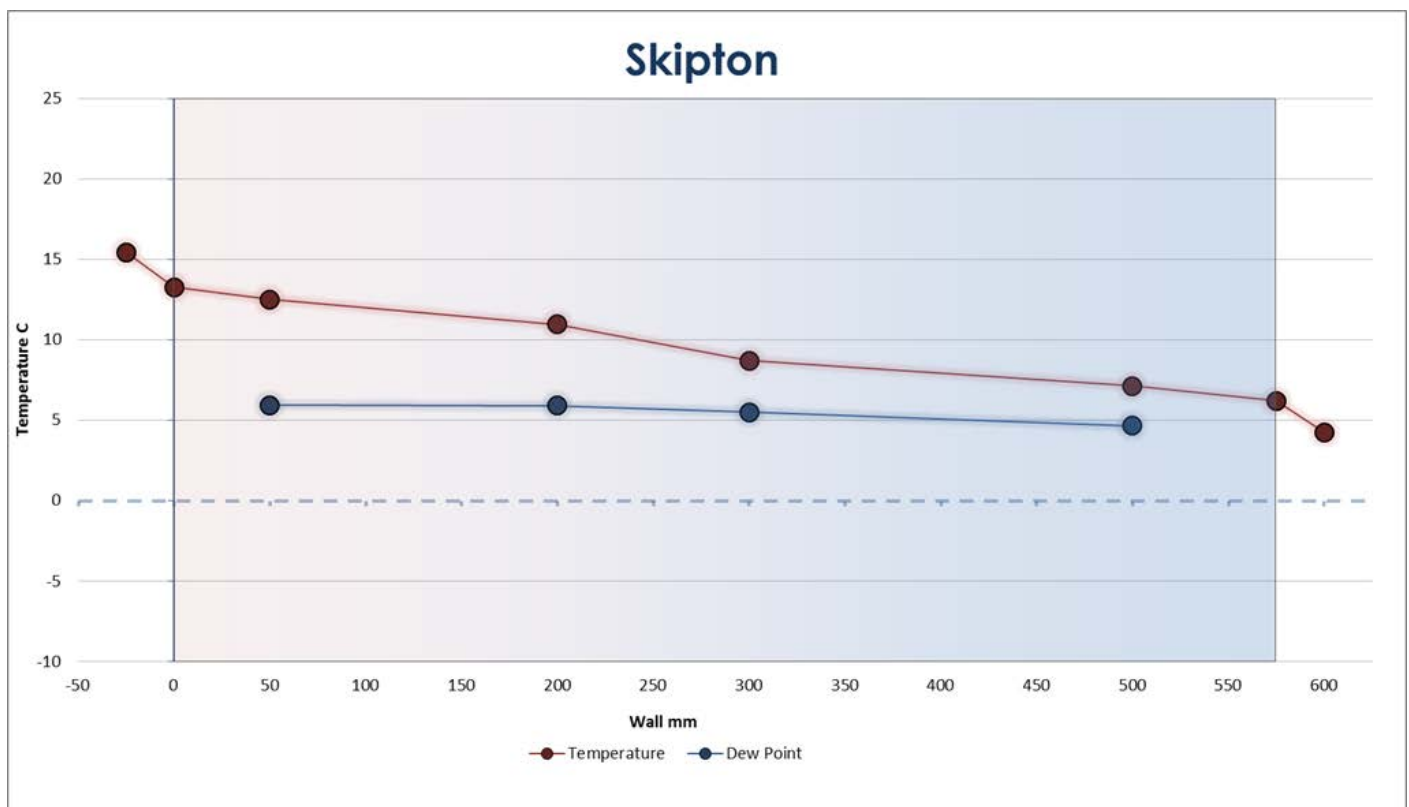
Figure 62: Hygrothermal Section, White House Farm, Skipton, 10th - 24th February 2011.

Figures 62, 63 and 19 show the average values of each sensor graphed as separate temperature and dewpoint gradients from both the pre and post-refurbishment monitoring periods. Data from the extended post-refurbishment monitoring has been graphed in two ways, Figure 63 shows a short time period (10th - 24th February) for comparison purposes with the pre-refurbishment interstitial hygrothermal monitoring shown in Figure 62. Figure 19 provides a section for the longer 13 month monitoring duration at White House Farm. The values derived from the relative humidity sensors have been converted to dewpoints in order to indicate the likelihood of condensation forming within the wall. (The temperature gradient is that much flatter in the long term post-refurbishment graph, Figure 19, because this covers a far greater period of time and includes both summer and winter time temperatures in contrast to the data in Figures 62 and 63 which was gathered over the winter only, between 10th - 24th February 2011/13, and so naturally shows a greater internal/external temperature difference). The 2011 analysis, pre-refurbishment, Figure 62, showed a variety of gradients between the sensor measurement locations indicating a non-homogenous wall with varying degrees of thermal resistivity/conductivity. The character and construction of this wall was ascertained during core drilling to install the interstitial sensors which revealed a variety of stone material types, a rubble core and plenty of voiding all of which would contribute to altering heat flow through the element. In Figure 19, the 2012 - 13 post-refurbishment section this same character is seen, the affect of the rubble core, bracketed between sensors 2 and 3, is still visible although differences in gradient between the sensor points is less pronounced due to the flattened temperature gradient in general. This centre part of the wall contains plenty of air which perhaps acts as a thermal break hence a slightly steeper temperature drop is seen across this part of the construction. The other steeper part of the temperature gradient in Figures 63 and 19 is seen between the measurements of internal surface temperature and sensor 1, either side of the lime and hemp/lime insulating plaster finishes. This indicates, once again, the insulation affect of this layer in the construction, something that is confirmed by the in situ U-values measured, post-refurbishment for this wall (Figures 43 and 44) which showed a 38% reduction in heat loss most likely due to the addition of the insulating hemp/lime plaster.

These Figures, 62, 63 and 19, also allow an examination of the average dewpoint margins for the wall at Skipton, that is the nominal temperature drop required at certain locations for condensation to possibly occur. As can be seen in both Figures 62 and 19 there is no instance in which the temperature gradient intersects with the dewpoint suggesting that, on average, there are no significant periods of interstitial condensation risk within the walls either prior to, or post, refurbishment. However, from measurements taken in Feb 2013 alone, Figure 63, does show a narrowing for the dewpoint margin particularly at sensor 4 where the °C margin becomes less than 1°C, 0.87°C. There is also, in Figure 19, a less pronounced narrowing of the dewpoint margin following refurbishment, particularly towards the inner side of the wall. However, this is, once again, mostly a result of the flattened temperature gradient over this extended 13

month time period. In 2011, pre-refurbishment, a dewpoint margin was averaged across all four interstitial sensors of 4.34°C . For the re-furbished wall in 2012 - 2013 this margin in February 2013 has dropped to 3.29°C but when calculated over 13 months has risen to 4.19°C to just below the pre-refurbishment value. However, considering each sensor position individually, there is of course an increased vulnerability with regard to condensation towards the colder, exterior side of the wall where temperatures are lower. And indeed Figure 63, for February 2013, shows a reduced dewpoint margin of 0.87°C at sensor 4, where as in 2011, pre-refurbishment, the margin here was found to be greater, 2.49°C . Figure 63 does not show dewpoint occurring which would of course be indicated by a margin of 0°C however it does suggest that the likelihood of condensation occurring at this point may have now increased. The slightly reduced dewpoint margins found for the wall following refurbishment, Figures 63 and 19, suggest that whilst it seems that there maybe an increased risk of interstitial condensation in the wall at Skipton during the winter months, particularly towards the external leaf the average dewpoint margins over an annual cycle including those for sensor 4 of 3.27°C suggests that significant quantities of condensation are unlikely to be deposited.
