THE SPAB RESEARCH REPORT 2

The SPAB Building Performance Survey 2013 Interim Report

OCTOBER 2013.

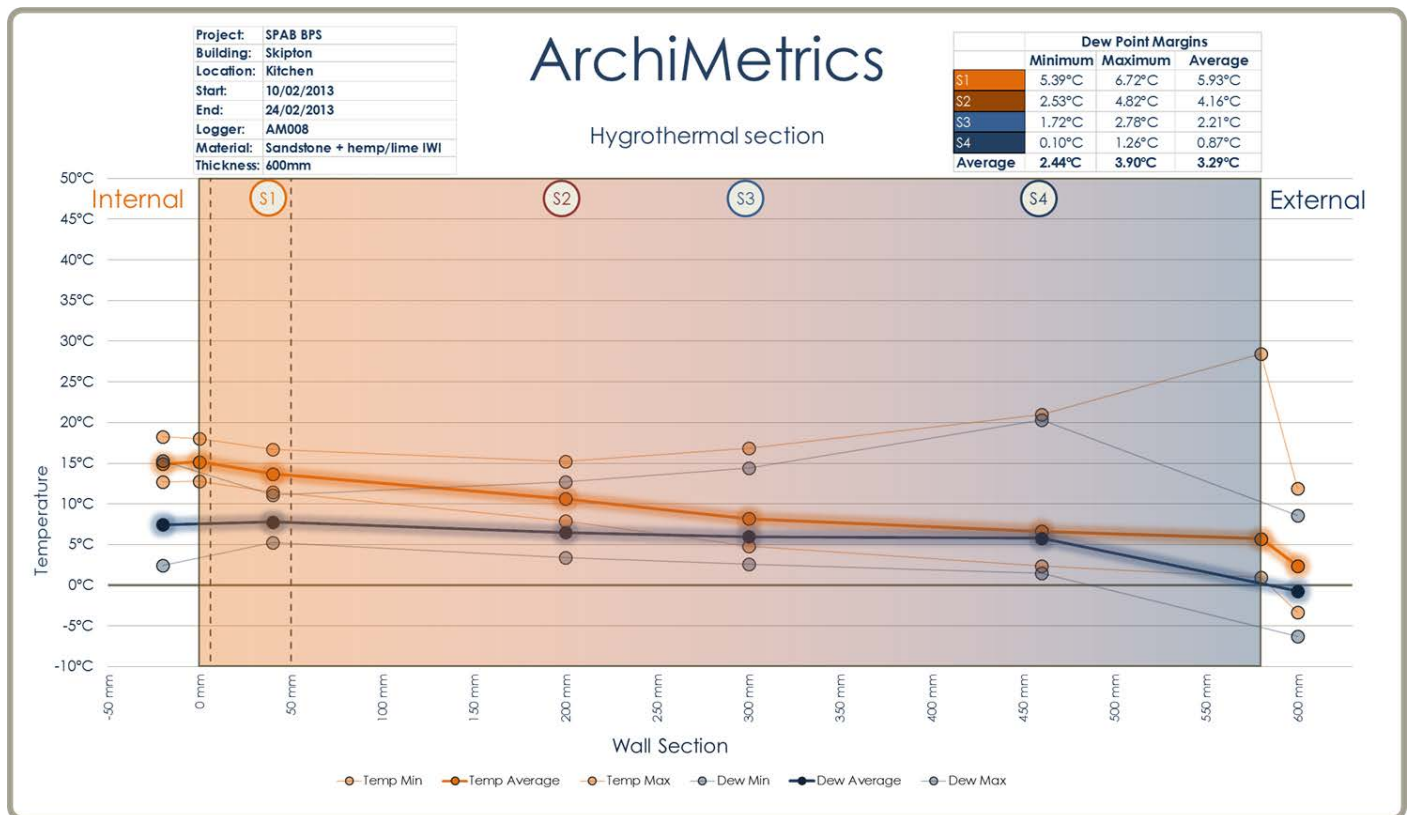
Figure 63: Hygrothermal Section, White House Farm, Skipton, 10th - 24th February 2013.

Figures 62, 63 and 19 show the average values of each sensor graphed as separate temperature and dewpoint gradients from both the pre and post-refurbishment monitoring periods. Data from the extended post-refurbishment monitoring has been graphed in two ways, Figure 63 shows a short time period (10th - 24th February) for comparison purposes with the pre-refurbishment interstitial hygrothermal monitoring shown in Figure 62. Figure 19 provides a section for the longer 13 month monitoring duration at White House Farm. The values derived from the relative humidity sensors have been converted to dewpoints in order to indicate the likelihood of condensation forming within the wall. (The temperature gradient is that much flatter in the long term post-refurbishment graph, Figure 19, because this covers a far greater period of time and includes both summer and winter time temperatures in contrast to the data in Figures 62 and 63 which was gathered over the winter only, between 10th - 24th February 2011/13, and so naturally shows a greater internal/external temperature difference). The 2011 analysis, pre-refurbishment, Figure 62, showed a variety of gradients between the sensor measurement locations indicating a non-homogenous wall with varying degrees of thermal resistivity/conductivity. The character and construction of this wall was ascertained during core drilling to install the interstitial sensors which revealed a variety of stone material types, a rubble core and plenty of voiding all of which would contribute to altering heat flow through the element. In Figure 19, the 2012 - 13 post-refurbishment section this same character is seen, the affect of the rubble core, bracketed between sensors 2 and 3, is still visible although differences in gradient between the sensor points is less pronounced due to the flattened temperature gradient in general. This centre part of the wall contains plenty of air which perhaps acts as a thermal break hence a slightly steeper temperature drop is seen across this part of the construction. The other steeper part of the temperature gradient in Figures 63 and 19 is seen between the measurements of internal surface temperature and sensor 1, either side of the lime and hemp/lime insulating plaster finishes. This indicates, once again, the insulation affect of this layer in the construction, something that is confirmed by the in situ U-values measured, post-refurbishment for this wall (Figures 43 and 44) which showed a 38% reduction in heat loss most likely due to the addition of the insulating hemp/lime plaster.

These Figures, 62, 63 and 19, also allow an examination of the average dewpoint margins for the wall at Skipton, that is the nominal temperature drop required at certain locations for condensation to possibly occur. As can be seen in both Figures 62 and 19 there is no instance in which the temperature gradient intersects with the dewpoint suggesting that, on average, there are no significant periods of interstitial condensation risk within the walls either prior to, or post, refurbishment. However, from measurements taken in Feb 2013 alone, Figure 63, does show a narrowing for the dewpoint margin particularly at sensor 4 where the °C margin becomes less than 1°C, 0.87°C. There is also, in Figure 19, a less pronounced narrowing of the dewpoint margin following refurbishment, particularly towards the inner side of the wall. However, this is, once again, mostly a result of the flattened temperature gradient over this extended 13

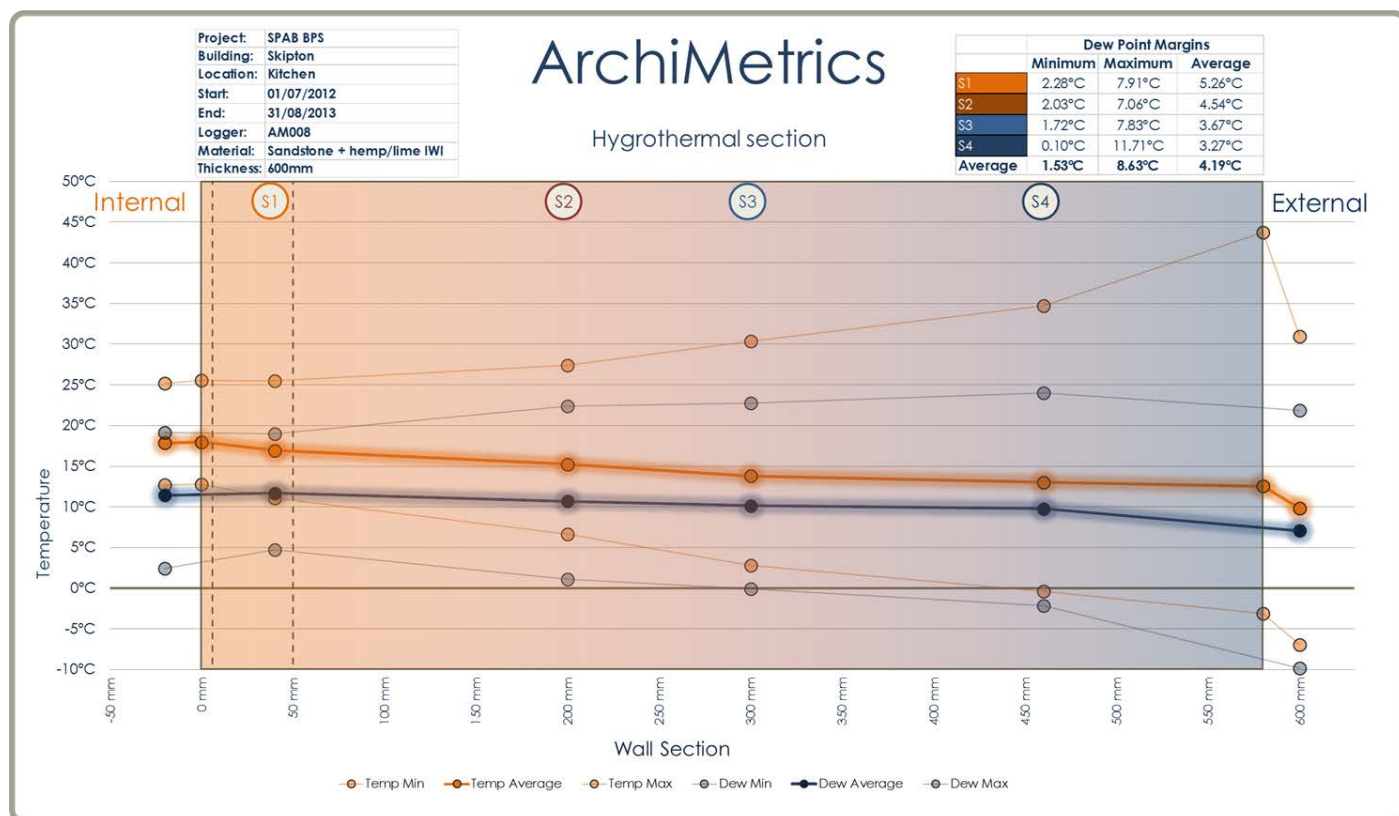
Figure 19: Hygrothermal Section, White House Farm, Skipton, July 2012 - August 2013.

dewpoint gradient narrows towards the colder external side of the wall as colder temperatures cause an increase in %RH. However, in Figures 18 and 19, Shrewsbury and Skipton, there is a gap between these two gradients showing that, over an annual cycle, on average, a temperature drop of roughly 3°C is required before saturation point is reached at sensor 4. Therefore possibly there is no significant risk of extended periods of condensation within these two walls. This is in contrast to the wall at Drewsteignton, Figure 20, where temperature and dewpoint gradients at sensor 4 are seen to be in close proximity to one another, the margin of difference being 0.57°C. As well as the wall at Riddlecombe, Figure 21, where at sensor 4 and sensor 3 they are affectively coincidental with margins of 0.03°C and 0.54°C respectively. This would seem to suggest that these walls, which were also found to both exhibit the trend of rising %RH, may be at greater threat from condensation over the long term.

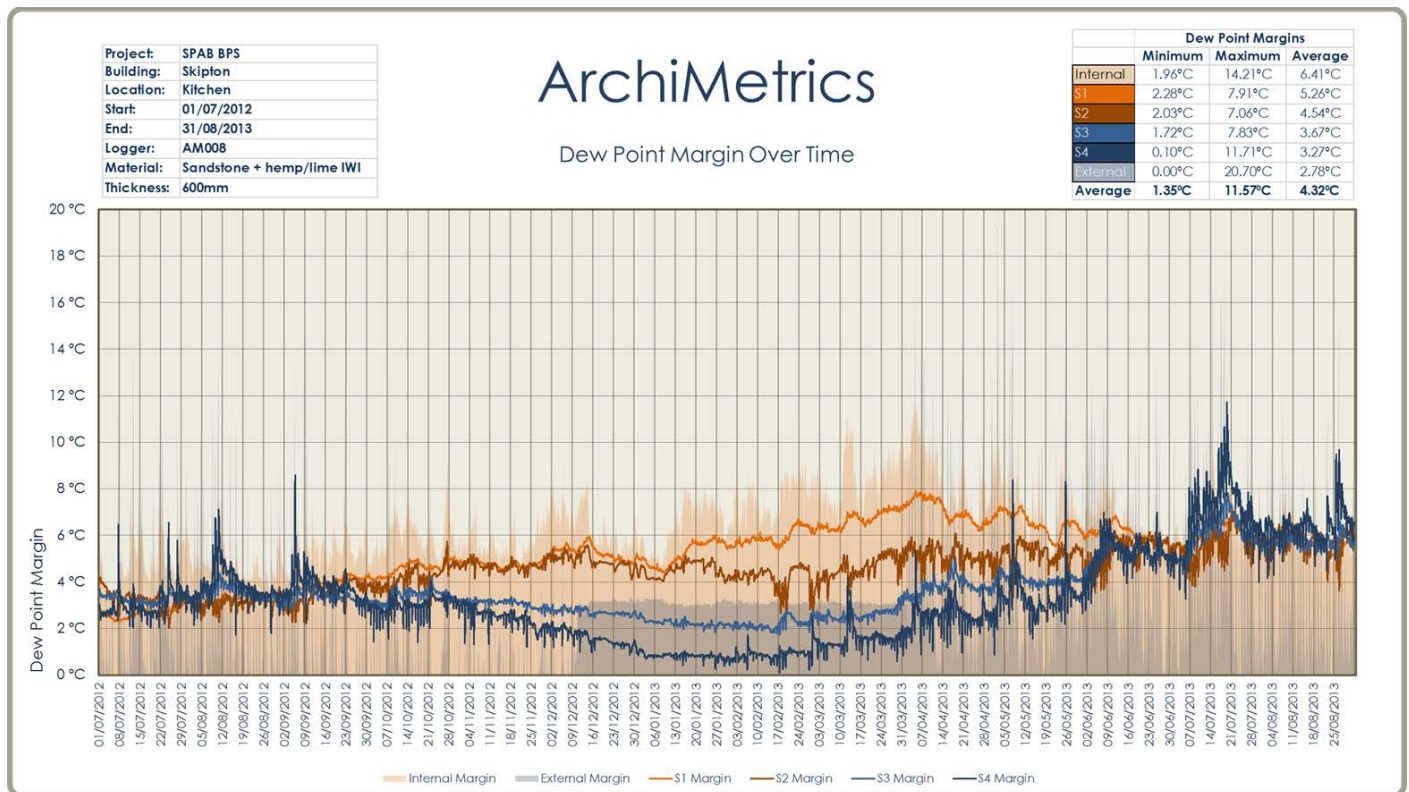
Figure 23: Dewpoint Margin over time, White House Farm, Skipton, 2012 -13.

In Figure 23 the dewpoint margins calculated for the four interstitial sensors in the wall at Skipton are plotted over time. From this it can be seen that the most vulnerable period of time with regard to the potential for condensation occurs not surprisingly during the coldest months of the year around the sensor positioned closest to external conditions, sensor 4. From December 2012 through to March 2013 the dewpoint margin calculated for sensor 4 remains below 2°C and records a minimum value of 0.1°C on or around 17th February 2013. Unlike all the other locations in this study this graph does not find a margin of 0°C, indicating dewpoint and therefore the likely formation of condensation, at any point over the monitoring period for the wall at Skipton. However, it should be noted that the position of sensor 4 is someway back into the body of the wall at Skipton, 255 mm away from external conditions, and low external temperatures

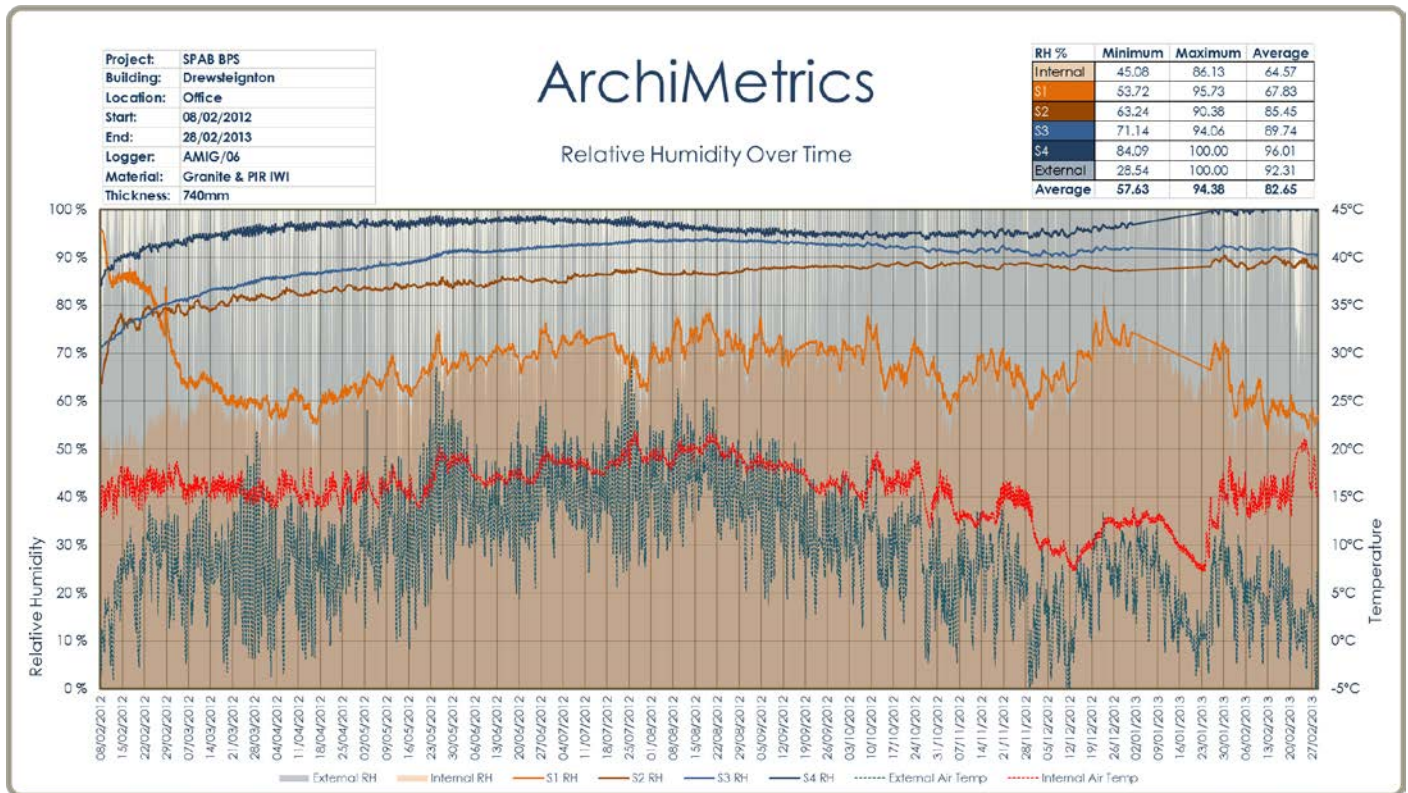
Figure 8: Relative Humidity over time, Mill House, Drewsteignton 2012 - 2013.

The walls at Drewsteignton and Riddlecombe (Figures 8 and 9) also share another feature, that is both these locations exhibit a trend of rising %RH over the reported monitoring period (12 months for Drewsteignton, 6 month at Riddlecombe). This is particularly clear in Figure 9 when measurements of %RH at sensor 4, the sensor closest to the external side of the wall at Riddlecombe, reaches 100% RH within a matter of weeks from the commencement of the graph and is followed, sixteen weeks later by sensor 3 and all four gradients have a mostly upward trajectory for the entire duration of the graph. At Drewsteignton, Figure 8, the trend is less obvious and there is also a period of time over the summer where measurements of %RH decline at sensors 3 and 4, however, over the full reporting period the predominate trend is one of increasing %RH with the exception of measurement from sensor 1 positioned in the air gap behind the plasterboard drylining of this wall which tracks internal room %RH conditions. Towards the end of the graph for Drewsteignton, in January 2013, sensor 4 reaches 100% RH. There is however a significant difference between these two walls in that peaks of %RH occur in opposing seasons suggesting two different and possibly opposing driving forces for this behaviour. By and large, and this can be seen in the other walls in this study (Figures 6 and 7) %RH increases and peaks during the winter when colder external temperatures cause the %RH to rise particularly within the colder, external side of the wall leaf. However, at Riddlecombe the rising trend, including peaks at 100%, occurs over the warmer summer months and it is thought that this may be due to vaporisation or sweating behaviour from the cob material that has a high moisture content due to the failing external cement render that previously covered the building and water introduced into the wall as part of the re-rendering process. (This phenomenon is explored in more detail in the individual report on Riddlecombe in Appendix A, pps. 102-121). Continued measurements of this wall into the winter period, 2013-14, should be able to shed more light on the high %RH measured in this wall and whether this is a seasonal and ultimately diminishing trend or a cause for concern over the longer term. However, measurements of %RH at Drewsteignton reveal a trend of rising %RH that occurs over a 12 month period, when normally perhaps one might expect any rise in %RH as a result of colder temperatures to be reversed during the warm summer. Both Drewsteignton and Riddlecombe also show higher interstitial %RH values where average %RH values measured at sensors 2-4 in both walls all exceed 80% the value often quoted as the threshold for mould growth conditions. In contrast, only measurements from sensor 4 exceed 80% RH in the walls at Shrewsbury and Skipton, averaging 83.49% and 81.43 respectively whereas averages for sensor 4 are much higher at Drewsteignton, 96.01% and at Riddlecombe, 99.82%.

Figure 8 plots levels of %RH recorded by the interstitial and internal and external sensors over time, along with internal and external temperature data. The trend of rising %RH at sensors 2, 3 and 4 that was noted in the previous report (*The SPAB Building Performance Survey 2012, Interim Report*) is confirmed by this graph which looks at %RH responses over a full annual cycle. Whilst it is possible to see a small reduction in %RH measured at sensor positions 3 and 4 over the months of July, August and September, once the cold weather recommences %RH begins to rise at these two locations once again. Indeed, at the beginning of February 2013 %RH reaches 100% at the outer sensor (sensor 4, 134mm back from the external wall face) and remains there throughout this month suggesting an increased risk of condensation at this point. Unlike sensors 3 and 4, there is no period in the year where %RH diminishes at sensor 2 which is located immediately behind the PIR insulation at the insulation/masonry interface. Here a steady rise in %RH is measured over the full 13 month reporting period, however, unlike sensor 4 neither sensor 2 or 3 reaches saturation (100% RH) over this time. The average %RH values of the three sensors position on the cold side of the insulation are all above 80%, a threshold commonly used to indicate the possibility of mould growth, and are; sensor 2 = 85%, sensor 3 = 80% and sensor 4 = 96% (see table at top right of Figure 8). Following the installation of insulation at Drewsteignton and the drying of the plasterboard's gypsum plaster skim coat behaviour of %RH at sensor 1 is, as was previously noted, closely coupled to that of the internal room %RH. This suggests that there is a high degree of vapour exchange from the room through the plasterboard to the air gap between the plasterboard and PIR insulation.

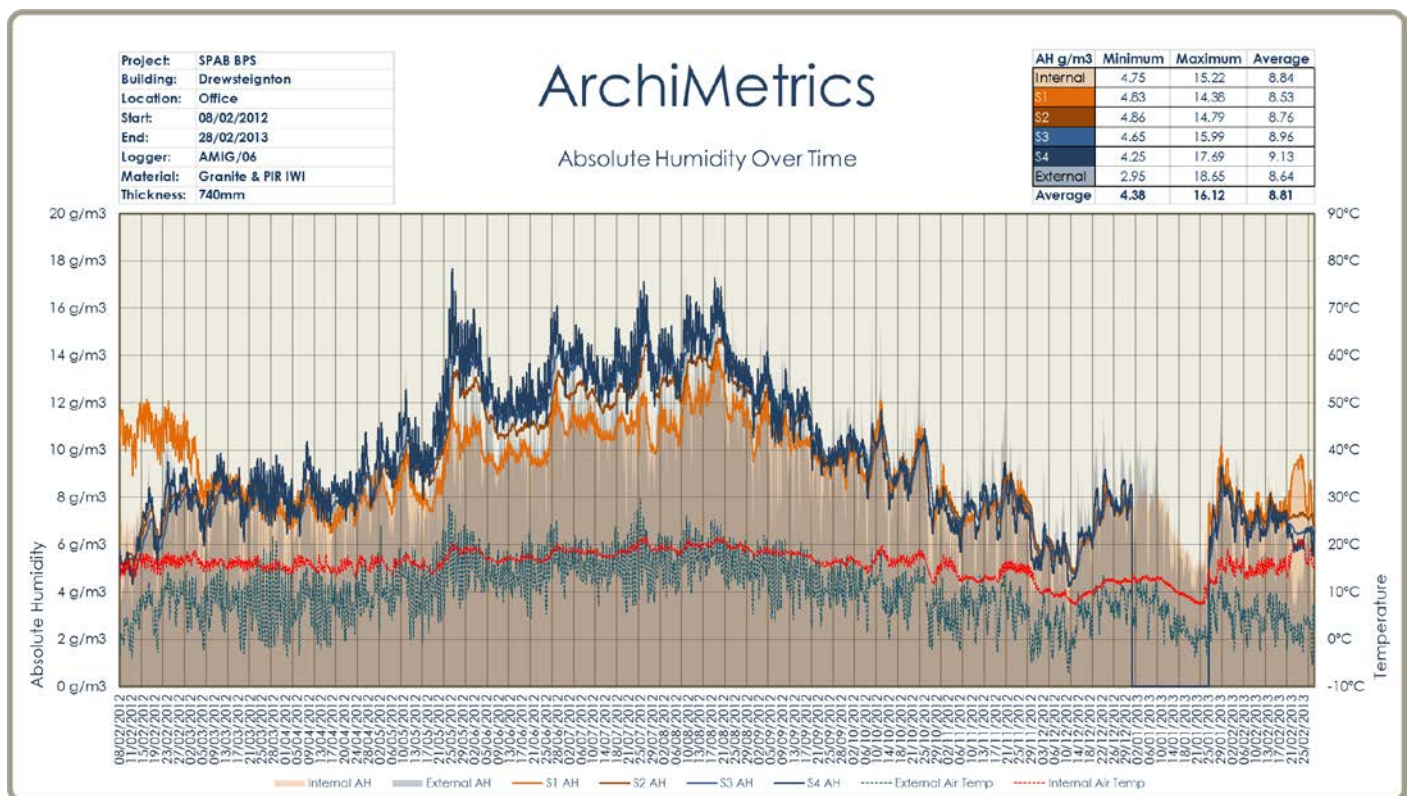
Figure 12: Absolute Humidity over time, Sensors 1 - 4, Mill House, Drewsteignton 2012 - 2013.

where it is only from January 2013 onwards that this arrangement is seen. (The peak absolute humidity at sensor 1 seen early on in Figure 12 is as a result of the drying of the gypsum skim on the plasterboard drylining). Drewsteignton also differs from the walls at Shrewsbury and Skipton in another way in that it seems to reverse a dispersal pattern. At Shrewsbury and Skipton measurements of the weight of vapour through the wall are more dispersed and differentiated during the winter, presumably, as with %RH, as a result of a greater temperature gradient through the wall section. However, at Drewsteignton a greater differentiation between g/m^3 of vapour is found in the summer and measurements of the weight of vapour through the wall section become more aligned in wintertime.

Figures 12 and 72 show plots of absolute humidity over time for the insulated granite wall at Drewsteignton (Figure 72 is given for clarity to show plots from sensors 1 - 3 which are obscured by the plot from sensor 4 in Figure 12). These show that humidity rises within the wall over the warmer summer months as warmer temperatures enable more vapour to be held in the air. The pattern for the summer months is also more dispersed, that is to say there is greater variation in the weight of water vapour measured at the four locations through the wall and, in general, this increases in relation to proximity to more humid external conditions. This relationship is clearly seen in Figure 72 for measurements from sensors 1 - 3 but is less defined in Figure 12 where plots from sensor 4, the outer most sensor, are more volatile reflecting more dynamic influences on quantities of water vapour in the immediate atmosphere. The drying of the gypsum plaster skim previously noted in relation to %RH can also be seen in plots of absolute humidity for sensor 1 installed in the air gap behind the plasterboard. Following this drying sensor 1 once again follows internal room conditions and shows the lowest weight of vapour by volume for this part of the wall during the summer. This changes in winter when, in general, quantities of water vapour are lower through the wall section as the colder temperatures are less able to promote evaporation and/or carry water vapour within the air. The quantities of vapour measured at each sensing point are also similar or more closely aligned during the winter period and now there are periods of time when the quantity of vapour is at its highest in proximity to warm, centrally heated, internal conditions. This is most marked in the week beginning 21/02/13 at the end of the reporting period where it

would seem in response to extreme internal and external temperature difference measurements of absolute humidity are unusually dispersed through the wall section and increase in quantity in proximity to internal conditions (the inverse of the summertime pattern). It has been speculated that this behaviour is in response to a very cold but sunny period where the internal room temperature is increased above its usual 18°C to a winter peak of 20°C by solar radiation (entering the building through it's glazing) heating the internal environment and increasing absolute humidity within the room and immediately behind the drylining. This, coupled with cold and dry conditions externally, provides an unusually sharp delineation of quantities of absolute humidity through the wall section.

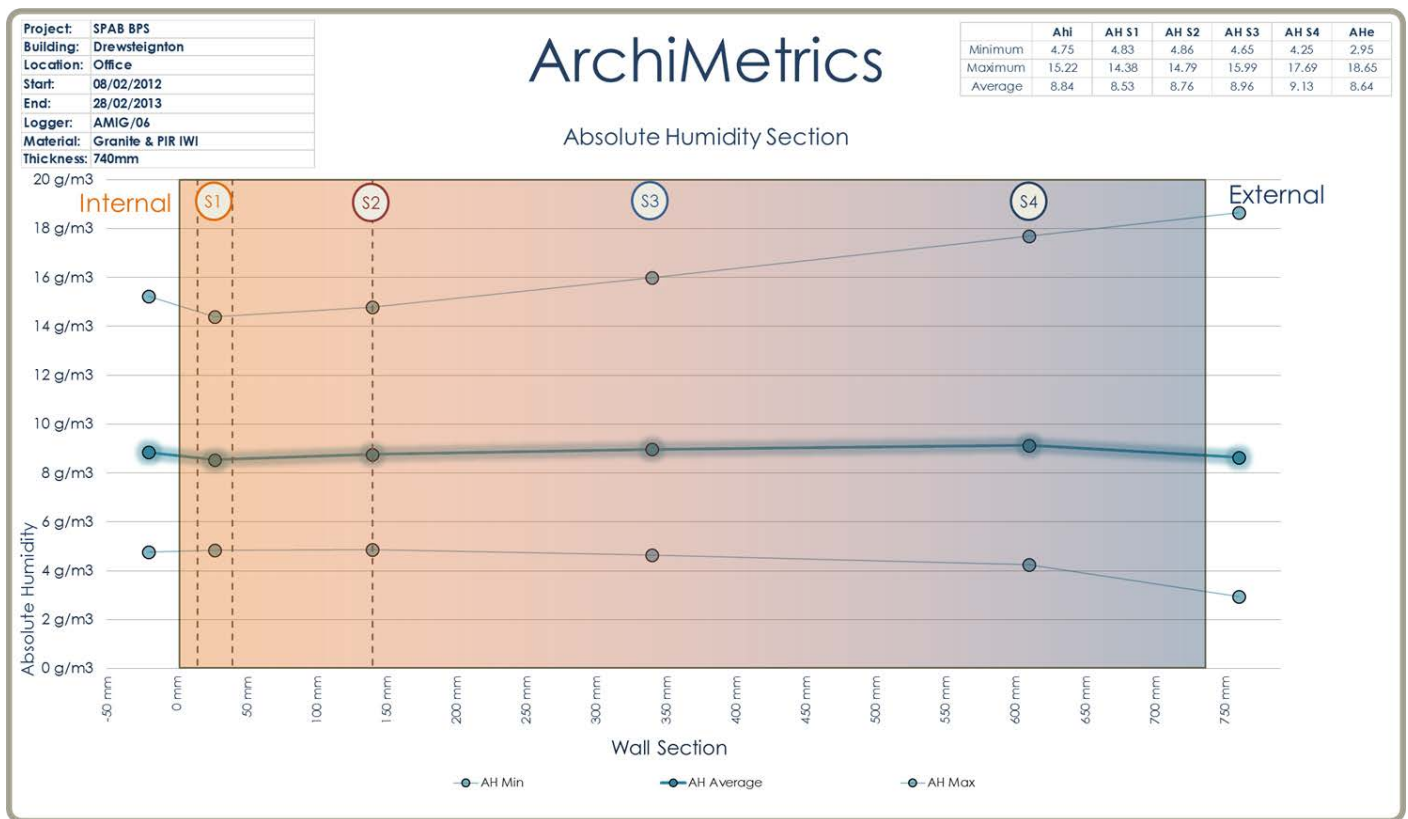
Figure 16: Absolute Humidity Section, Mill House, Drewsteignton 2012 - 2013.

The absolute humidity section for Drewsteignton, Figure 16, provides an indication of the average g/m³ of water vapour either side of and through the wall section over the period 8th February 2012 - 4th March 2013. From this graph it can be seen that at this location quantities of internal and external water vapour are very similar, 8.84 g/m³ internally and 8.64 g/m³ externally, suggesting that by and large conditions with regard to quantities of water vapour are similar both inside and outside the property. The highest average weight of water vapour over the reporting period is recorded within the wall at the sensor 4 position towards the exterior wall face and diminishes in quantity travelling back through the wall section to the interior side. This gradient may be significant with regard to other observations of humidity conditions within the wall as it suggests that vapour movement through the wall may be static or indeed in a reverse direction, that is to say travelling towards the interior side of the wall. As is standard, the PIR insulation is sandwiched between aluminium foil and the joints of these boards are taped with adhesive foil tape upon installation. This foil creates a mostly impermeable layer and resists the passage of water both in a liquid and vapour form. In situations of reverse vapour flow this layer may prevent the progress of vapour through the wall section thus causing humidity to increase within the structure. Therefore perhaps it is possible that the incorporation of this insulation may account for the trend of rising %RH previously noted for this wall (Figure 8).

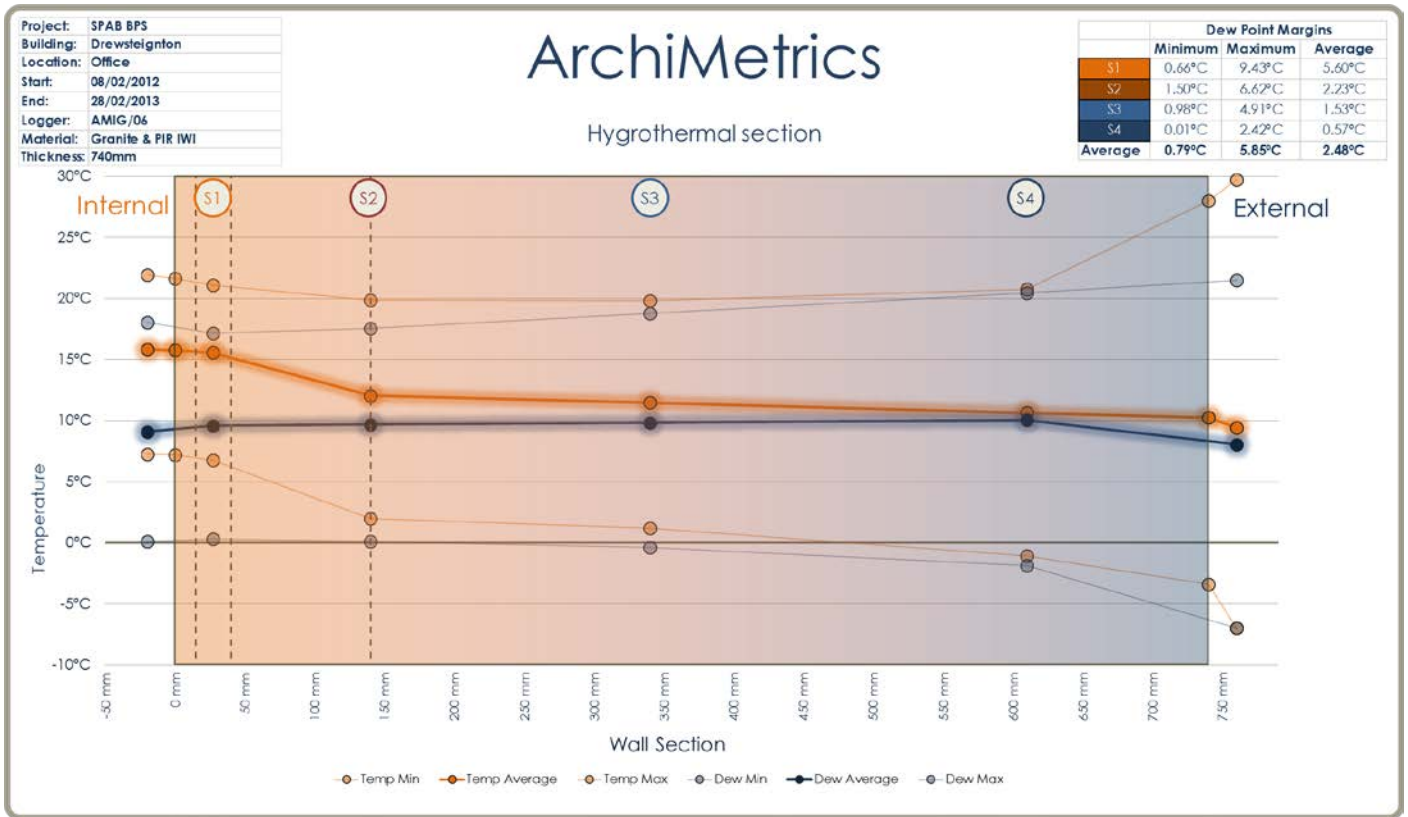
Figure 20: Hygrothermal Section, Mill House, Drewsteignton 2012 - 2013.

Figure 20 allows an examination of temperature and dewpoint gradients through the wall section at Drewsteignton recorded over 13 months, between 8th February 2012 - 4th March 2013. Figure 73 reproduces the graph from the 2012 Interim report which shows plots of these same gradients over a shorter period, spring and summer 2012. The temperature profile through the section remains very similar over the two reporting periods and shows the different thermal resistances of the wall materials. The gradient is steep through the PIR insulating layer section (the addition of 100mm of PIR reduced the wall's measured U-value from 1.20 W/m²K to 0.16 W/m²K) and much more shallow, 1 - 2°C difference, through the original granite masonry of the wall reflecting the reduction of heat travelling through this part of the wall as a result of the internal wall insulation. As is to be expected the dewpoint margin (the temperature drop required for dewpoint to occur at a certain point) is at its narrowest towards the coldest part of the wall. Prior to insulation, in 2011, the dewpoint margin averaged across all four measurement sensors for the wall was 4.01°C, and the average at the most vulnerable outer 4th sensor in isolation was 2.38°C. From the spring/summer 2012 data (Figure 73) the average dewpoint margin across all four sensors was reduced to 2.77°C and 0.64°C for the fourth sensor alone. Now, with a complete annual cycle of data (Figure 20) the margins are found to have reduced slightly once more and are 2.65°C averaged across all four sensors and 0.61°C at sensor 4. This further reduction reflects the addition of colder autumn and

winter temperatures into the data set, cold temperatures inevitably increase %RH and thus moves conditions within the fabric closer towards dewpoint.

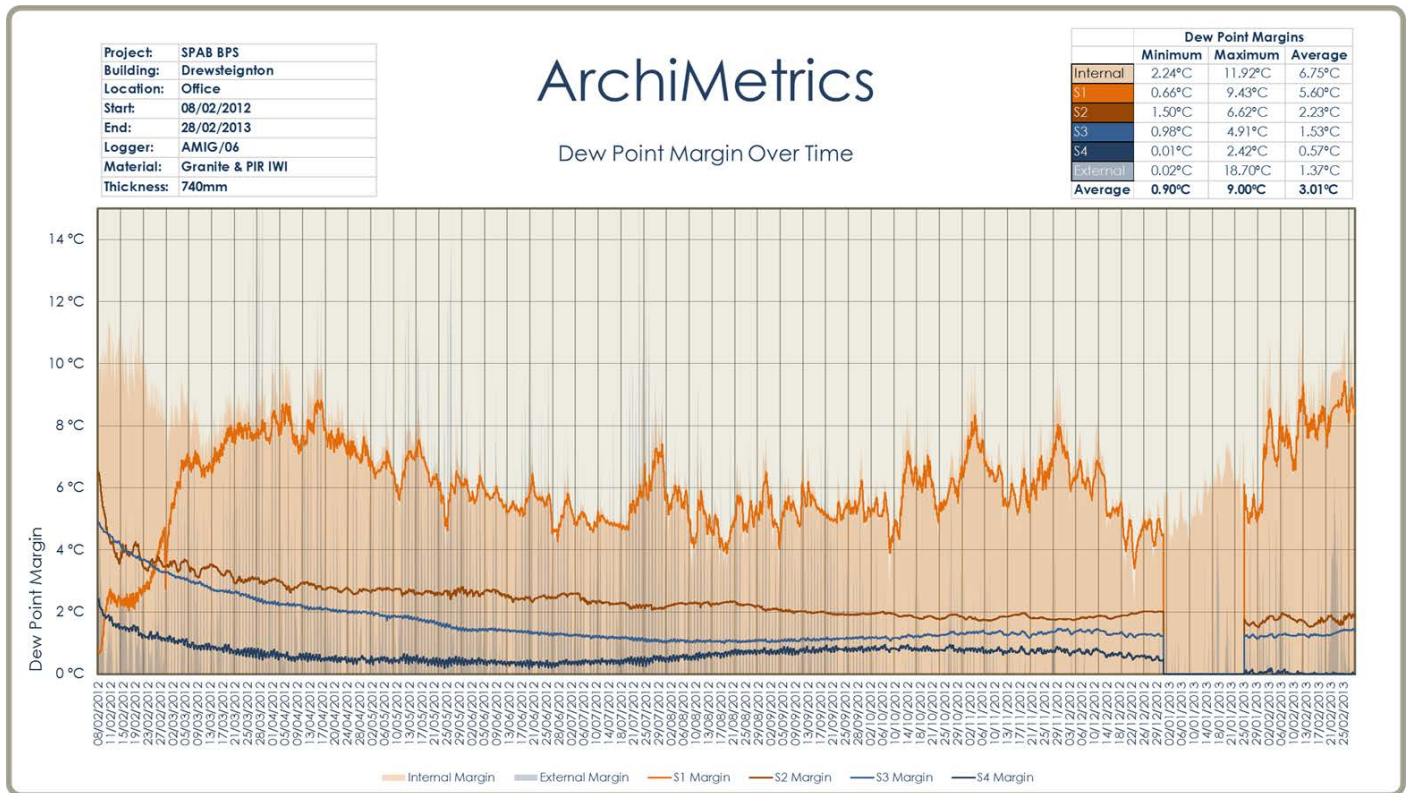
Figure 24: Dewpoint Margin over time, Mill House, Drewsteignton 2012 - 2013.

Figure 24 presents a plot of dewpoint margins over time for the wall at Drewsteignton. Dewpoint is a function of %RH thus, as with the trend of increasing %RH for this wall (Figure 8) an inverse trend of decreasing dewpoint margins is found over the reporting period. Likewise, as with the plots of %RH there is an interruption in this trend at sensors 3 and 4 for a period of time (although not at sensor 2 at the insulation/masonry interface) but following this, entering the coldest months of the year, margins at all three sensors continue to narrow. Indeed, from the end of January 2013 the margin at sensor 4 has reached 0°C, i.e. there is no margin and this location is at 100%RH or saturation. The reduction of dewpoint margins found for the wall at Drewsteignton is similar to that found for other internally insulated walls and is probably at least in part a response to the reduction of heat passing into the original fabric of the wall as the colder temperatures increase %RH. However, the reduction in dewpoint margins at Drewsteignton, particularly at the 4th node (average 0.61°C) are quite extreme and in this sense may be a response to the extreme heat loss reduction that has occurred as a result of the application of 100mm of PIR insulation and also the introduction of a vapour barrier, in the form of the aluminium foil facing either side of the PIR insulation, which prevents the migration of vapour. The addition of insulation reduced the U-value measured for the wall from 1.20 W/m²K to 0.16 W/m²K a reduction in heat loss of 87%. The highly reduced dewpoint margins at Drewsteignton may also be a reflection of the increased presence of vapour within the wall over time as indicated by the overall trend of rising %RH, as vapour accumulates dewpoint is more likely to be reached. In this context however it should be noted that as condensation is a function of both humidity and temperature it is highly dependent upon ambient conditions, particularly external weather conditions and this reporting period covers a year which has been noted for high rainfall and cold winter temperatures. The degree to which the temperature and moisture behaviour of the wall at Drewsteignton is a response to these extremes of weather, rather than the addition of internal wall insulation, is difficult to determine. However, by monitoring the wall over the longer term the drivers of hygrothermal behaviour should become clearer. For example, we may find after a warm and dry summer %RH starts to reduce and falls below 80% once more or that the wall reaches some form of thermal and moisture equilibrium which reflects the affect of significant heat loss reduction over the longer term.

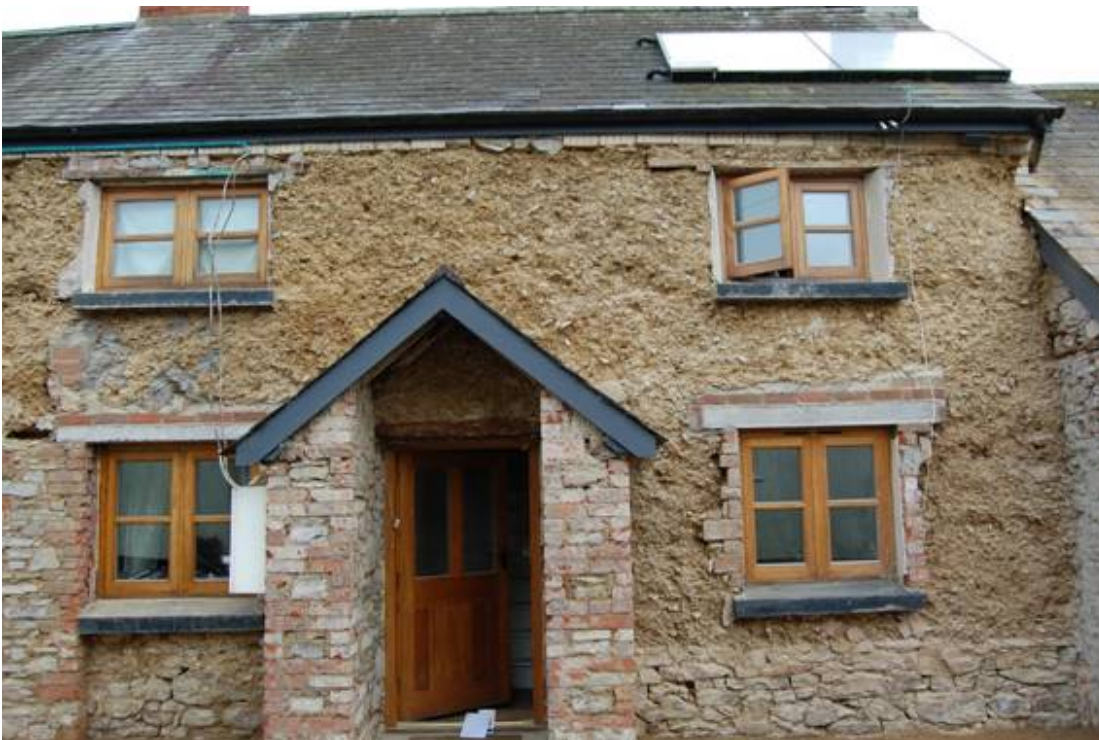
Figure 76. The Firs, Riddlecombe front elevation showing masonry buttress bottom left of frame.

In the summer of 2011, during the re-rendering of the south facing front facade at The Firs, Riddlecombe, it became apparent that the area of the wall under examination in this survey included an external stone buttress that had previously been hidden under the cement render (Figure 76). The addition of this component altered the build up of the wall used for U-value calculation purposes and new U-value calculations were undertaken for both the uninsulated and insulated walls to take account of these differences. These were reported in Table 10 of the 2012 version of the Building Performance Survey report (naturally the measured in situ U-values were unaffected by these changes). Subsequently, during the monitoring that has taken place in 2013, further details of the wall build ups at Riddlecombe have emerged resulting in minor alterations to the dimensions of the individual components that comprise the measured wall section. To reflect these changes new U-values have been calculated once again and details of these calculations and updated wall build ups are given in Table 16 below. The pre and post insulation calculated U-values have altered slightly increasing from 0.93 to 0.95 W/m²K for the uninsulated wall at Riddlecombe, reflecting the greater quantity of more conductive stone within the overall build up and decreasing from 0.6 to 0.56 W/m²K for the same wall post insulation, as a result of an increase in the quantity of insulating render ascribed to this wall.

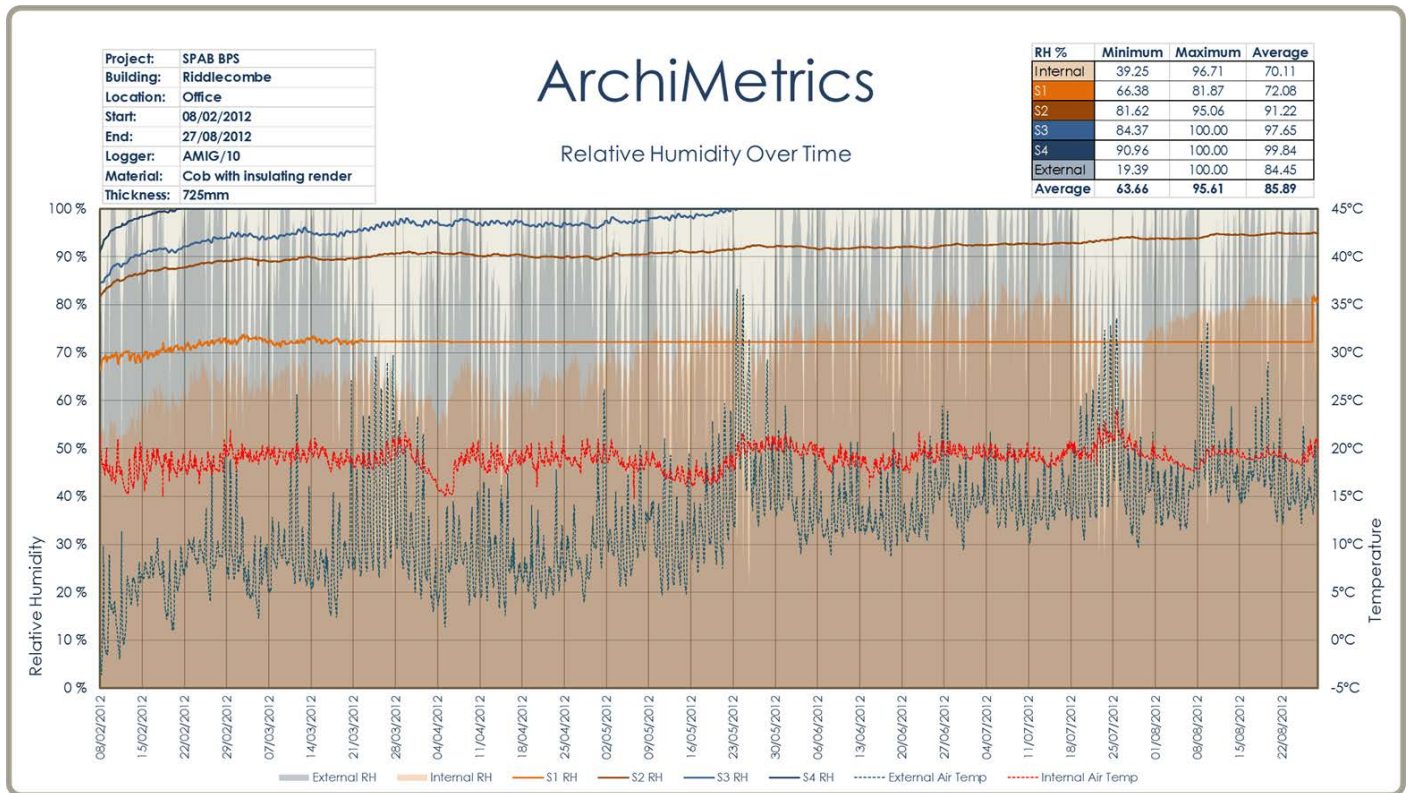
Over the same period the previous year, February - August 2012, a very similar plot of %RH behaviour over time was produced for the insulated wall at Riddlecombe (Figures 79 & 9). Both graphs show %RH rising within the wall at all four sensor positions over time and levels of %RH reaching 100% indicating saturation and the possibility of condensation, first at sensor four and then later into the summer, further back within the wall at sensor 3. However, there are some slight variations in the plots of %RH recorded during 2013 which may give some cause for optimism given the alarming trend of raised %RH within the wall. At sensor 3, 395mm into the body of the wall, in 2012 %RH rose from 84.37% to 100% over a period of 15 weeks and the average %RH over the whole reporting period, February - August 2012, was 97.65%. In 2013, at the same sensor, %RH rises from 85.6% to 100% over a longer period of time, 18 weeks and the average %RH at sensor 3 over the reporting period Feb - Aug 2013 is slightly lower, 96.57%. Furthermore, unlike the graph for 2012 (Figure 79) in 2013 there is also a hint that levels of %RH at sensor 3 may begin to reduce towards the end of the reporting period, around the week beginning 7th August 2013.

Figure 79. Relative Humidity over time, The Firs, Riddlecombe Feb - Aug 2012.

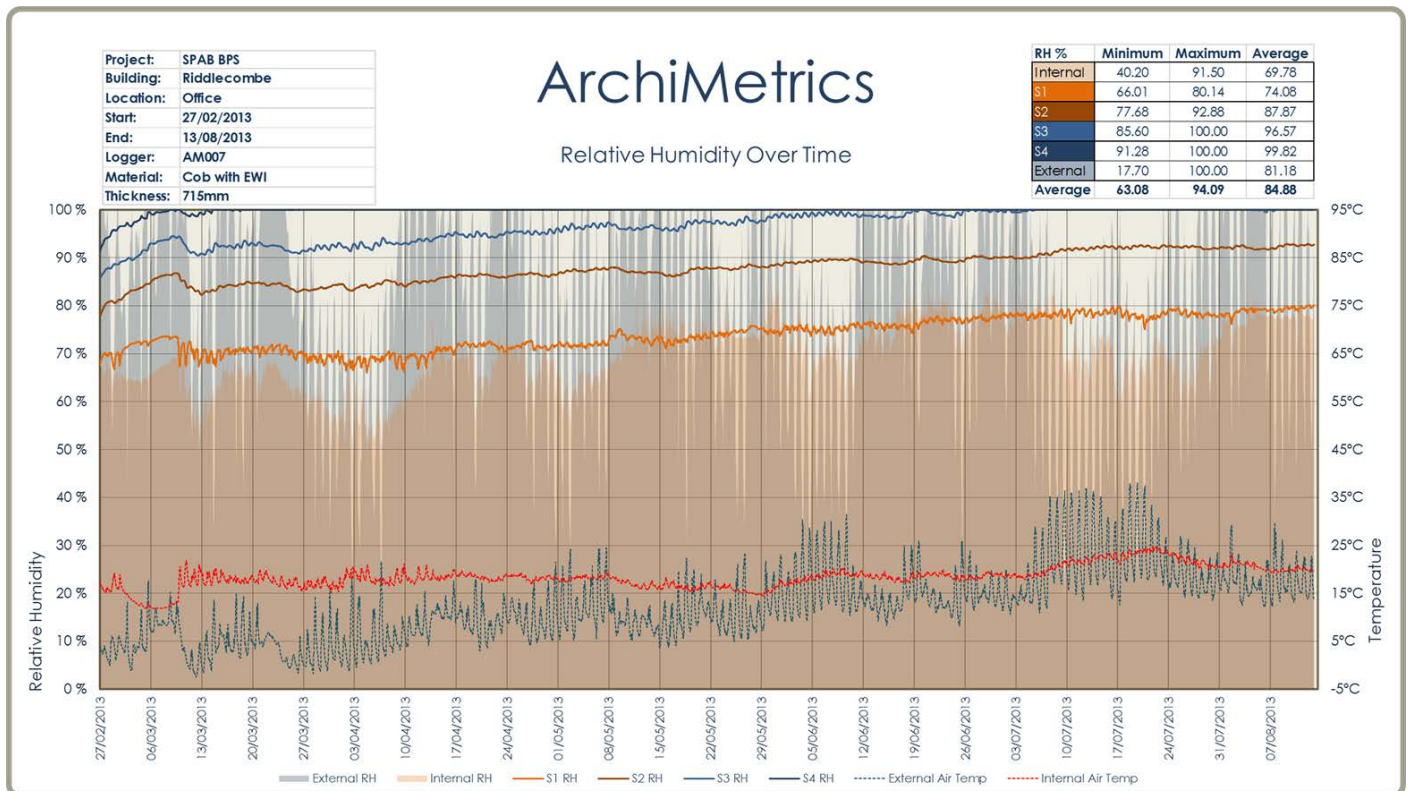
Figure 9: Relative Humidity over time, The Firs, Riddlecombe Feb - Aug 2013.

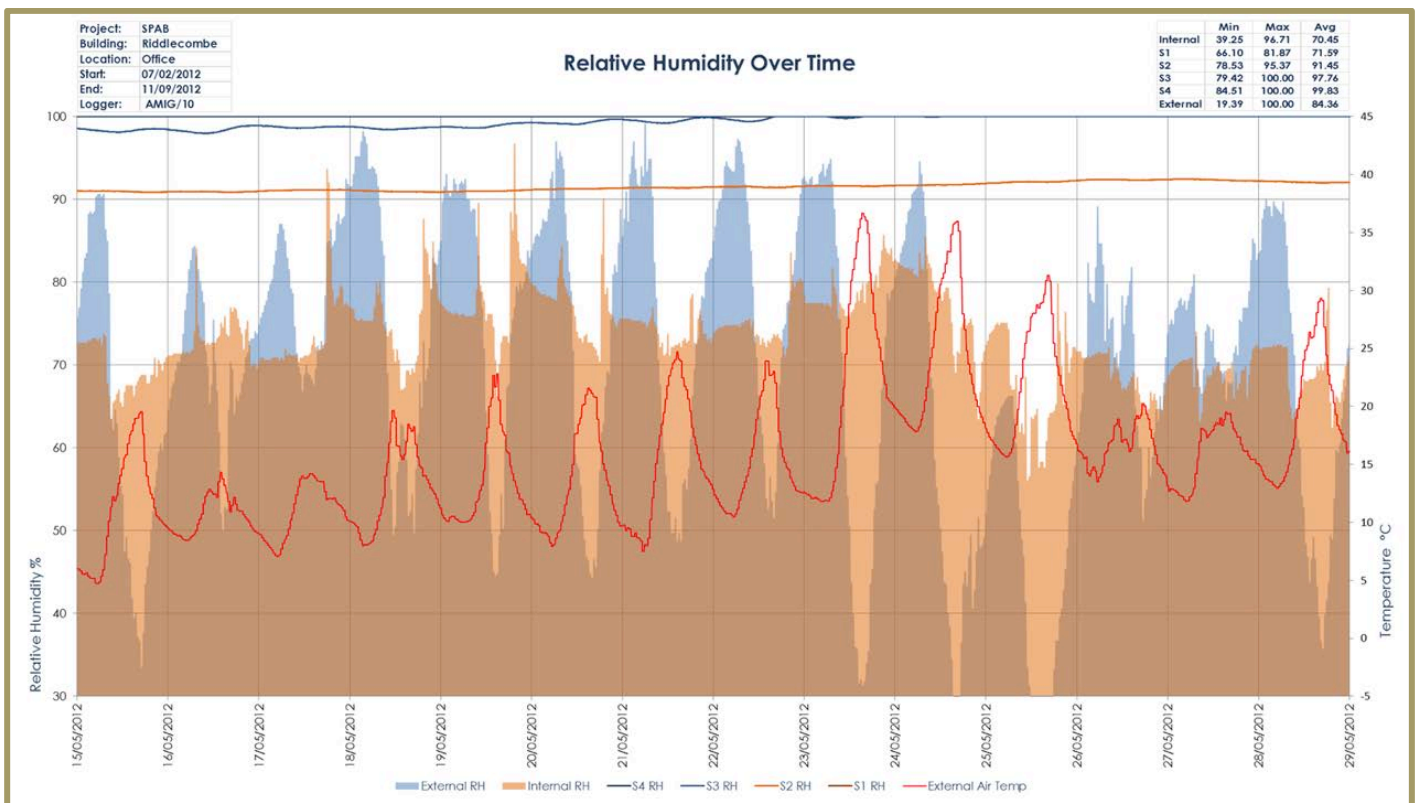
The discussion in the 2012 report stated "Figure 80 shows a detailed plot of the RH values for the wall at Riddlecombe between 15th - 29th May. It is during these two weeks that the level of RH measured at sensor 3 exceeds 100%. It appears that this occurs in parallel with rising external temperatures and a similar although somewhat delayed and less pronounced increase can be seen in sensor 2....In contrast to the wall at Shrewsbury where interstitial RH more or less maps that of external temperature and RH i.e. when temperatures rise interstitial RH falls the opposite appears to be happening in the wall at Riddlecombe. RH increases with external temperature increase and continues to accumulate over time. This leads us to speculate that the raised temperatures are perhaps causing bound construction water to develop into vapour which is in turn slow to migrate out of the wall due to the now in tact and much thicker external render system."

Figure 80. Detail - plots of interstitial RH, internal room RH and external RH and temperature, The Firs, Riddlecombe, 15th - 29th May 2012.

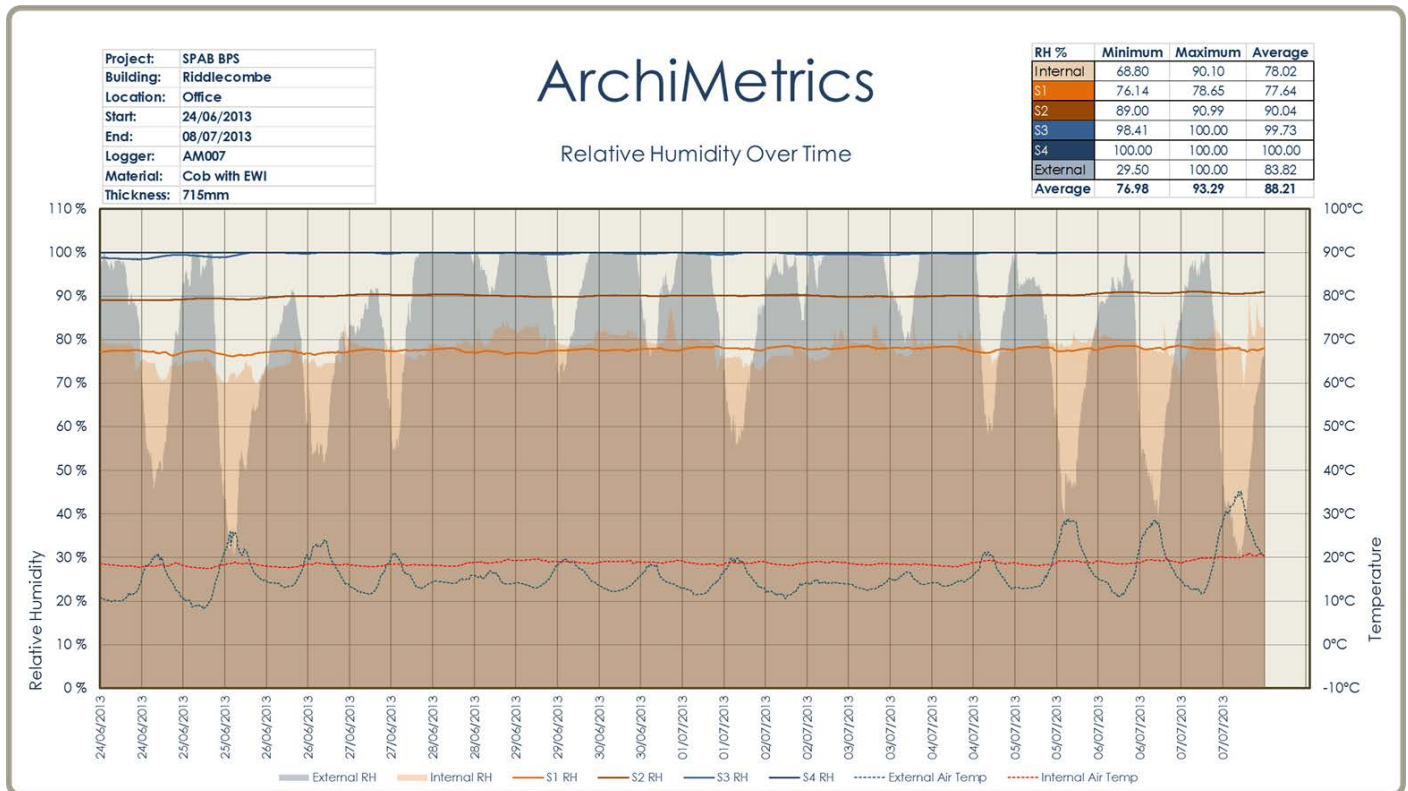
Figure 81 provides a detailed description of %RH behaviour during the two weeks that sensor 3 exceeds 100% this time over the summer of 2013. As with the previous year, this shows that the peak at 100% is achieved just shortly after a peak in external temperature on the 25th June and that, following this, humidity then hovers just below 100% during a period of slightly lower external temperatures but returns to saturation on the 4th July and remains there over the very warm days that follow.

Figure 81. Relative Humidity over time, Sensors 1 - 3, The Firs, Riddlecombe, 24th June - 8th July 2013.
