THE SPAB RESEARCH REPORT 2

The SPAB Building Performance Survey 2013 Interim Report

OCTOBER 2013.

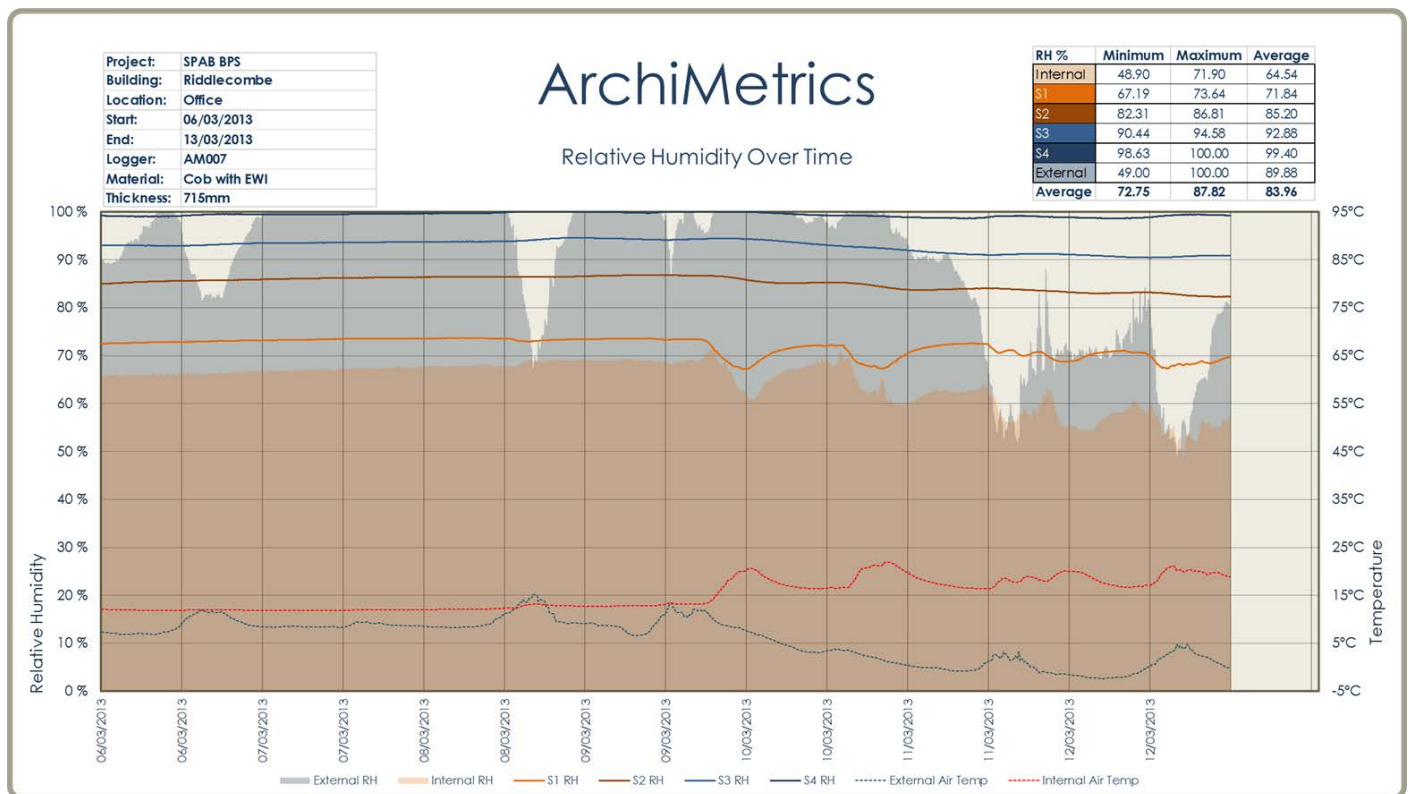
A detailed graph for a week earlier in the year also shows some interesting trends regarding %RH behaviour in the cob wall, Figure 82. Week beginning 6th March 2013 coincides with the end of the holiday period previously mentioned and therefore sees quite low internal room temperatures over the early part of this week. After the family has returned heat is once more input into the building and patterns of %RH measured at sensor 1, 60mm back from the internal wall face, immediately respond following the conventional pattern of decreasing %RH during periods of raised internal temperature. However, measurements from the other three sensors seem to be less determined by internal conditions and may be affected, contrary to orthodoxy, by a decline in %RH which follows the decline in external temperatures. Sensor 4, closest to the external wall face, in particular, seems to be responding to external conditions in this contrarian way where %RH peaks close to 100% during periods of slightly warmer temperatures during the days of the 11th and 12th of March.

Figure 82: Relative Humidity over time, Sensors 1 - 4, The Firs, Riddlecombe 6th March - 12th March 2013.

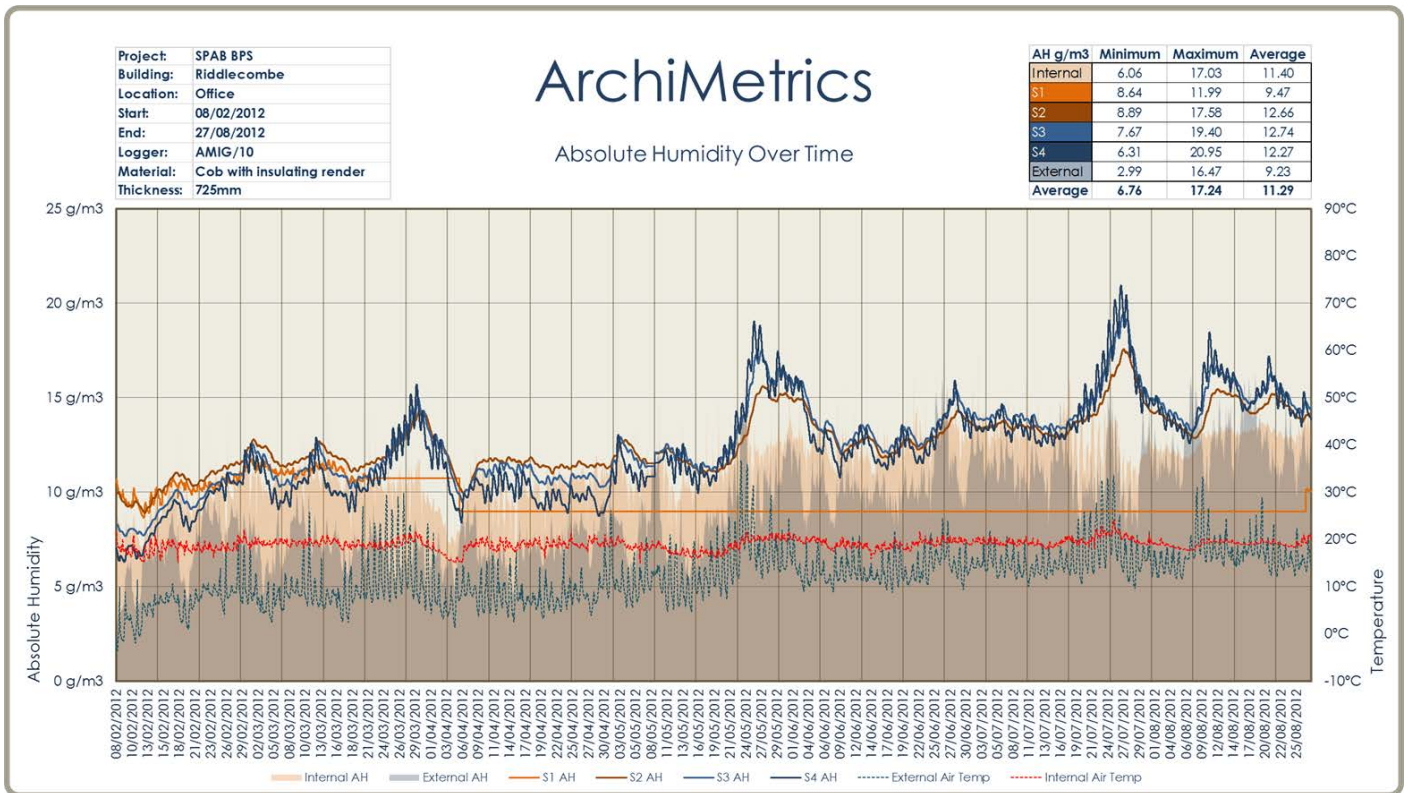
Following on from observations made concerning rising levels of %RH coinciding with warmer temperatures in the wall in Riddlecombe, plots of absolute humidity over time show an increase in vapour in the wall during higher external temperatures. This behaviour can be seen in the plots for both the 2012 spring and summer data (Figure 83) as well as this year's records, Figure 13. In both years the weight of vapour measured within the wall increases and peaks alongside peaks in external air temperature. Furthermore, over both years, these peaks are cumulative, that is quantities of vapour increase over time. In the discussion concerning %RH in the wall at Riddlecombe it was suggested that the increase in %RH measured in the wall over summer could be explained by vaporisation occurring from the wet cob material as a result of the higher temperatures within the wall. The plots of absolute humidity would seem to reinforce this notion as we can see vapour levels increasing during periods of high external air temperature. Once external temperatures diminish however neither absolute nor relative humidity levels return to those found prior to the warm spell. The fact that these levels of vapour appear to be cumulative suggests that once a certain quantity of moisture has vaporised from the cob material it then remains in a vapour form due to the warm temperatures and struggles to migrate out of the wall until such vapour has accumulated for parts of the wall to reach 100% RH despite summer time conditions.

Figure 83: Absolute Humidity over time, Sensors 1 - 4, The Firs, Riddlecombe February - September 2012.

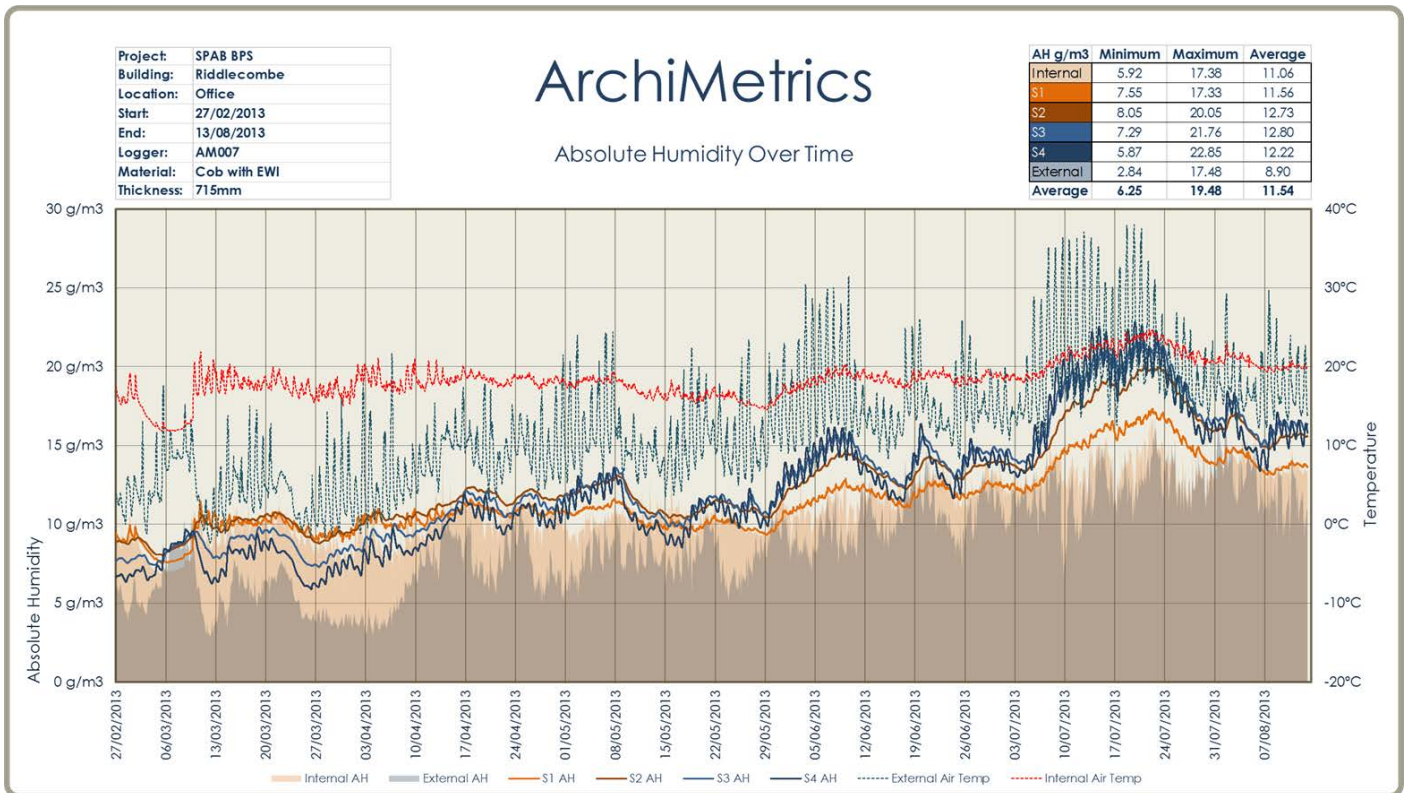
Figure 13: Absolute Humidity over time, Sensors 1 - 4, The Firs, Riddlecombe February - August 2013.

Although the graph for Riddlecombe, Figure 13, covers a shorter time period the increase in absolute humidity here also follows the seasonal pattern and increases with increasing external

temperatures/external absolute humidity. There is, however, a significant difference in the plots of absolute humidity for the wall at Riddlecombe compared with those at the other locations. By and large, plots of absolute humidity in the other walls broadly match, sit between or fractional surmount, those of internal and external levels of absolute humidity showing a close correlation between internal/external and interstitial conditions. At Riddlecombe plots of interstitial absolute humidity are detached from and significantly higher than those of external humidity and also internal absolute humidity from May 2013 onwards. This suggests that there is an additional or additional factors driving quantities of vapour in this cob wall independent of ambient internal and external vapour conditions. In the previous discussion on %RH and in the individual report on Riddlecombe it is suggested that excess moisture is contained within the cob as a result of a past failing external render as well as water added to the wall during the re-rendering process and this is vaporising during periods of warm temperatures as sun falls on the south facing wall. This might explain the detachment seen between internal and external vapour conditions and those within the wall, as the moisture within the cob material provides an additional and independent source of vapour.

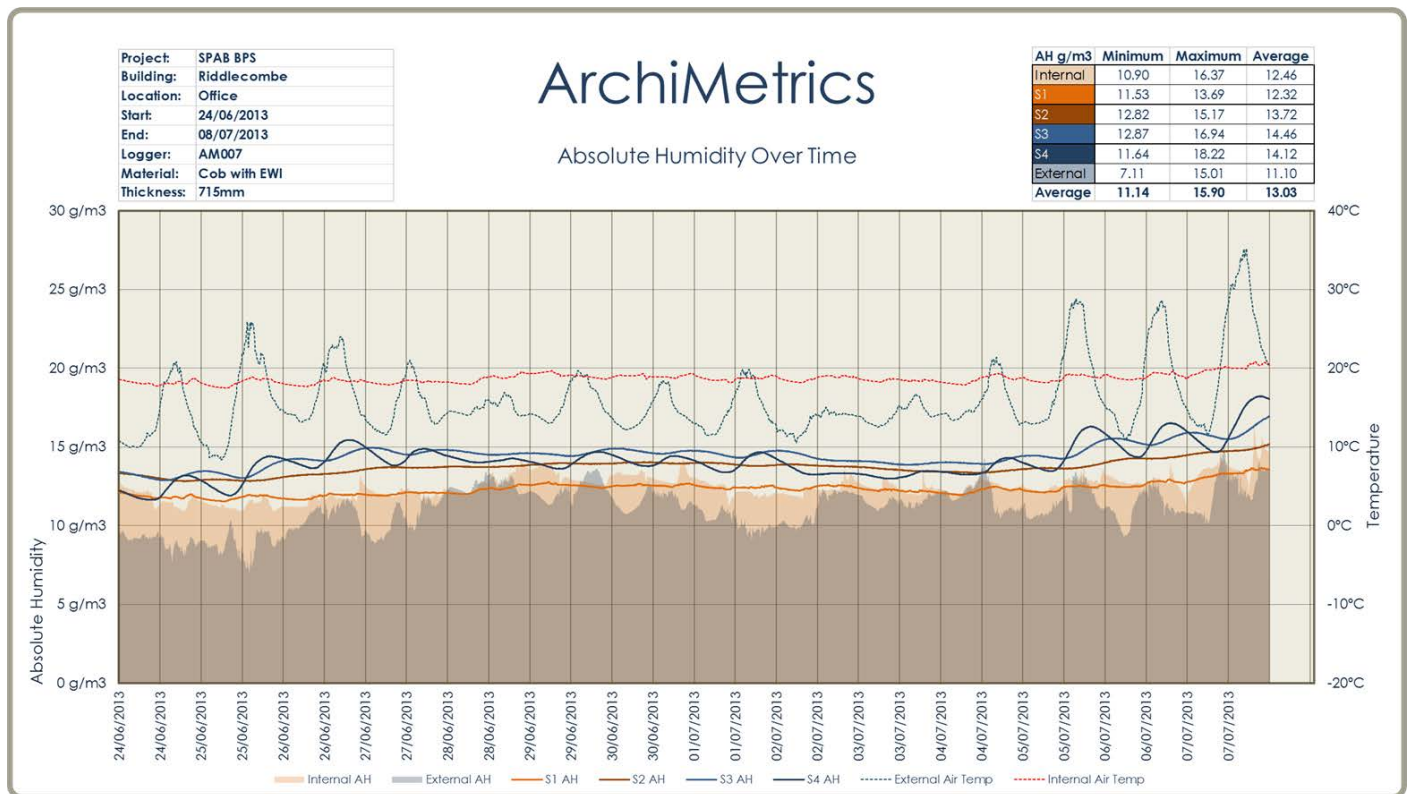
The same detailed weeks discussed in the commentary on %RH above have been graphed to provide a picture of the behaviour within the wall with regard to absolute humidity, Figure 84. Vapour responses at sensor 4 can be clearly seen to map increases in temperature in Figure 84, with similar, if slightly delayed and increasingly muted responses seen for the other three sensors in the wall. The period of time when external temperatures peak above 20°C and then 30°C beginning on the 4th July see an increase vapour throughout the wall section over this time.

Figure 84: Absolute Humidity over time, Sensors 1 - 4, The Firs, Riddlecombe 24th June - 8th July 2013.

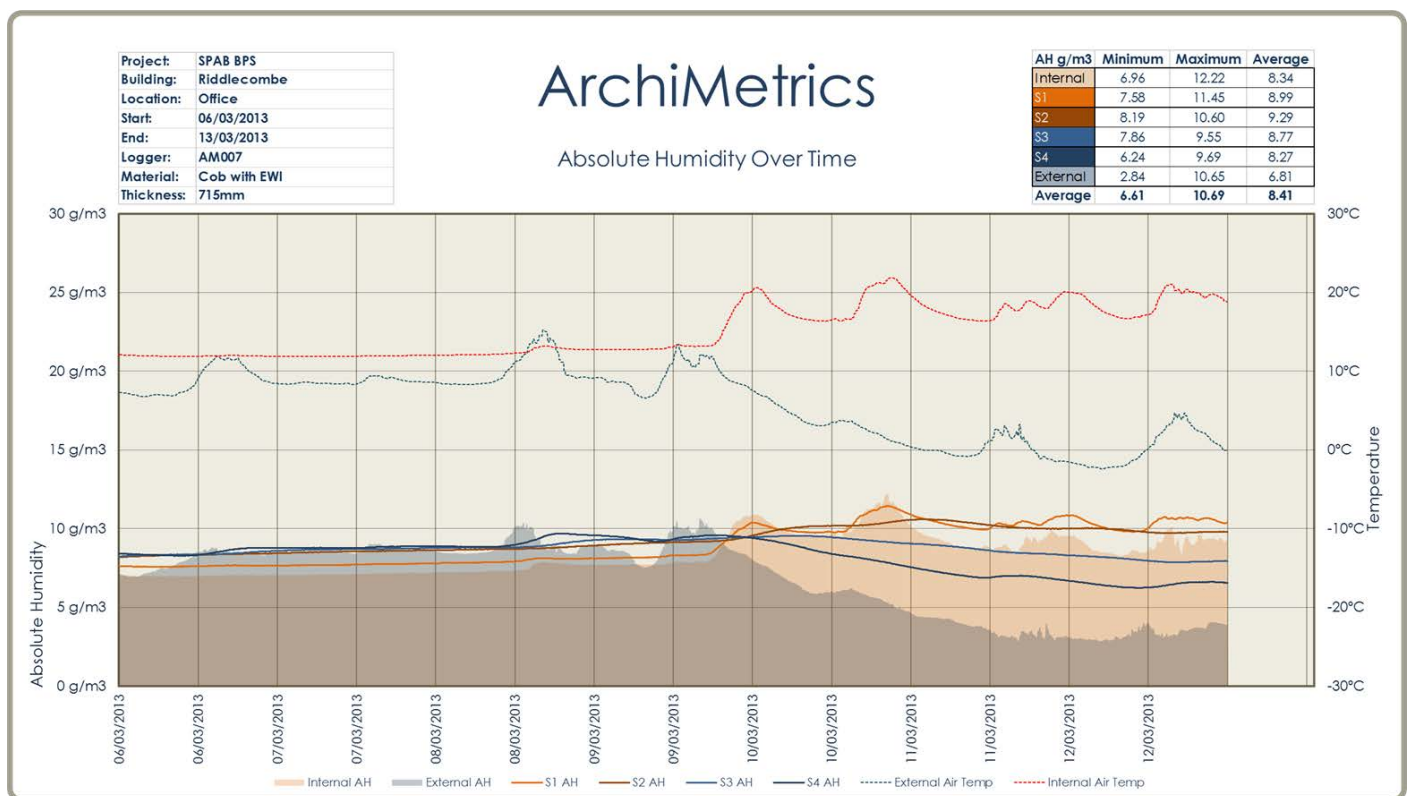
The detailed graph for the earlier week in the 2013 reporting period, Figure 85, shows increases in the g/m^3 of vapour at sensor 1 starting on 9th March which are a response to increases in internal room heat (despite the increase in vapour %RH declines at this location during these periods due to the ability of warm air to hold greater quantities of water as a vapour, Figure 85). Quantities of vapour measured at sensor 2 may, in this early colder period of the year, also be mostly determined by heat originating from inside the building, as, at least initially, following 9th March g/m^3 of vapour increase at this location like that of sensor 1. However, this increase in vapour quantities following the input of interior heat to the wall is not seen further out towards the exterior at sensors 3 and 4, where, contrary to sensors 1 and 2, g/m^3 of vapour decline over this time and show only slight increases (at sensor 4 only) during slightly raised daytime temperatures on 11th and 12th March 2013.

Figure 85: Absolute Humidity over time, Sensors 1 - 4, The Firs, Riddlecombe 6th March - 12th March 2013.

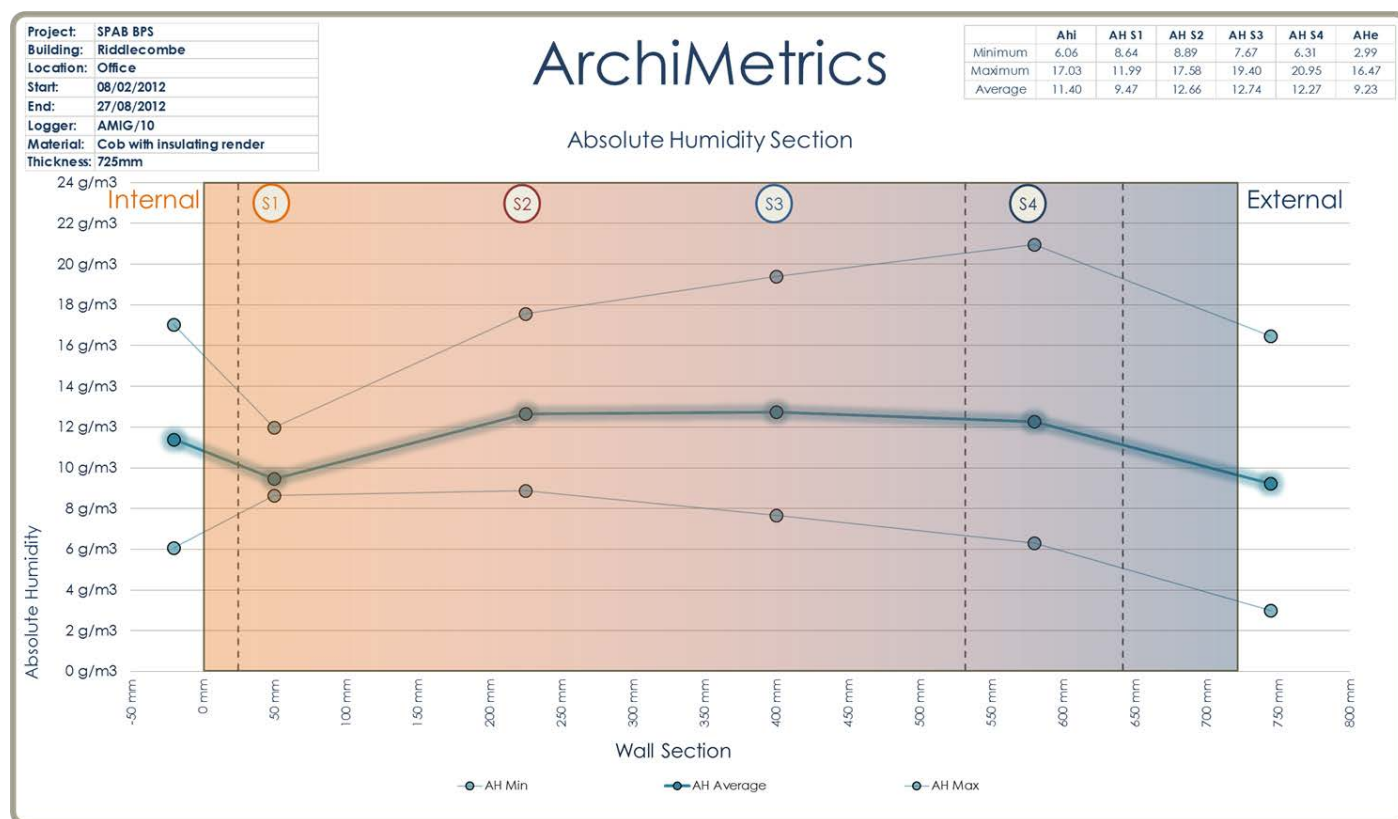
The absolute humidity profile of the wall at Riddlecombe is also provided in the form of a section graph which plots the average g/m^3 of water vapour either side of and through the wall. Figure 86 shows the section for the 2012 data and Figure 17 the section for 2013. Both the 2012 and 2013 sections finds that of the four sensors in the wall sensor 3 records the highest weight of vapour by volume; 12.74 g/m^3 in 2012 and the slightly higher value of 12.80 g/m^3 in 2013. On average the total weight of vapour in the wall has increased from 47.07 g/m^3 in 2012 to 49.31 g/m^3 in 2013 but comparison of the two years shows that vapour is also distributed slightly more evenly throughout the section in the 2013 readings. This may suggest that whilst vapour still seems to be accumulating in the wall at Riddlecombe that there is also some movement in this vapour outwards from the centre of the wall towards the wall surfaces where, given suitably vapour permeable finishes, there may be some chance of vapour migration to the inside/outside occurring.

The relative and absolute humidity data from Riddlecombe leads us to speculate that we may be watching the damp cob wall at Riddlecombe drying out, or at least beginning to dry out, albeit very slowly. The cob was found to be wet prior to refurbishment, mostly likely as a result of the cracked external cement render. Whilst the replacement of this render took place over 4 weeks in the summer, which provided a short opportunity for drying of the cob, the application of the new insulating external render also involved the significant wetting of the substrate with a water hose. In these circumstances, it may be that the cob at Riddlecombe has a high moisture content; additional measurements, as well as damp insulating material removed from the monitoring wall cores prior to the commencement of refurbishment monitoring, suggest this is the case. Therefore, rather than seeing vapour accumulating within the cob material due to low rates of ventilation and air permeability, high rates of internal humidity and the inhibition of internal to external vapour flows, instead, during periods of high external temperatures, the south-facing wall heats up enough to cause the moisture that is bound within the cob material to vaporise. If, as is may be suggested by the 2103 absolute humidity section (Figure 17), this vapour then migrates towards internal or external wall surfaces then there is a possibility that it can be dispelled into the atmosphere. Whilst the quantity of vapour appears to have increased over time between 2012 and 2013 this may be a factor of the quantity of moisture held within the cob and the warmer temperatures of the 2013 summer encouraging more vaporisation. However whether this actually leads to lower quantities of moisture overall within the wall relies on the ability of this vapour to travel through the materials to exit the wall. In Figure 9, the %RH over time graph for summer 2013 for this wall, it is possible to see a very slight recovery in %RH measurements at sensor 3, which dip below 100% RH occurring around the week beginning 7th August. This may suggest that vapour is able to successfully migrate through the wall structure and therefore we may see %RH values measured in this wall begin to reduce however, at present, overall vapour quantities appear to still be increasing. Monitoring over the longer term will

Figure 86: Absolute Humidity Section, The Firs, Riddlecombe February - September 2012.

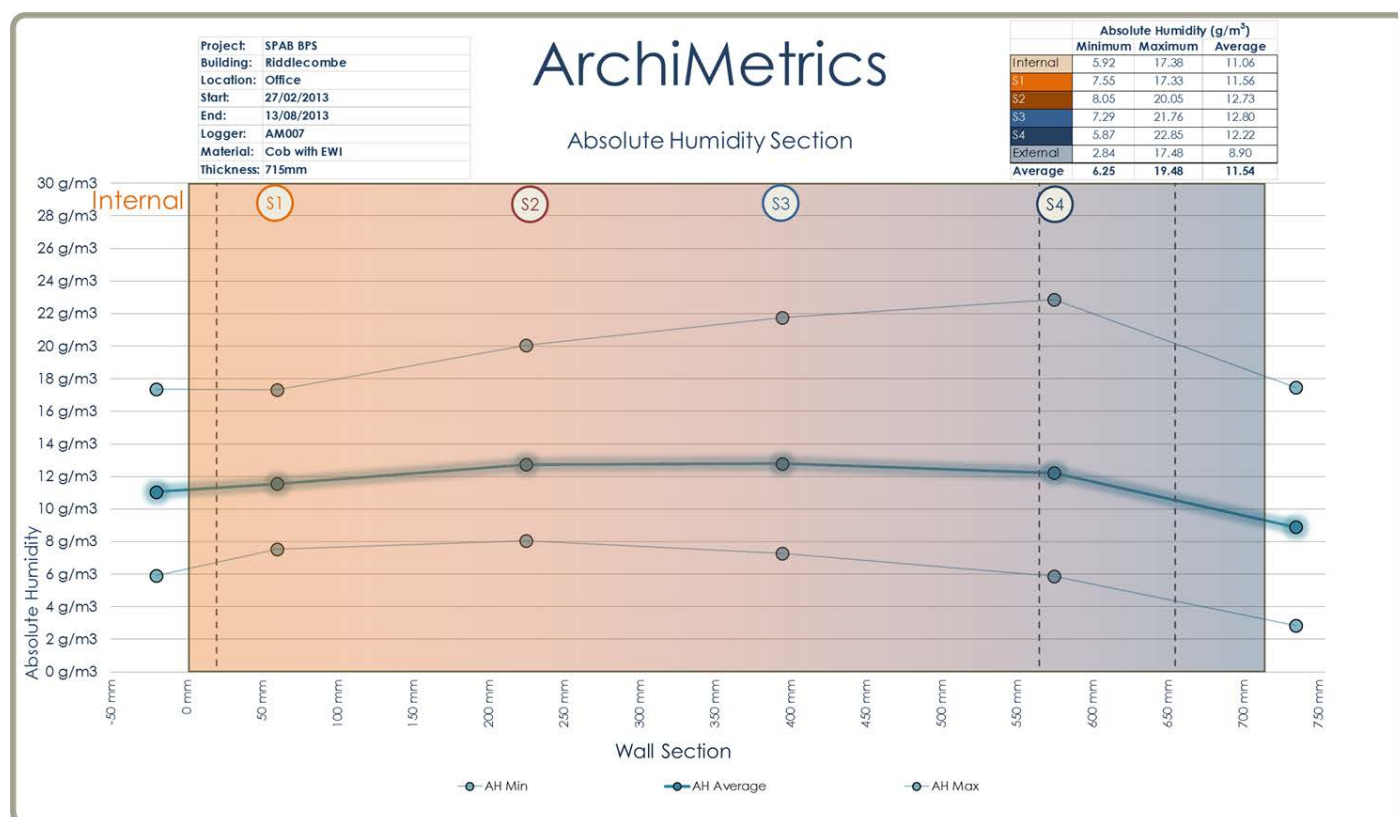
In Figures 14-17 the average absolute humidity values through and either side of the four wall sections under study have been plotted along with the maximum and minimum values recorded over the reported monitoring period. These result in more or less flat gradients, showing more or less similar quantities of vapour through the wall sections with the exception of Riddlecombe, Figure 17.

Figure 17: Absolute Humidity Section, The Firs, Riddlecombe February - August 2013.

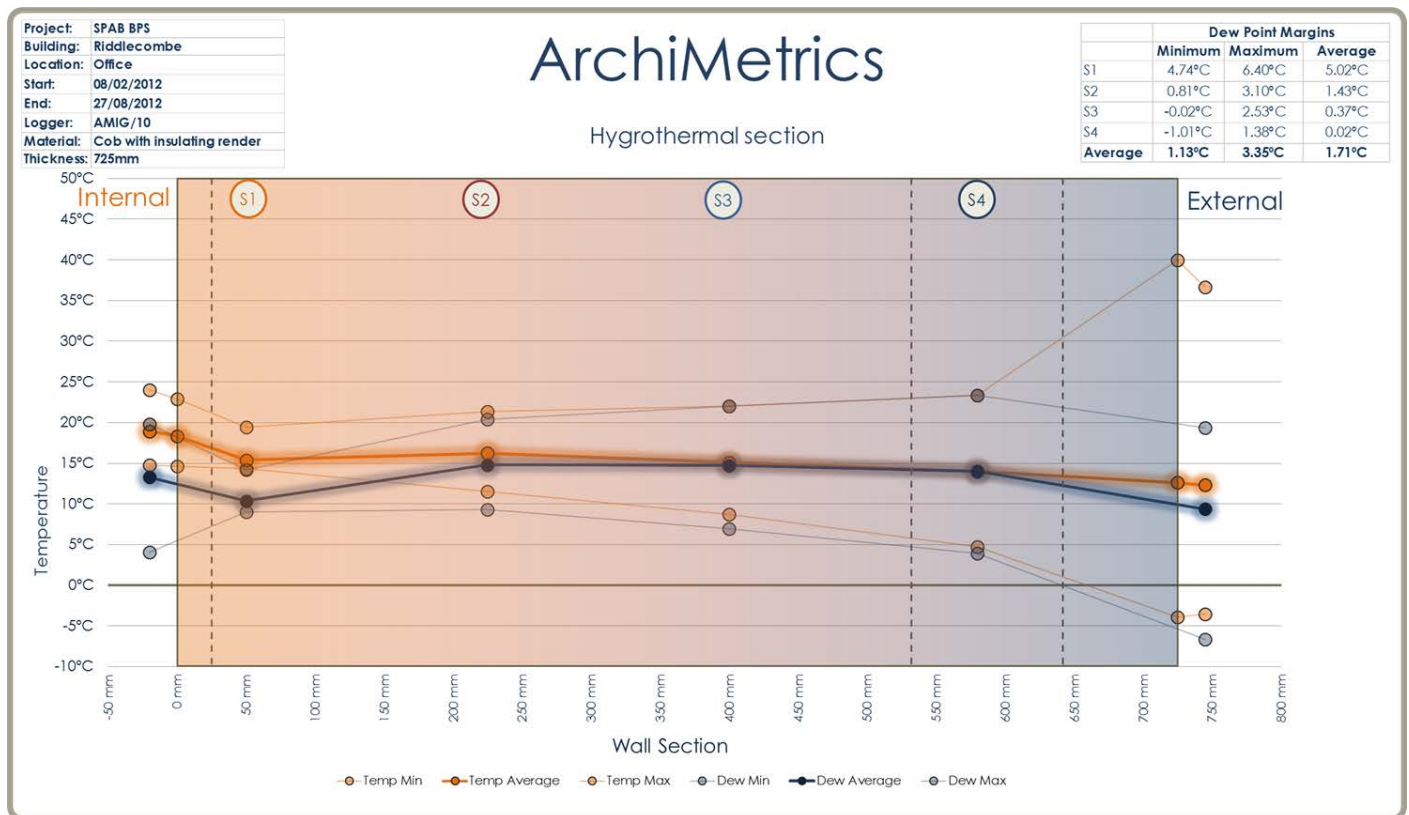
Figures 87 & 21 allow an examination of the temperature and dewpoint gradients through the wall section at Riddlecombe recorded over the periods February - August 2012 and 2013. Ostensibly these look very similar for both years where the temperature and dewpoint margins narrow towards the external side of the wall and are coincidental between sensors 3 and 4. There is a slight difference for the plots of temperature gradient towards the internal side of the wall; in 2012 there is a dip in the temperature/gradient at sensor 1 between the internal surface and sensor 2, whereas in 2013 the temperature recorded at sensor 1 has increased and the gradient begins to decline through the wall from this point. Whilst the temperature at sensor 1 seems to have improved at this location the dewpoint margin (the hypothetical temperature drop required for dewpoint to occur) has, however, decreased from 5.02°C in 2012 to 4.70°C. This narrowing is unexpected as %RH should decrease with increased temperatures and was occasionally found to do so during the early part of the year, see Figure 9. Therefore, this is perhaps a reflection of the increased quantities of vapour found in general over the longer term at this point in the wall in 2013 as compared with 2012, something that is confirmed by records of absolute humidity for 2012 and 2013 at this location (Figures 86 & 17).

Figure 87: Hygrothermal Section, The Firs, Riddlecombe February - August 2012.

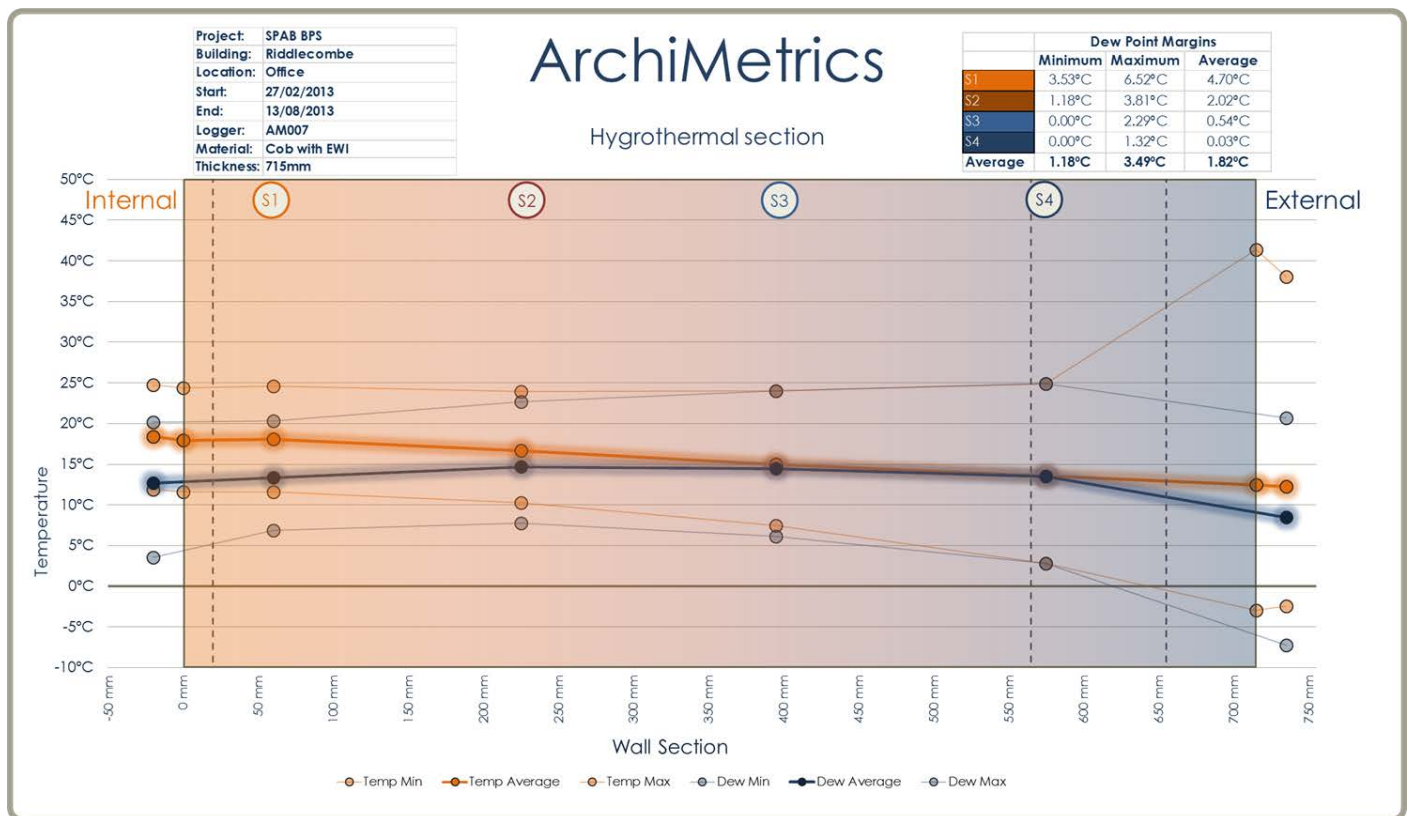
Figure 21: Hygrothermal Section, The Firs, Riddlecombe February - August 2013.

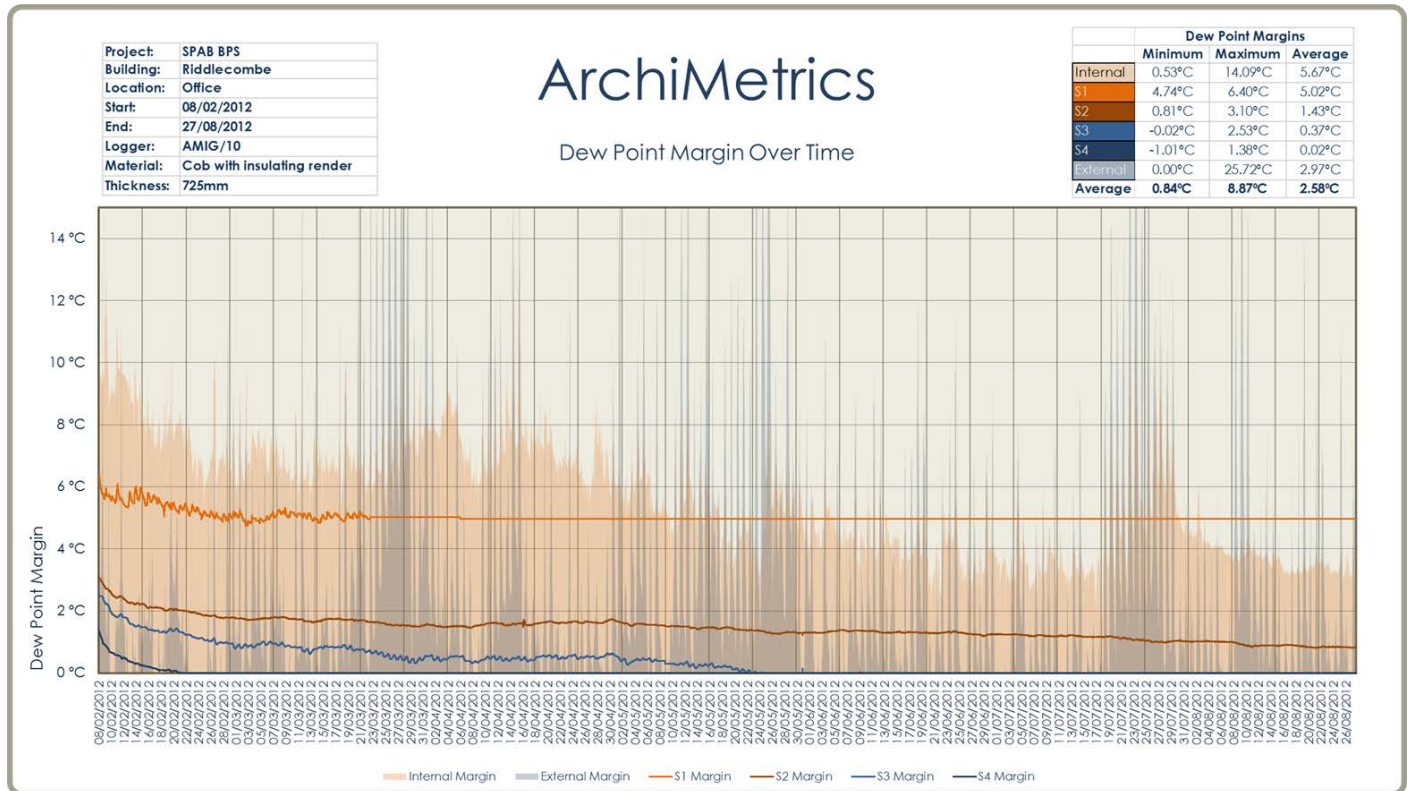
The dewpoint margins for the wall at Riddlecombe are also expressed for each sensor plotted over time, Figures 88 and 25. Once again, the graphs for 2012 and 2013 do not appear to be significantly different to one another and both show the same pattern of decreasing dewpoint margins over time. Over the two reporting periods first the margin at sensor 4 reaches a margin of 0°C followed later by sensor 3. However, there are slight differences between the two years and whilst it would appear that saturation is occurring within some parts of the wall, as with the %RH findings (Figure 9) it takes a longer period of time for this to occur at sensor 3 in 2013. But perhaps most significantly, despite a slight increase in quantities of vapour in the wall in 2013 (Figure 17) the overall dewpoint margin for all four sensor positions has also increased very slightly from 1.71°C in 2012 to 1.82°C in 2013. This may reflect the slightly higher temperatures recorded at 3 of the 4 sensor positions for the 2013 period, which, despite high and increasing quantities of vapour, are able to lower the %RH sufficiently to cause this small increase in the overall dewpoint margin for 2013. Indeed records of %RH for the wall overall show a fractional improvement in overall %RH between 2012 and 2013, from 90.20% in 2012 to 89.59% in 2013. Furthermore, as with the 2013 plots of %RH over time (Figure 9) a slight recovery can be seen towards the end of the reporting period in the dewpoint margin at sensor 3. This may indicate the start of an improving situation for the wall where excess material moisture is slowly reducing via cycles of

Figure 88: Dewpoint Margin over time, The Firs, Riddlecombe February - August 2012.

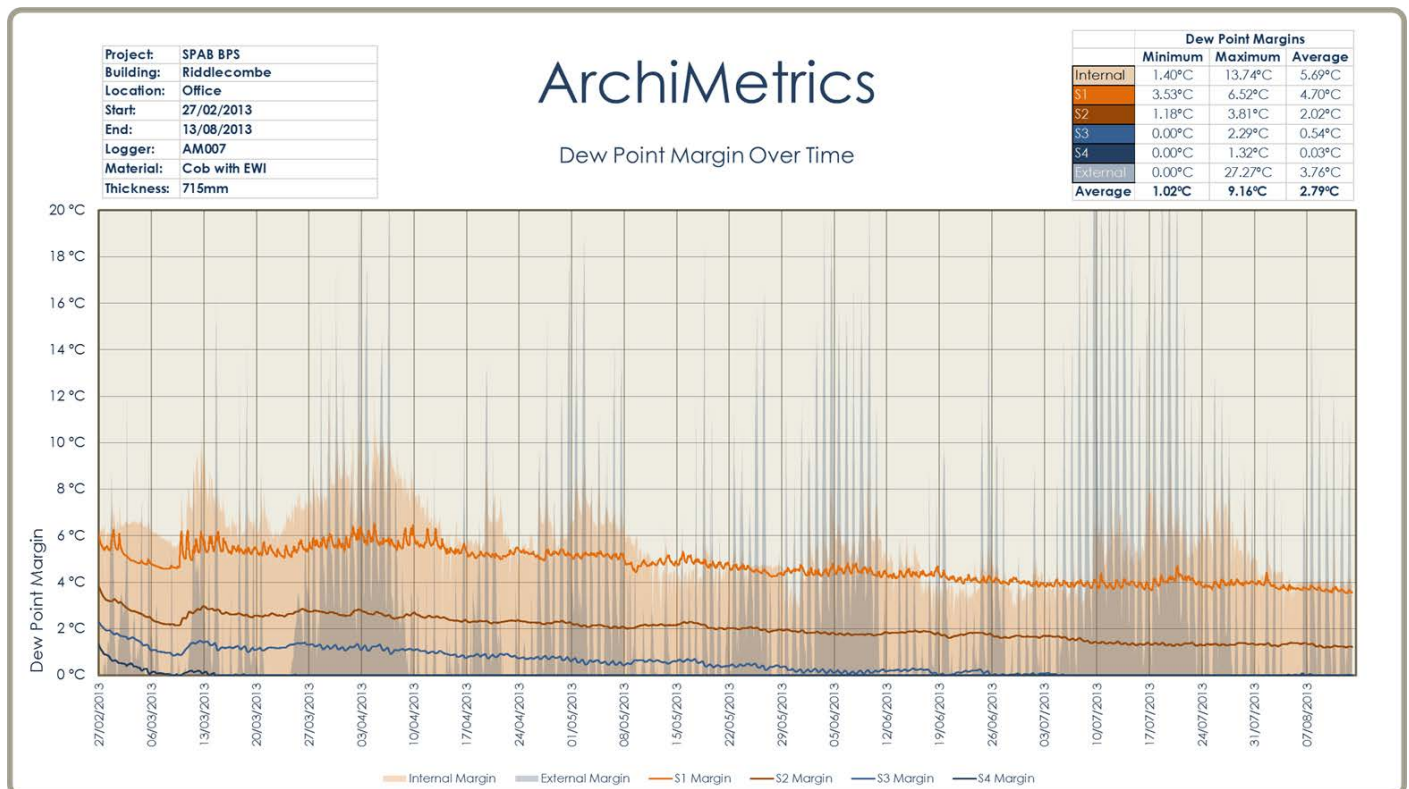
Figure 25: Dewpoint Margin over time, The Firs, Riddlecombe February - August 2013.
