Repair of Wood Windows

SPAB Technical Advice Note

Andrew Townsend, Architect and SPAB Lethaby Scholar
Martyn Clarke, Carpenter/Joiner and SPAB William Morris
Craft Fellow

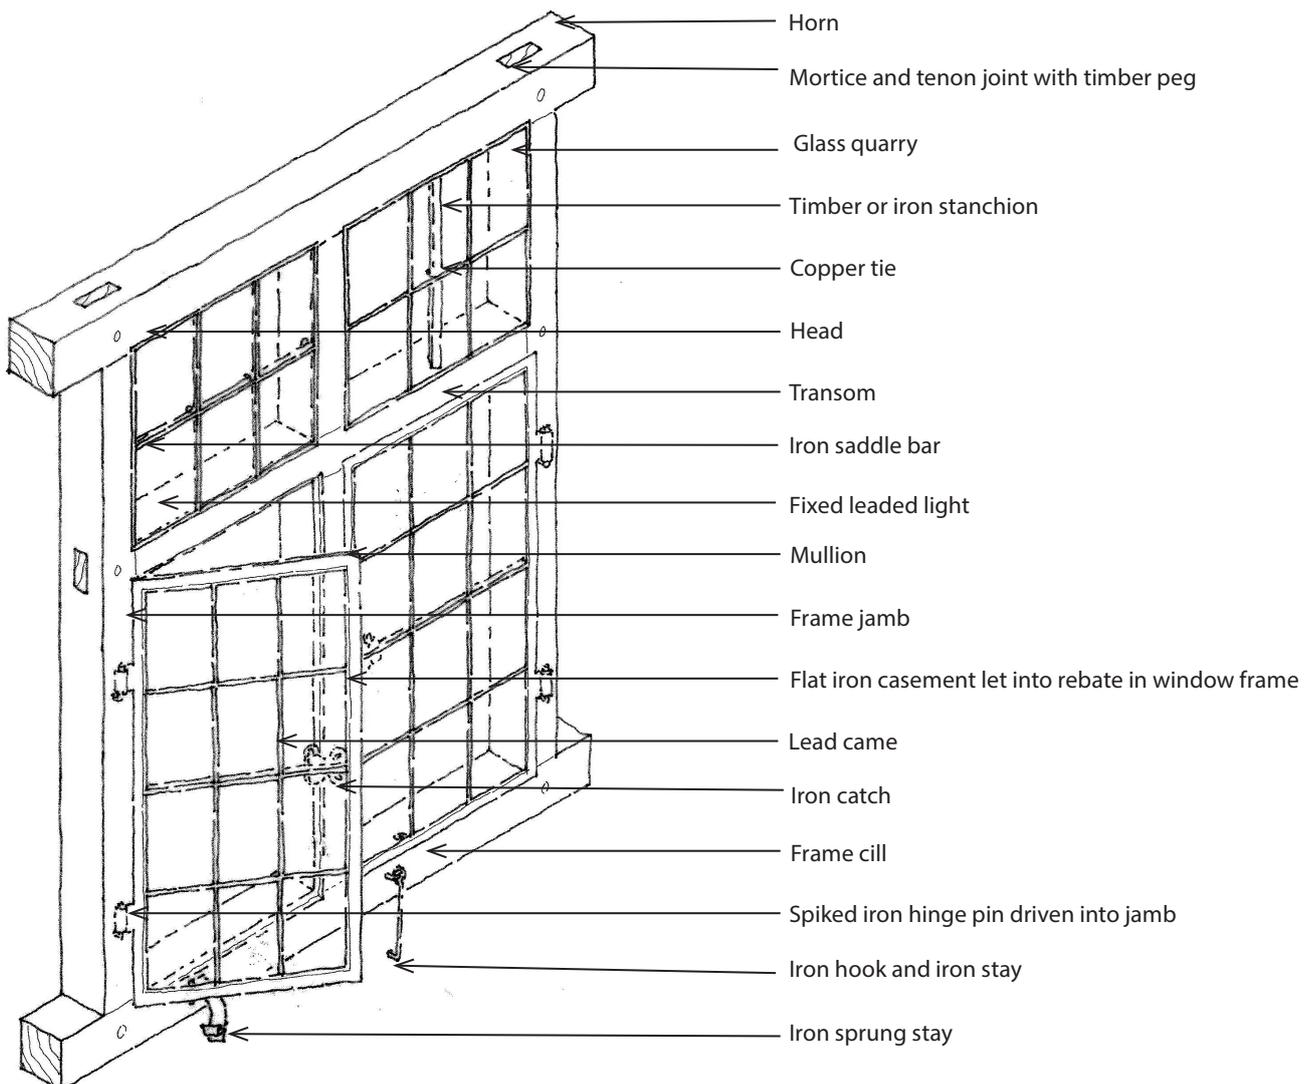
Figure 1: Typical mullion and transom window.

Figure 1 illustrates the main components of a typical mullion and transom window. Technical terms used in this guidance are defined in our online glossary.²

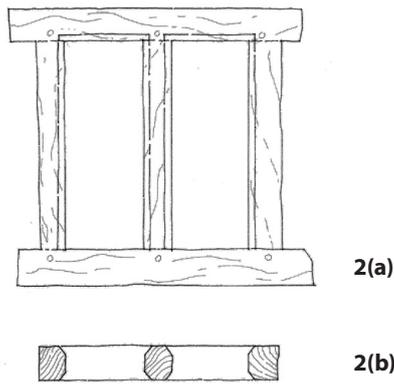
Figure 2: Example of an early unglazed window from a house in Fairford, Gloucestershire: (a) Elevation. (b) Plan.

The earliest wood window frames known in the British Isles were simple openings formed as an integral part of timber-framed buildings (with cills, heads and jambs formed from members of the structural frame of the building, often with timber mullions as in figure 2) or as frames set within masonry.³

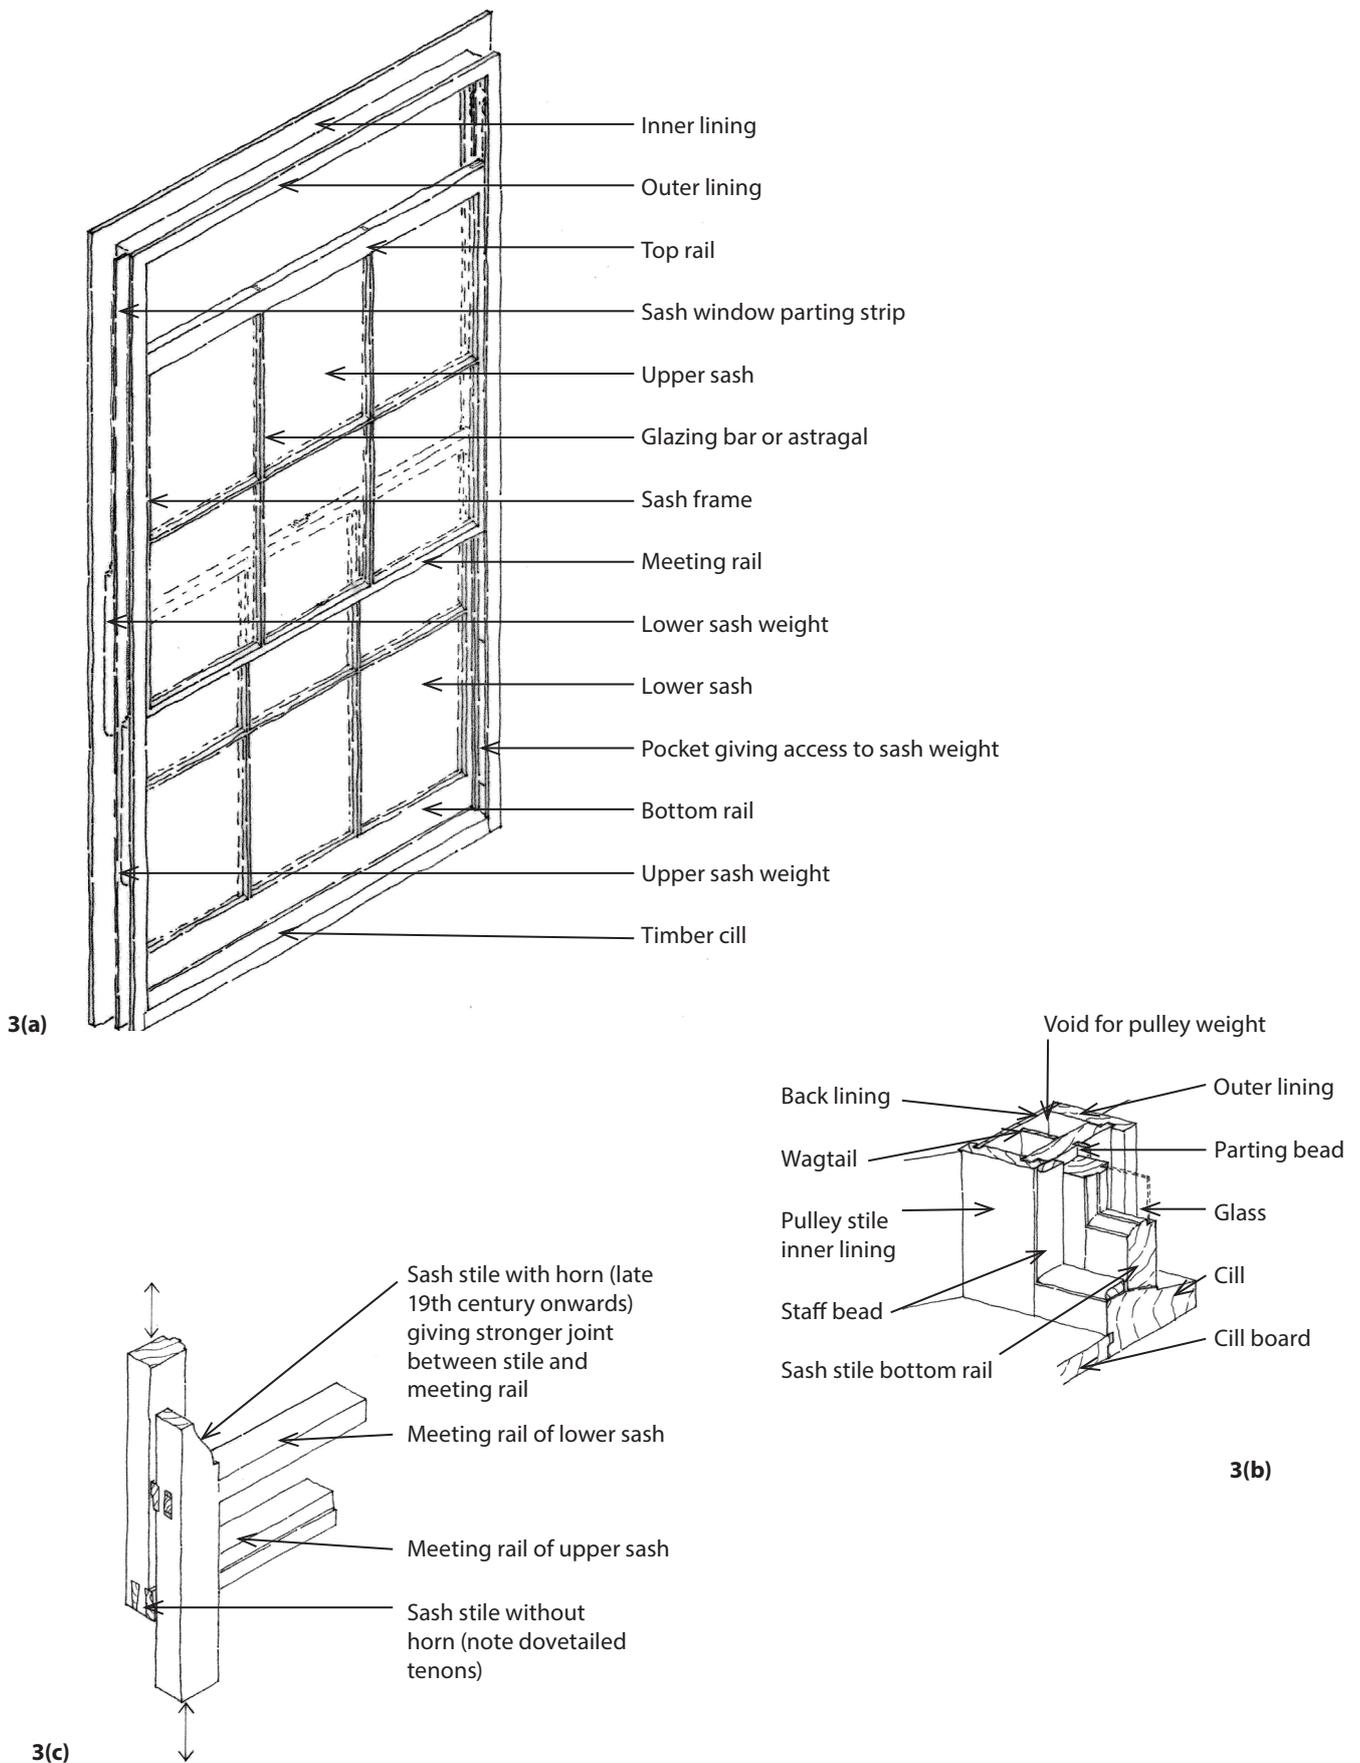
Figure 3: Typical vertical sliding sash window: **(a)** Main components. **(b)** Cill detail. **(c)** Detail of junction of upper/lower sash. Illustrations: SPAB

Subsequently, sash window design evolved to produce a general lightening of glazing bars and frames, with sash boxes formed from separate sections of timber linings and pulley stiles (see figures 3(a) and 3(b)). With the advent of ever-cheaper and larger panes of glass (especially with the invention of drawn sheet glass), the number of panes per window decreased from twelve or sixteen throughout the 18th century to four or two towards the end of the 19th century. A 19th-century development was the introduction of 'horns'

(projections) at the base of the stile of the upper sash and at the head of the lower sash stile (see figure 3(c)). As fewer glazing bars were included in the design, horns were required to increase the strength of these joints.

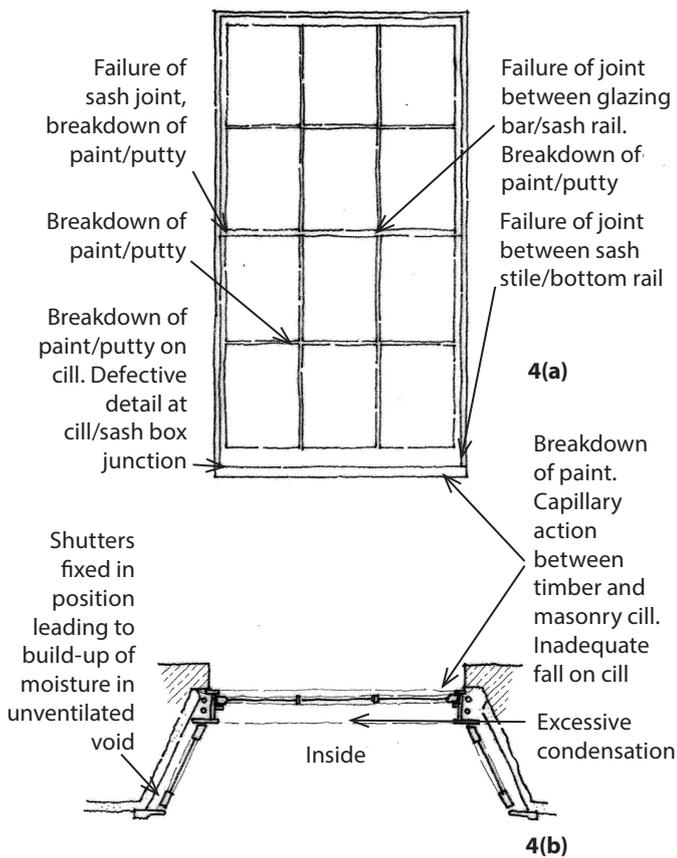
Figure 4: Sash window elevation (a) and plan (b) showing typical areas of decay. Illustrations: SPAB

A detailed inspection of windows for defects should ideally be made annually or at least as regularly as redecoration. It is essential first to diagnose the precise nature and causes of decay (see figure 4).⁴

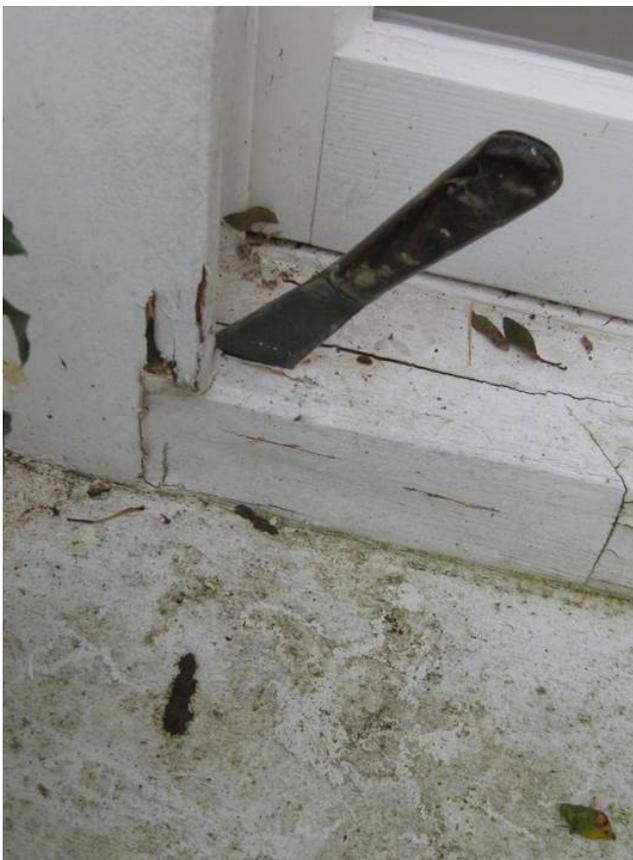
Figure 5: A sharp instrument is essential for investigating the extent of decay in a window. In this case, rot has occurred following the use of poor quality timber for a past repair. Photo: Joseph Bispham

Although an inspection of the surfaces of a window may reveal much about its condition, probing vulnerable areas with a sharp instrument (for instance, bradawl or pen knife) is also necessary (see figure 5).

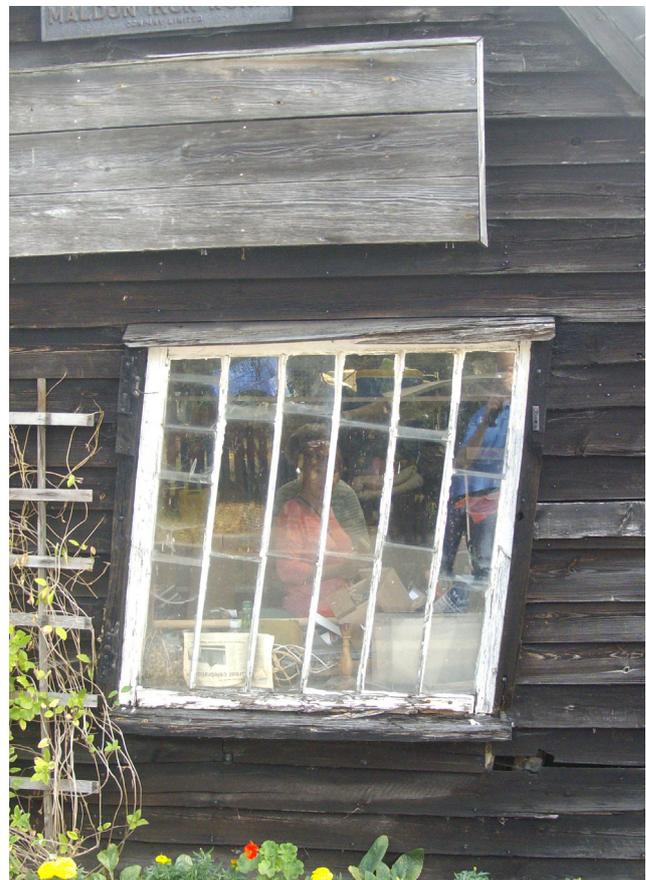
Figure 6: Structural movement.

Movement in masonry or timber-frame walls surrounding a window may lead to deformation of the window with jamming of working parts (sashes, casements) and even the breakage of window glass (see figure 6). Look for obvious signs of general movement within the fabric or more localised movement caused, for example, by the decay of a timber lintel above a window, or where differential movement in the cill and jambs (due to compression in the masonry below the latter) has occurred, giving a bowed appearance to the cill. Any structural movement may require remedial measures and could require the advice of a structural engineer experienced in dealing sensitively with old buildings.⁷ Windows which have become deformed by past movement in a surrounding wall have often been adjusted to suit their realignment, and continue to work effectively.

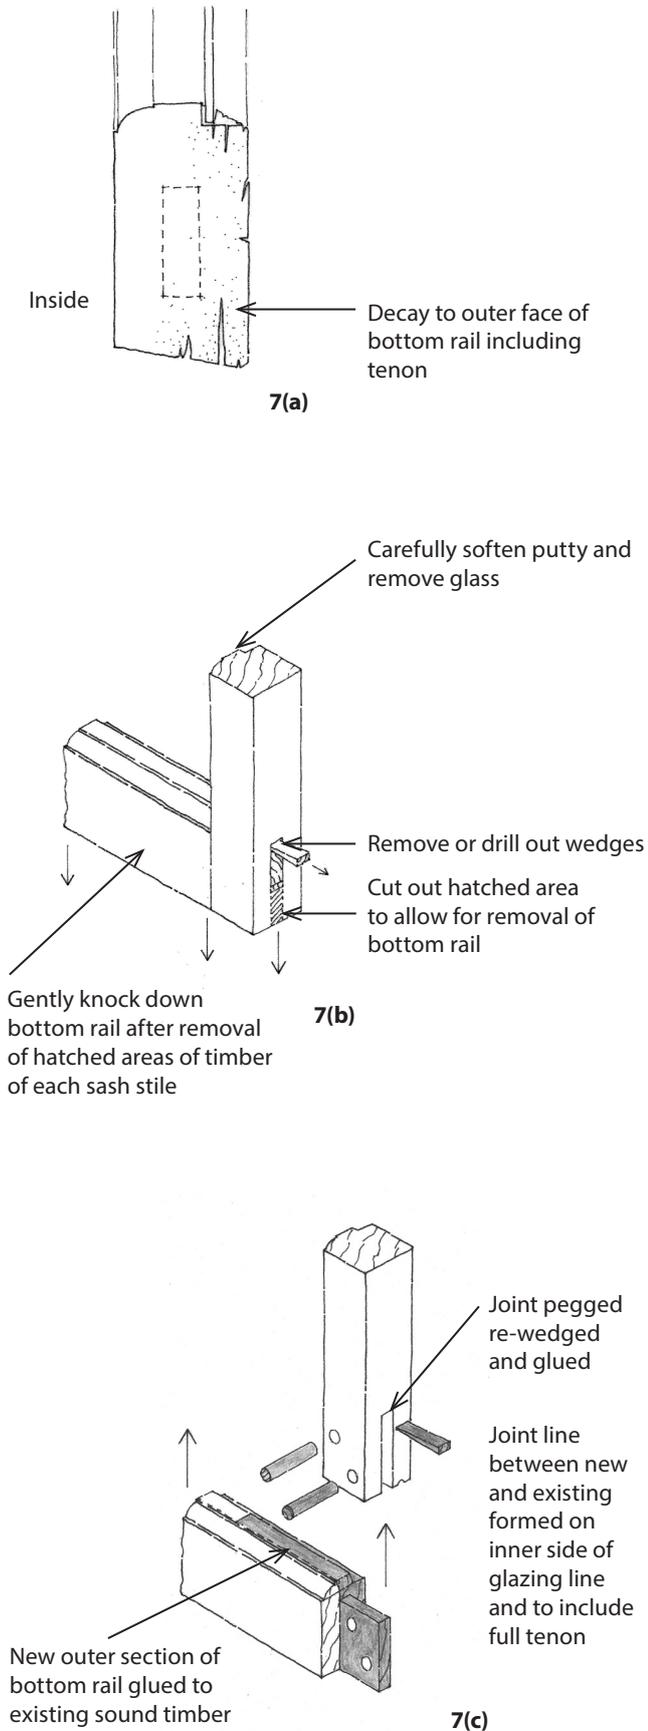
Figure 7: Bottom rail of sash: (a) Decay. (b) Dismantling. (c) Repair. Illustrations: SPAB

The method of repair illustrated in figure 7 allows for the work to be carried out without dismantling the sash. The same procedure for removal and replacement may be used where total renewal of the bottom rail is necessary, although removing the existing decayed rail is easier if a series of vertical cuts are made through the rail before removal.

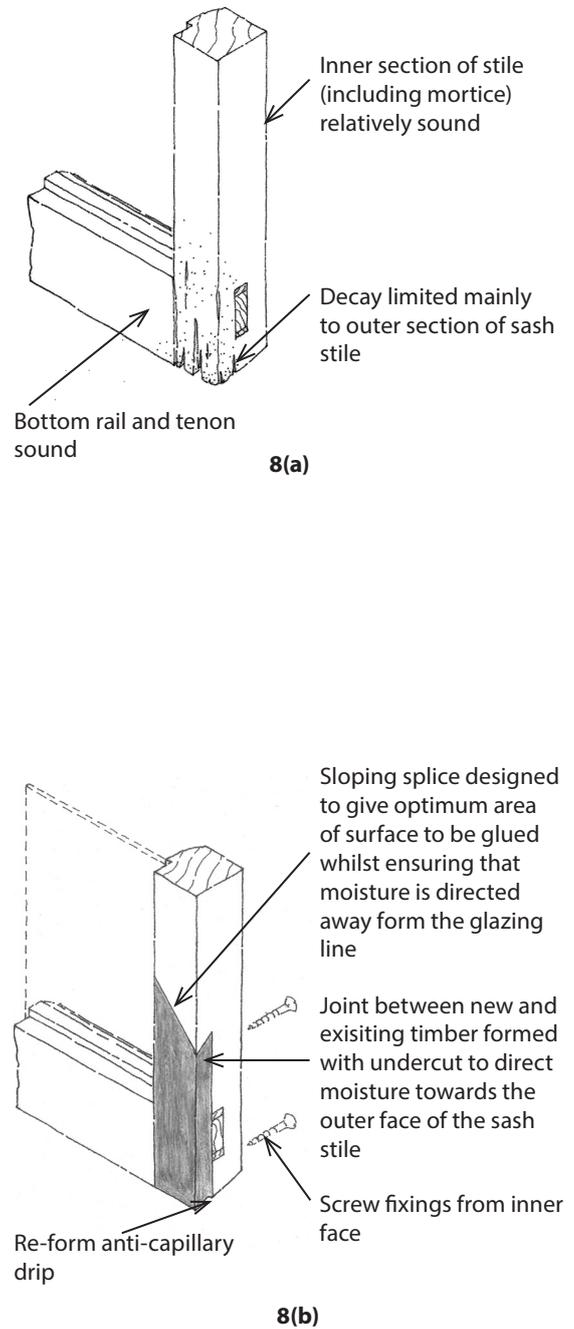
Figure 8: Sash stile (outer face): (a) Decay. (b) Repair. Illustrations: SPAB

See figure 8.

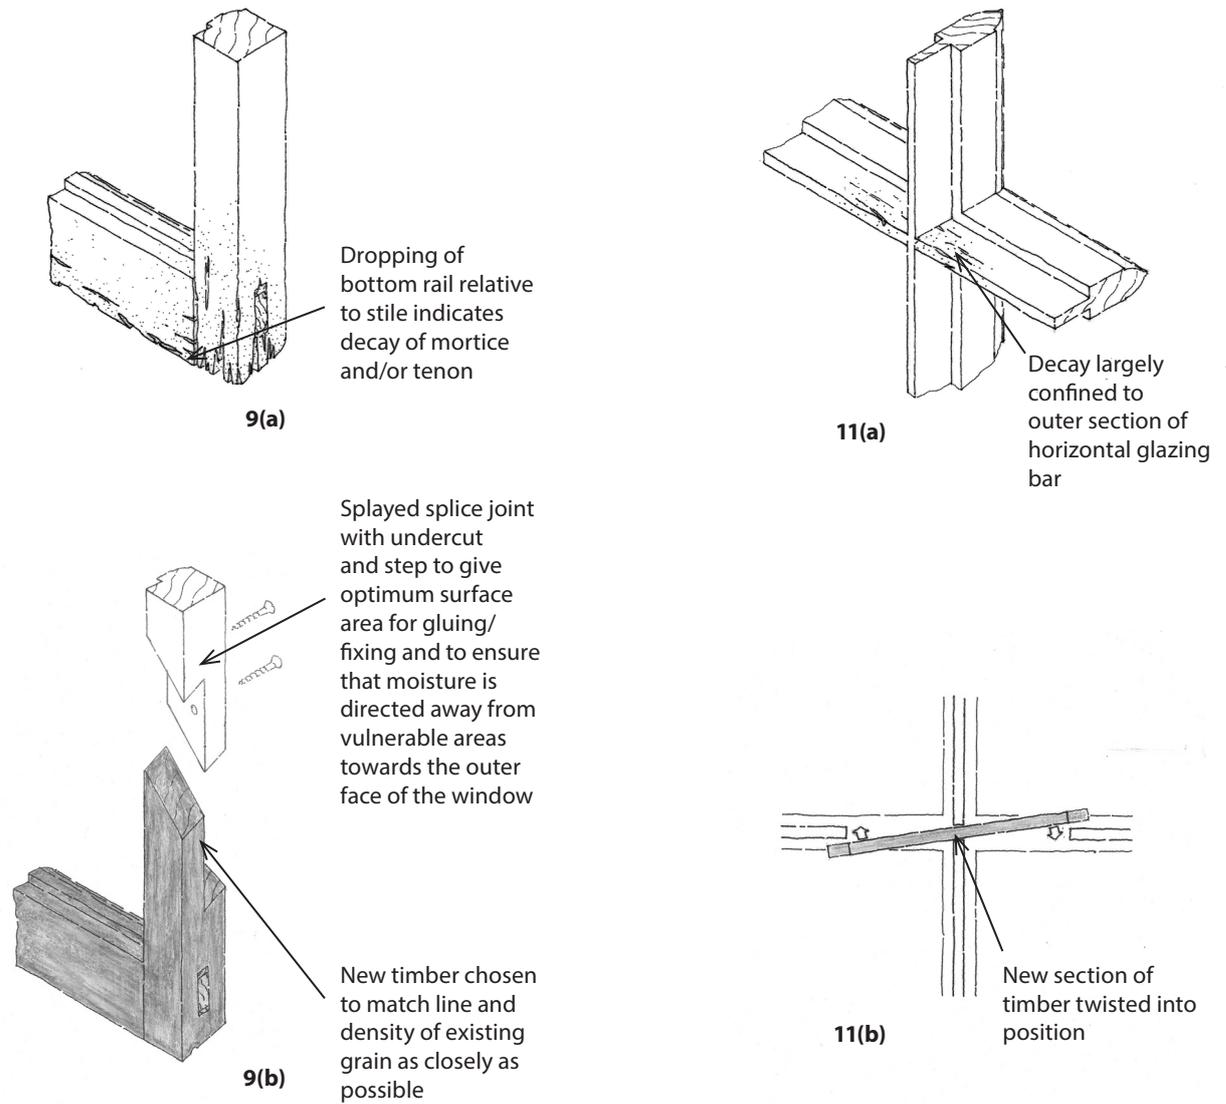
Figure 9: Bottom rail/base of sash stile: **(a)** Decay. **(b)** Repair. Illustrations: SPAB

A similar repair method may be used where the replacement of only the base of the sash stile is necessary, as shown in figure 9.

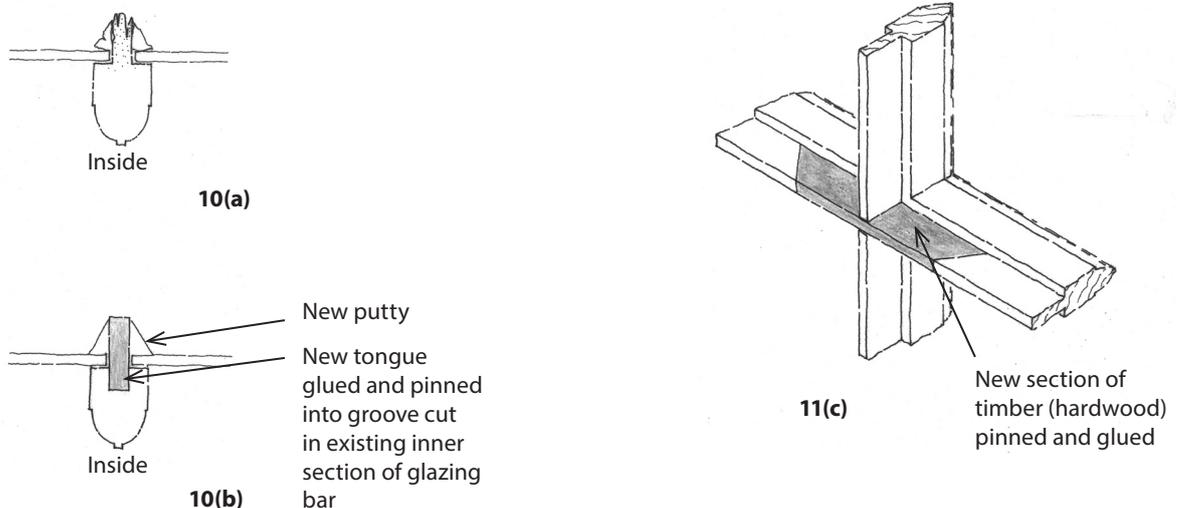
Figure 10: Tongue of glazing bar: **(a)** Decay. **(b)** Repair. Illustrations: SPAB

For replacement of short sections of a glazing bar where only the outer tongue section is decayed, as illustrated in figure 10. If care is taken, this repair can be carried out without dismantling the sash or removing the glass. In most cases, hardwood (for strength and durability) should be used for the new tongue, even where the existing glazing bar is softwood.

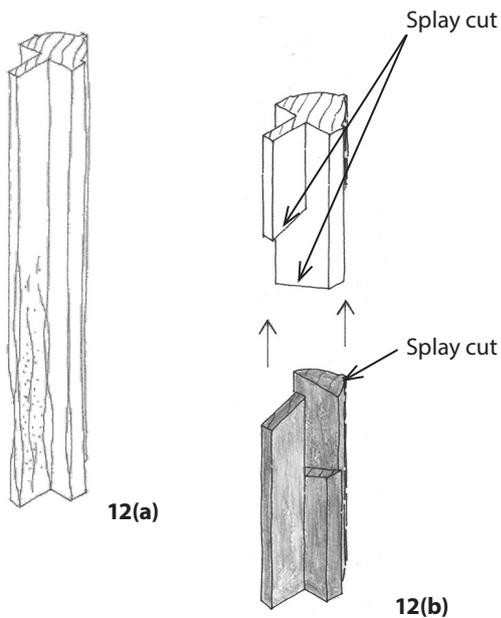
Figure 12: Glazing bar: (a) Decay. (b) Repair. Illustrations: SPAB

See figure 12.

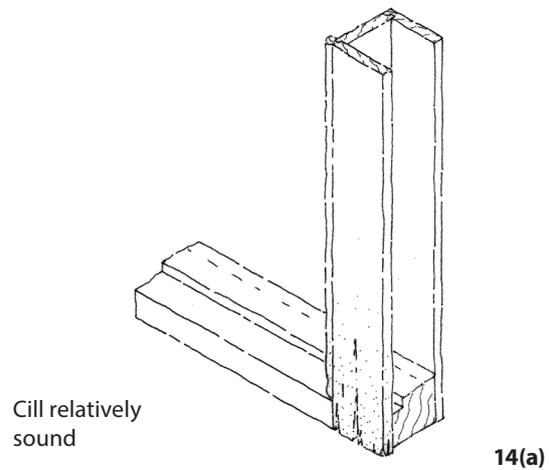
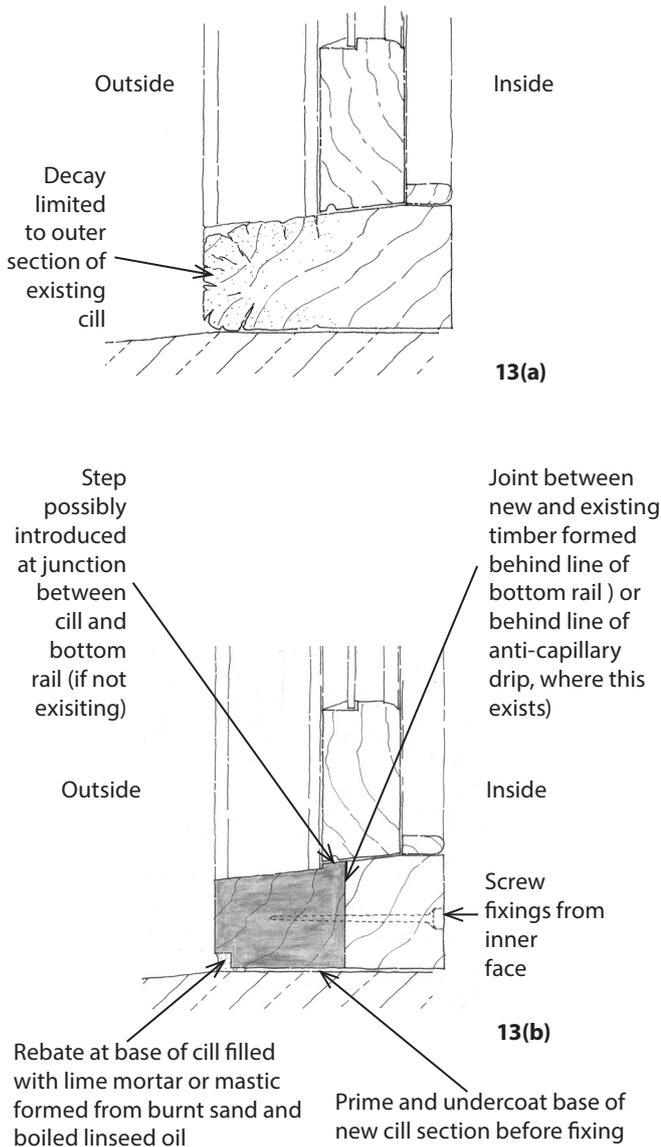
Figure 13: Cill to sash window: (a) Decay. (b) *In situ* repair. Illustrations: SPAB

5.7 *In situ* repair of cill to sash window

See figure 13.

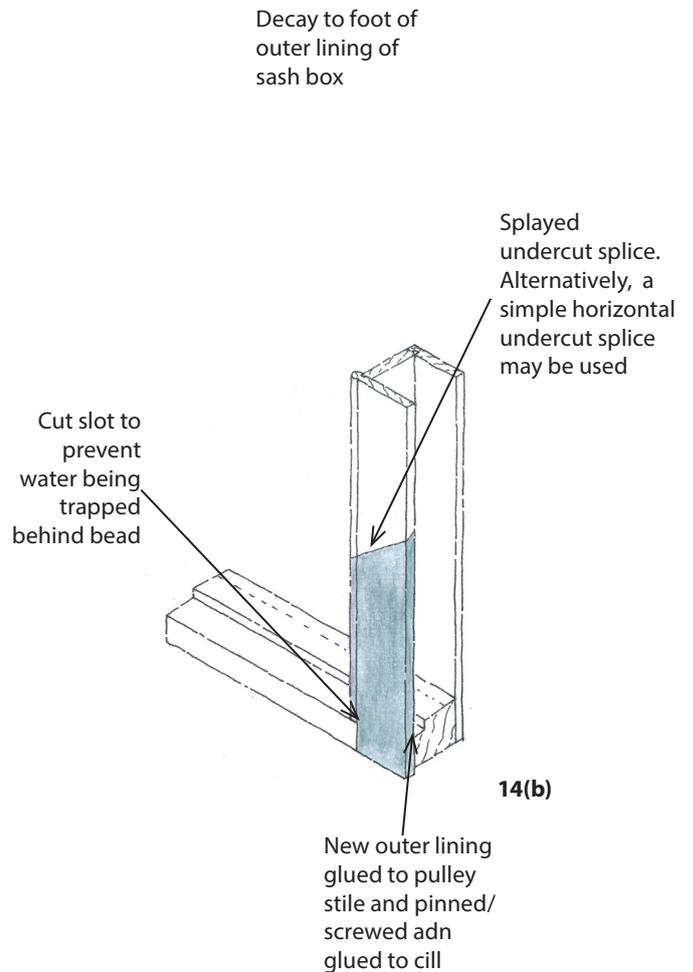
Figure 14: Outer lining of sash box: (a) Decay. (b) Repair. Illustrations: SPAB

The type of repair depicted in figure 14 can be carried out *in situ* where the sash box is not situated behind a reveal.

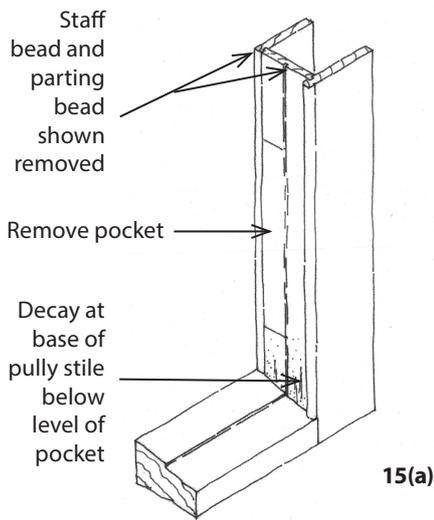
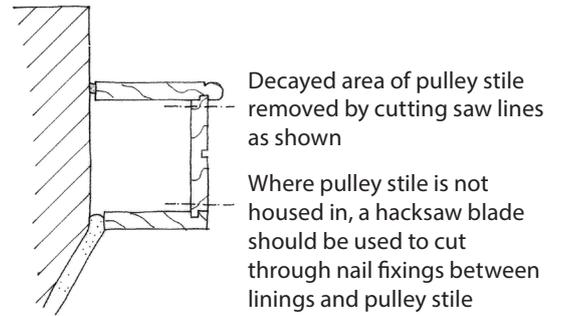
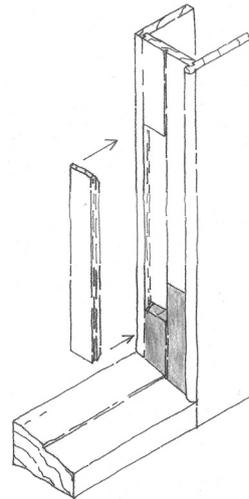
Refix pocket
New section of pulley stile glued and re-wedged to rebate in cill. Outer and inner linings screwed or pinned (non-ferrous) to pulley site

Figure 15: Base of pulley stile: (a) Dismantling. (b) Cutting back shown on plan of sash box. (c) Repair.

See figure 15.

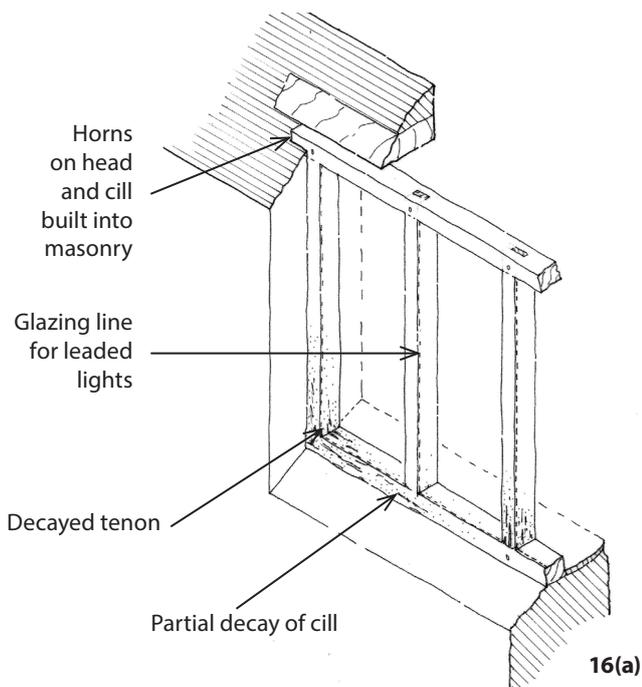
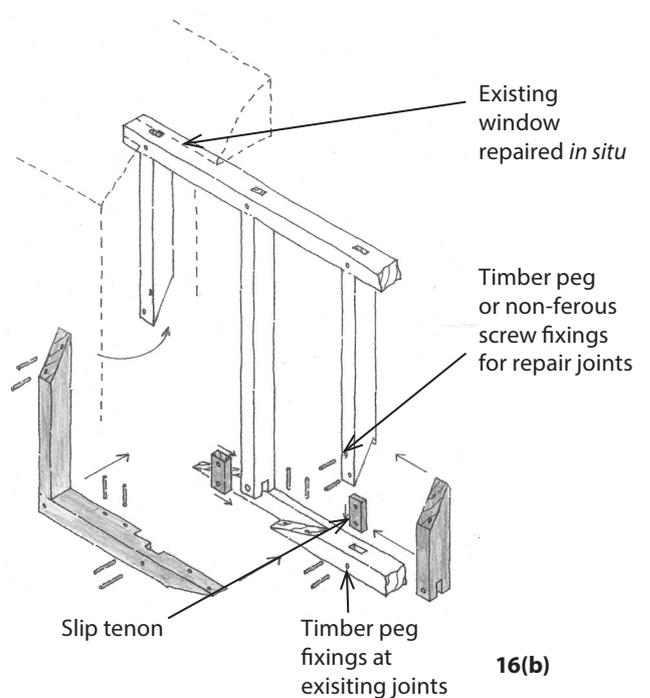
Figure 16: Mullion window: (a) Decay. (b) General repairs.

See figure 16.

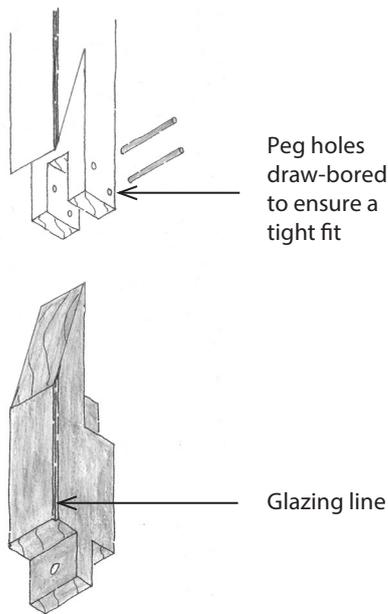
Figure 17: Mullion window – alternative repair to base of jamb or mullion
Illustrations: SPAB

The type of repair shown in figure 17 is appropriate where the window is performing a load-bearing role and a simple splice repair may not be strong enough. It also ensures that more of the internal face (including mouldings) of the existing mullion is retained than would be the case if the splice illustrated in figure 16 were to be employed.

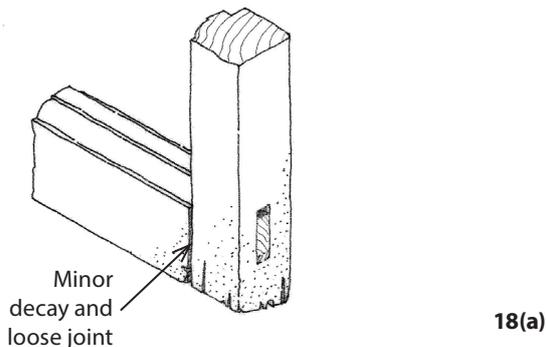
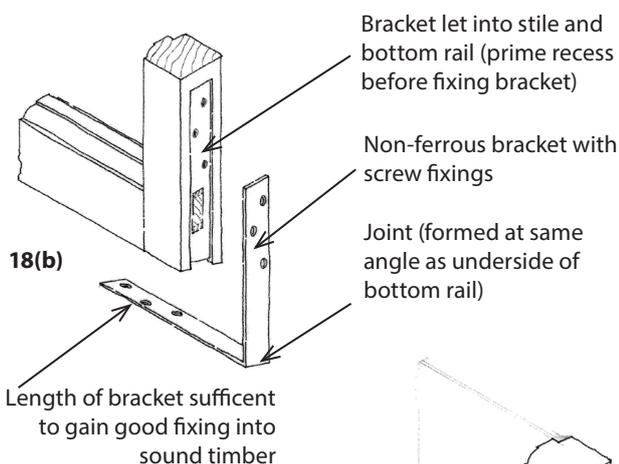
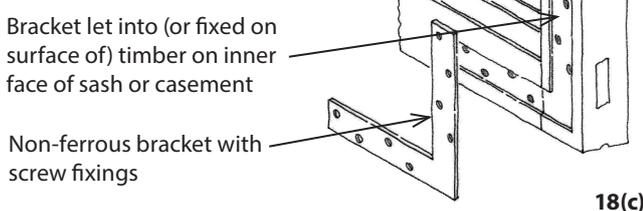
Figure 18: Dealing with loose joints. Illustrations: SPAB

Where opening of joints is combined with minor decay such that regluing alone will be inadequate, reinforcement of the timber at the joint can be achieved with a non-ferrous bracket (see figure 18).

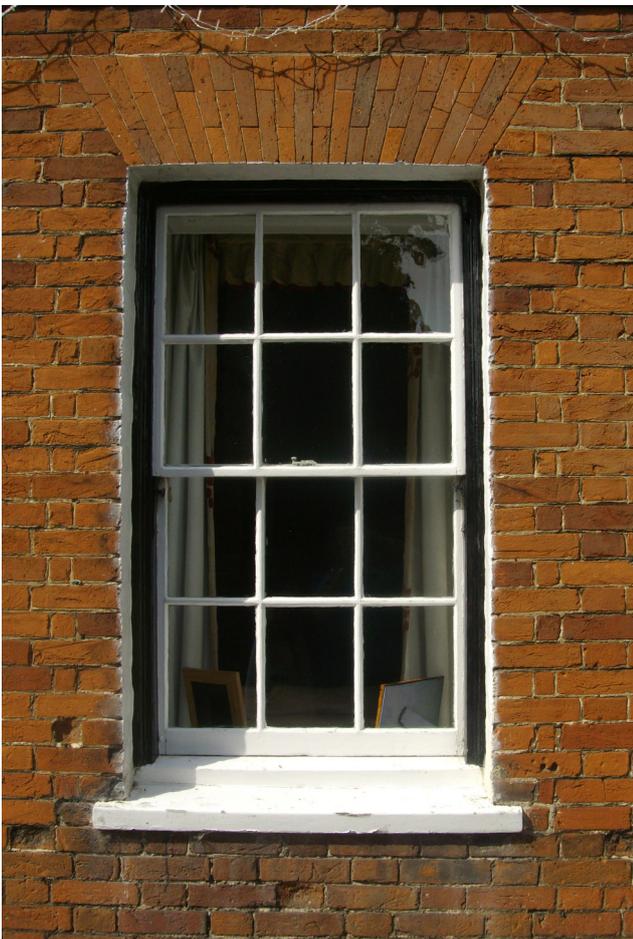
Figure 19: Windows post-dating the 18th century are commonly made of softwood and require regular redecoration for protection. Photo: Douglas Kent

With the exception of some early oak windows, timber windows were usually painted from construction both for aesthetic reasons and to give the timber a protective coating (see figure 19). However, a poor paint specification or badly maintained paint will lead to deterioration in the paint surface, allowing water to penetrate into the body of the timber. This will lead to swelling of the timber, causing further deterioration of the paint finish and a continuation of the cycle of decay.
