History at Your Feet: the care & repair of old floors 3

Reproduction of this publication's content in whole or part is prohibited without prior written permission of the SPAB. Copyright 2016 SPAB. This downloadable booklet is a version of the SPAB's Technical Pamphlet 'The Care and Repair of Old Floors' by Adela Wright.

History at your feet: care and repair of old floors

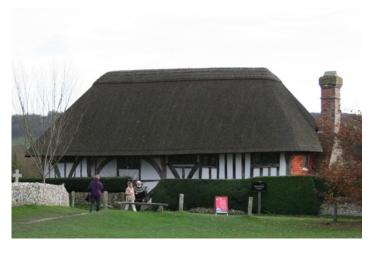
The chalk floor of the Medieval Great Hall of the Clergy House at Alfriston, owned by the National Trust, was renewed in 1998. Fine dusty chalk from a local quarry was laid and compacted to produce a smooth surface.

Large chalk aggregate at the surface was thought to be the reason for the failure of the previous floor. Thirty gallons of unpasteurised sour milk was poured over the chalk floor and left to soak in. An initial mould growth occurred, but this has subsequently died back. It took several months for the floor to solidify and harden but it has since withstood heavy visitor footfall.
