History at Your Feet: the care & repair of old floors 3

History at your feet: care and repair of old floors

This pamphlet (based on an original SPAB document written by Adela Wright, RIBA) has been produced as part of the SPAB's History at Your Feet campaign to make people aware of the importance of old, original floors.

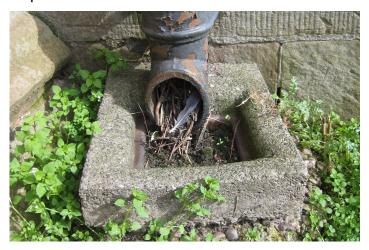
Image left - a blocked downpipe at Albrighton St Mary. Credit: SPAB.

The SPAB's experience is that many dampness problems are related directly to construction defects or interventions, which have undermined the previous breathing potential of the floor or rooms. Initially, with any dampness related problems, thought should be given to common potential problems: faulty guttering, downpipes and drains; external ground levels; adequacy of ventilation and mis-diagnosis of condensation as rising dampness, and the use of rubber-backed wall-to-wall carpets which have acted as a membrane and held moisture back. In the last case, and also after constructional defects have been resolved it may take some time for the floor to dry. The testing of drains and soakaways to establish where they run and their condition is also important.

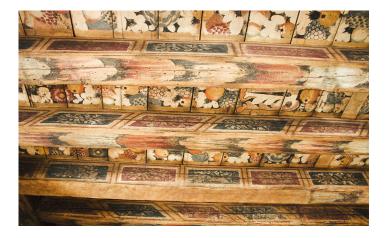
Left image: the underside of wooden floorboards at Gladstone's Land, Edinburgh. Credit: National Trust for Scotland

Any cleaning or removal work proposed should only take place after sample / trial areas have been carefully carried out. Care should also be taken that early painted decorative schemes, found particularly to the underside of floorboards where originally exposed, are not removed. Such schemes are valuable evidence on the history of a building.

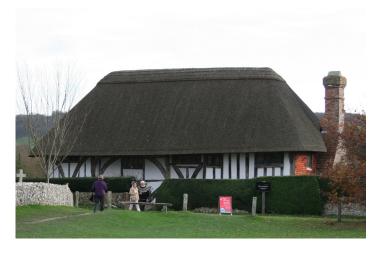
The chalk floor of the Medieval Great Hall of the Clergy House at Alfriston, owned by the National Trust, was renewed in 1998. Fine dusty chalk from a local quarry was laid and compacted to produce a smooth surface.

Large chalk aggregate at the surface was thought to be the reason for the failure of the previous floor. Thirty gallons of unpasteurised sour milk was poured over the chalk floor and left to soak in. An initial mould growth occurred, but this has subsequently died back. It took several months for the floor to solidify and harden but it has since withstood heavy visitor footfall.
