# 4. Site clearance

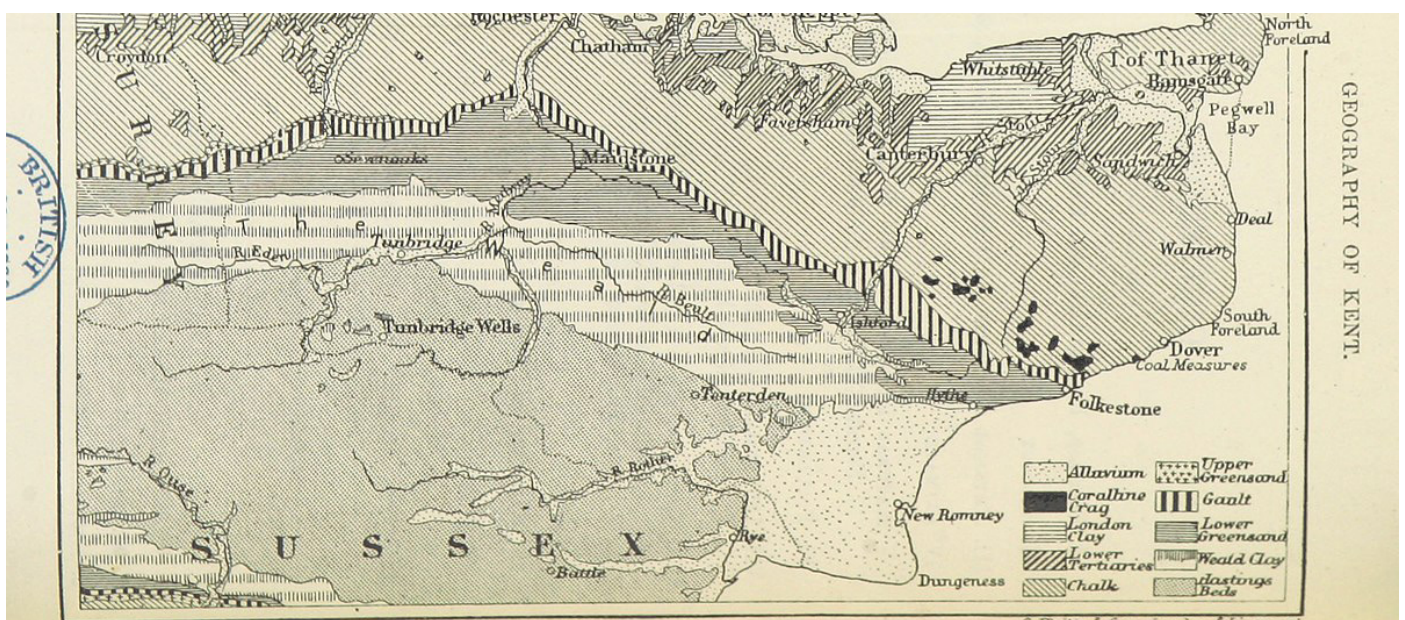
Whilst clearing the site we also decided to carry out some basic ground investigations. We dug a vertically-sided square hole - first by hand and then by mini digger. This was done with the help of Stephen Clifton, a local archaeologist with Maidstone Area Archaeological Group who helped position the hole with thought, and on a part of the site that would not affect any future or planned works. Therefore after excavation it could be back-filled as garden or left as a pond that might help to encourage new wildlife. Unexpectedly we found that the topsoil was only 200mm thick lying on a 1 metre deep layer of Marl. The Marl was made-up of a mix of clay, sand, crushed chalk, shells and flint. This layer in turn was lying on

top of a distinct seam of blue grey clay known as Gault Clay that started at 1.2metres and continued down to and beyond 2.5metres. For comparison against historic soil data and information on what lay below that level we referred to information found on the British Geological Survey geological maps and their online Geology of Britain viewer. It appears for areas close to Boxley and the Medway river geological maps give the depth of the Middle White Chalk as 60 to 76 metres and seams of the Grey Chalk below that at 49 to 58 metres thick. In the area of the Old House Project it appears to be an 11 metre thick layer of Gault Clay found over a layer of Glauconite Sand at a depth of approximately 13 metre below the surface. Conveniently, it appears that the Old House Project site sits in the centre of a relatively thin strip of land approximately 1 Km wide containing Gault Clay with layers of white chalk and grey chalk bedrock approximately 0.5 Km to the north and Folkestone Sandstone 0.5 Km to the south. If we include the large amounts of ancient woodland surrounding the area, particularly along the North Downs, then the site of the Old House Project has most of the nation's vernacular building materials within one square mile. This knowledge provides us with options on sourcing materials for repair and utilising the diverse palette of materials for any new build or extensions proposed.

In addition to establishing geological horizons (different layers of soil) we also discovered that the root matter of local trees was very shallow, using only the thin topsoil layer with a few root ends being found in the top zone of the Marl. Furthermore, when first digging a hole by hand we were able to ascertain that the water table of the site was quite high. Water filled the hole quicker than we could dig at around 800mm deep and then following a period of rain over the winter, continued to fill the hole until it stopped at 400mm below the surface. By using a three-ton mini digger we could continue digging down to 2.5 metres comfortably before any risk of the sides needing lateral support and the reach of the mini digger being lost.

Understanding the ground under the site has meant that we are more aware of possible risks of flooding and trees with shallow roots systems. Undertaking simple field tests we understand that the clay on site does shrink when dried and with the help of further more directed soil investigations by a professional geotechnical engineer we hope to lessen the risks of flooding and movement using appropriate land drainage and landscaping. Knowledge of ground conditions will particularly assist our understanding of the structural issues affecting the building's west bulging wall.
