# Vernacular Slating in the East Midlands

SPAB Regional Technical Advice Note

This advice note describes the production and use of the roofing slates and stones of the East Midlands of England.

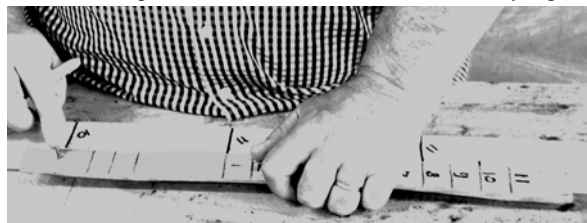
Figure 4: Gauging  
The stick is used to set out the margins and the lath gauges and these diminishes all the way up the roof.  
Terry Hughes

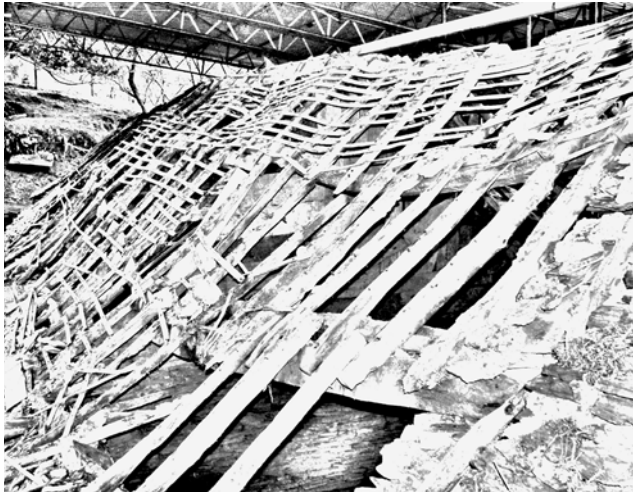
Figure 6a  
 Movement of the roof structure may not require any correction or perhaps just stabilising. But if there are severe or abrupt undulations they can be impossible to slate over without the slates gapping even if small or narrow slates are used. In this case the undulations can be eased.  
 Terry Hughes

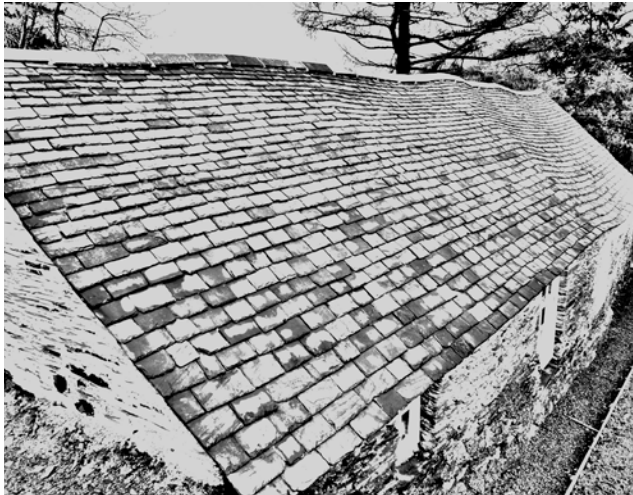
Figure 6b  
 If undulations are only eased by the minimum to allow tight slating the roof's charm will be conserved.  
 Terry Hughes

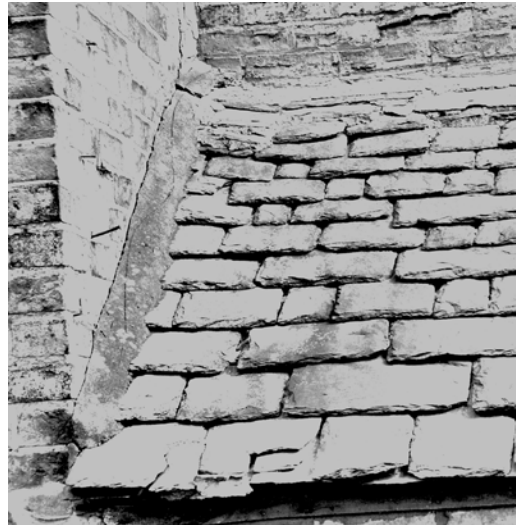
Figure 12  
Before the availability or affordability of lead for soakers abutments were weathered with simple mortar flaunches.  
Terry Hughes

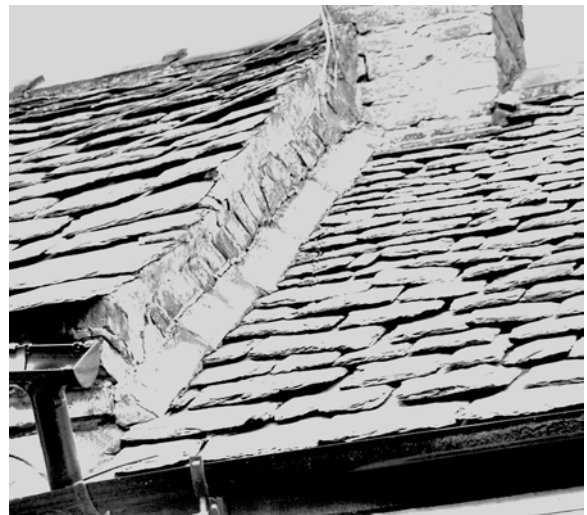
Figure 13  
Mortar flaunches are prone to cracking and leaking. One technique to help prevent this is to bed slates, thin stones or tiles into the flaunch. In some regions these are known as listings.

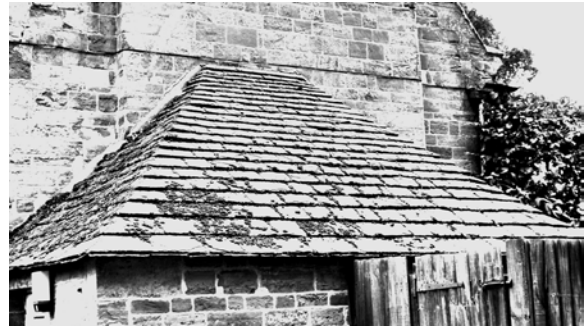
Figure 17  
Mitred hips are vulnerable to wind so wide slate should be used to ensure sufficient width and therefore strength at the top of the raking cut.  
Terry Hughes

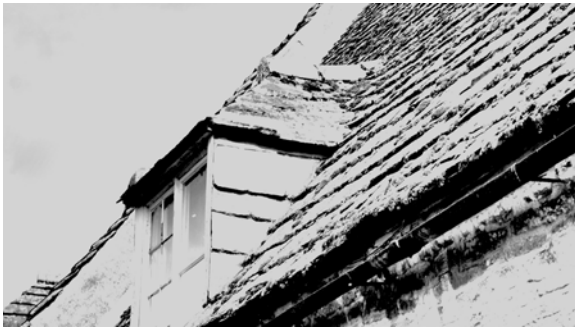
Figure 16a  
Where dormer ridges run into the main slating they are either swept up into the main slope or the junction is weathered with a lead saddle.  
Terry Hughes and Ray Harrison

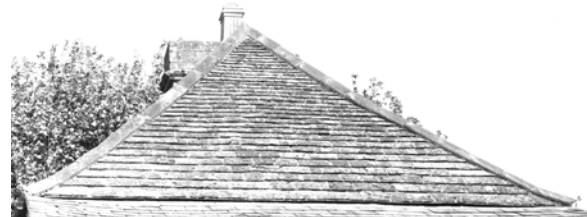
Figure 18  
An alternative wind resistant hip is achieved by bedding on heavy ridge tiles supported by a hip iron at the eave.  
Terry Hughes

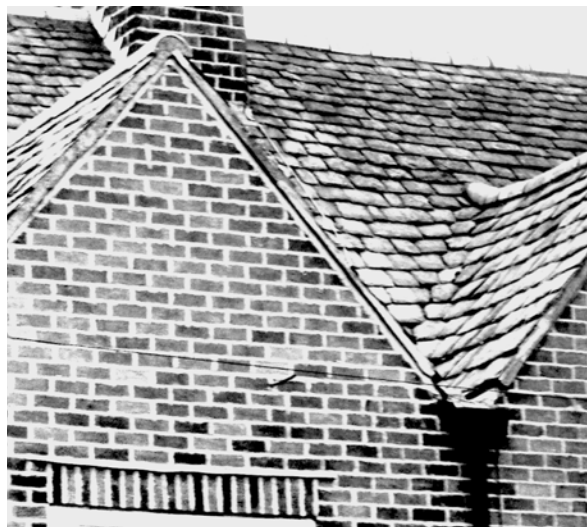
Figure 19  
There are very few pre-nineteenth century Swithland roofs and those that still exist do not generally include valleys (or hips). So the valleys that are seen today - Welsh and a swept type - seem to be none-vernacular innovations. Later still even these have regrettably been replaced with open lead and close mitred types.  
Terry Hughes

On Swithland roofs two valley types are seen: Welsh and a swept version (Fig 19) but there are very few examples and these may be no vernacular later innovations. Today, non-traditional lead lined and close mitred

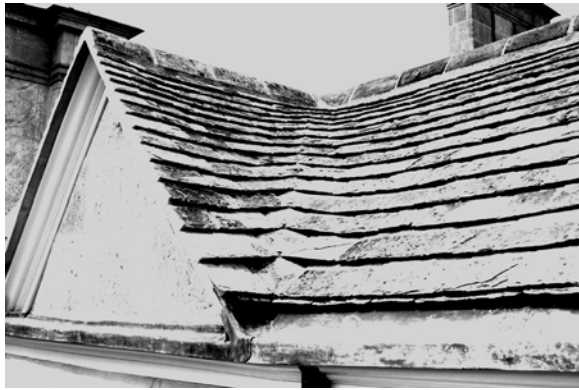
Figure 20  
Collyweston slate valleys are always laced.

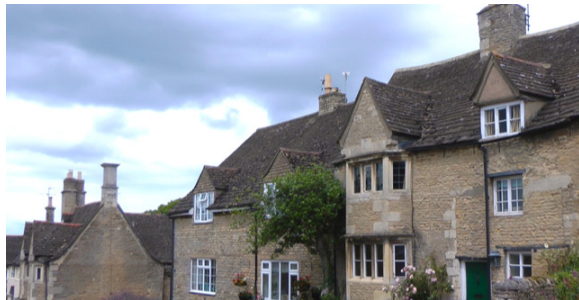
Figure 21  
Collyweston dormers can be below, braking and above the eaves and monopitch, gabled or hipped.

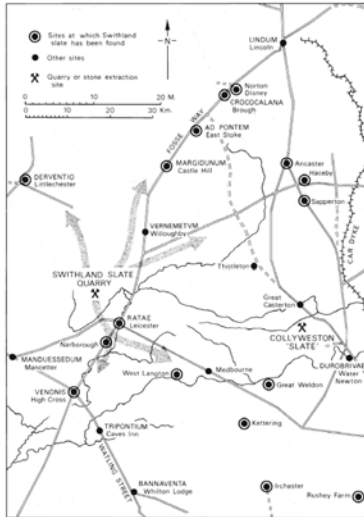
Figure 25  
Swithland slates were used from Roman times and were so valued that they were carried as much as 50 miles away. McWhirr<sup>9</sup>

The first evidence of their use for roofing is from Roman archaeological sites including at Narborough, West Langton and Haceby and as far as 50 miles away from the quarries at Great Staughton in Cambridgeshire (Figure 25)<sup>8</sup>. As at other Roman sites the slates are hexagonal (Figure 26). These are often described as diamond shaped or four-sided but the actual hexagonal shape is fundamental to the way they are laid to form a water tight roof.

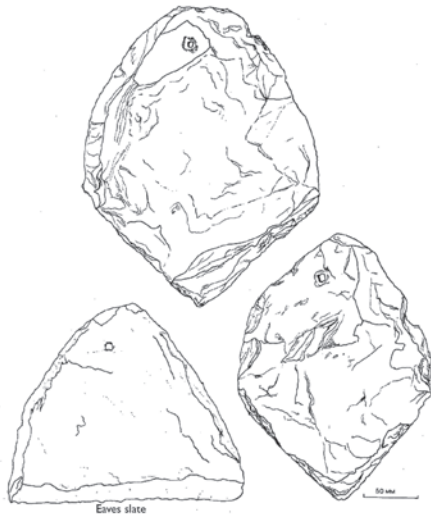
Figure 26  
As at other Roman sites the slates are hexagonal. These are often described as diamond shaped or four sided but the actual hexagonal shape is fundamental to the way they are laid to form a water tight roof. McWhirr<sup>9</sup>

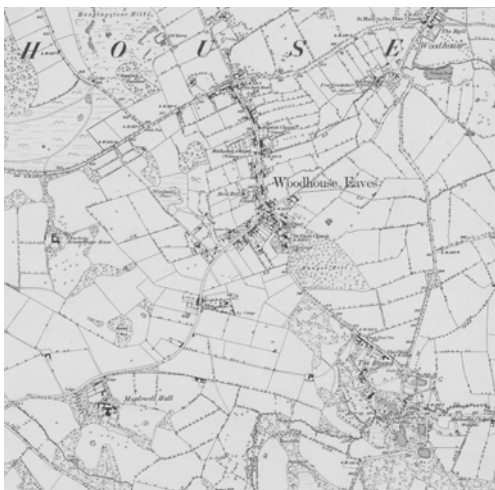
Figure 27a  
There were three areas of production of Swithland slates: to the west of Swithland village at the Brand Estate and in Swithland Wood; in the Hangingstone Hills north-west of Woodhouse and at Groyby. [National Library of Scotland https://maps.nls.uk/index.html](https://maps.nls.uk/index.html)

Swithland slate was quarried in and around Charnwood Forest in the area between Leicester, Loughborough and Coalville. There were three areas of production: to the west of Swithland village at the Brand Estate and in Swithland Wood; in the Hangingstone Hills north-west of Woodhouse; and at Groby (Figures 27a & 27b).

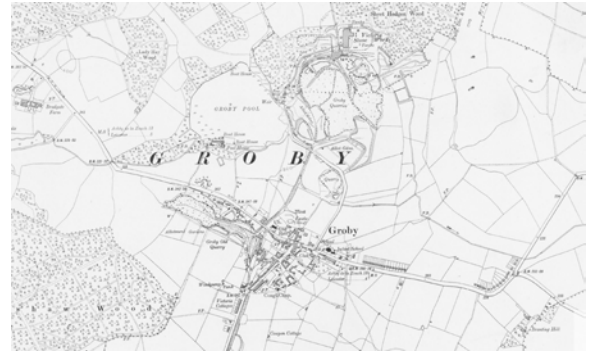
Figure 27b  
There were three areas of production of Swithland slates: to the west of Swithland village at the Brand Estate and in Swithland Wood; in the Hangingstone Hills north-west of Woodhouse and at Groyby. [National Library of Scotland https://maps.nls.uk/index.html](https://maps.nls.uk/index.html)

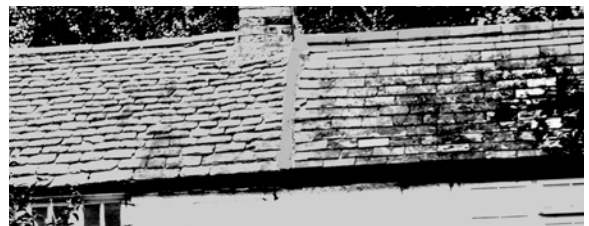
Figure 28  
It is possible to obtain facsimile Swithland slates made from Welsh slate rock. However, a mix of standard sizes from the quarries stock will not produce a convincing roof. Terry Hughes

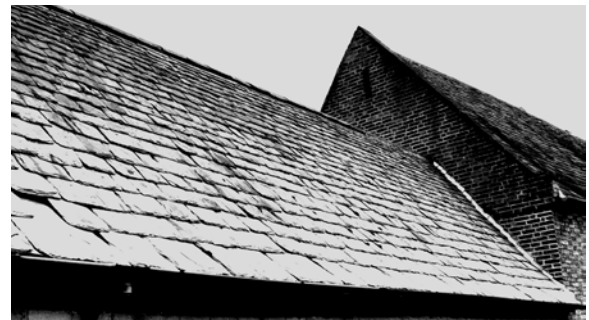
Figure 29  
The eaves of swithland roofs are often formed with one or two courses of much larger and thicker slates giving the roofs a distinctive appearance. Terry Hughes

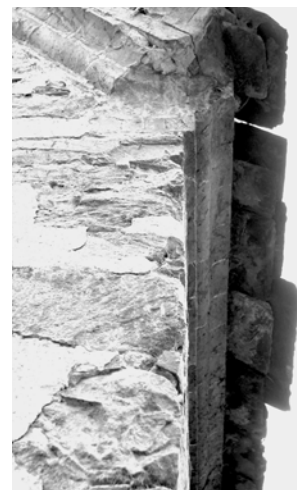
Figure 30  
During the nineteenth century a large eaves overhang was formed by corbelling the wall head with decorative brickwork. Terry Hughes

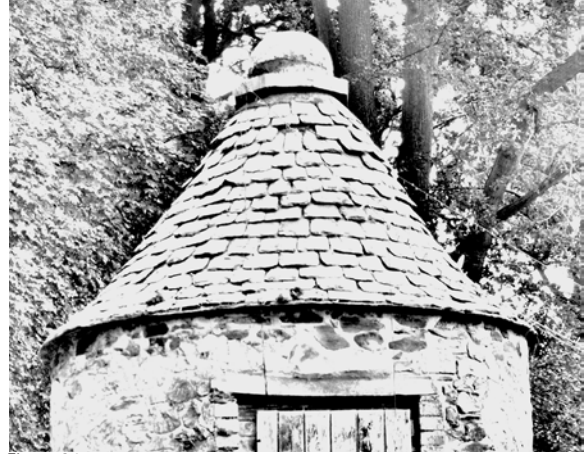
Figure 34  
Curved Swithland slating is rare even though the log narrow slates are well suited to conical roofs.  
Terry Hughes

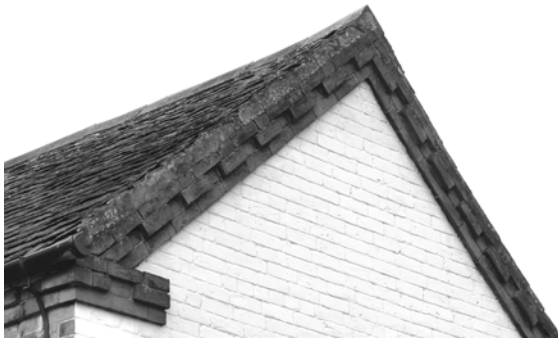
Figure 32  
On later roofs verges were extended with decorative brickwork or terracotta.  
Terry Hughes

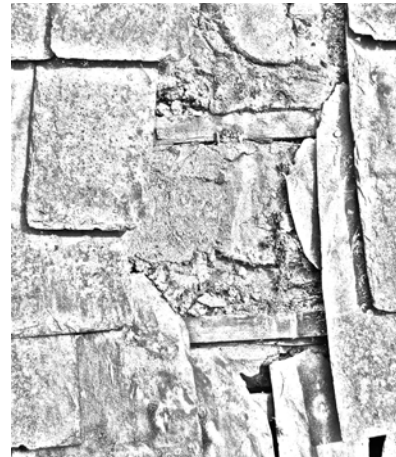
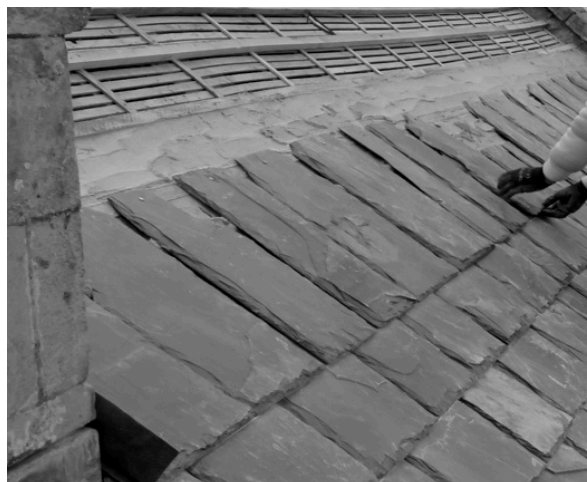
Figure 35a  
Mortar is used for all the normal techniques of bedding and torching. One unusual example is known, at Thorpe Satchville Church, where the slating was solid bedded in hot lime onto the ceiling laths. This was renewed as found in 2015.  
Terry Hughes

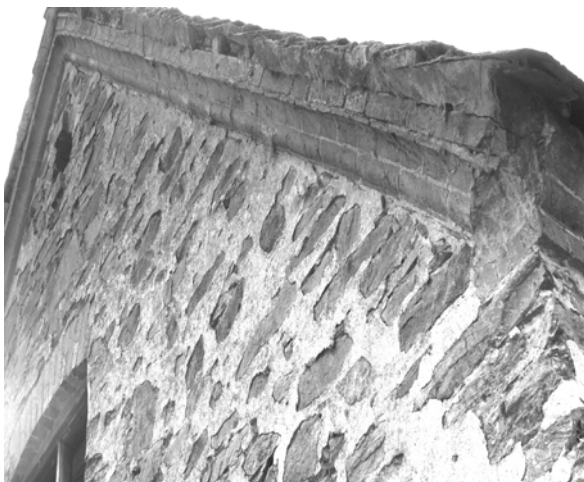
Figure 33  
On later roofs verges were extended with decorative brickwork or terracotta.  
Terry Hughes

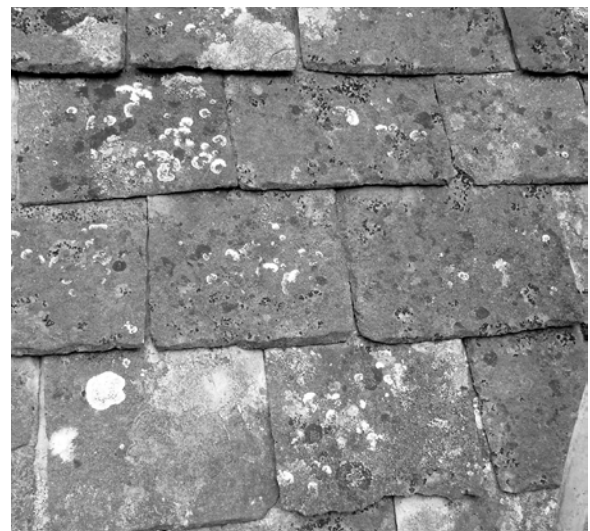
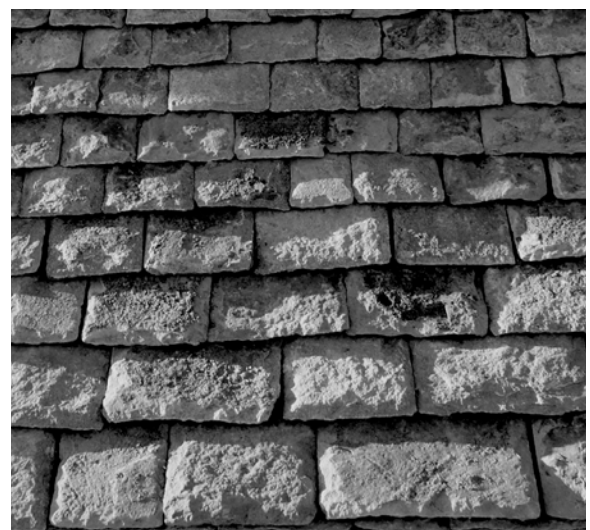
Figure 36  
The texture of limestone slates varies between quite smooth, Collyweston for example, and rough for some Cotswold types and magnesian limestone.  
Terry Hughes

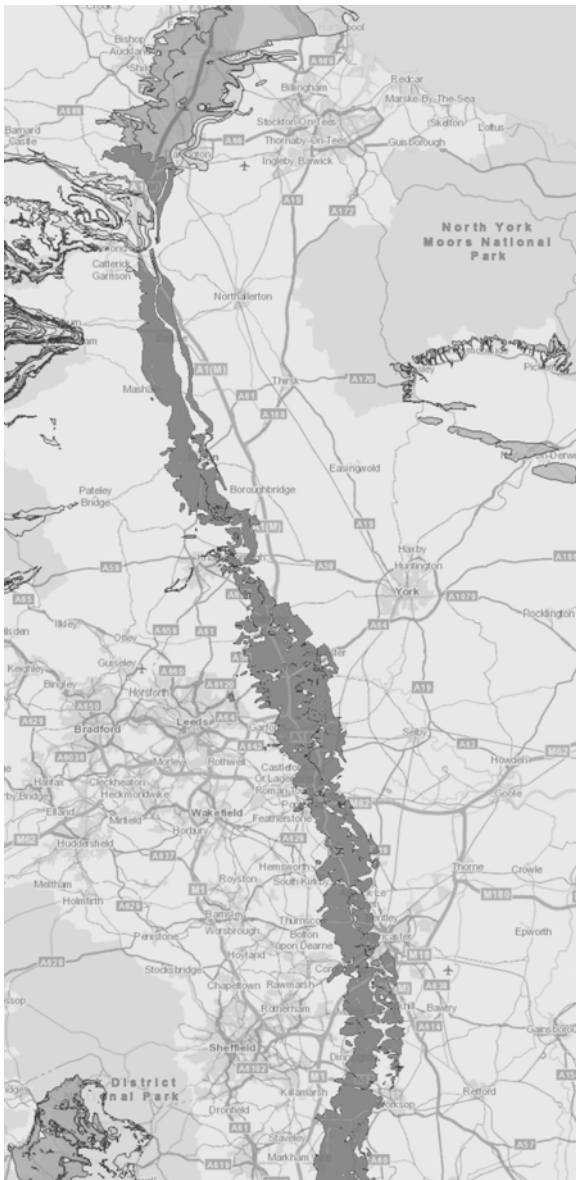
Figure 38 The Magnesian Limestone extends for 200 kilometres from Nottingham to Sunderland only a few roofs known today in an area from Mansfield to Doncaster - at Steetley, Barlborough and Whitwell.

The Magnesian Limestone extends for 200 kilometres from Nottingham to Sunderland (Figure 38). There are historical records that indicate it may have been a significant stone slate in the past but there are only a few roofs known today in an area from Mansfield to Doncaster - at Steetley, Barlborough and Whitwell. Excavations at Dale Abbey (1162) in Erewash, Derbyshire discovered Magnesian limestone roofing along with Swithland slates.

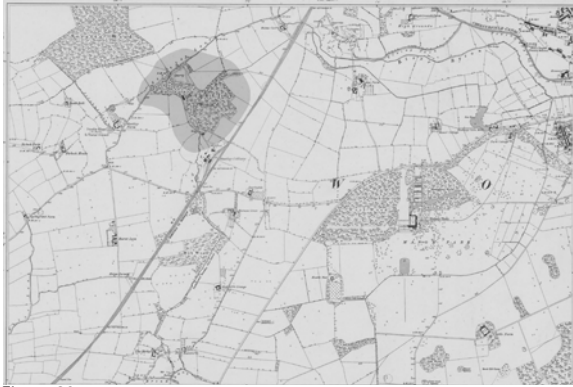
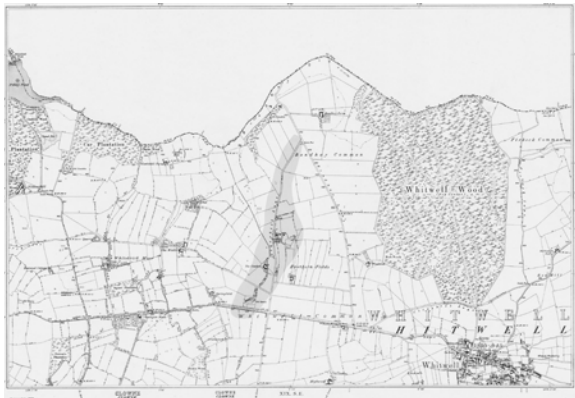
Figures 39 & 40

Magesian limestone was quarried for roofing at Steetley on Bakestone Moor and in at least one of the many small quarries around Gypsy (Gypsyhill) Lane in Whitwell.

Quarrying for roofing is recorded at Steetley (Figure 39), Bakestone Moor; in at least one of the many small quarries around Gypsy (Gypsyhill) Lane in Whitwell (Figure 40) and possibly at a quarry near Gildingwells, Worksop. It was found in near surface workings in thicknesses suitable for roofing. Although there are many quarries working the stone for aggregates and several could potentially have fissile stone in their surface levels there are no active sources of stone slates at present (2018). Currently the most appropriate stone for repairs would be from one of the Cotswold or Wiltshire limestone quarries.

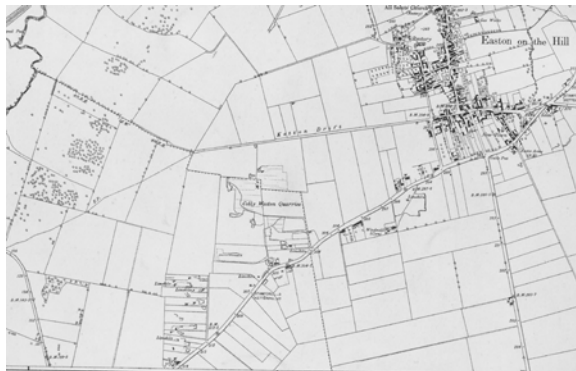
Figure 41

Once the easily accessed Collyweston slate outcrop was exhausted the rock had to be extracted from open quarries and ultimately, as the depth of overburden increased, from mines as here at Collyweston village.

There is documentary evidence of the production of Collyweston slates for Cambridge Castle in 1286 and by the fourteenth century production was well established with records of 14,000 slates being supplied to Rockingham Castle in 1375 and 5,000 to Oakham Castle in 1383.<sup>11</sup> The earliest production would have been along the outcrop at the side of the Welland valley to the west of Collyweston and Easton on the Hill (Figure 41). However, once the easily accessed outcrop was exhausted the rock had to be extracted from open quarries and ultimately, as the depth of overburden increased, from mines (Figure 42). Mining continued until about the mid twentieth century.

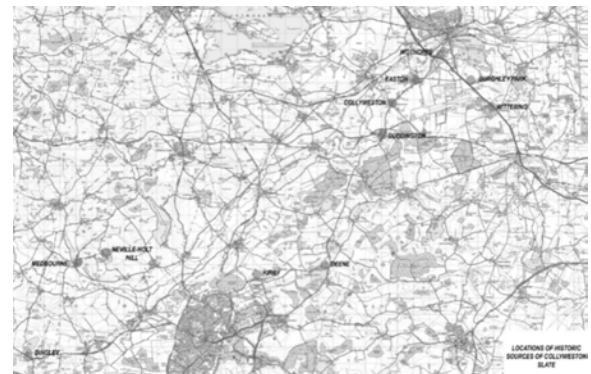
Figure 43

Once the easily accessed Collyweston slate outcrop was exhausted the rock had to be extracted from open quarries and ultimately, as the depth of overburden increased, from mines as here at Collyweston village.

many mines, the productive beds occur intermittently south-westward from Wothorpe, Burghley Park and Wittering through Collyweston and Duddington to Deene Park and Kirby Hall near Corby (Figure 43).<sup>12</sup>

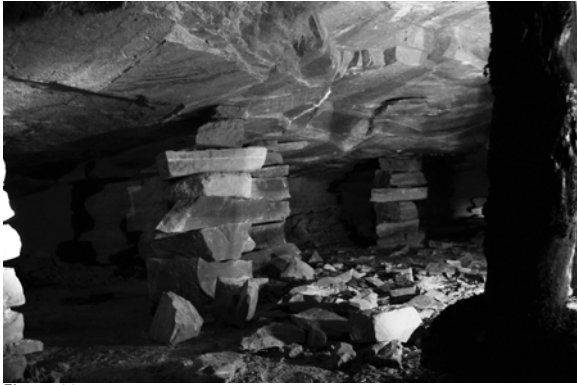
Figure 44  
Historically Collyweston log mined by extracting the sand from below and propping the roof using a pick and the roof on temporary pillars until an area about 12 or 15 feet deep had been cleared. The pillars were then removed and the log allowed to fall.  
Terry Hughes

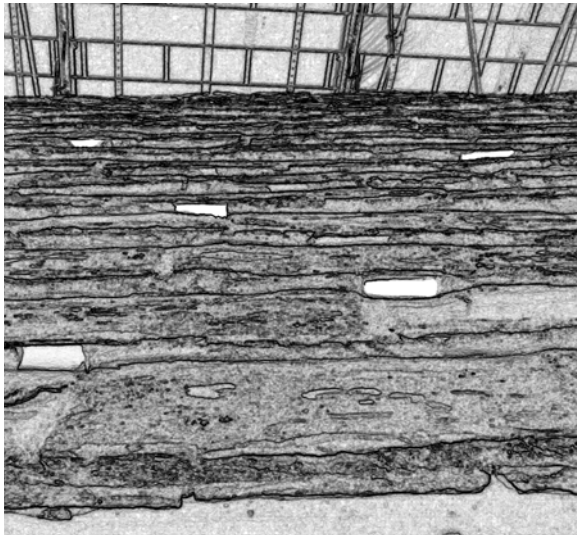
Figure 45  
Fully bedded Collyweston slating is effectively sealed and cannot readily ventilate moisture from inside the roof. If ventilation is necessary small gaps can be left in the bedding. This also works as access for small bats.  
Terry Hughes

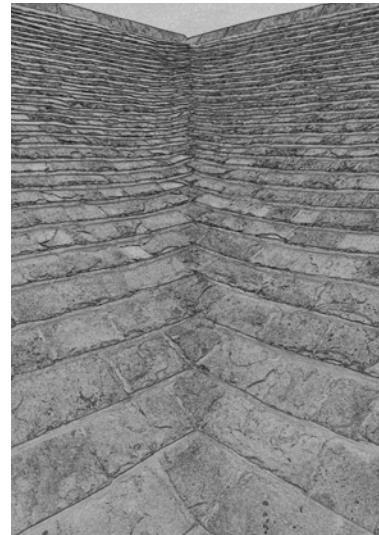
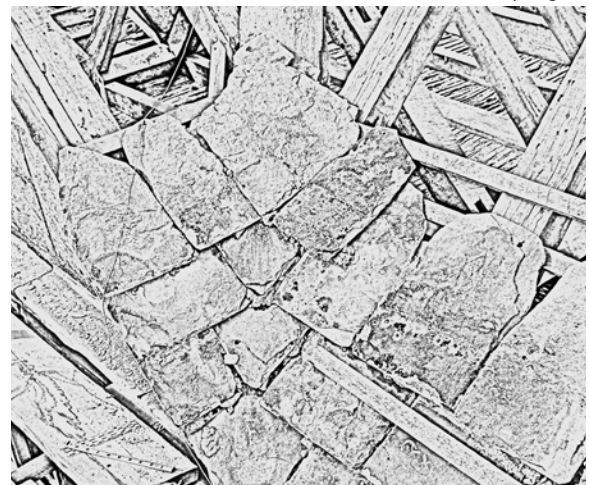
Figure 48  
Collyweston valleys are always laced by laying a roughly square slates diagonally up the valley and turning the adjacent slates on each to butt up against them.  
Terry Hughes

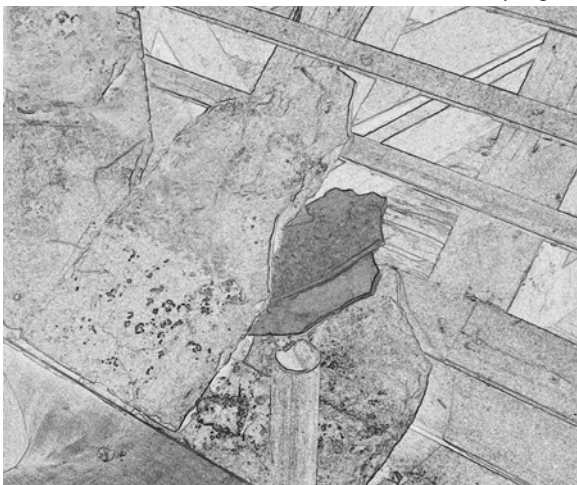
Figure 46  
Shales or shadows are bedded in a small amount of mortar as the slates are laid to support their span from tail to head.  
Terry Hughes

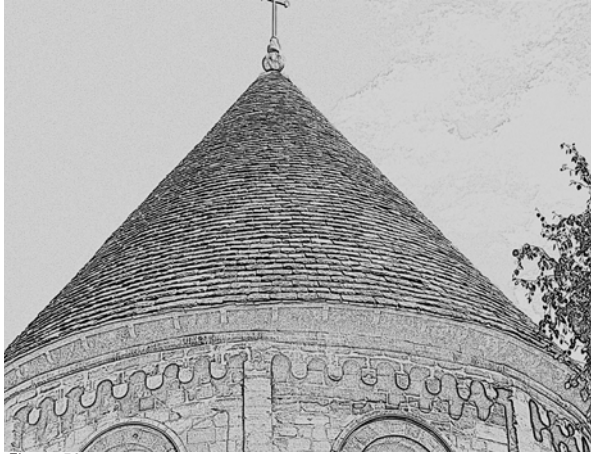
Figure 50  
There are successful examples of curved Collyweston slating but they are uncommon.

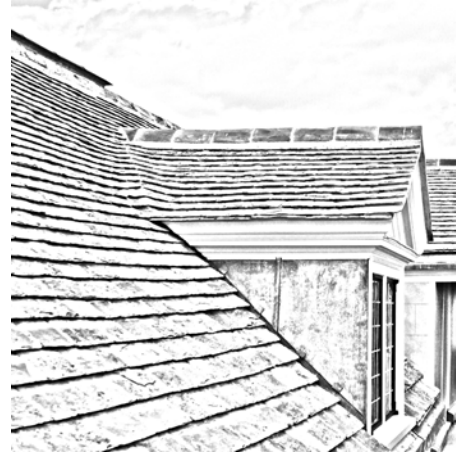
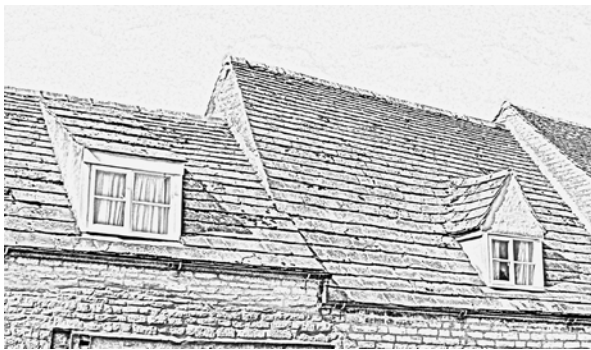
Figure 53  
Dormer windows are common in Collyweston roofs and the full range of types - monopitch, gabled and hipped are common positioned below, breaking and above the eaves and in the roof slope.

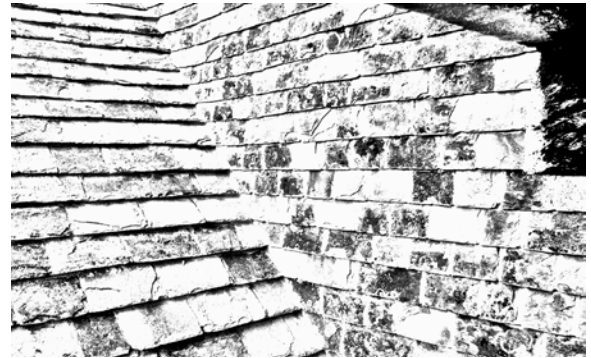
Figure 54  
Wall cladding is uncommon with Collyweston slates - mainly seen on dormer cheeks. Where it is applied it is good practice to match the coursing it with the adjacent slope.

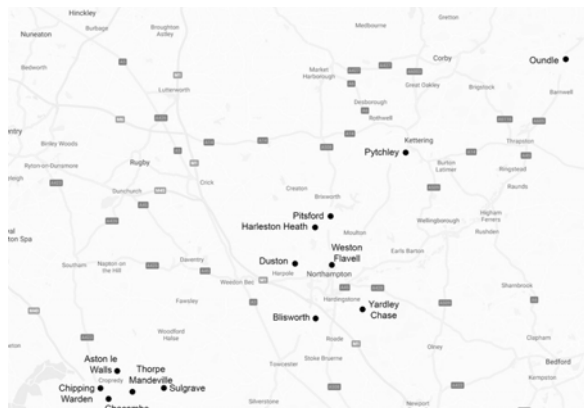
Figure 52  
Limestones were formerly mined and quarried for roofing around Northampton. Notably at Duston and New duston and in various geological formations from Oundle to Chacombe near Banbury.

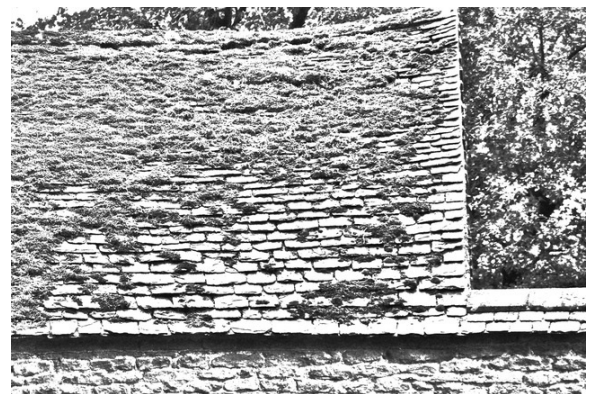
Figure 55  
The roofscape of the Northampton area is confused because it includes original local stone slates, Collywestons and various Cotswold types. Many are not easily distinguished from each other without petrological analysis.
