DAMP PROBLEMS IN BRICK WINDMILL TOWERS

MILLS SECTION

Vincent G. Pargeter

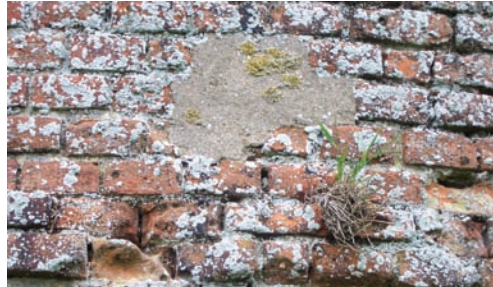
Untreated brick surface outside showing worn bricks, degraded pointing and crude cement repair. Vegetation starting to grow.

Conventional brickwork repairs, such as re-pointing and renewing damaged facing bricks should be tried first on a leaky tower. Matching bricks of a similar hardness and nature to the existing ones should be laid in a suitable lime mortar. Where the original pointing is defective, joints should be carefully raked out to a depth in excess of the joint width, and re-pointed flush with lime mortar. The original mortar should be analysed, and a mix of similar hardness and composition created.

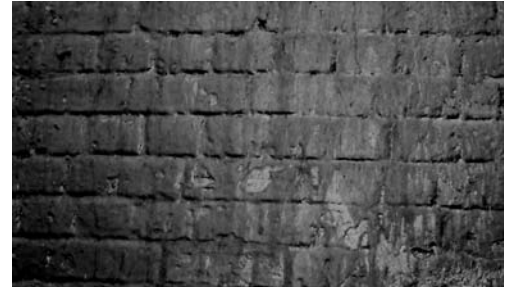
Tarred surface outside, in good condition.

Often, millers tried to solve damp problems by tarring the towers, and this is why so many towers are tarred today. The tar was actually a mixture of pitch and coal tar in appropriate proportions to make the coating flexible, but not too runny. The mixture would, very gradually, flow down the tower in hot weather becoming thinner at the top and remaining thick at the bottom. Tarring cured most of the problem by keeping the rain out, but the tar had to be maintained by applying it regularly, say every four years or so. If the tarring was not kept up, the tar could worsen the problem. This is because water got in where the tar had broken down, but as most of the tower would still be coated with tar, the water would not be able

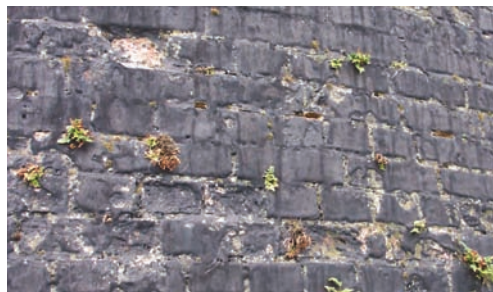
Broken-down tarred surface outside. Bricks spalling and vegetation starting to grow.

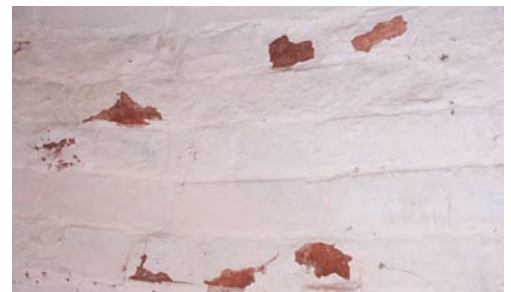
Limewashed surface inside showing effects of incipient damp penetration.
